Evaluation of Fish Passage Remediation Methods Used in Tasman District's Freshwater Improvement Fund Programme

Prepared for:
Tasman District Council

Prepared by:
Tim Olley¹, Ricky Olley¹ and Robin Holmes²
¹Olleycology Limited
²Cawthron Institute

28th March 2024

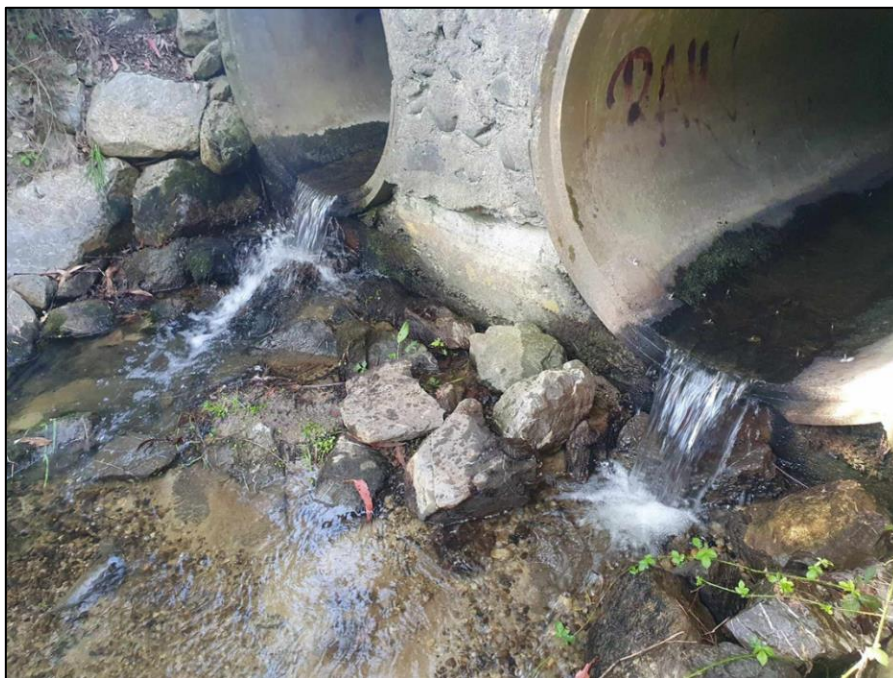
At the start of the first fish passage remediation evaluation, on the 26th of September 2023, both culverts were undercut by 0.05m, with fall heights of 0.38 m on the true right culvert and 0.4m on the true left. Both culverts had a concrete headwall that extended below the invert into the streambed that was being constantly wetted from the “splash zone”. Under base flow conditions, the average water velocity within the culverts was 0.8m/s (true left pipe) and 0.7m/s (true right pipe). Flow rates were 4.2L/sec and 6.9L/sec through the true left and right pipes, respectively.

Figure 10. Perched culverts at Williams Creek in September 2023 (prior to any remediation for fish passage).

With reference to the Fish Passage Remediation Training Aid 2022 (Olley et al 2022), culvert remediation involved installing a total of seven flexible baffles that were secured within each of the culvert pipes. All fourteen baffles used were 450 mm wide and 100 mm high. Baffles were spaced at 2.4m intervals where culvert gradients were 0-1%, and 1.2m intervals where gradients were between 1-2%. The most downstream baffle was a V-baffle.

A flexible fish ramp, made of reinforced PVC rubber, was installed at the outlet of both pipes (Figure 11). Both ramps were 900mm wide by 1500mm long. The ramp included a central bundle of four strands of looped mussel-rope fixed to the ramp invert.

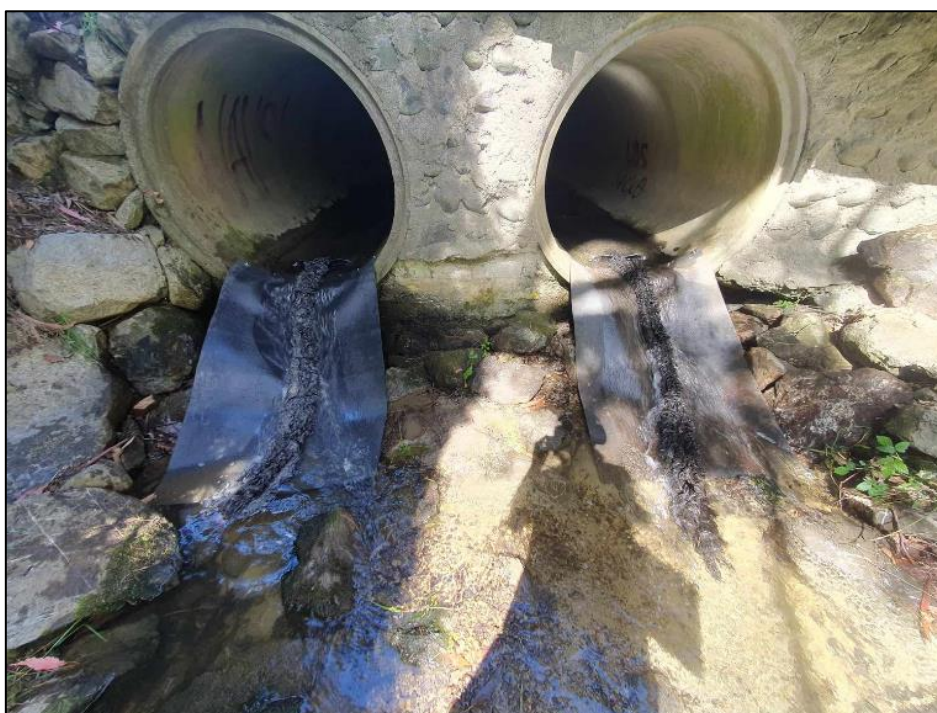
Figure 11. The remediation at the Williams Creek culverts, showing two flexible rubber ramps with mussel-rope and V-baffles.

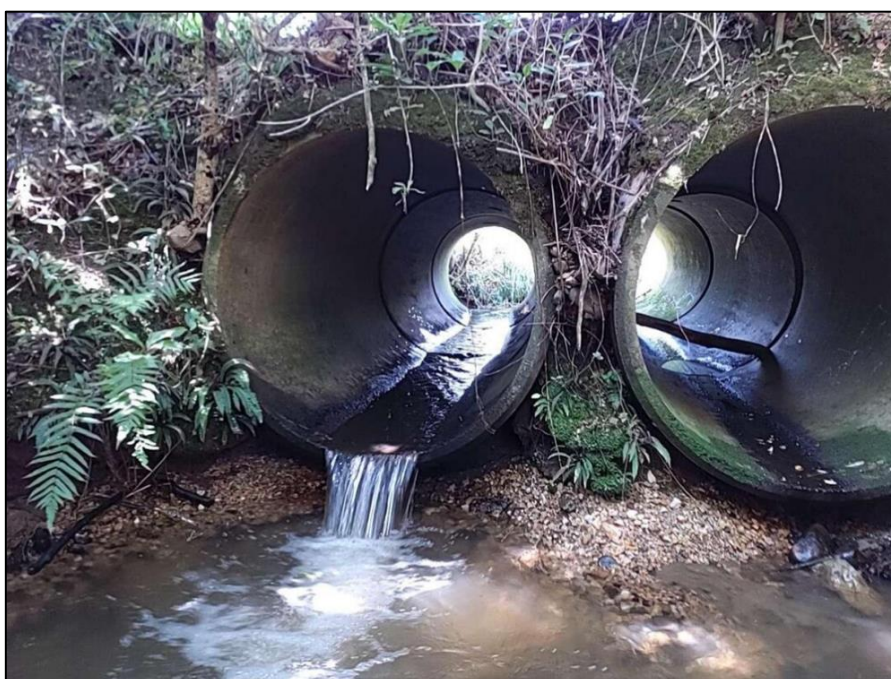
Mulligans Creek is a small tributary of the Otere River. Diadromous fish species with a predicted presence greater than 10% include īnanga, banded kōkopu, giant kōkopu, long and shortfin eels, common bully, redfin bully and giant bully (Leathwick 2008). Approximately 90m upstream of its confluence with the Otere River, Mulligans Creek is piped through dual culverts where it crosses a private driveway crossing (Figure 16). Both culverts are 1.2m diameter, 7.2m long. This crossing is located approximately one kilometre inland from the Onekaka estuary and it is the first barrier fish encounter when migrating up from the coast. The true right culvert receives most of the flow and was the focus for evaluating fish passage at the site. At the commencement of the evaluations at Mulligans Creek on the 4th of October 2023, the true right culvert was undercut approx. 0.42m, had a fall height of 0.26m, and internal gradients ranging from 1-3%. The average water velocity within the culvert was 1.8m/s, and the average flow rate was 12.8L/sec.

Figure 16. Perched culverts at Mulligans Creek (prior to any remediation for fish passage).

A flexible fish ramp, made of second-hand conveyor belt rubber, was installed at the outlet of true right pipe (Figure 17). The ramp was 900mm wide by 1400mm long. The ramp included a bundle of looped mussel-rope fixed to the ramp invert consisting of four strands of rope.

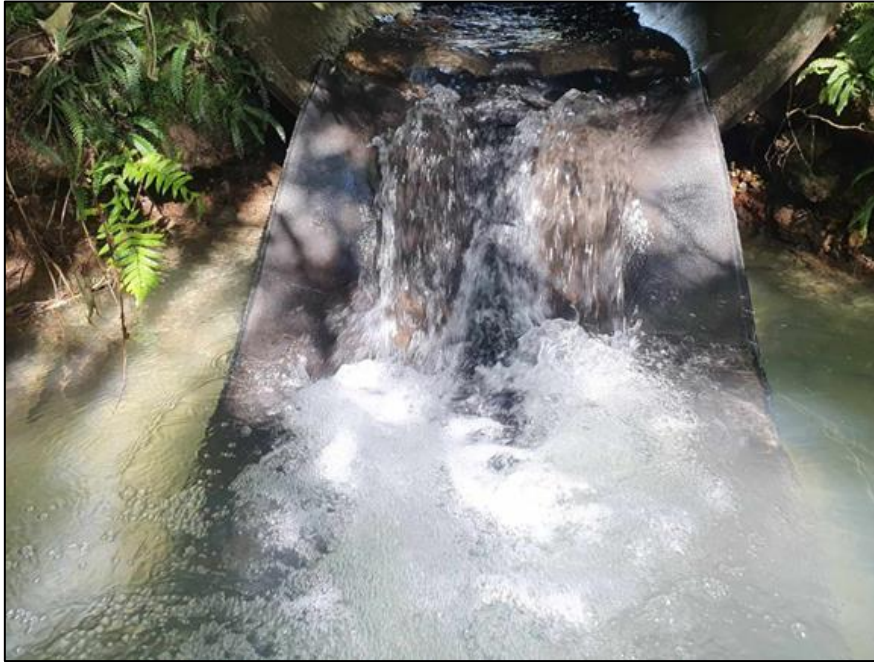
Figure 17. The remediation at Mulligans Creek on the true right culvert, showing a flexible rubber ramp with mussel-rope and a V-baffle.

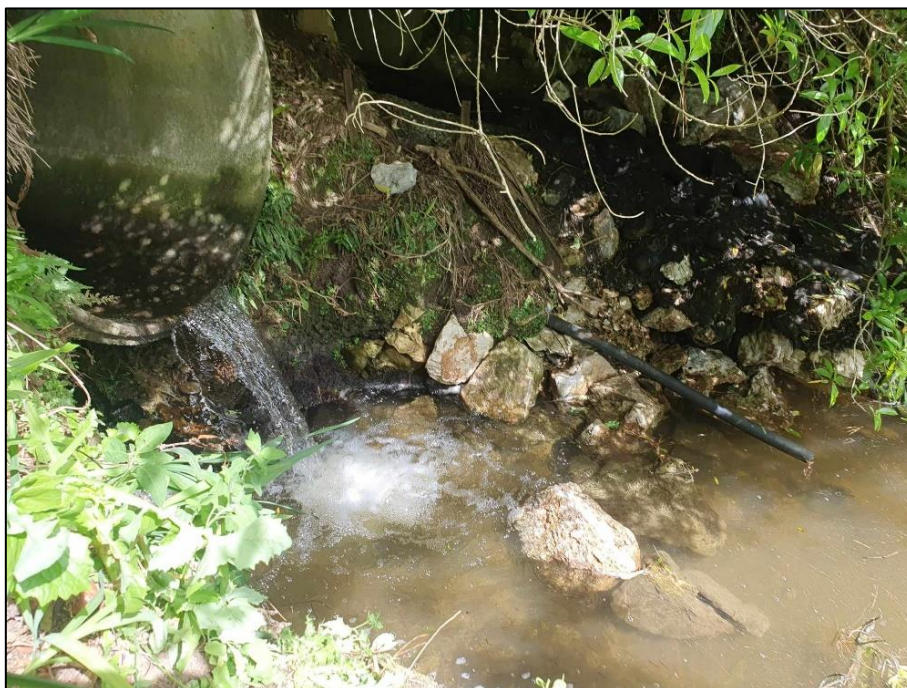
At the commencement of the evaluations at Shambhala Creek on the 2nd of October 2023, the true right culvert was undercut approx. 2.2m, had a fall height of 0.7m, internal gradients ranging from 1-6%. The average water velocity through the culvert was 1.3m/s, and the average flow rate was 8.5L/sec.

Figure 19. Perched true right culvert at Shambhala Creek (prior to any remediation for fish passage).

A flexible fish ramp, made of second-hand conveyor belt rubber, was installed at the outlet of true right pipe (Figure 20). The ramp was 900mm wide by 1800mm long. The ramp included a bundle of looped mussel-rope fixed to the ramp invert consisting of four strands of rope.

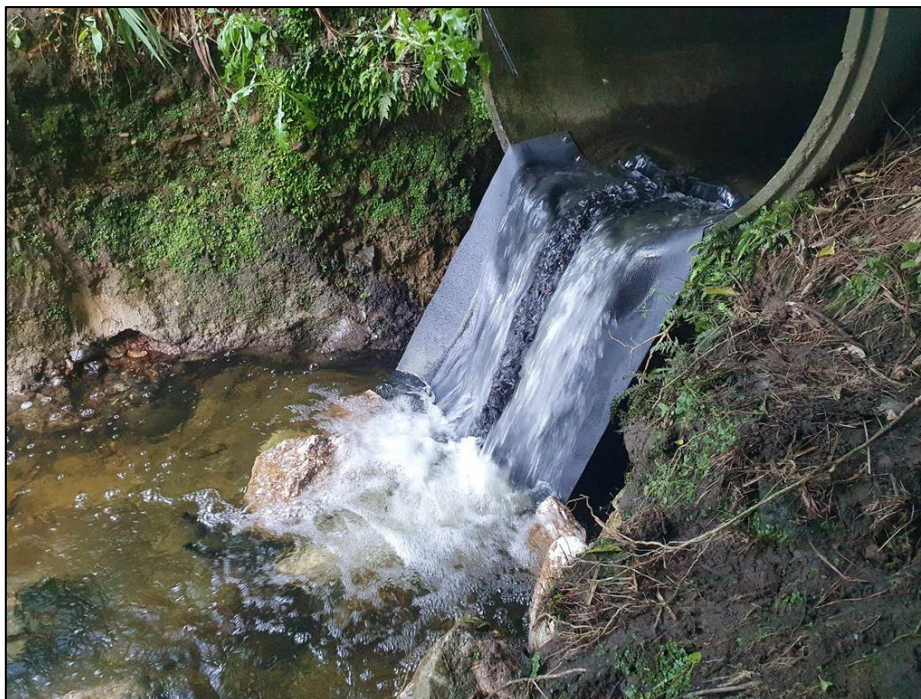
Figure 20. The remediation at Shambhala Creek on the true right culvert, showing a flexible rubber ramp with mussel-rope and a V-baffle.

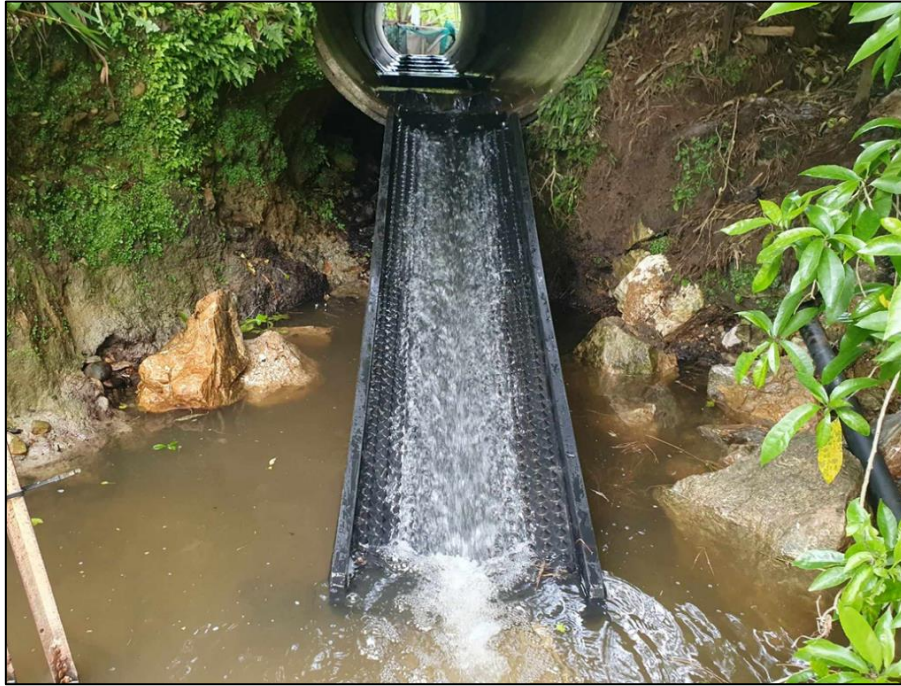
Figure 21. The remediation at Shambhala Creek on the true right culvert, including a floating fish ramp and flexible baffles.

The remediation with a flexible ramp and baffles created improved passage for YOY banded kōkopu and shortfin eel elvers and the remediation with a floating ramp and baffles created improved passage for banded kōkopu, but without a downstream trap in place during the evaluation period it is difficult to assess the degree of improvement, or whether the lack of shortfin eel elvers using the floating ramp remediation represents a failure of this method for this species.

A plastic floating fish ramp was installed at the outlet of the true right-hand culvert (Figure 21). The ramp was 540mm wide, 2400mm long and lay at a 17 degree angle. The ramp had Miradrain® attached to its top surface. Note that the NZ Fish Passage Guidelines (Franklin et al 2018) suggests that these ramps are installed at 15 degrees or less, so the floating ramp installation at Shambhala Creek represents the upper limit for its recommended use as per the guidance.

All flexible baffles that were installed as part of Remediation 1 remained in place within the true right hand culvert barrel. The V-baffle at the outlet was replaced with a regular flexible baffle.
