Groundwater Monitoring Review Following Soil Remediation at the Mapua FCC Site

✦ Prepared for
Tasman District Council

✦ March 2011

JOB REFERENCE CJ41604

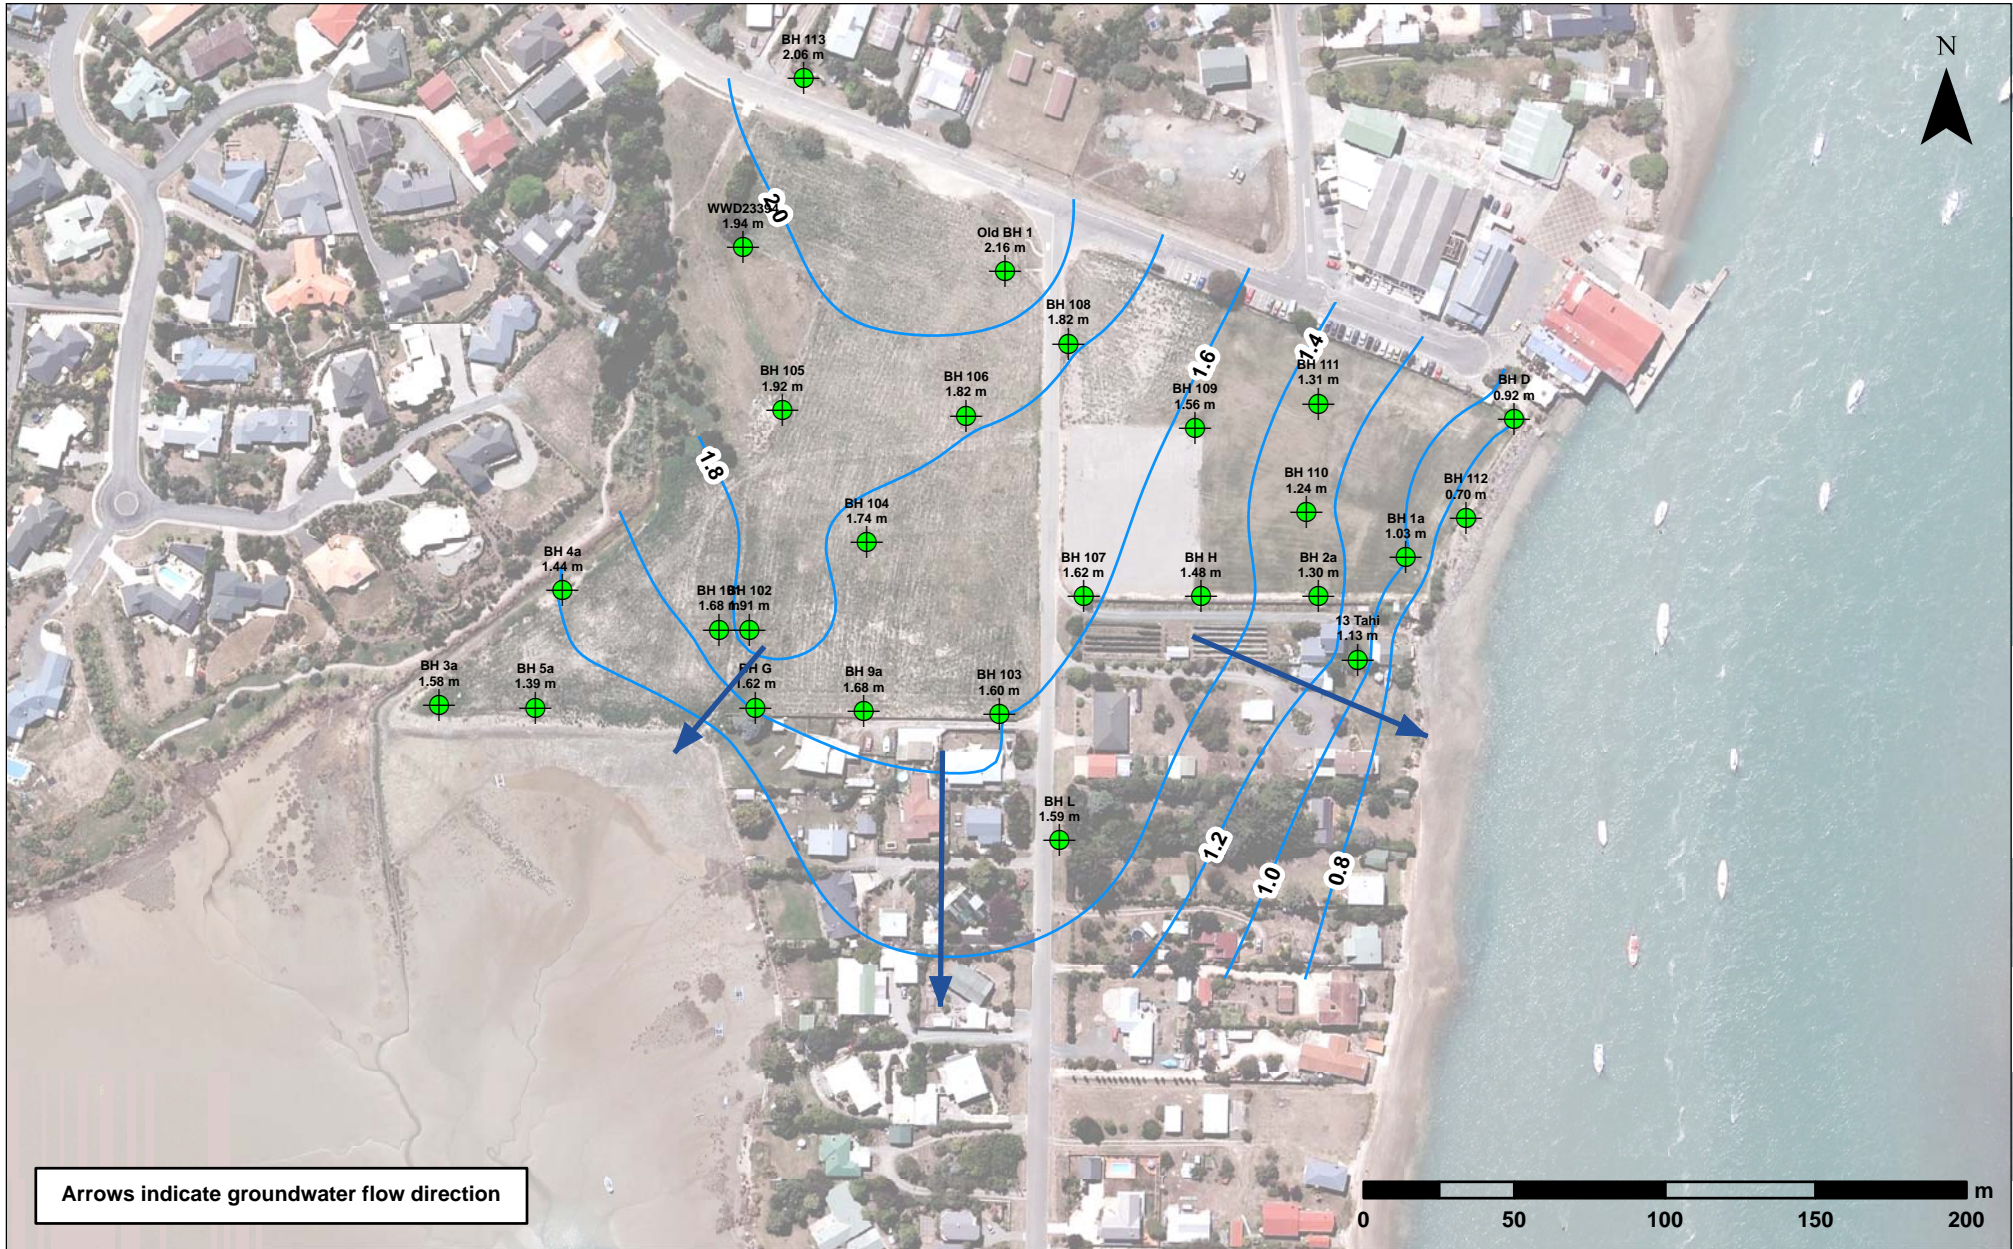
Figure 5a : Piezometric contours at times of low groundwater levels (early May 2010)

- groundwater enters the site from throughflow from the land to the north of Aranui Road, as well as from the direct infiltration of rainwater from within the site soils;
- groundwater moves through the site and exits it to the following locations:
 - to the Mapua channel to the east;
 - to the western site drain and the Waimea Inlet to the south-west;
 - a small proportion of the site contributes to groundwater flow across the southern boundary of the site, which moves towards the west and eastern coastal margins of the Mapua peninsula.

The water table has a relatively flat hydraulic gradient across the northern inland part of the site (i.e. the northern section of the site adjacent to and west of Tahī Street) at around $2-3 \times 10^{-3}$. Towards the coastal discharge sections of the site, the hydraulic gradient steepens considerably to values of around 2×10^{-2} under low water level conditions (Figure 5a) and 5×10^{-2} at times of high groundwater levels (Figure 5b).

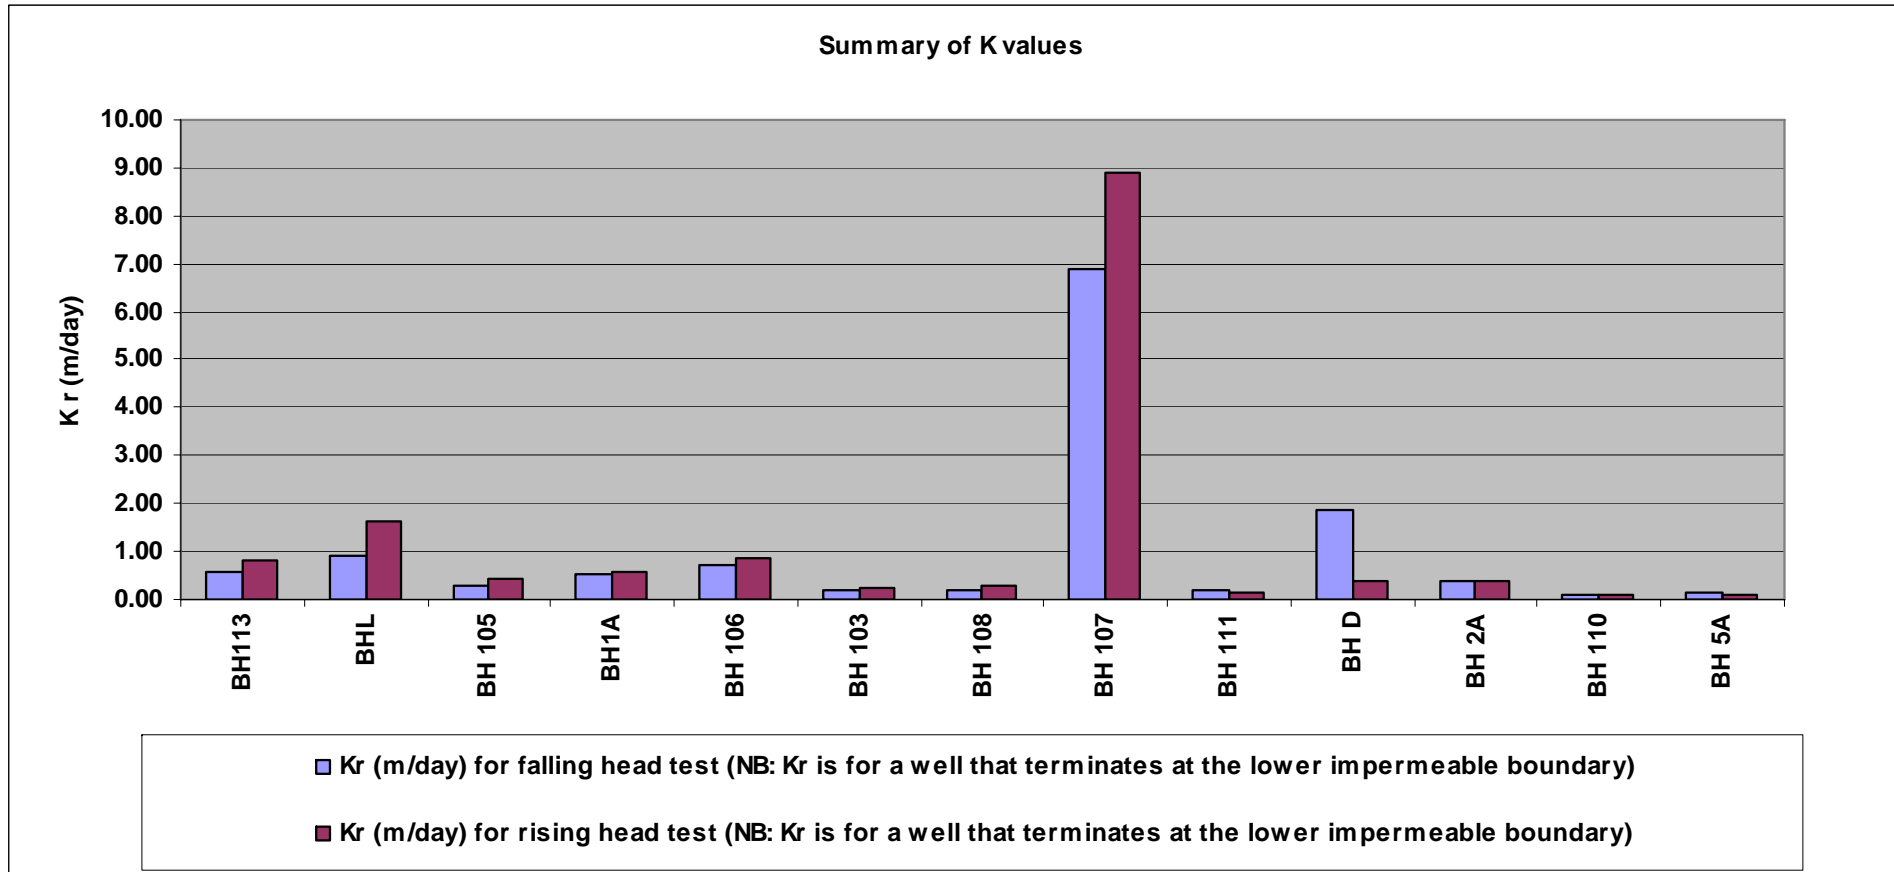
Figure 7: Summary of Hydraulic Conductivity Values from Slug Tests

The highest hydraulic conductivity of 6-9 m/day in BH107 may be attributed to the occurrence of a nearby permeable rubble filled zone of backfill in the area and a notable loss of drilling circulation water at a depth of 1.8 m. Other monitoring bores have lower and more consistent hydraulic conductivities in the range from 0.08-1.9 m/day with a geometric mean of 0.35 m/day.

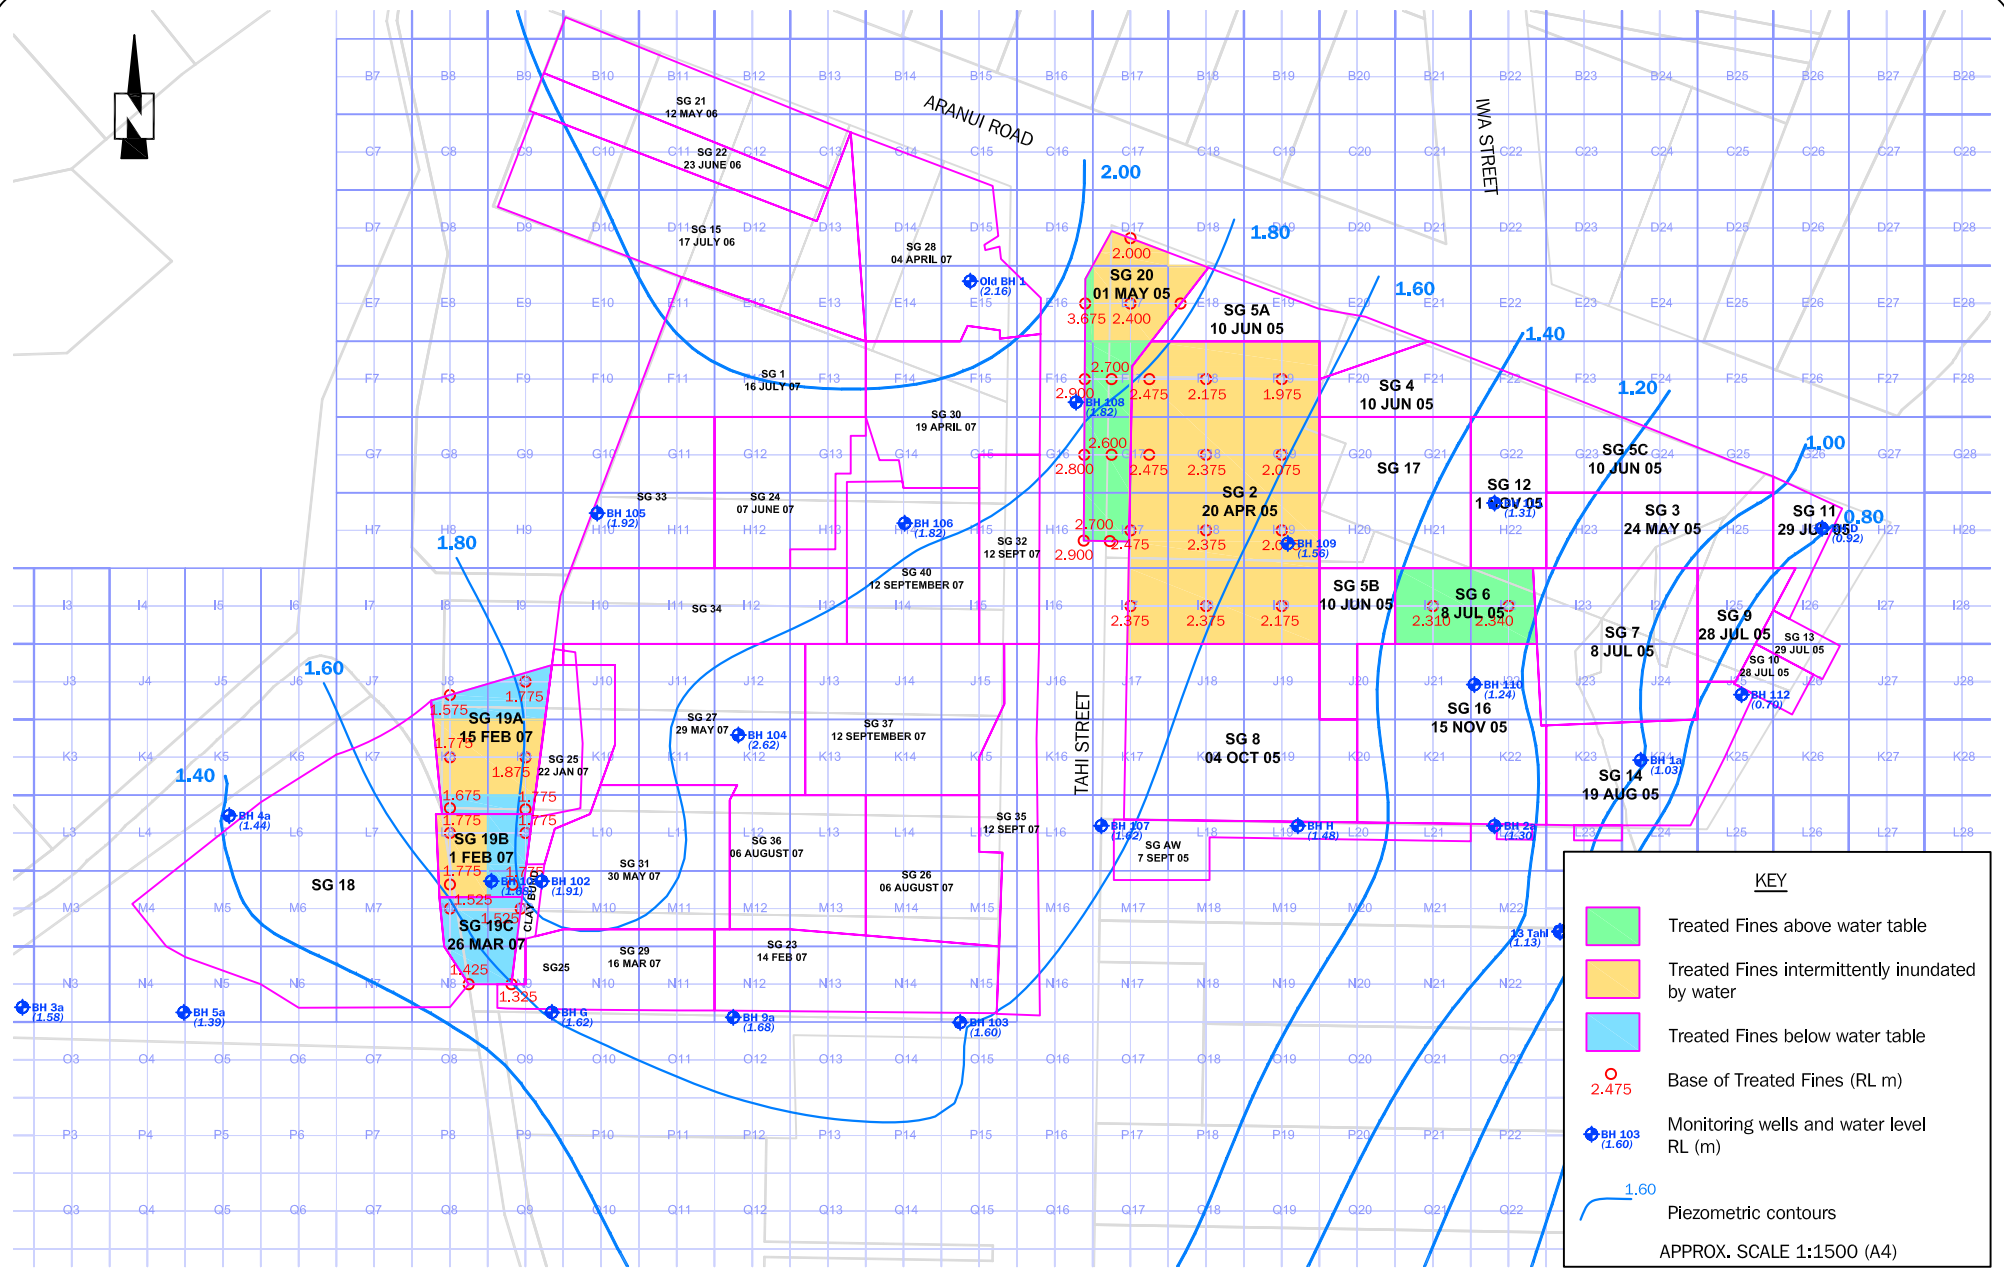
Figure 9 : POSITION OF TREATED FINES (UNMIXED WITH OTHER MATERIALS) RELATIVE TO THE WATER TABLE

Figure 9 shows the position of the Treated Fines cells with no mixing from other site materials. This is the most concentrated source of contaminants, as shown in Table 3. Figure 9 indicates that to the east of Tahi Street these materials mostly occur above the lowest water table location, but are present in some locations at elevations where they can be inundated by the water table. They also occur in a small area of the western site, where they are often inundated by groundwater.

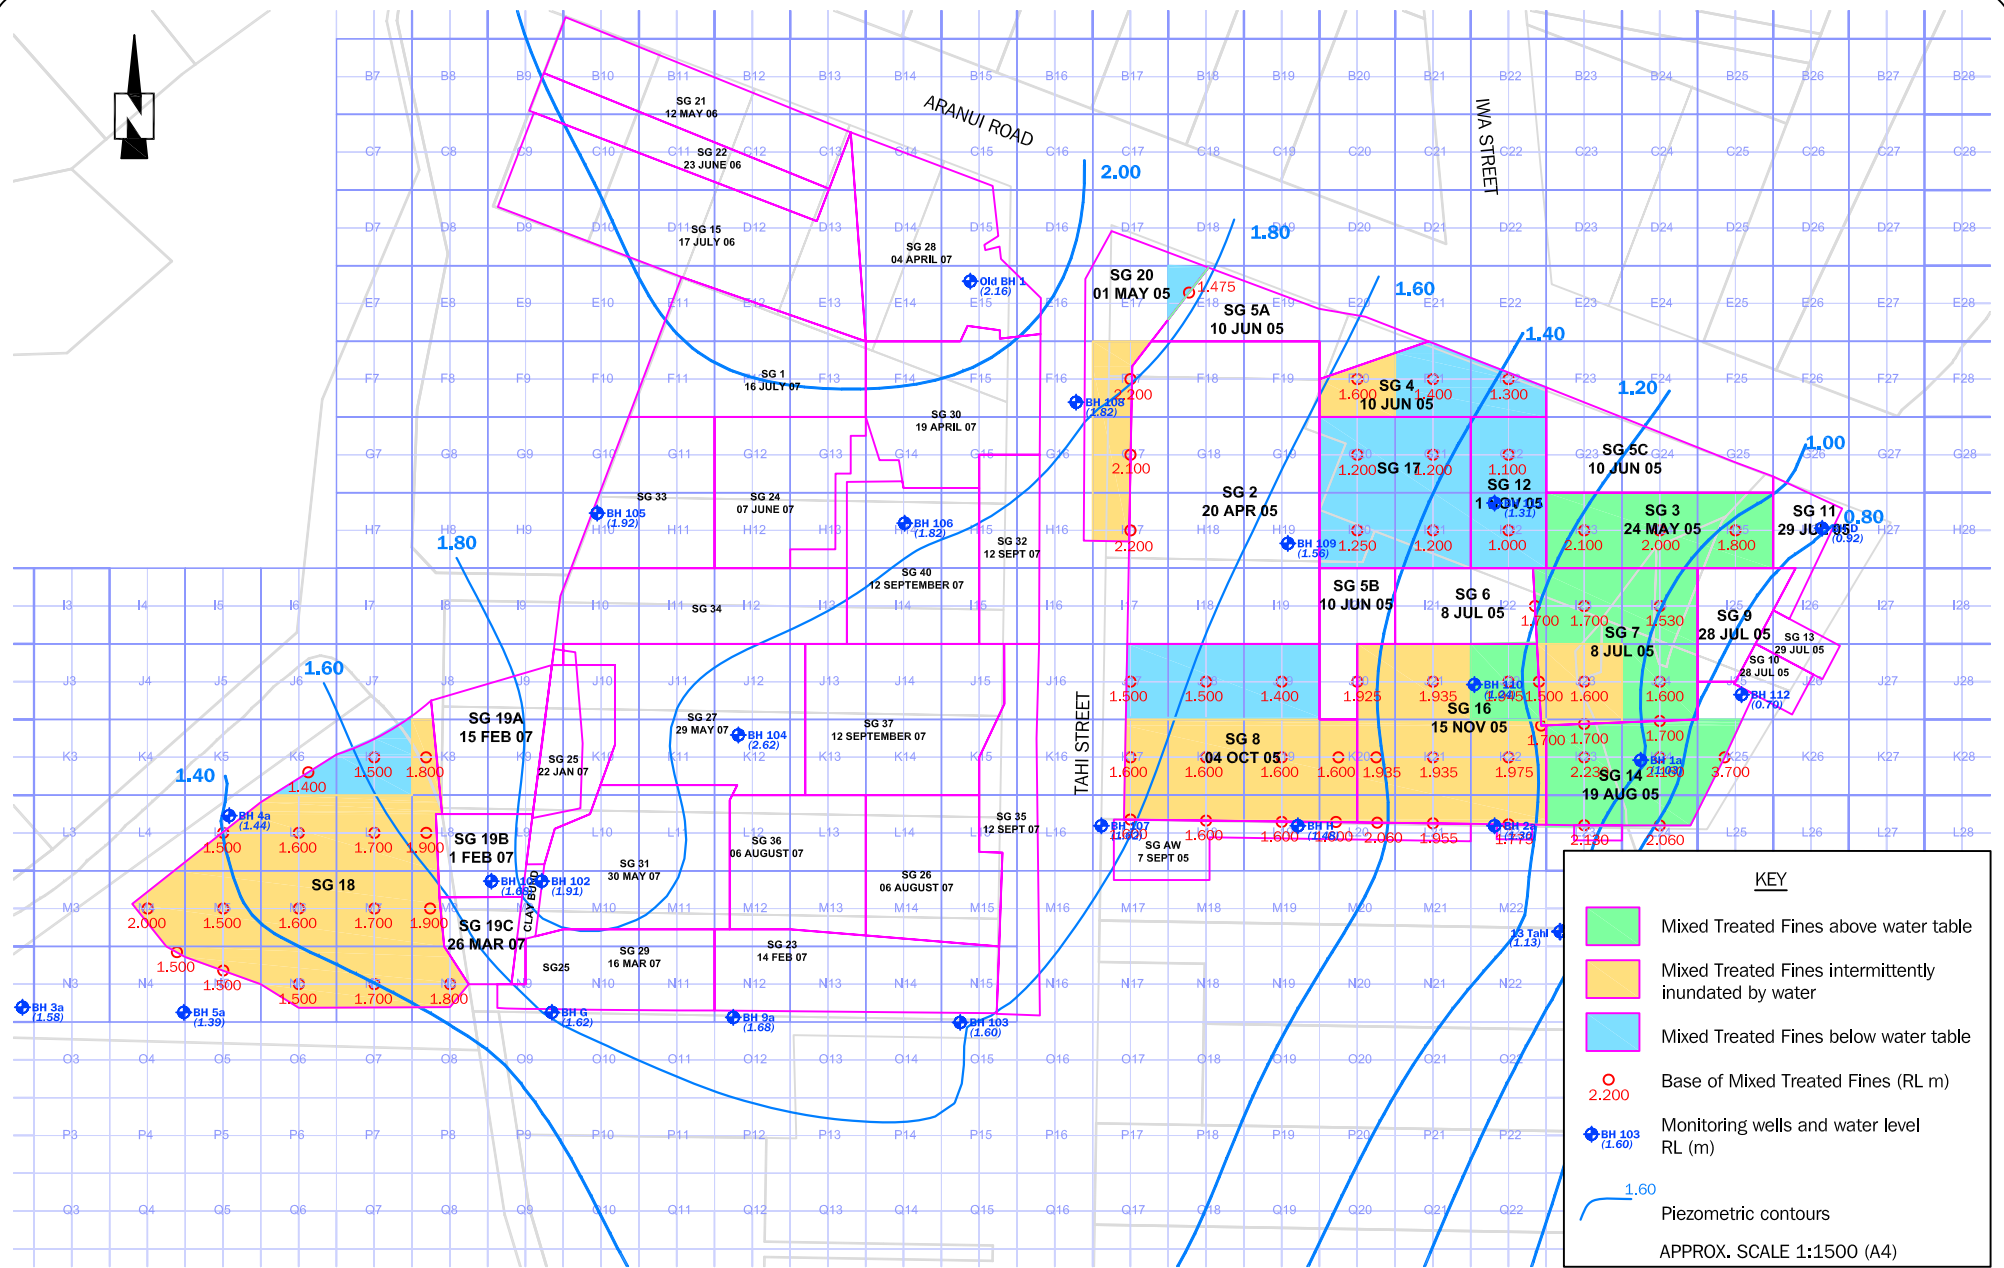
Figure 10 : POSITION OF TREATED FINES (MIXED WITH OTHER MATERIALS) RELATIVE TO THE WATER TABLE

Figure 10 shows the placement of Treated Fines materials which are mixed with other site materials (oversize, commercial or foreshore sediments). As shown in Table 3, this mixing reduces the overall contaminant concentration. Figure 10 indicates that these Treated Fines mixtures represent a larger volume that occurs below the water table or at a depth where they can be inundated by the water table from time to time, particularly in the eastern part of the site, but not the soils closest to the Mapua Channel.

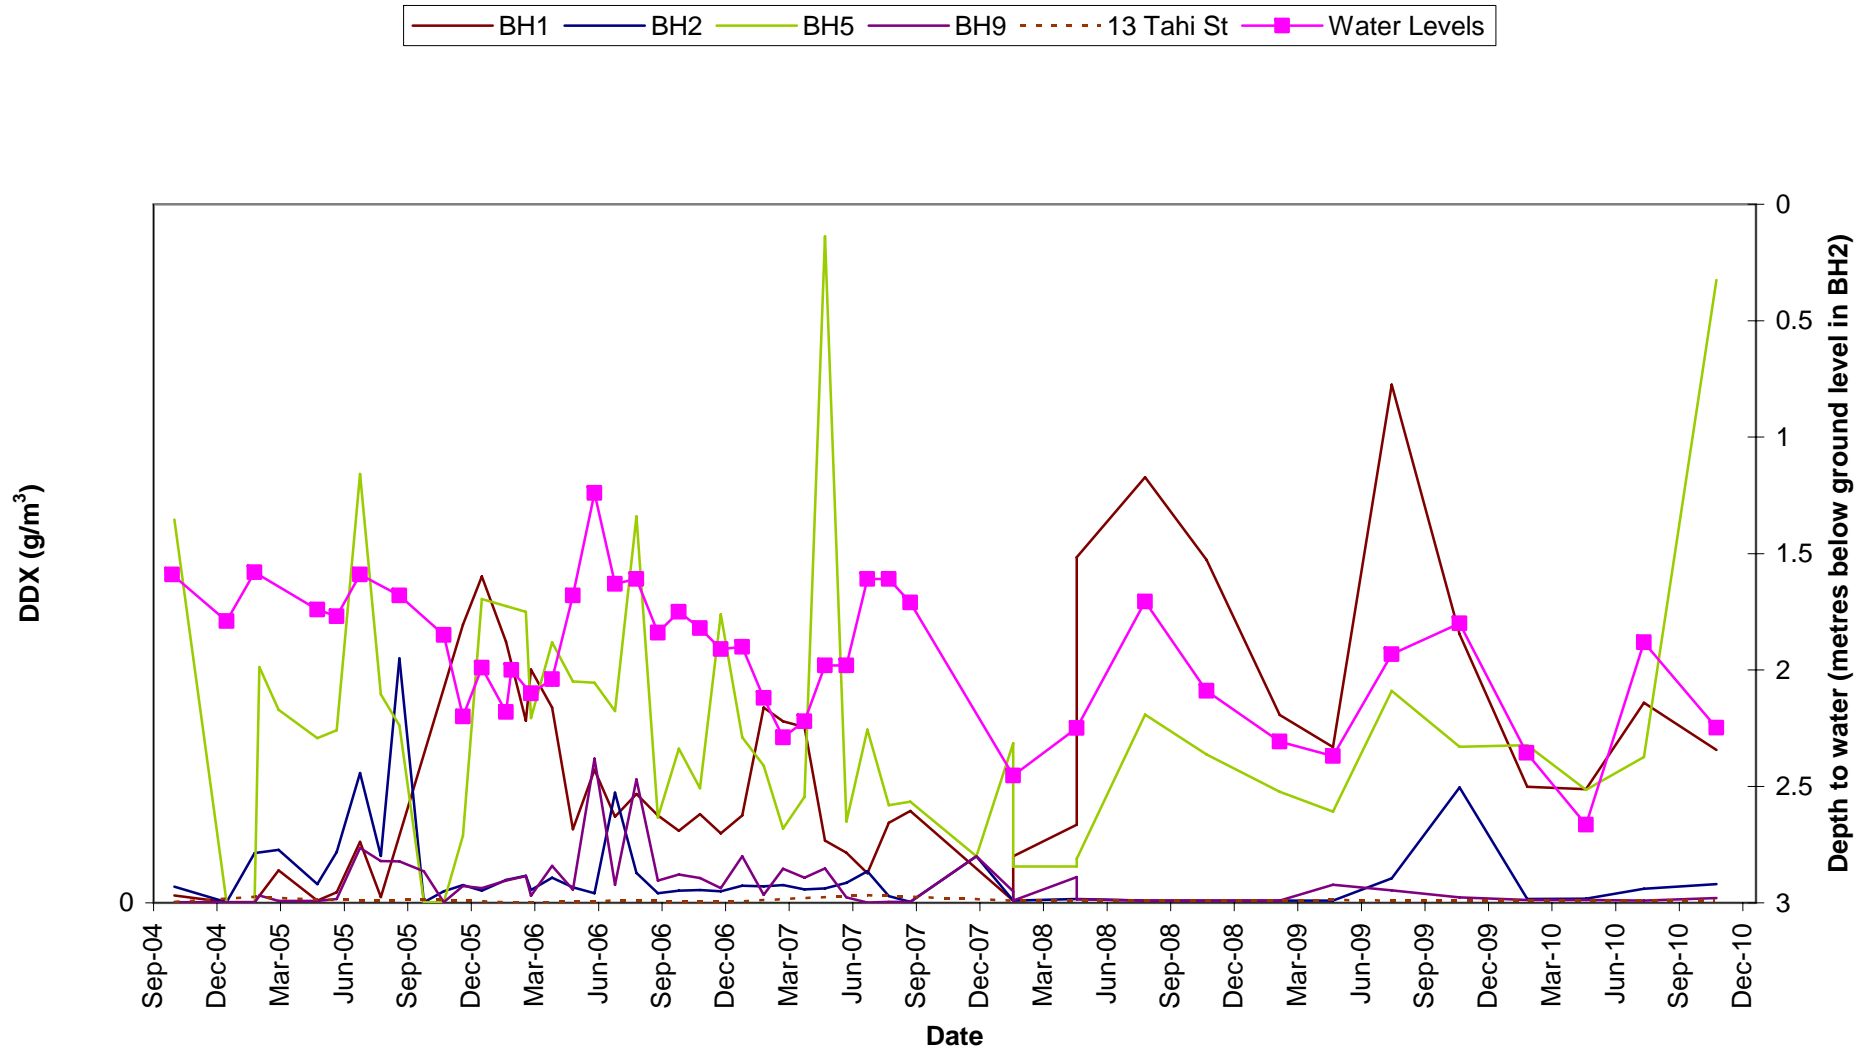
Figure 20: DDX (g/m3)

Figure 20 shows the variation in groundwater levels and DDX, indicating that following the completion of the MCD treatment process (mid-2007), higher concentrations occur at times of higher groundwater levels, which is most likely due to a greater degree of leaching by infiltrating rainwater and a greater volume of Treated Fines and commercial grade soils inundated below the water table.

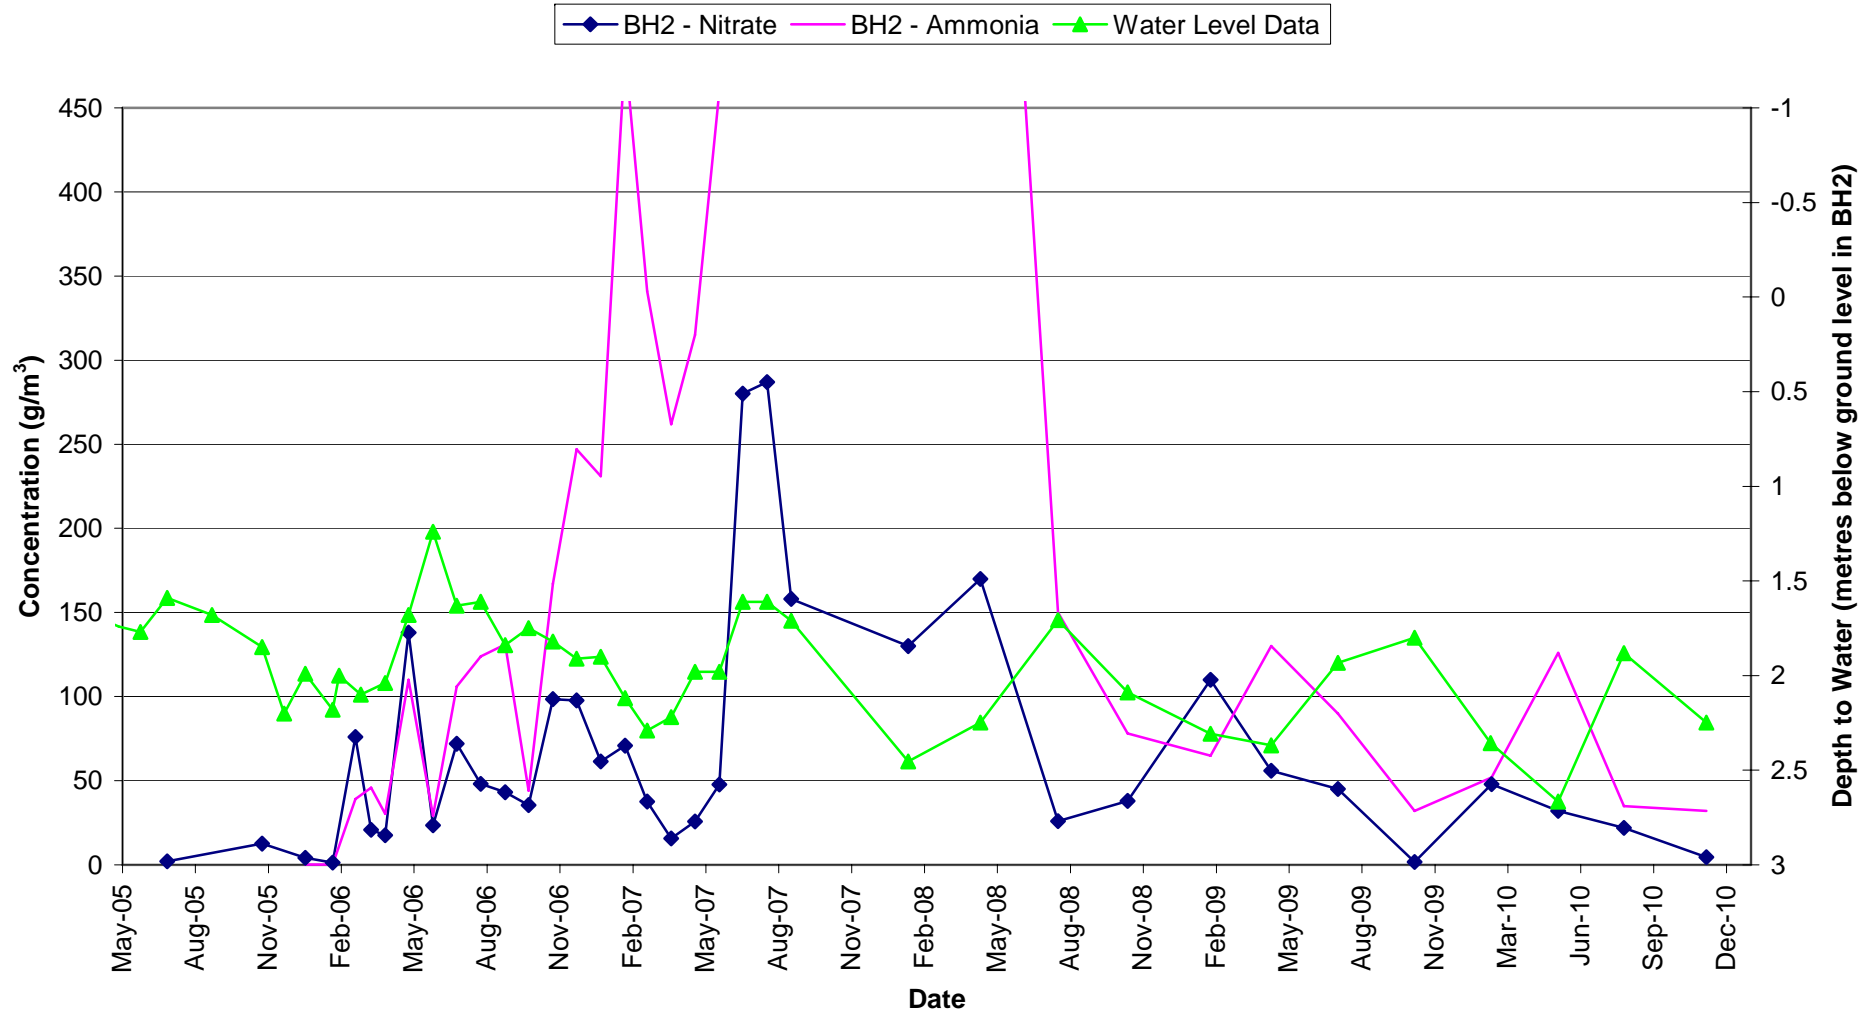
Figure 21: Nitrogen Concentrations in BH2

In contrast, Figure 21 suggests that in the post-remediation period, higher concentrations of ammonia occur at times of lower groundwater levels. It is assumed that these different patterns relate to the differing factors affecting the inputs of leachate from the affected soils and the diluting effect of throughflow that has not passed through the contaminants. In particular, the nitrogen species are more readily leached into the groundwater and at times of low water levels, those chemicals present in the groundwater will be more concentrated. Furthermore, redox conditions are more likely to favour the occurrence of nitrogen in ammoniacal form. DDX compounds are likely to preferentially adsorb onto the soil particles and so will be most prevalent in groundwater during the most active conditions of water throughflow.

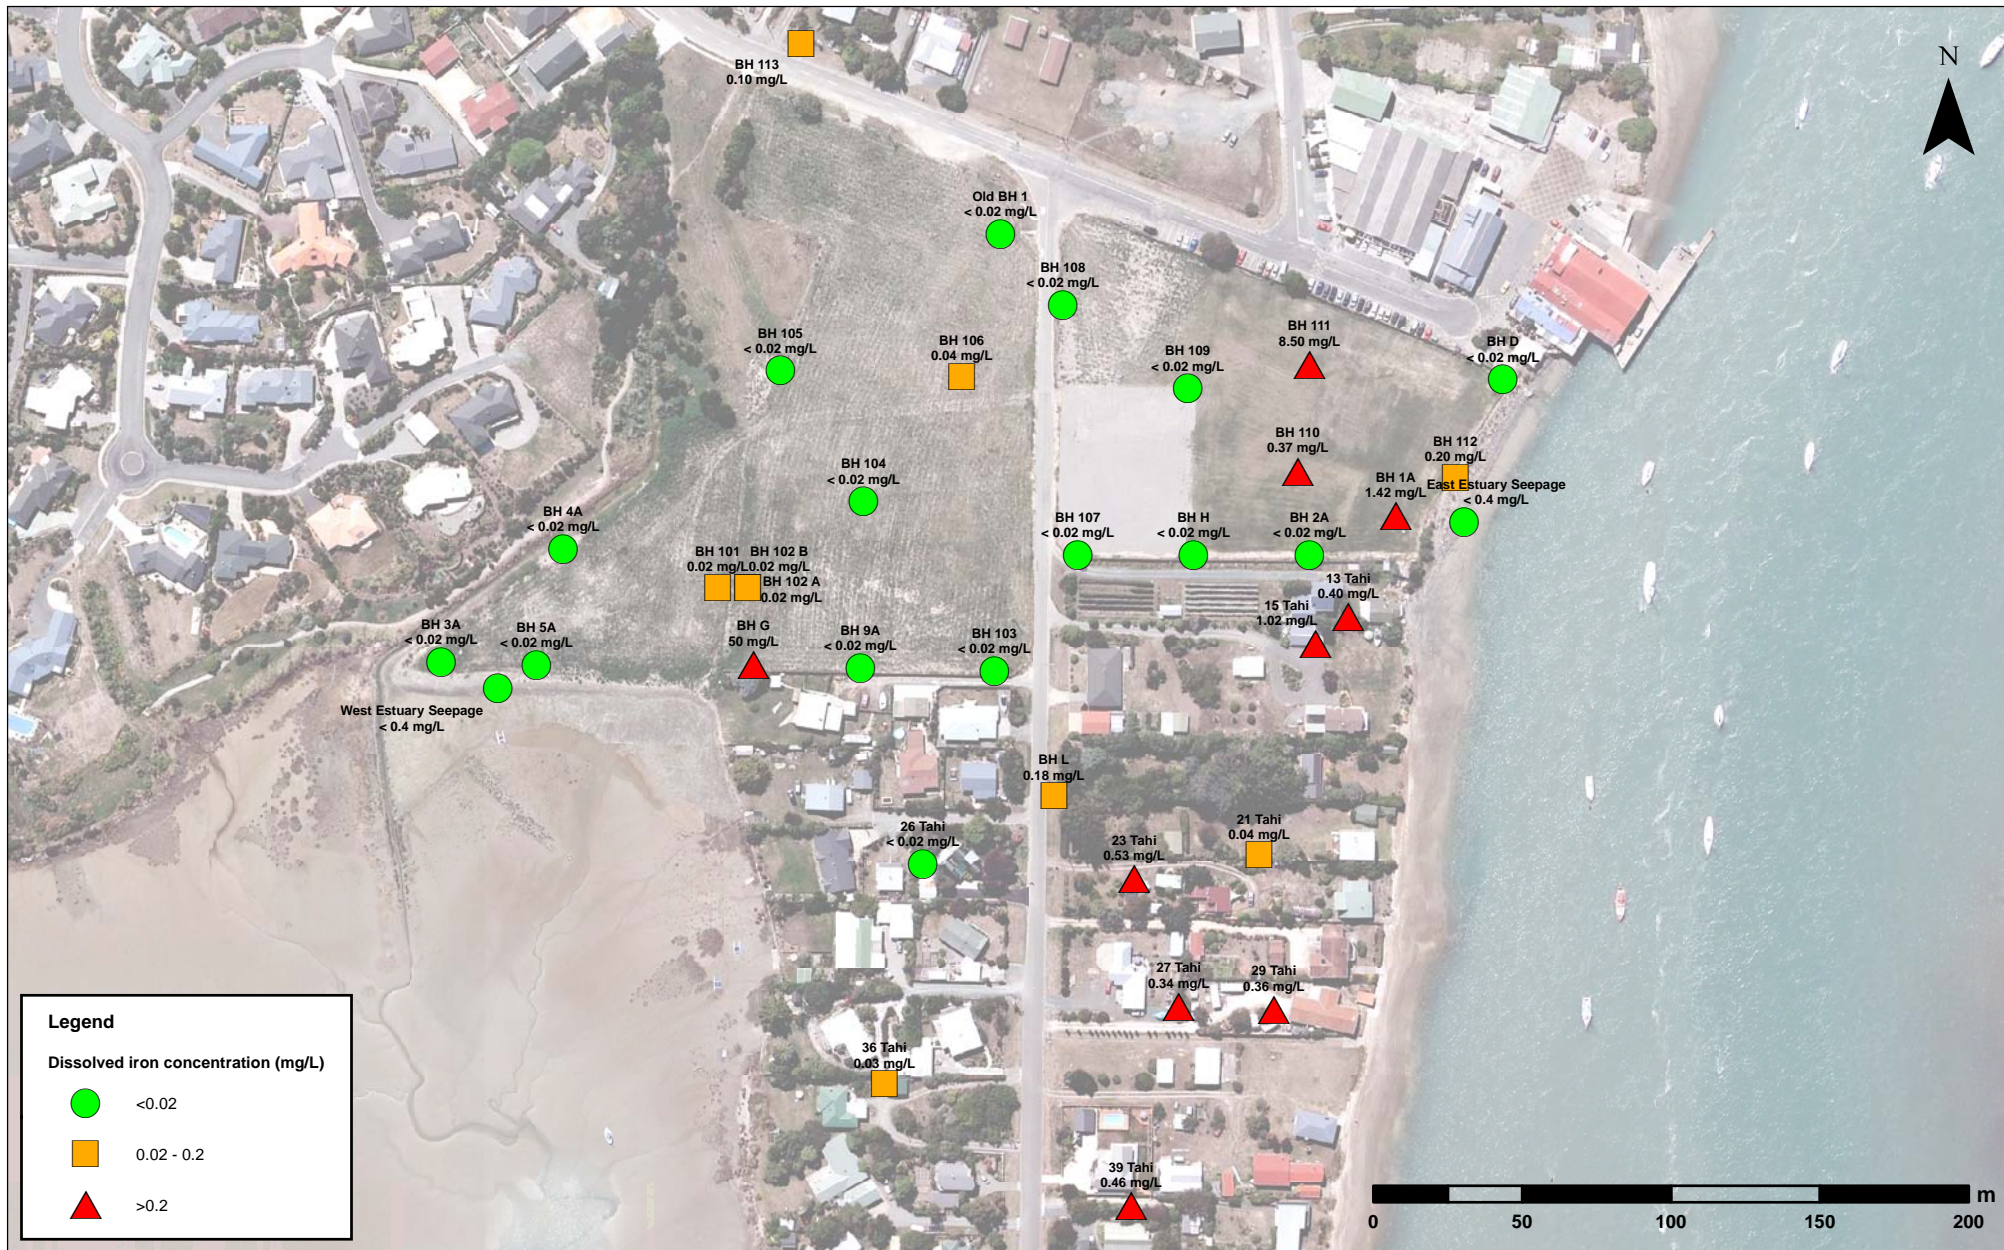
Figure 30 : Dissolved iron concentrations in November 2010

The results show generally low concentration across the site, although significantly higher values occurred at BHG and BH111. Elevated iron can occur if any suspended sedimentary particles become incorporated into the sample, and both these bores show elevated values at 260 and 650 NTU respectively. Anoxic groundwater conditions associated with organic rich sediments can also contribute to iron being dissolved in the groundwater.
