Tipple Residence, Kaiteriteri

Geotechnical and Structural Deck Commentary

Brief: 38 Kaiteriteri Sandy Bay Road, Kaiteriteri – New Deck Commentary

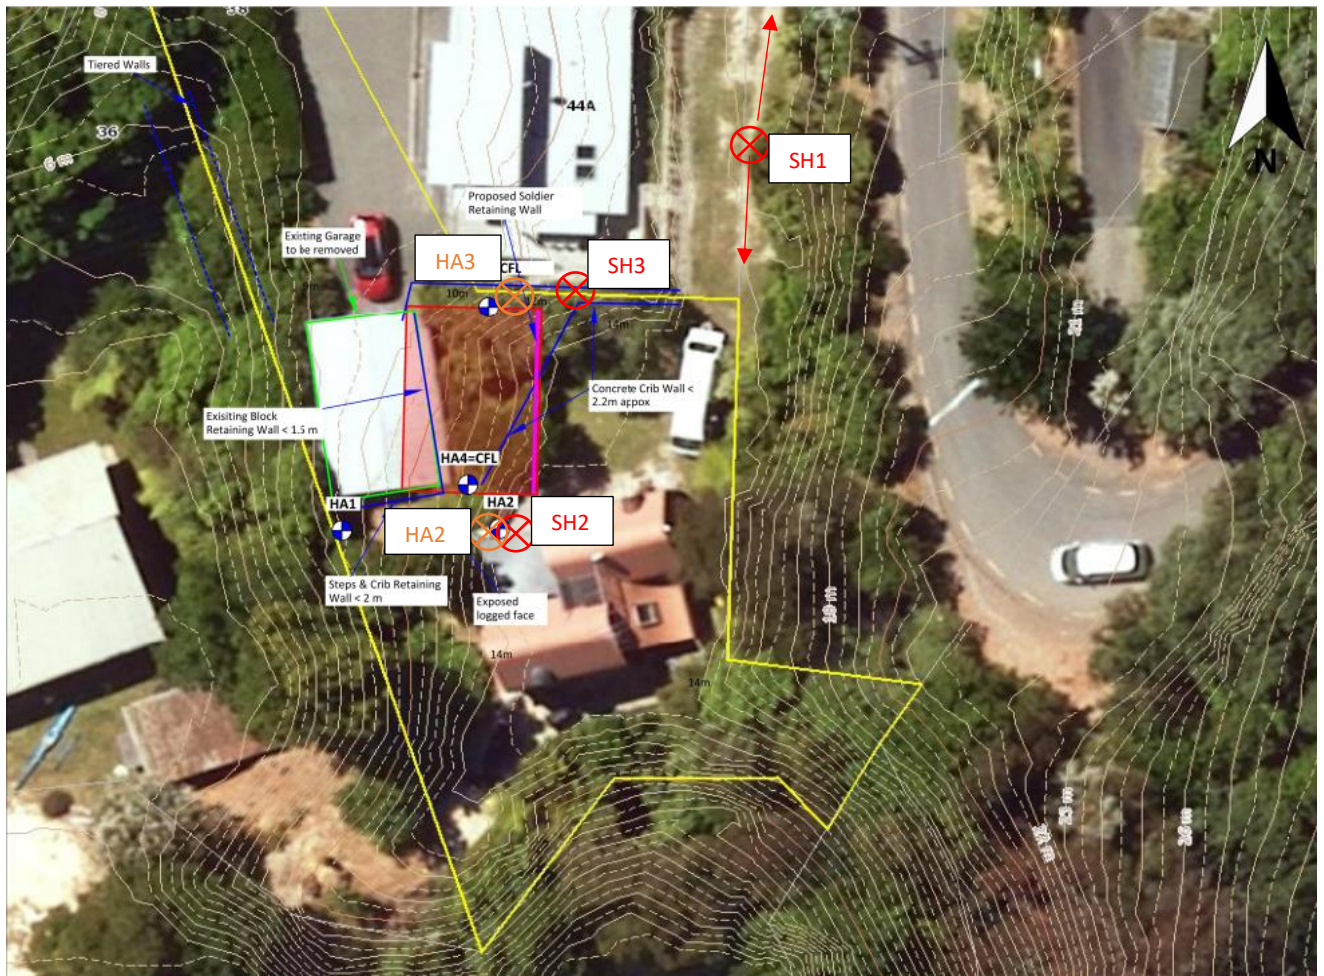
Figure 1. - Site Overlay with September Sampling Hole (SH) & Geoconsult Hand Auger (HA) test locations.

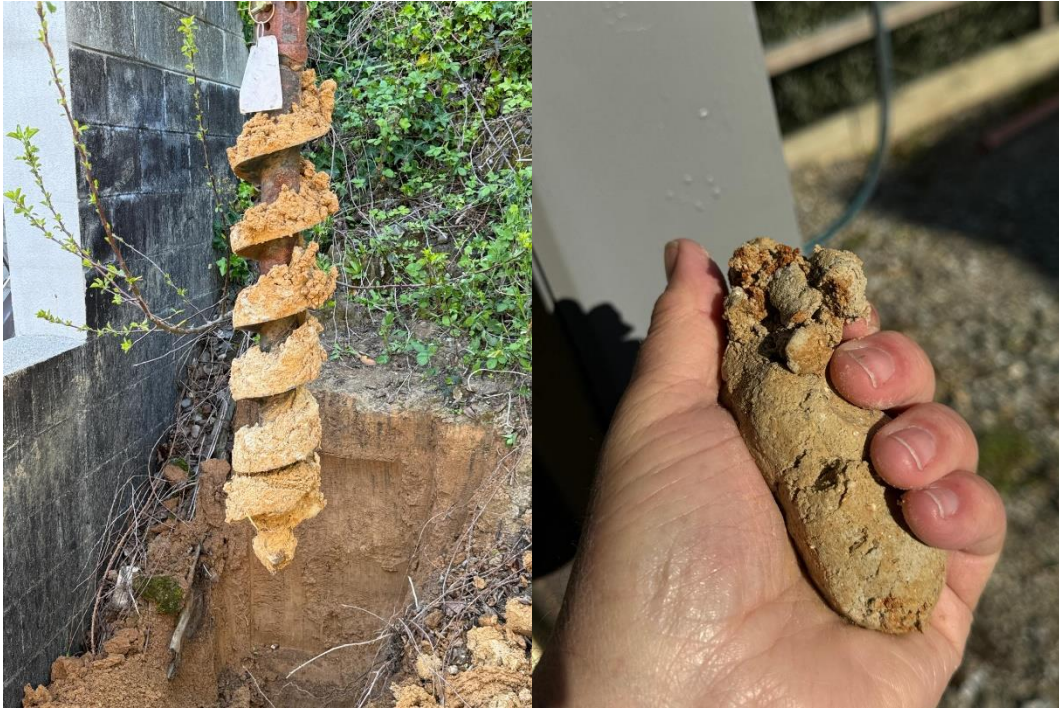
- 1.1 First Sampling Hole – **SH3** Bores undertaken by GDM referenced by **HA3** Geoconsult in 2021 report. The soil bank below the house, which had been cut during the house construction some years ago, revealed layers of yellow clay. As the depth increased, the clay became drier and lighter in colour, with minor quartz grit present. At 1.3 m, the soil was dense and moisture-free.

Figure 2a & 2b. - Yellow clay layer samples from SH3 V HA3

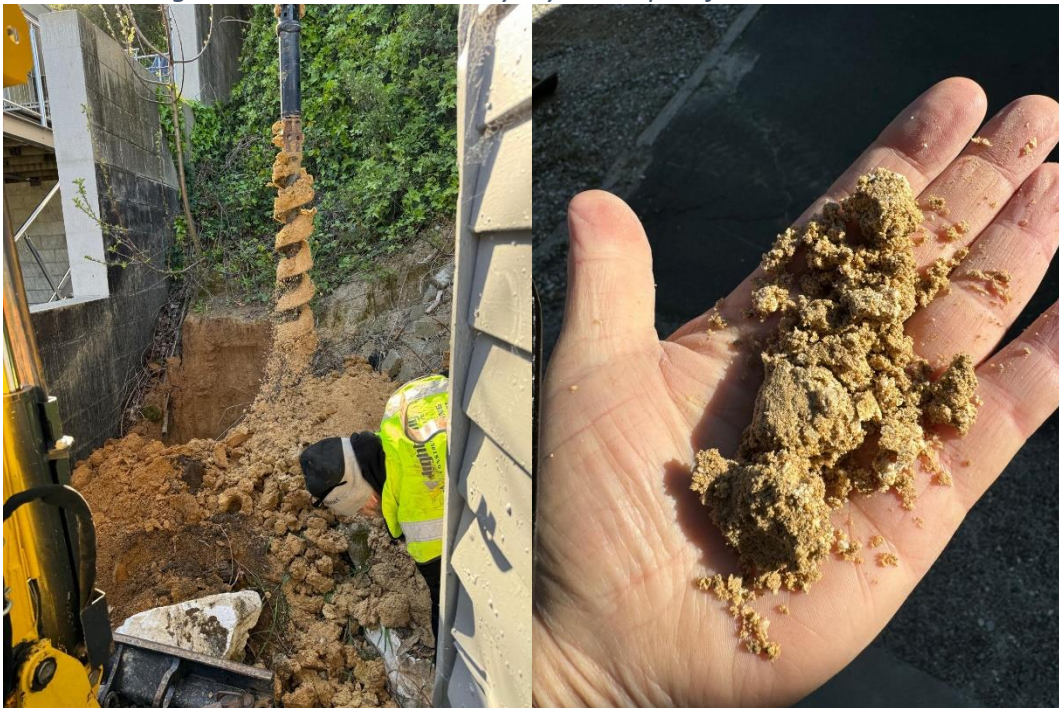
Figure 3a & 3b. – More dry, lighter clay with the presence of small quartz grit from SH3 versus HA3

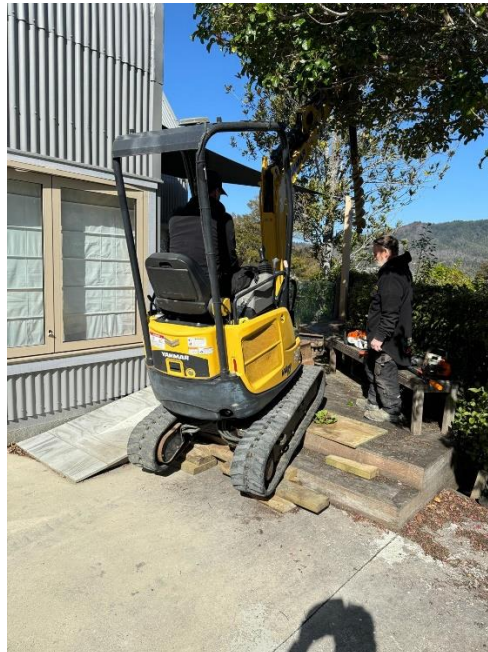
Figure 4. - Excavator positioning on deck for SH2 sample hole with existing dwelling to the left

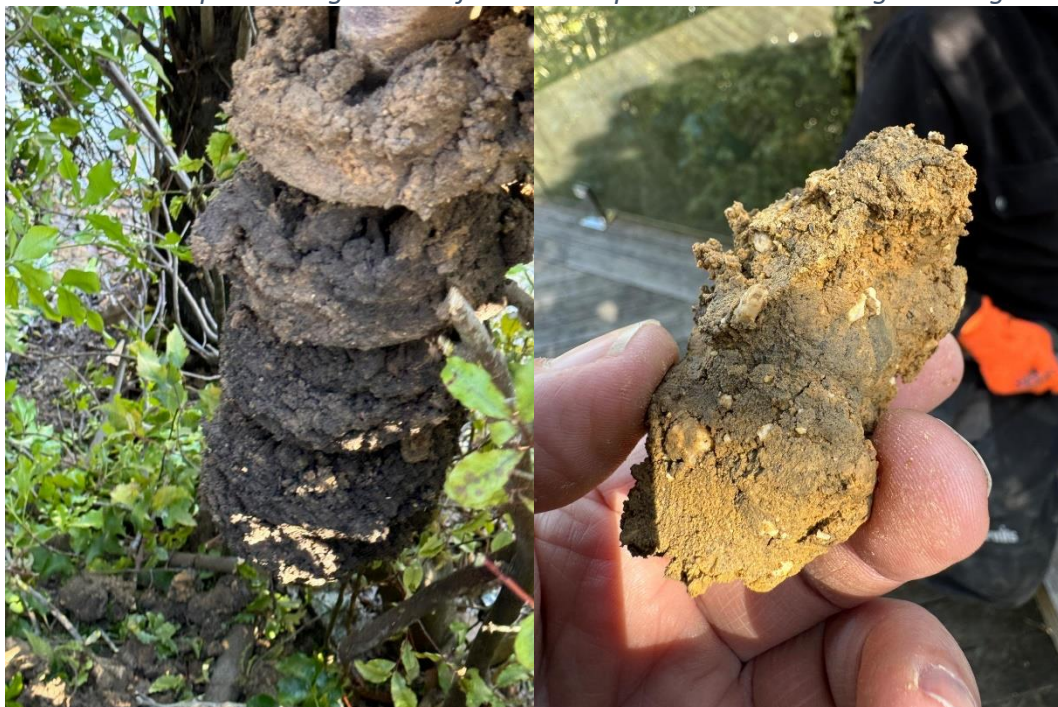
The second sample showed a composition of mud and clay. Although a 150 mm auger was used for this test, it was noted that the original piles were placed using a 300 mm auger to match the larger foundation poles of the house, some of which measure 270 mm in diameter on the north-facing side.

Figure 5a & 4b. - Composition of mud and clay from SH2

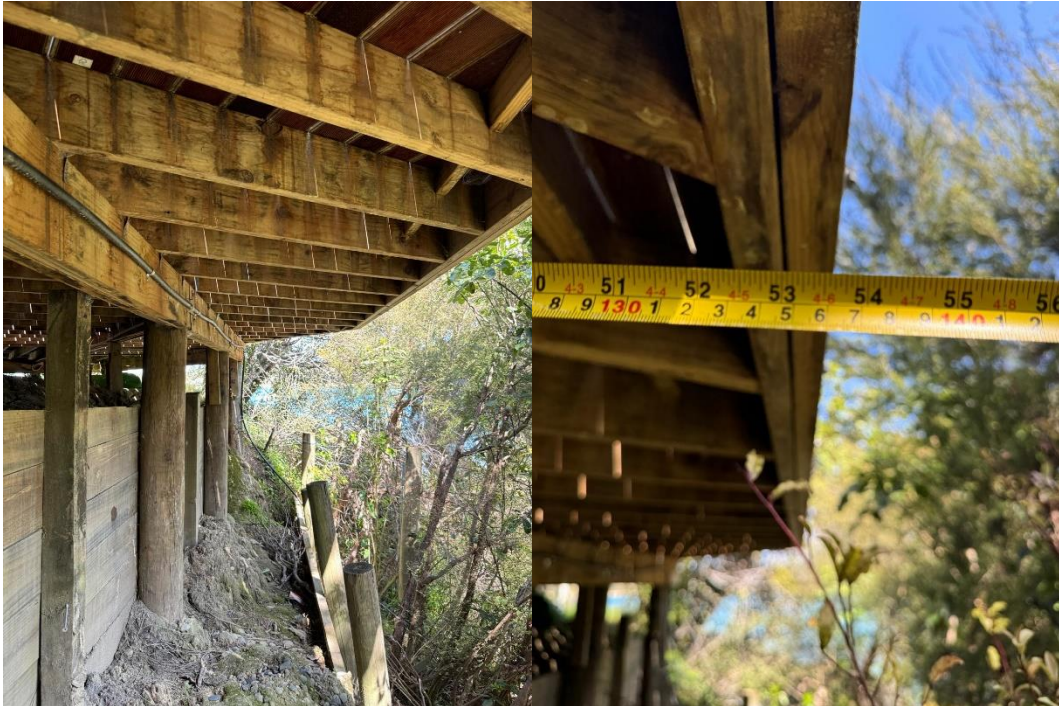
The western deck overhang extends 1.37 m maximum from a row of 8 piles spaced at a maximum distance of 1.9 m. The deck's southwest boundary is positioned 100 mm from the neighbouring property, spanning approximately 7.6 m along the boundary.

The patio's maximum loading point is located at the corner where an external post is embedded to a depth exceeding 2.0 m. This post, typically 250-270 mm in diameter, supports the deck and is accompanied by small retaining timbers extending to a height of 1.0 m. Additional site images are included in Appendix A.

Figure 6a & 6b. - Row of Round Posts with 1m high retaining wall held by square posts (left) and 137cm overhang of deck from row of piles (right) along the west edge of the deck

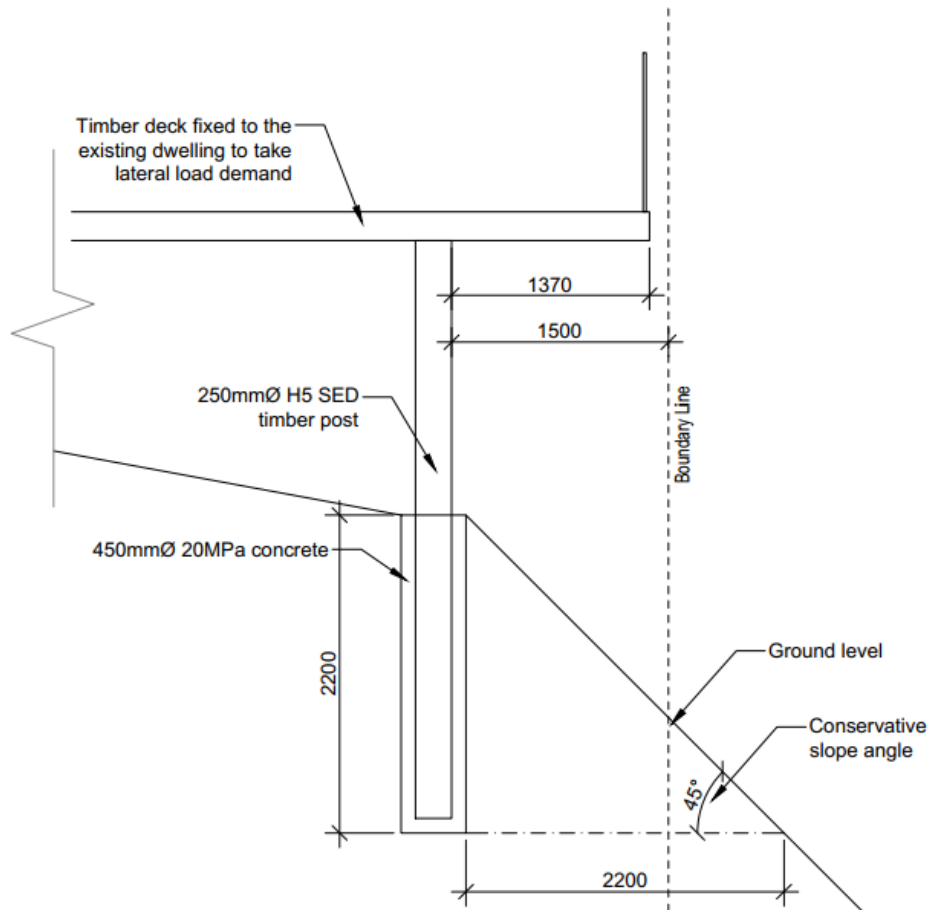
The deck loads include 1.5 kPa live load (Q) and 0.25 kPa dead load (G) providing a working load of $G + Q = 1.75$ kPa. The loaded area for one of the 250mm diameter SED H5 piles located on the edge of the deck is $1.90 \text{ m} \times 1.37 \text{ m} = 2.60 \text{ m}^2$. This results in a total axial load demand of 4.6 kN. With a 450 mm diameter base for the footing, the demand on the soil is 29 kPa.

The safe allowable bearing pressure of the sandstone clay at a minimum depth of 2.0m indicated 300 kPa. Compared to the bearing demand from the post, this provides a factor of safety of 10.4 times, hence, this doesn't impose added risk to the lower neighbours.

Figure 7a. - Deep Post Section

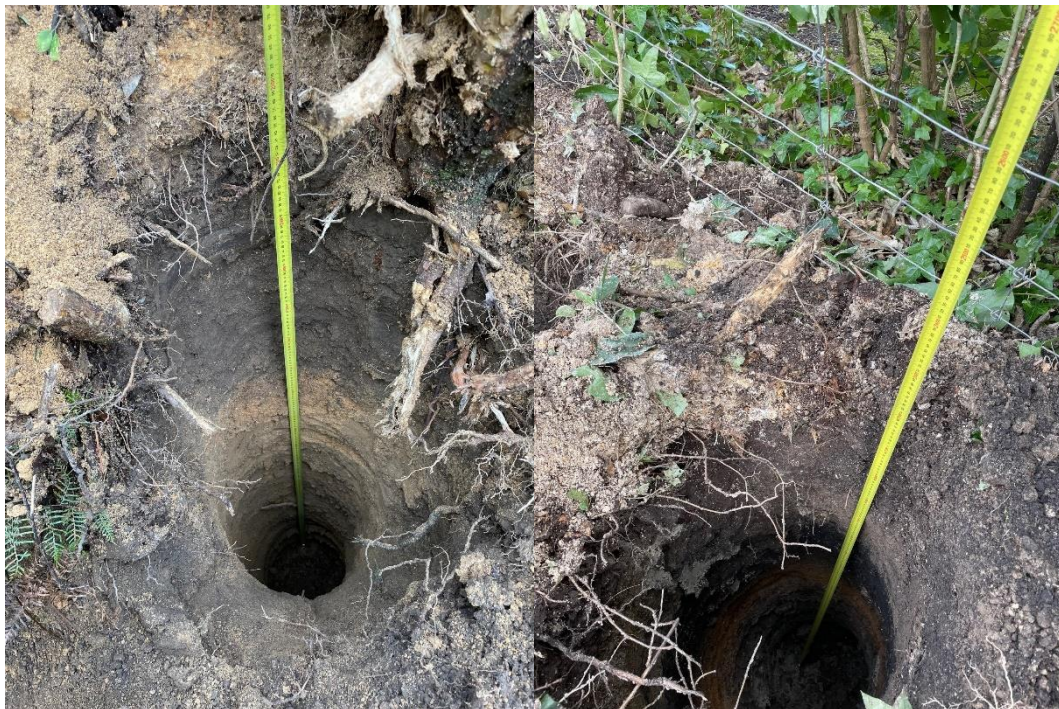
Figure 7b & 7c. – Construction images of the post holes depths. More images are included in the appendix under PS3 images.

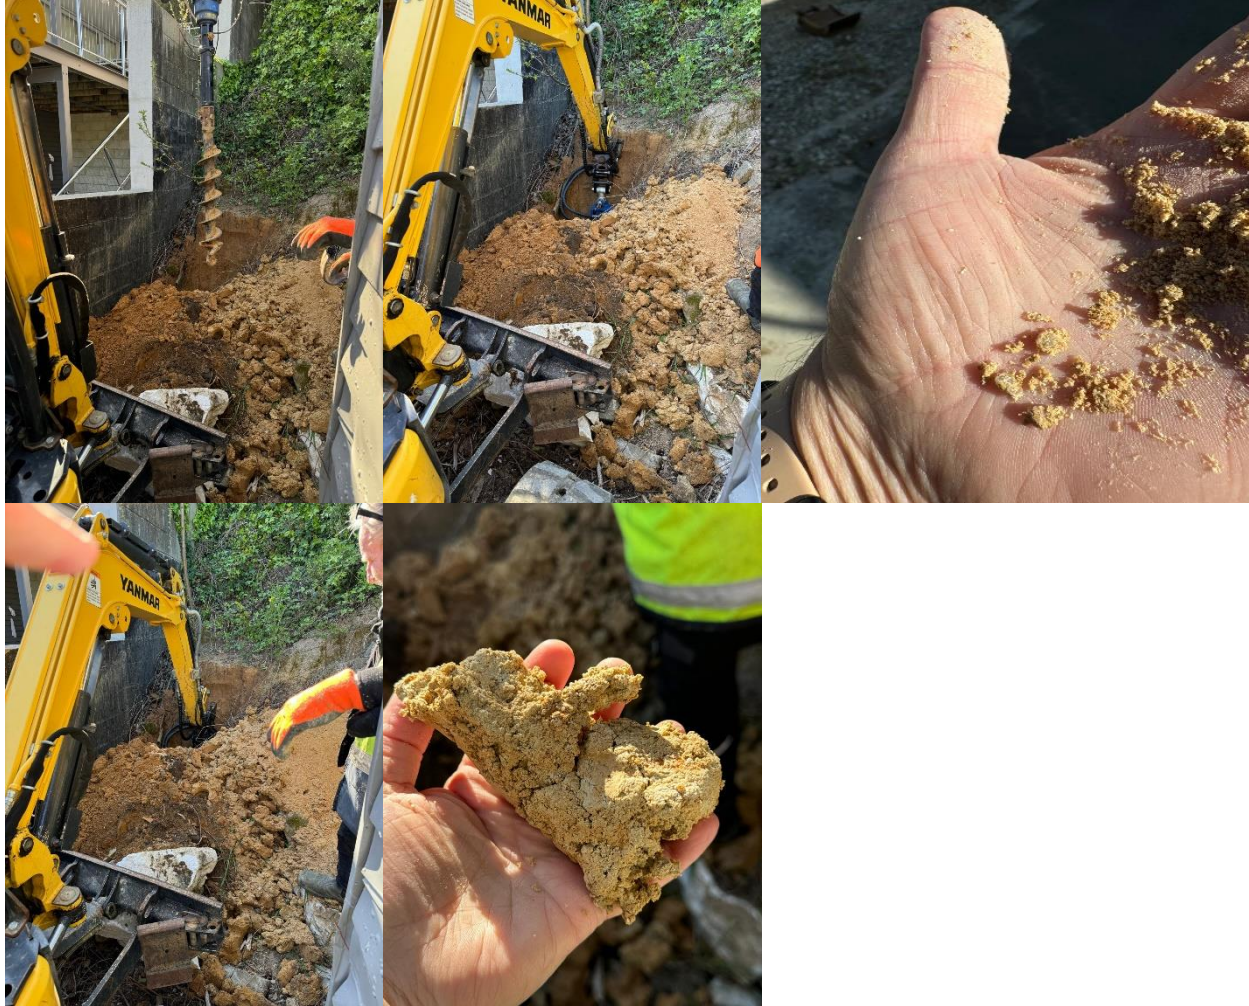
SH3 GDM – HA3 Geocosult – Sampling Hole 3 depth to the base drilled to 2.3m establishing the Geoconsult report.

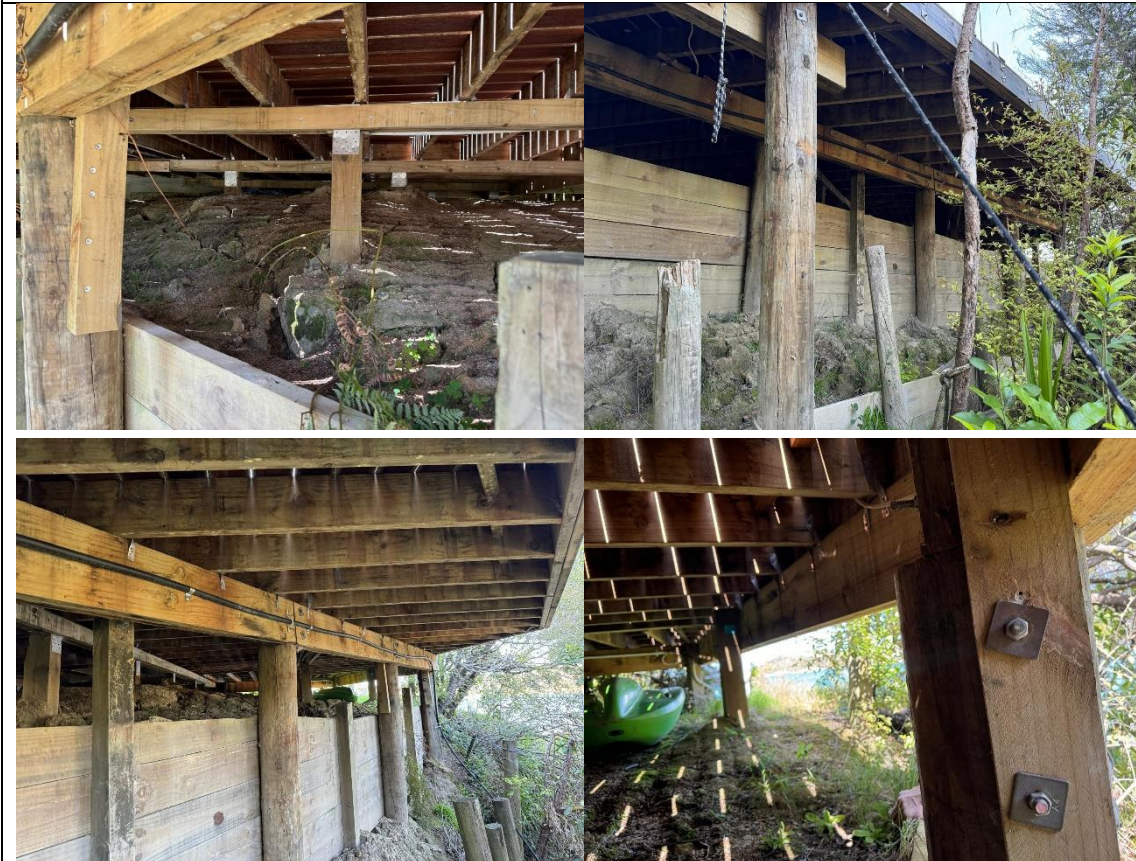
F 1-4

Below: Fig 1- 4 below shows the sound fixing of the new deck to the upper cantilevered poles and piles.

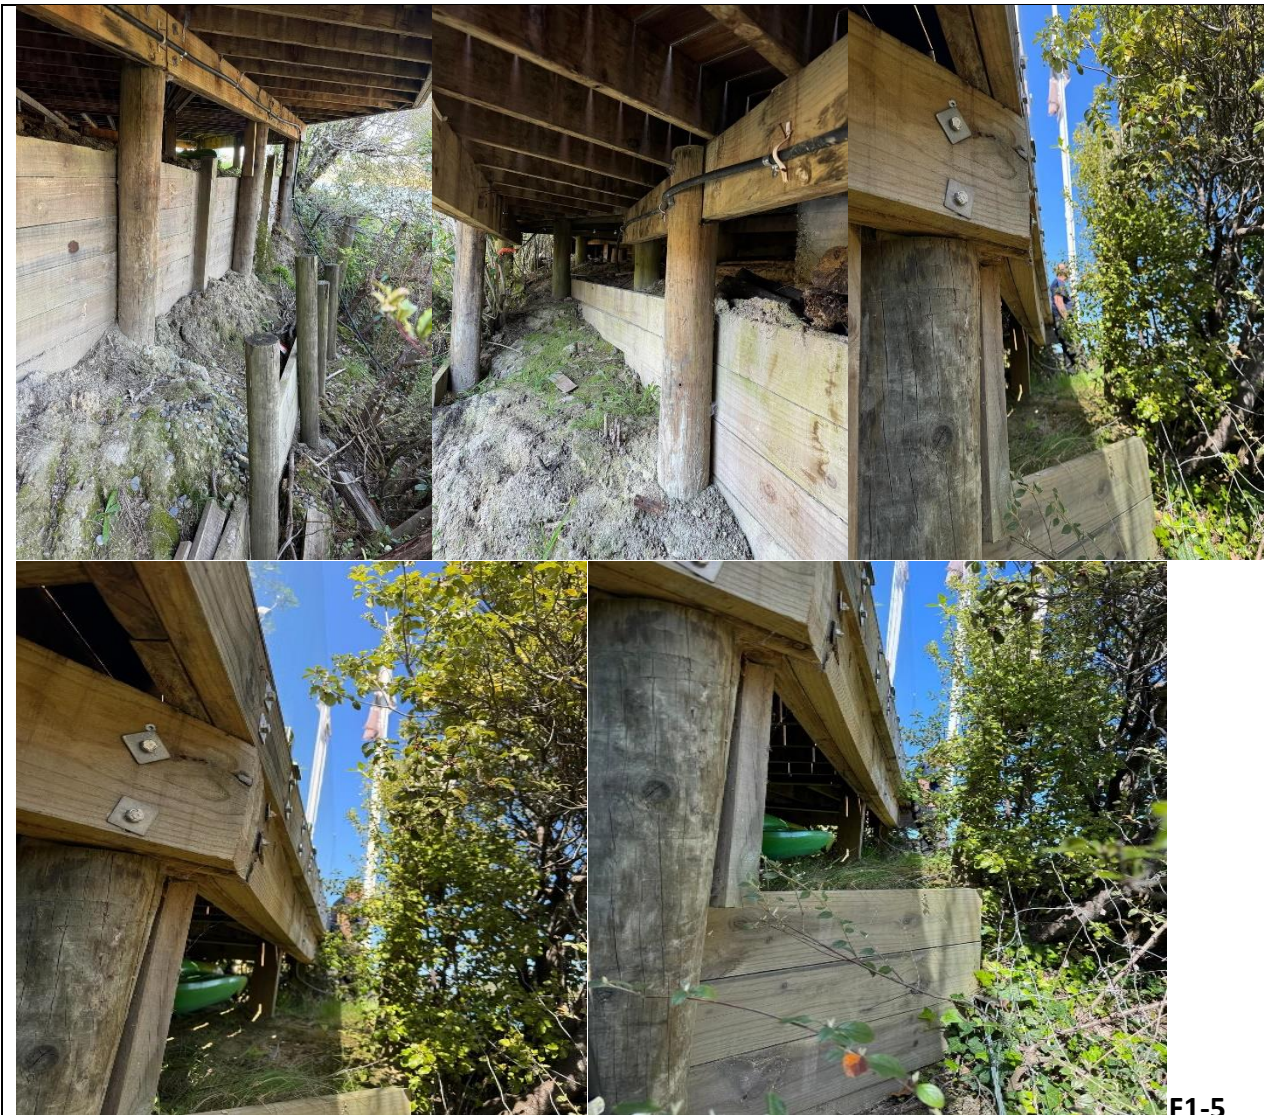
F1-5

Fig 1-5 above, Shows sound fixing of the newly bolted deck with the end fixing of double stringer beams bolted to the piles around the perimeter of the new deck.

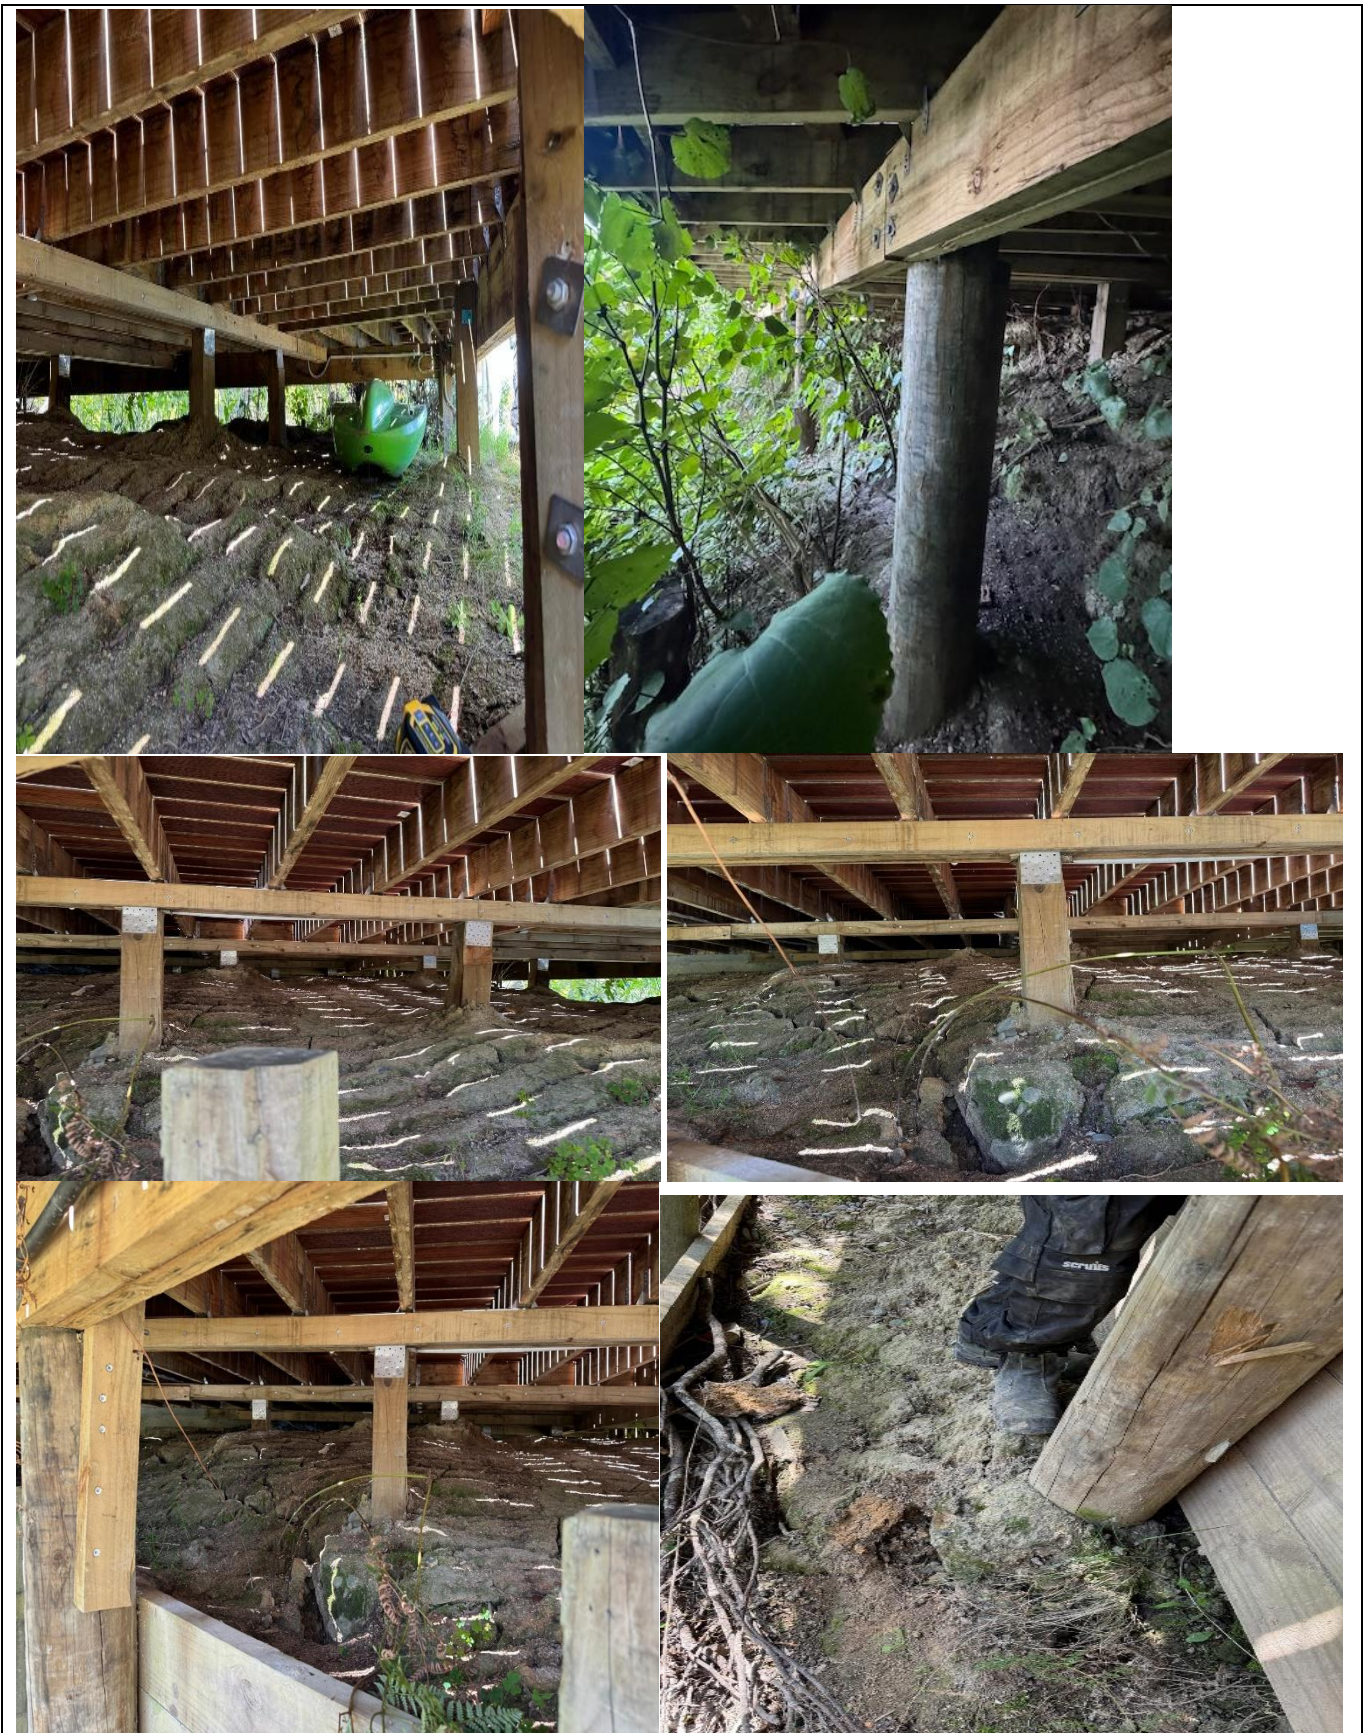
Fig 1- 6 Above, show surfaces that need erosion protection to control upper sandstone instability, which can be achieved using sealed DPM

Deck Images: F 1-6 above depict the required overlays to secure the erosion-free weathering properties of the upper crust directly under the upper decking. The cracks below are undesirable, and need fixing to prevent further issues and ensure this mechanism for the long-term plan on this site achieves overall acceptability. We conclude a protective cover over the upper crust is required.

To prevent erosion. A damp-proof membrane (DPM) of at least 150 microns should be applied around the base of all critical piles. This membrane should extend from the house edge and around the posts to prevent water migration and soil erosion.

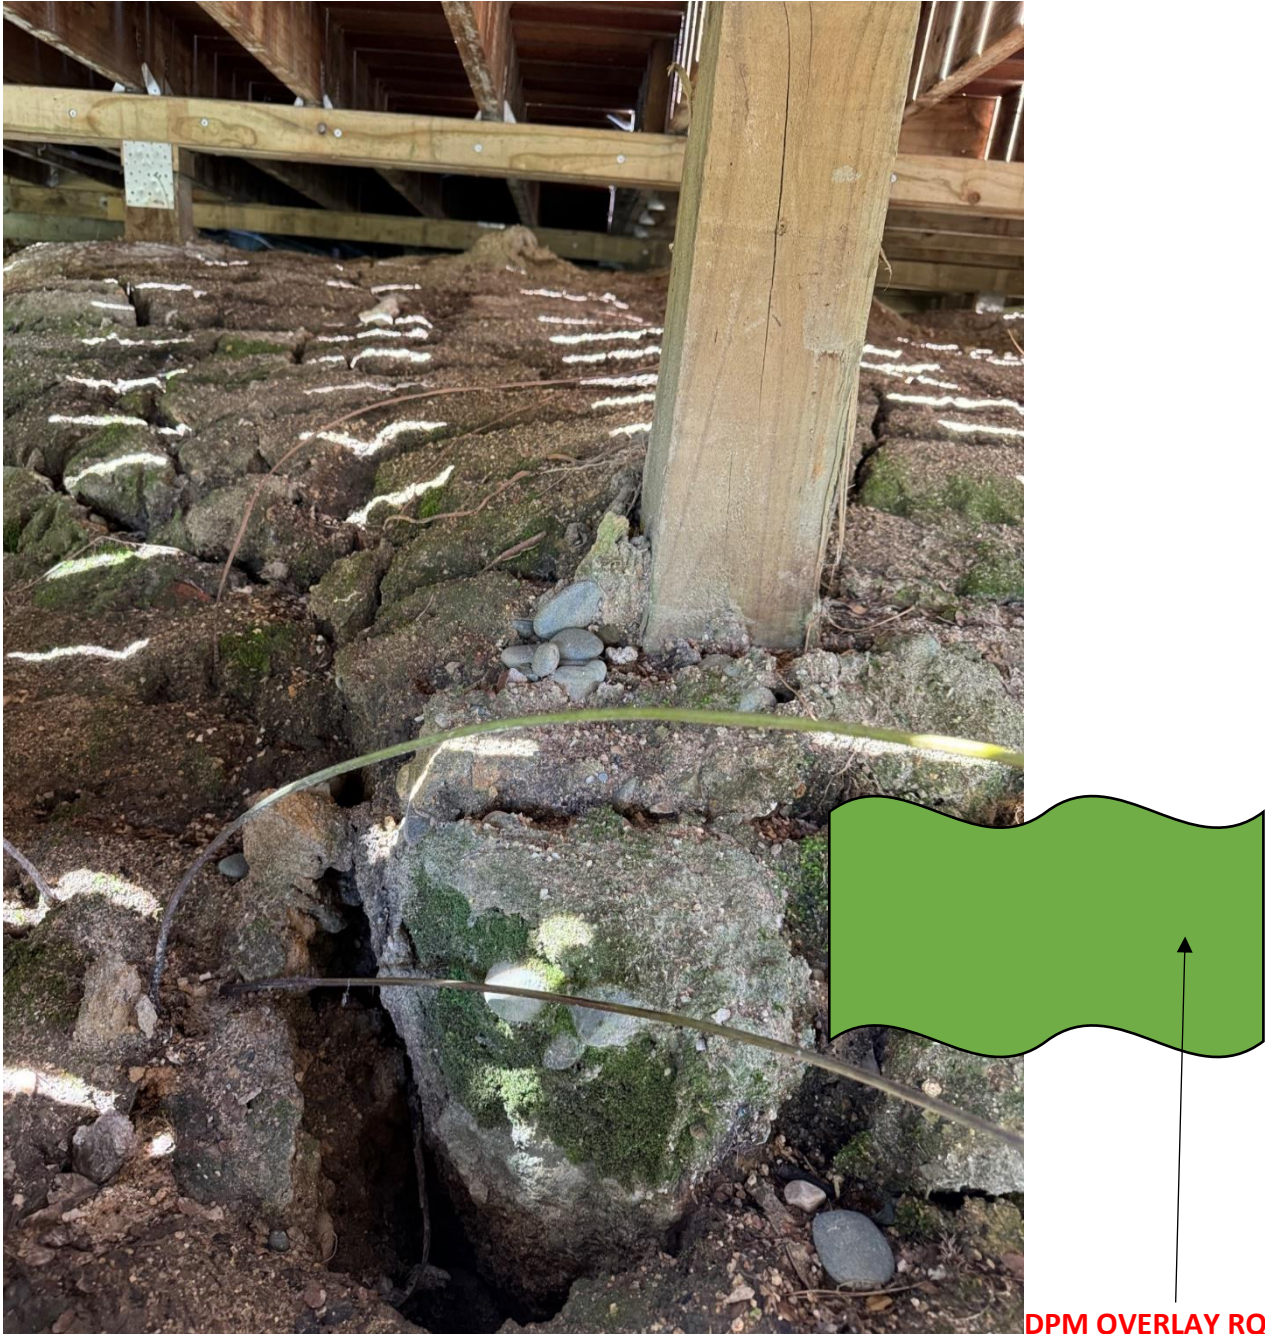
The above feature is where the original erosion, caused by the flow of water runoff, has caused this undesirable breakdown of the upper crust of the graduated topsoil and lower weathered sandstone. This needs fixing with the tampering by using clay to fill up all void holes. These veins or cracks in the upper crust shall then be overlaid with well-formed flow dish channels, say 150mm wide and graduated depth, so that the water from the house under the deck to the outside and down the bank away from any infrastructure to the natural water channels double-lined with Agtuf 150 micron film as the approved DPM medium.

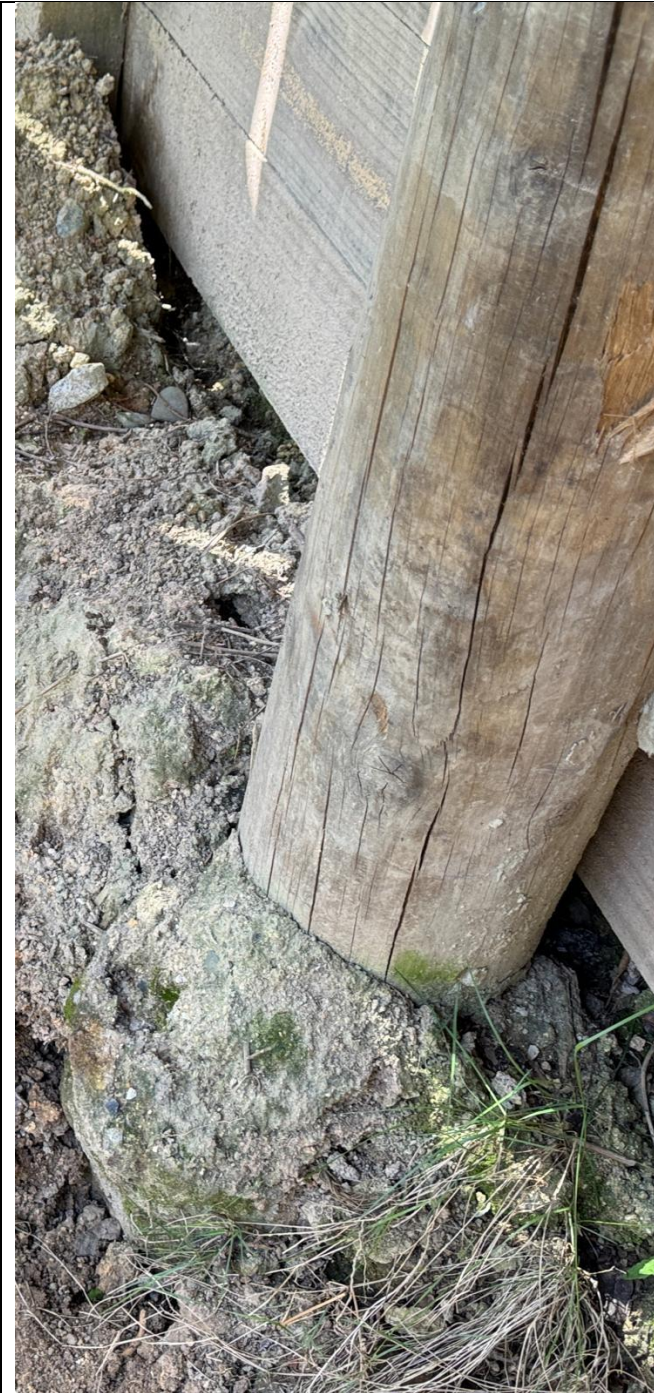
Figure G1. – Post to ground interface that highlights the top of the concrete partially hidden by topsoil used in the soil loading calculations. Additionally, the image shows the importance of placing waterproof membrane around the base of the pile to protection from weathering and erosion.

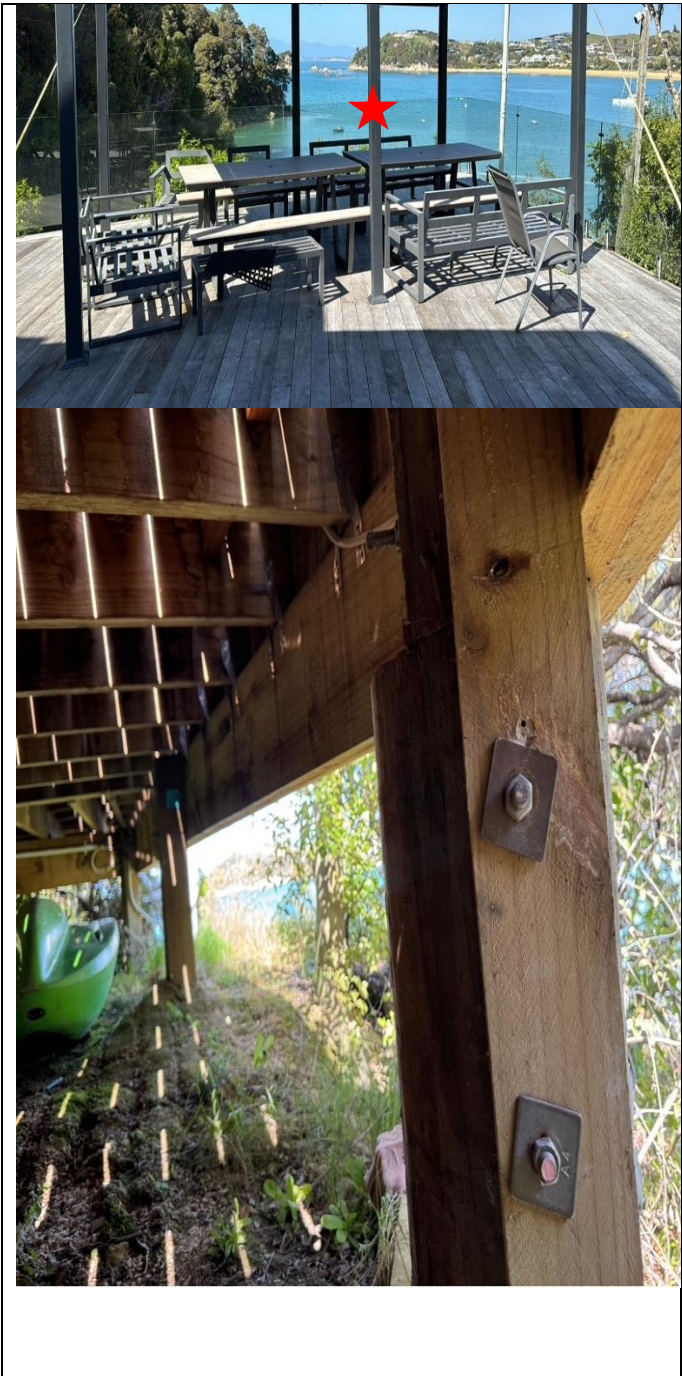
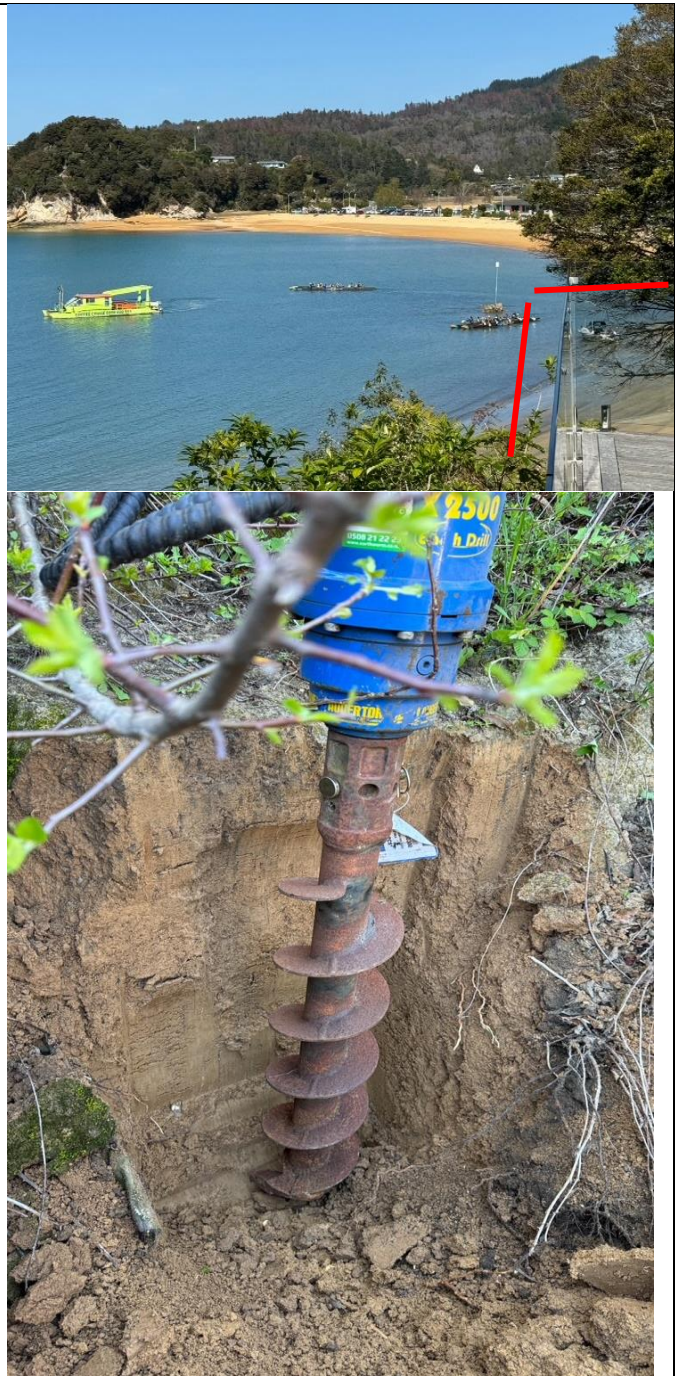
Views of the Bay F1&2 above and SE corner of the new Deck < 900mm off the firm ground.
 : The sunshade is a structure because of its roof and obstruction within 4.0m of the edge. This **must be removed as it can be seen from below, which is detrimental to our argument that the deck can stay subject to planting** green foliage to hide the deck itself from any views below, excluding the translucent glass.

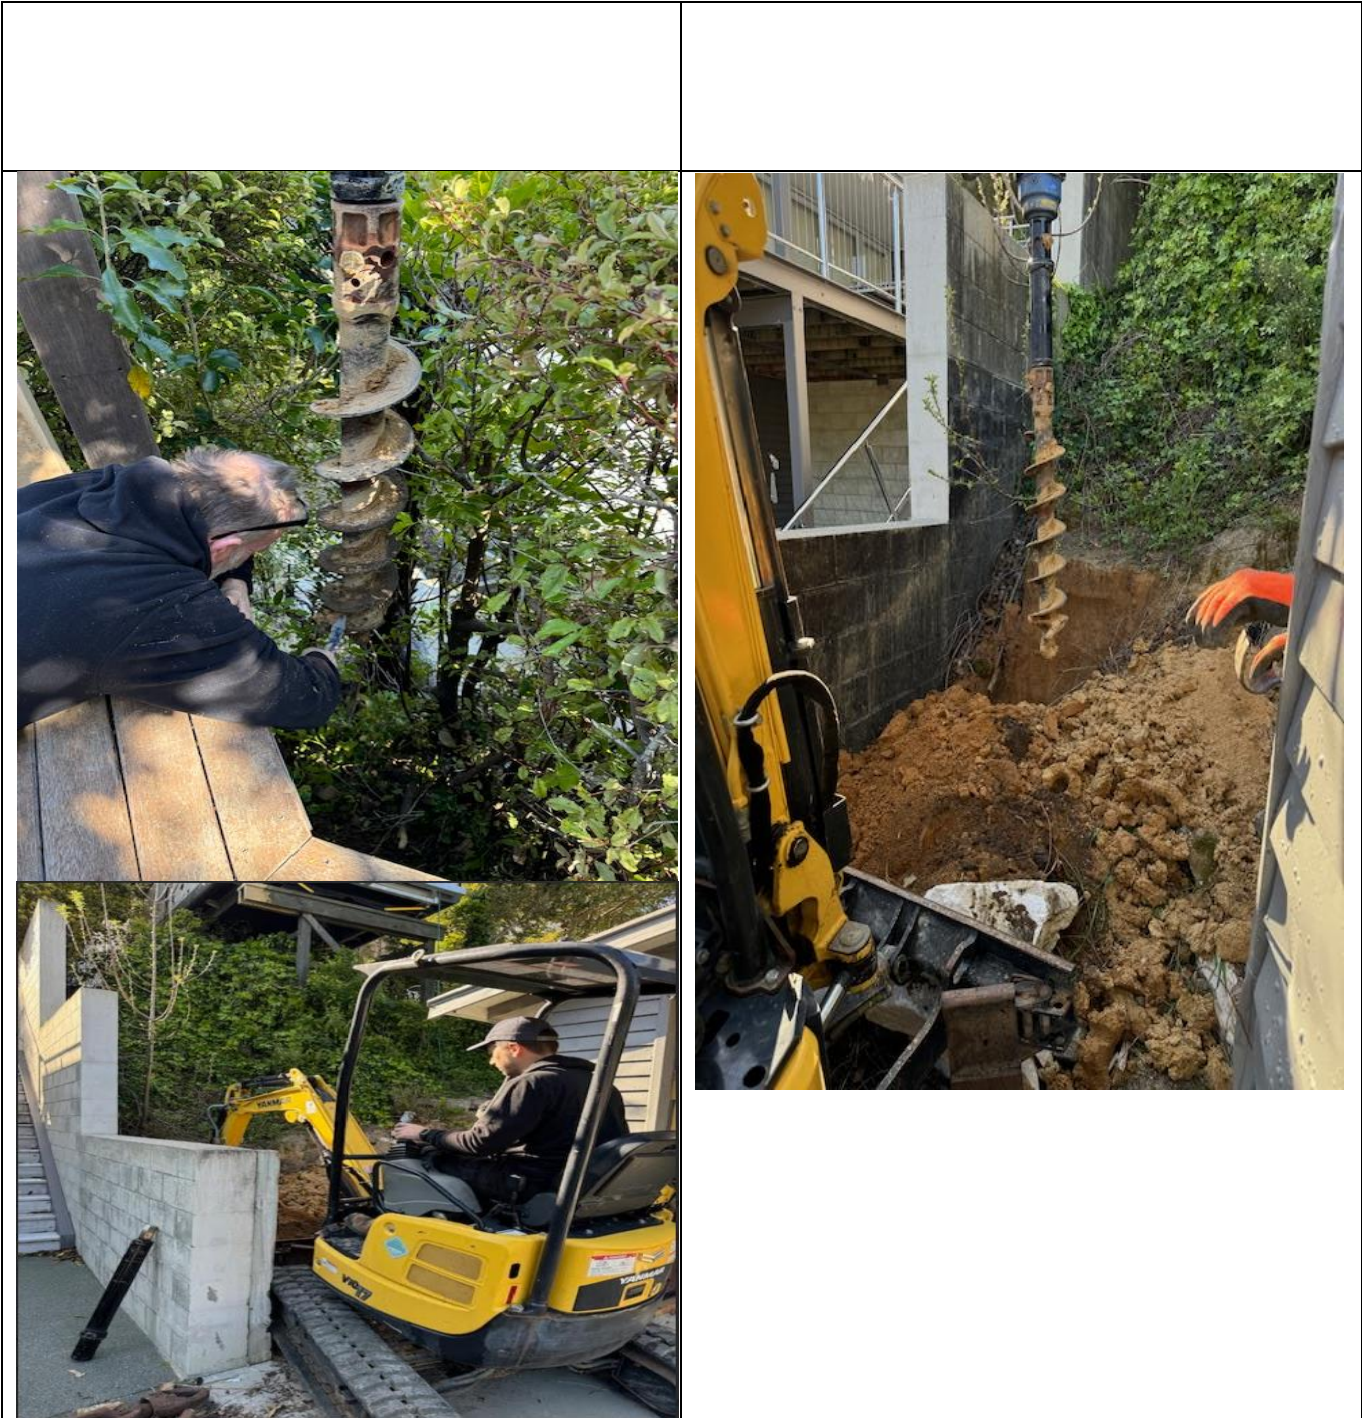
Fig 1 Top LHS; Fig 2 Top RHS
Fig 3 Bottom LHS

These augured holes were at the same location as those defined and reported on by the Geoconsult report, which we determined was commonality within our peer review of their work. SH2 Fig 1 And SH3 Fig 2 & 3 reflecting on Ha2 & Ha3

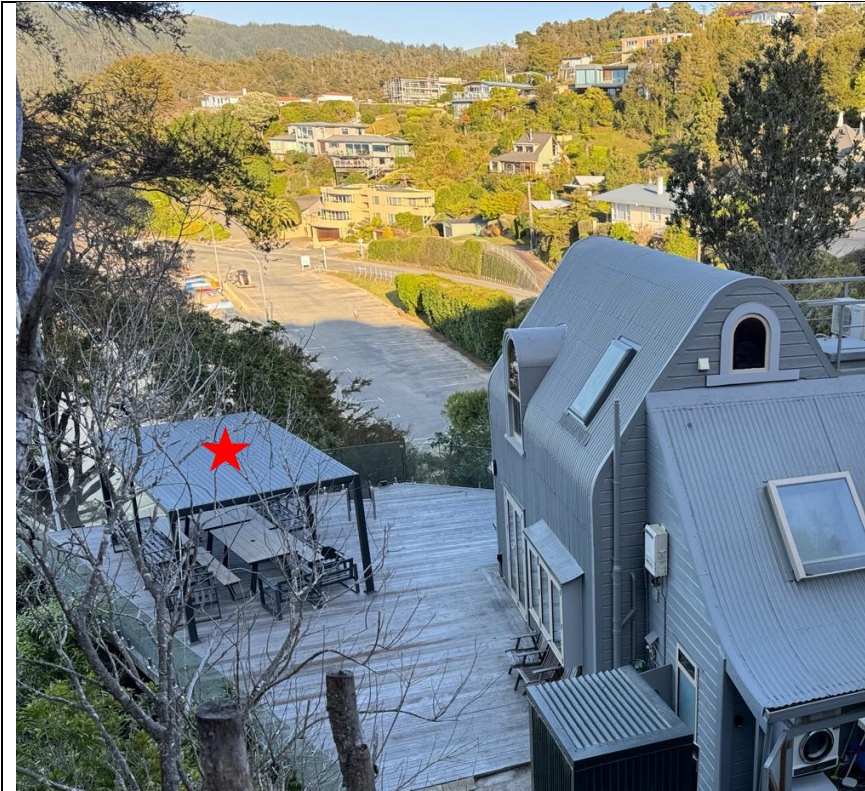
The above image is south facing from the north side of the dwelling. The red star indicates the sunshade structure that is placed on the deck that should be removed due to its intrusion on natural views from the beach level to the public.
