STAFF REPORT

SUBJECT: Failure of Reticulation Systems Over The Christmas Period

Tasman District Council Tapu Bay Pump Station - Wastewater Overflow 31 Dec 2005

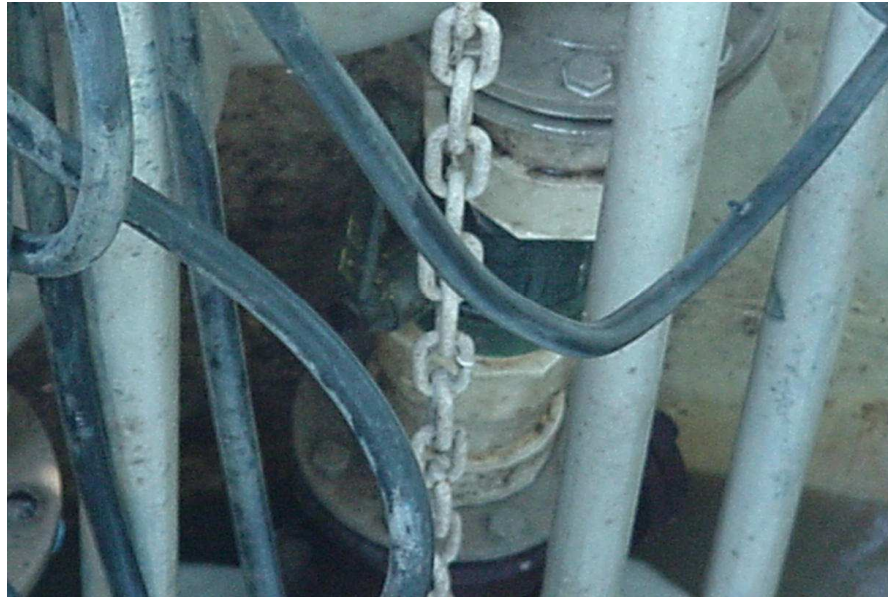
The Kaiteriteri wastewater pump stations were all constructed circa 1989. The pump riser pipes are Class B PVC and valves are located near the top of the risers inside the pump chamber.

On 31st December part of the PVC assembly in the Tapu Bay pump station failed, disabling the effective operation of the pumps.

Fig 1 - Repaired Riser Pipe

The Tapu Bay pump station normally discharges through a valved manifold in the adjacent chamber. This valve chamber also houses the motorised valve and associated pipe work that controls the discharge from Kaiteriteri into the main crossing Tapu Bay. The failure of the pump riser in the Tapu Bay pump station allowed some of this Kaiteriteri flow to discharge back into the pump wet well, exacerbating the problem.

The use of Class B pipe materials in a pumping situation is no longer industry standard practice. Currently, TDC Engineering Standards and Policies detail galvanised steel pump risers.

Immediate steps have been taken to review all pump risers in all coastal wastewater pump stations. The Tapu Bay pump risers will be replaced with current industry standard materials before 31 January 2006. PVC material in other Kaiteriteri – Riwaka pump stations will also be upgraded. TDC pump stations at other locations will also be reviewed and upgraded as required.

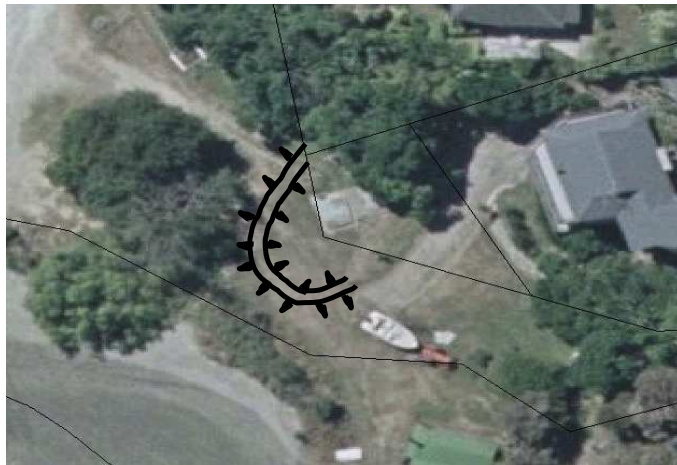
Fig 1 – Proposed Low Bund

A proposal to raise the access track levels, and effectively create a bund around the Tapu Bay site that will prevent immediate overland flows to the bay is being investigated. Construction of this bund, as indicated schematically in Fig 2, is anticipated to be complete by 31 January 2006.
