STAFF REPORT

REFERENCE: RM070601

SUBJECT: **SUSTAINABLE VENTURES LIMITED - REPORT EP09/07/05 -**
Report prepared for the hearing of 1 to 3 July 2009

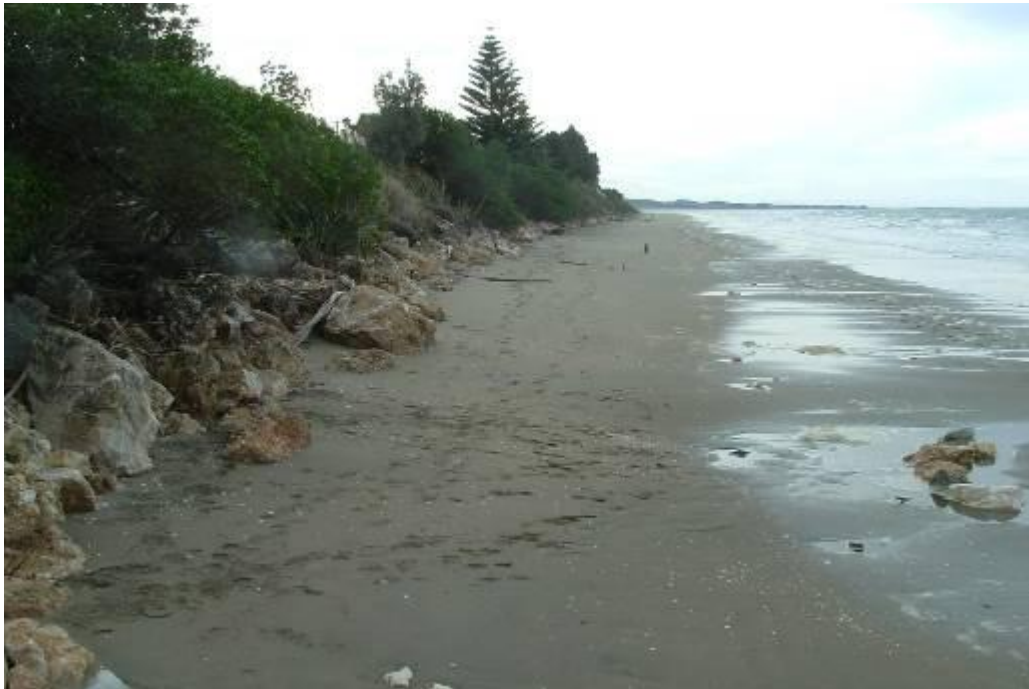
The entire 230 metre property frontage of the application site is protected by a disintegrating rock revetment. The revetment appears to have been in existence for some time and has almost certainly been periodically added to given the variable rock types present and degrees of weathering (Refer photograph 1).

The revetment has not been built to a specific design. The rock armour layer is variable in size and includes many oversized rocks. Some of the rocks have become isolated from the main revetment and are less effective in preventing erosion than would be the case if they were integrated into a competent structure. The revetment does not incorporate any bedding or geotextile filter layer, does not have any uniform face slope, nor is it built to any consistent height. It also contains concrete rubble and vegetation of various types is growing through the revetment.

Photograph 1: Rock protection at site

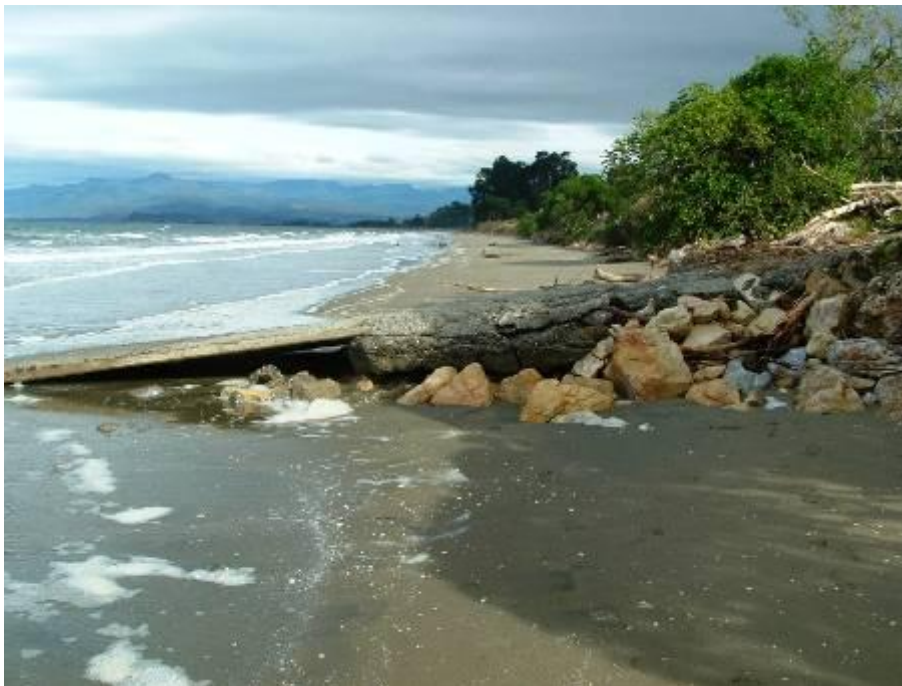
The northern end of the revetment ends with some sporadic and minor rock work on the adjacent property and terminates at the southern end with an informal concrete topped ramp made of rubble and prestressed telephone poles (Refer photograph 2).

Photograph 2: Existing boat ramp at southern end of site

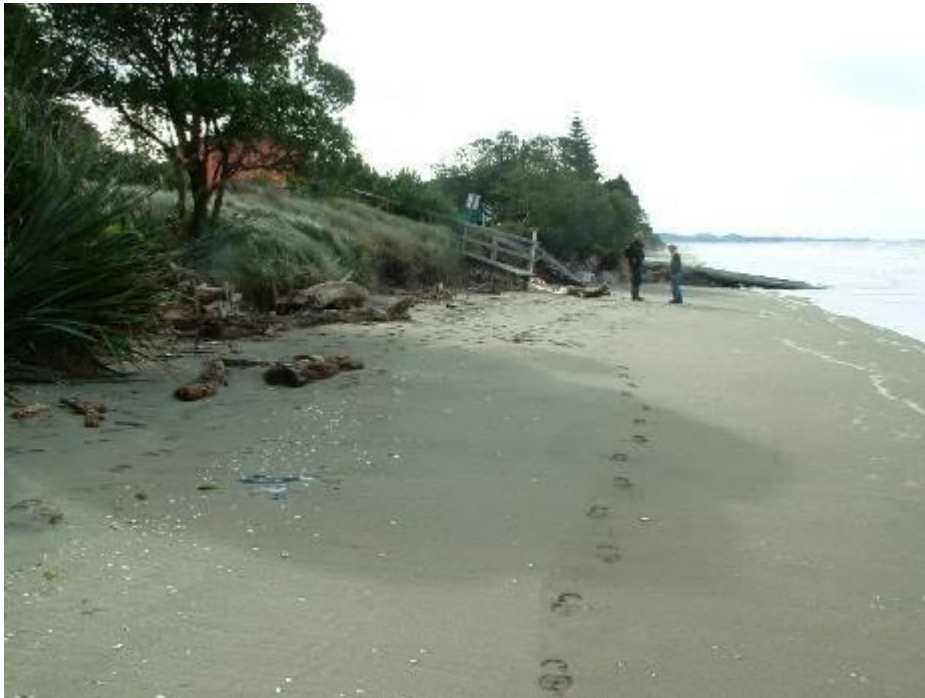
There are no protection works immediately to the south of the ramp, although Coast Care dune vegetation planting has been undertaken to stabilise the low rear dune. (Refer photograph 3).

Photograph 3: Unprotected coastline to the south of the site

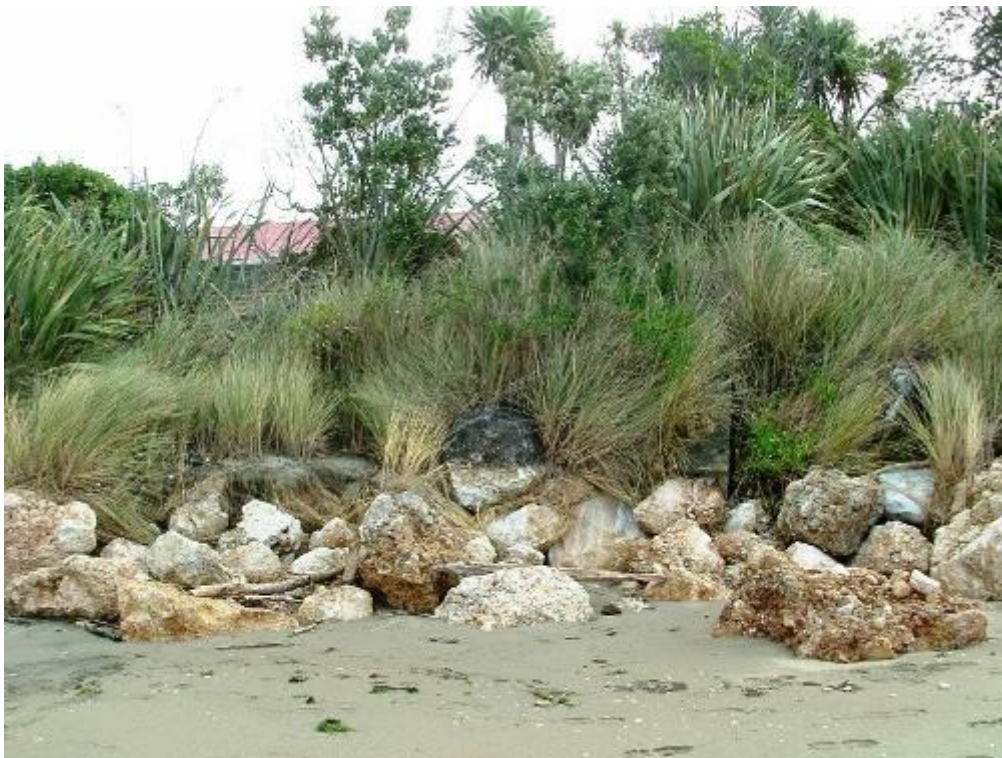
In most locations the rock armour layer does not form a tight, interlocking matrix and the underlying base and bank material (sand and soil by appearance) is visible (Refer photographs 4 and 5). The base material is susceptible to wave erosion, which causes rock undermining and slumping, as well as upper bank failure. This is beginning to become more evident in a number of locations along the revetment.

Photograph 4: Photograph illustrating the condition of much of the existing rock revetment

It is considered that many of the existing rock armour elements will need to be temporarily removed to facilitate the reasonable placement of smaller rock and graded bedding material wherever possible within the acceptably placed and appropriately sized existing rocks, over which a 2-layer interlocking rock armour revetment can be constructed. Two layers are considered necessary in order to prevent underlying sand material being washed out from beneath the revetment armour during wave attack, both now and increasingly into the future. A face slope of 2H:1V is desirable, to a height around RL 4.5m amsl.

1. Rock of an appropriate size shall be added to the existing structure so that all voids are filled creating an effective, interlocking 2-layer revetment armour layer overlying a graded bedding layer of minimum 200mm thickness, with a uniform face slope of 2H:1V and height of **RL 4.5 amsl**, being approximately 2.0m – 2.5m above the head of the existing sand beach. Some relocation and repositioning of existing rock shall be undertaken to make better use and advantage of isolated large rocks and to remove existing airspaces beneath and between existing rocks. The infilling shall include the creation of a uniform line of embedded toe rock material, beginning at the location of the most distant existing revetment toe rocks.

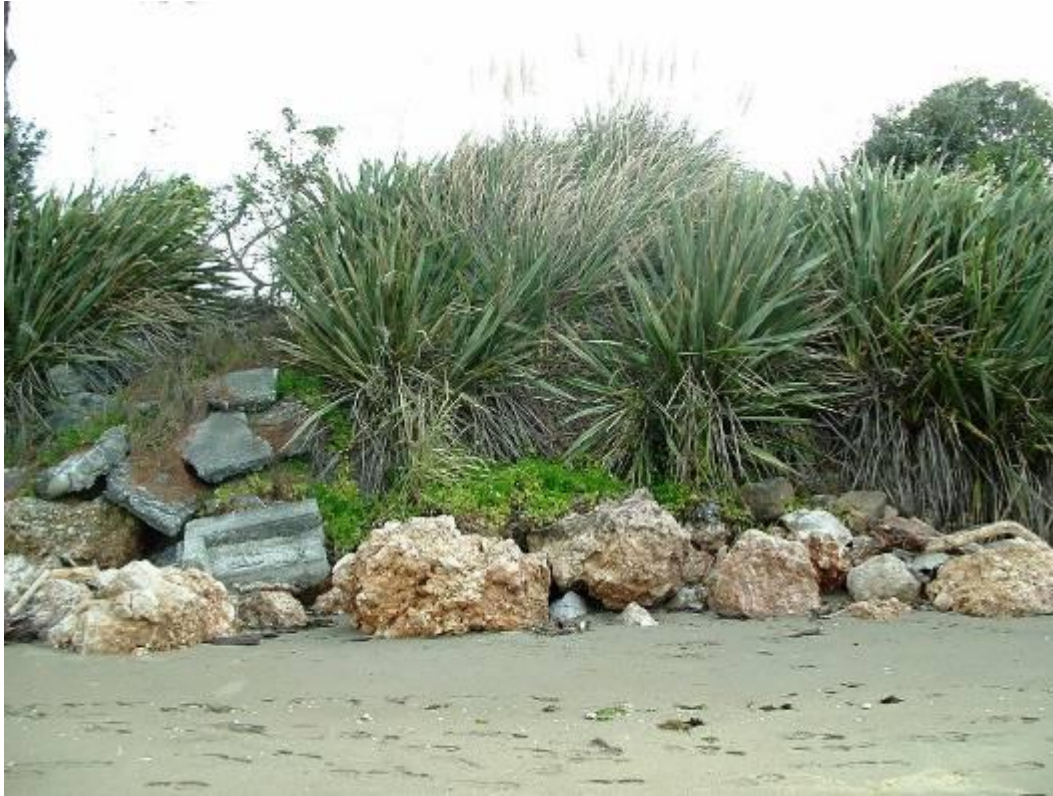
Photograph 5: Photograph illustrating the condition of much of the existing rock revetment
