TASMAN DISTRICT COUNCIL CONTRACT NO 682 - PROFESSIONAL SERVICES

Date: 27 January 2009
To: Peter Thomson
Copy to:
Reference: Z1448907
Subject: SALISBURY SUSPENSION FOOTBRIDGE, AORERE – BRIDGE NO. 112302

ASSESSMENT AFTER BRIDGE TEMPORARY CLOSURE

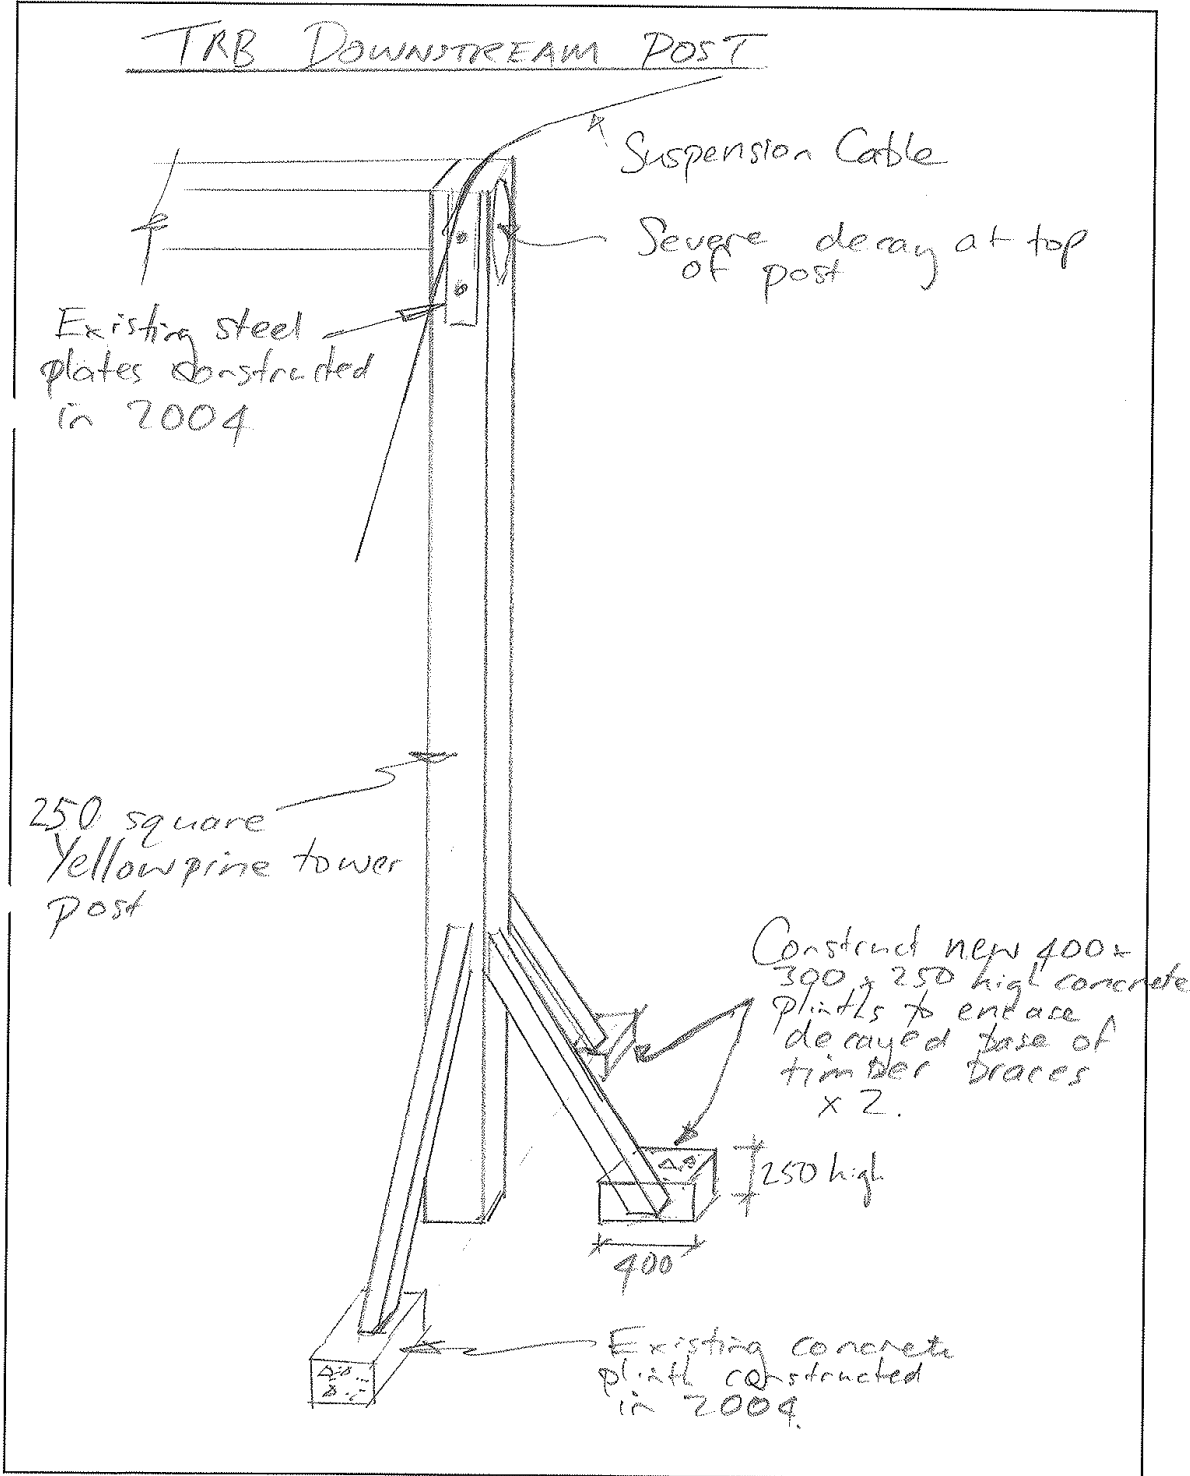
PROJECT Salisbury Suspension Bridge PROJECT No. _____
 DESCRIPTION TRB Downstream Post.
 COMPUTED/PREPARED BY _____ DATE _____ 20____
 REVIEWED/CHECKED BY _____ DATE _____ 20____
 REF/DWGS _____ SHEET _____ OF _____

The base of two of the bracing posts on the TRB downstream post are decayed at ground level. It is recommended that the base of these two posts be encased in concrete using the same detail that was used on other braces in 2004. (Sketch attached).

The base of the two braces that have decayed on the same tower should be encased in concrete as per the attached sketch.
