# Moutere Catchment Ecological and Water Quality Survey

Trevor James, 2018

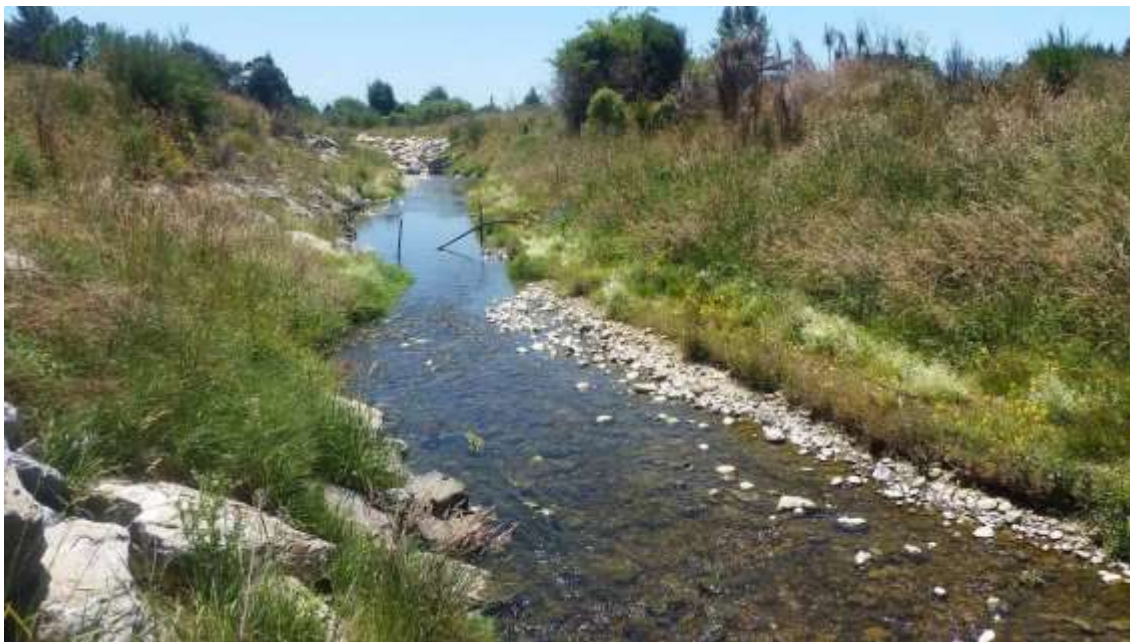
There was a strong correlation between the amount of shading of the water (mostly by trees) and water temperature. Where there was limited shading of the stream, water temperatures were highest. The maximum water temperature was found at Wilson Road (25.7°C) with similar temperatures all the way to the estuary. Inanga appeared to be absent when stream temperatures got over 25°C. Note that 24°C was the maximum recorded in continuous sampling over a week in Feb 2014 at the State of the Environment site at Chings Road. This is the zone where significant adverse effects to stream invertebrates occur. Where there was rock rip-rap, there was limited shading (see photo below).

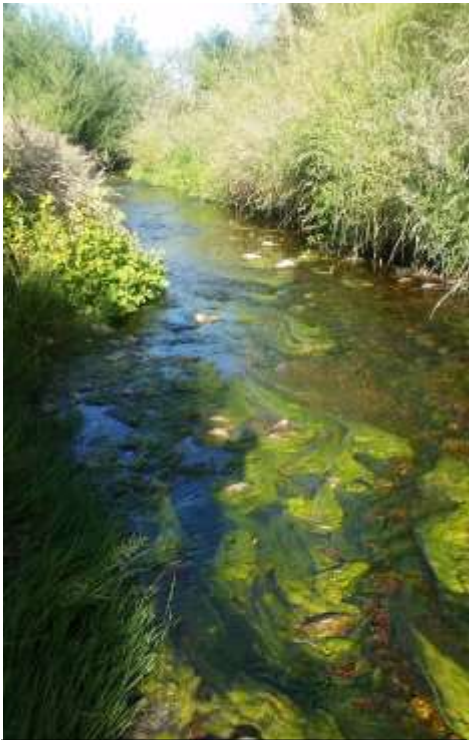
Photo above: 80% filamentous green algae in lower Rosedale Stm

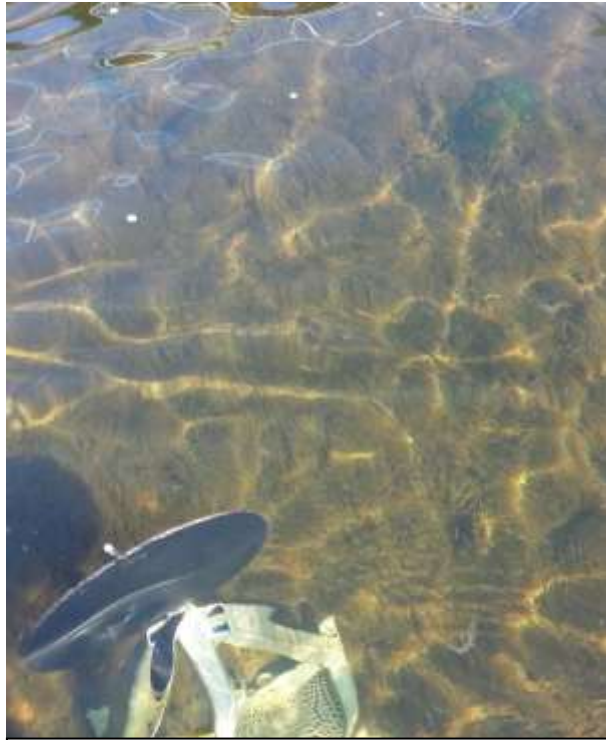
Photo above: 100% filamentous green algae cover in near Chings Rd (SOE site)

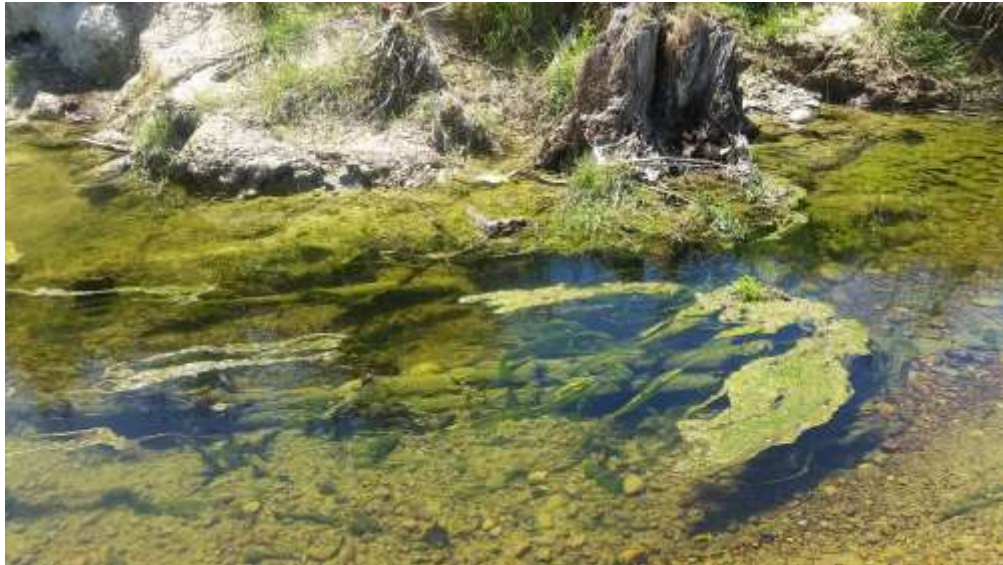
Photo above: A deeper zone caused by the old willow stump. Filamentous green algae about 30% cover. About 2km downstream Kelling Road.

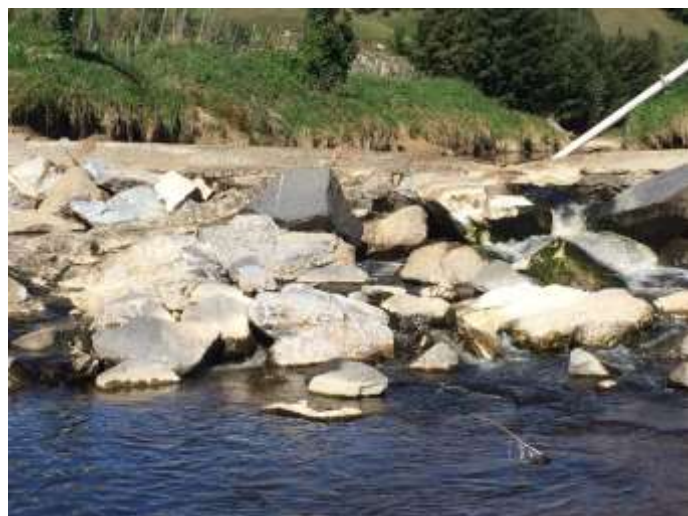
**Fish passage barriers.** There is only one known significant fish passage barrier (about 500m downstream of Old House Rd – see photo to the right) and several less significant fish passage barriers on public land. However, very little investigation of in-stream structures has been undertaken on private land in this catchment.

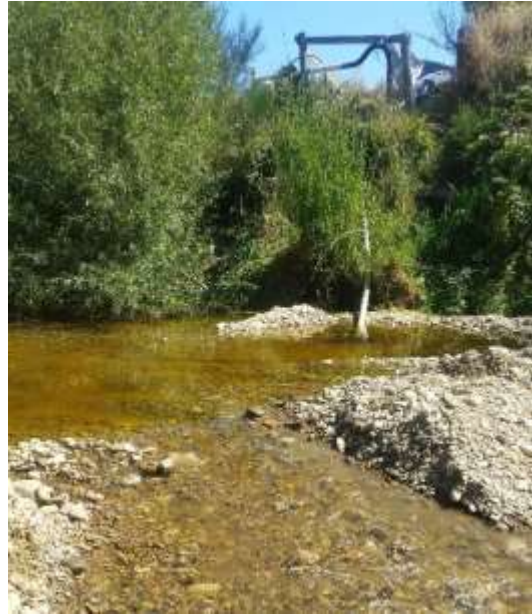
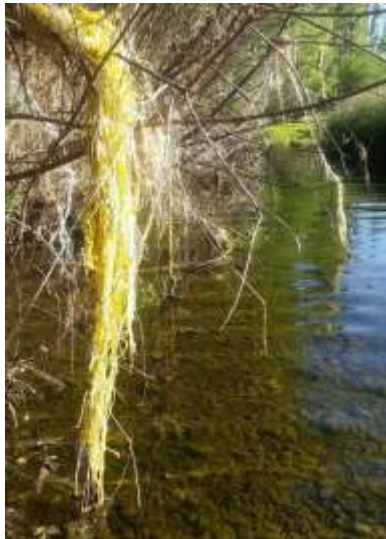
**Unauthorised water takes.** Only one unauthorised water take was found in this study but no follow-up undertaken. The photo to the right shows how it is typical to dig a hole in the waterway to install the intake structure (this was compliant). Several of the screens on these intakes have velocities at the screen that are too high and therefore are likely to suck up fish. The TRMP rules require low velocities at the intake to avoid this. McCallum 2015 noted that in the drought to 3 March 2015 (34mm over the 3 months prior), flows were 12-14 L/sec at Holdaway Road. This is substantially higher compared to a similar drought in 1998-99 when the river ran dry. This is most likely due to all consented water takes now having a cease-take minimum flow when the river reaches 20 L/sec.

**Litter.** Generally very little litter was found in the Moutere catchment. The main litter found was plastic twine (see photo to the left taken upstream Davey Road on Motuere ditch), most likely from hop orchards and baleage wrap.

3. Undertake an on-the-ground audit of water takes should be undertaken in the catchment at peak demand times to ensure that there are no unauthorized takes.

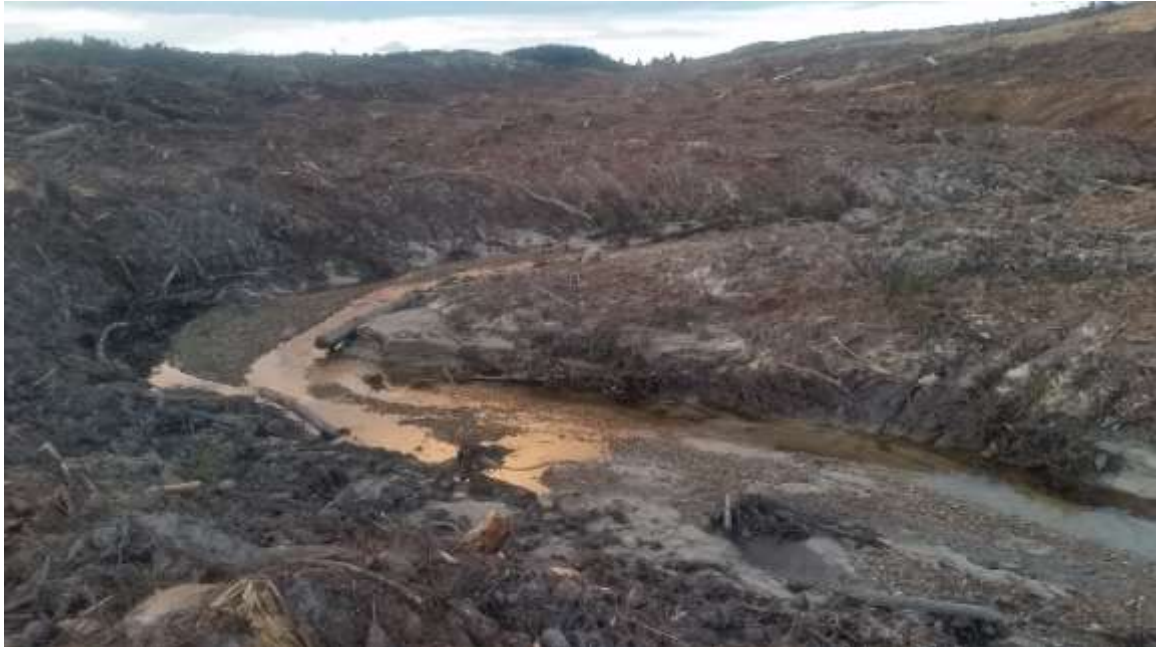
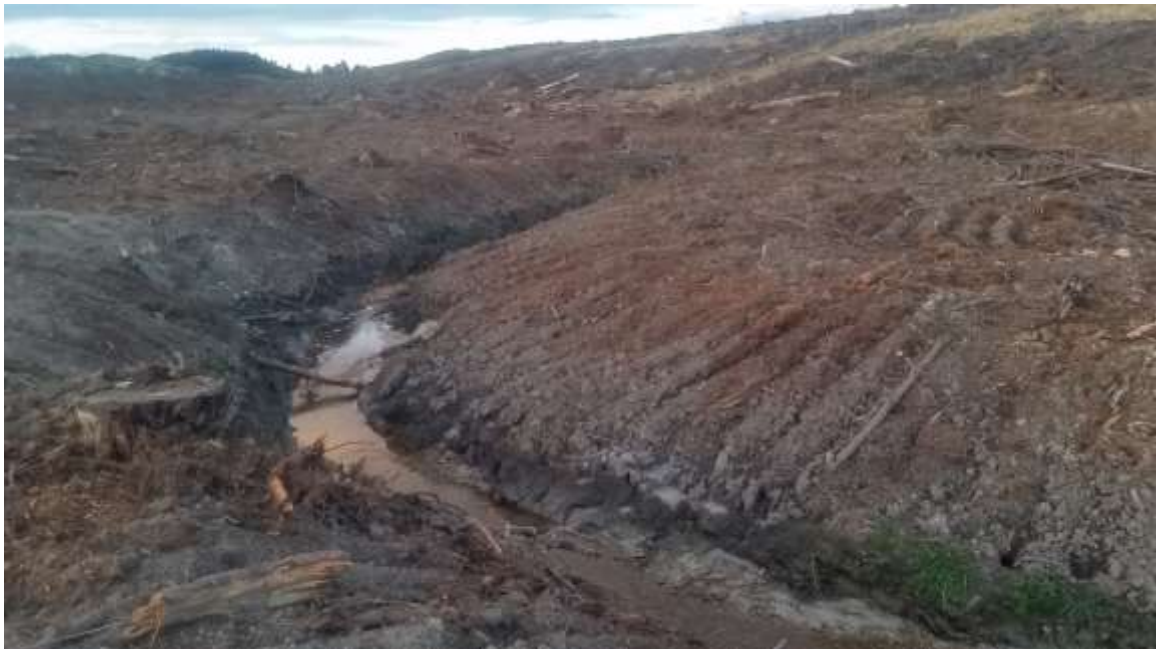
Below: The landscape following forest harvesting operations SW of Upper Moutere in autumn 2017 (near Cut Hill west of the Moutere Highway). Root-raking (particularly perpendicular to the contour) is well known to make the stream banks and riparian zone very vulnerable to erosion and is the reason the TRMP rule (28.1.6.1(d)(viii)(d)) was proposed. The follow-up with the forestry company (Nelson Forests Ltd) was limited.

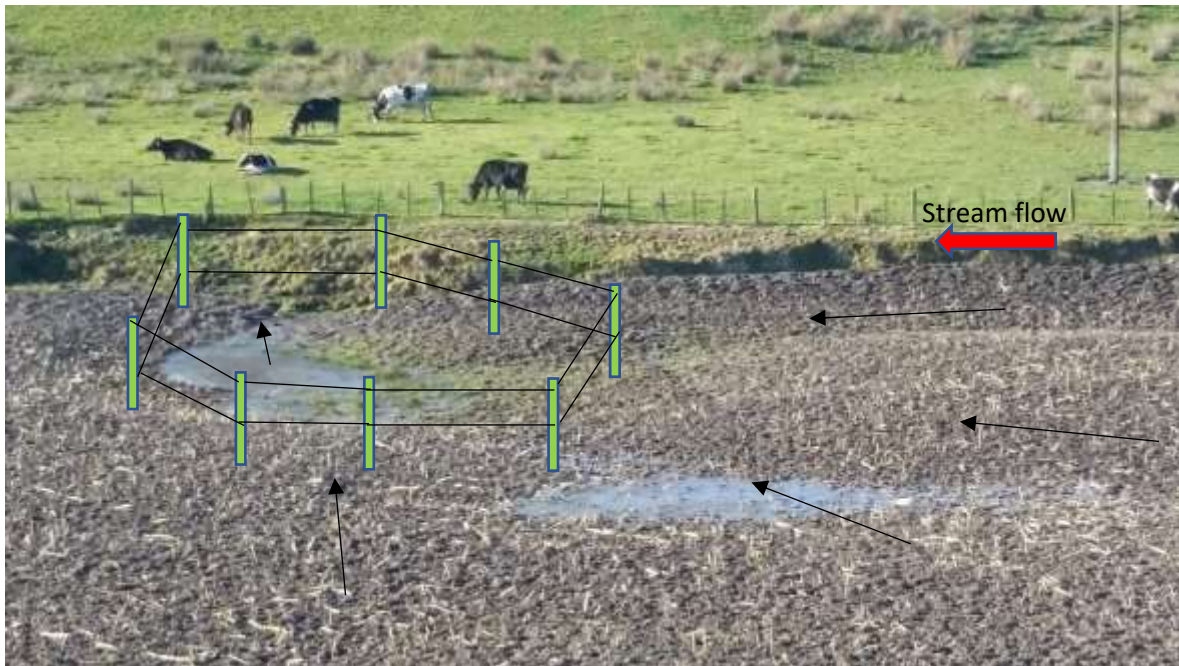
Below: Erosion potential and fine sediment discharges from winter cropping seen from Neudorf Road (August 2016). The stream is in the channel indicated by the red arrow. It is important to fence off areas where runoff funnels into the stream. Black arrows indicate direction of flow of runoff. This stream is now fenced.

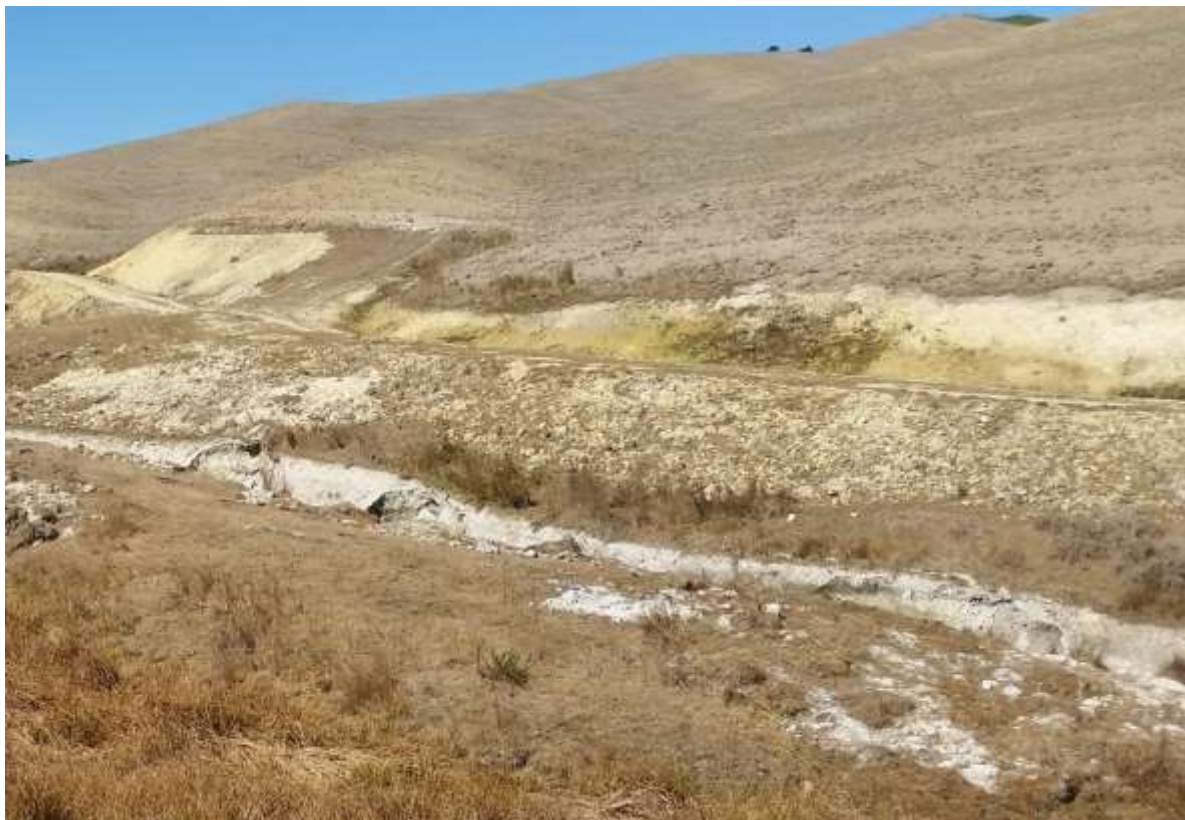
Below: Potential fine sediment discharges from cultivation and side-casting from road building as seen from upper Rosedale Road (September, 2016). The lower part of this slope would ideally have been left in rank grass to trap any eroded soil washed off during higher rainfall events.

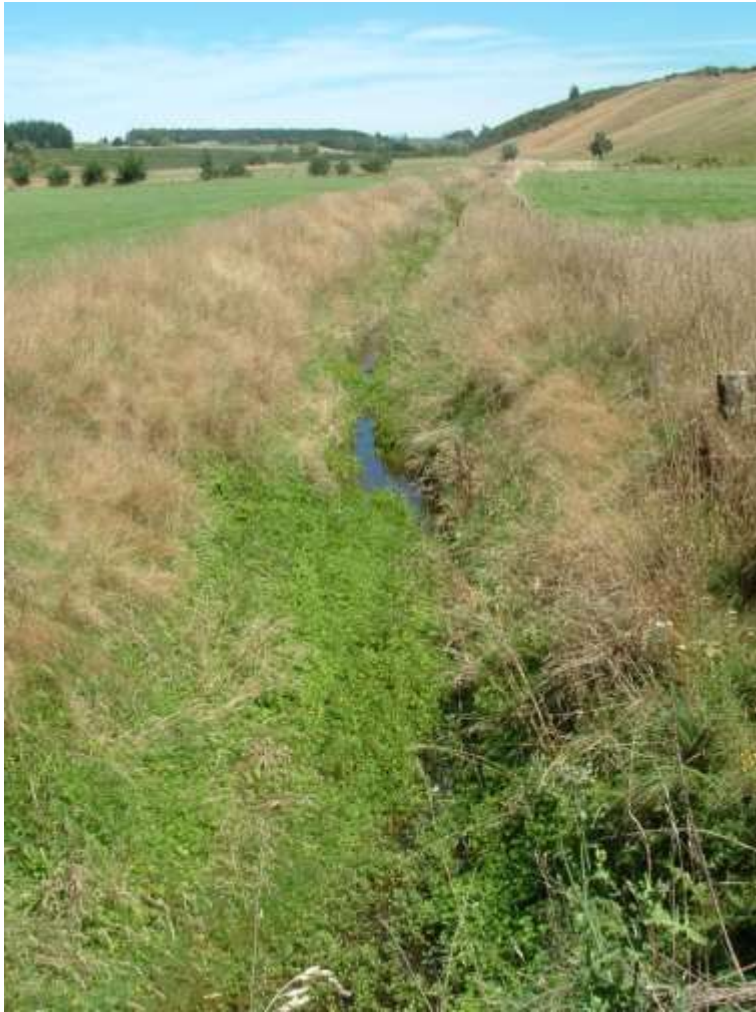
Left: **Unnamed creek at Central Road**, between Davey and Wills Roads, view upstream. This stream had **low dissolved oxygen** in summer (below national standards). This is an example of a small tributary that would benefit greatly with shading from riparian trees and wetlands in the headwaters. While this stream almost dries up in many years, there are enough residual pools to support life until the flows return.

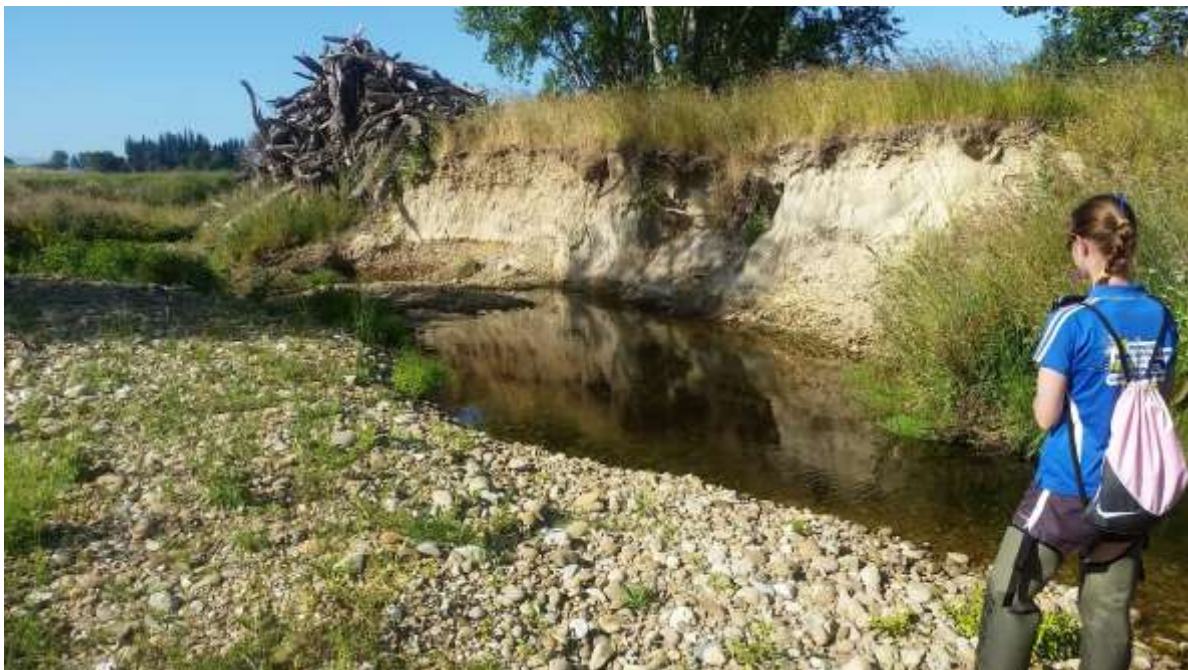
Below: Note the deep pool adjacent to the steep bank. The geology of this material is more resistant to erosion than in other parts of the catchment where the banks consist more of silty material. Some planting at the top of the bank would be advantageous for shading/feeding the stream as well as bank stability. **'Rosedale Stream' ~300m downstream Old House Road.**

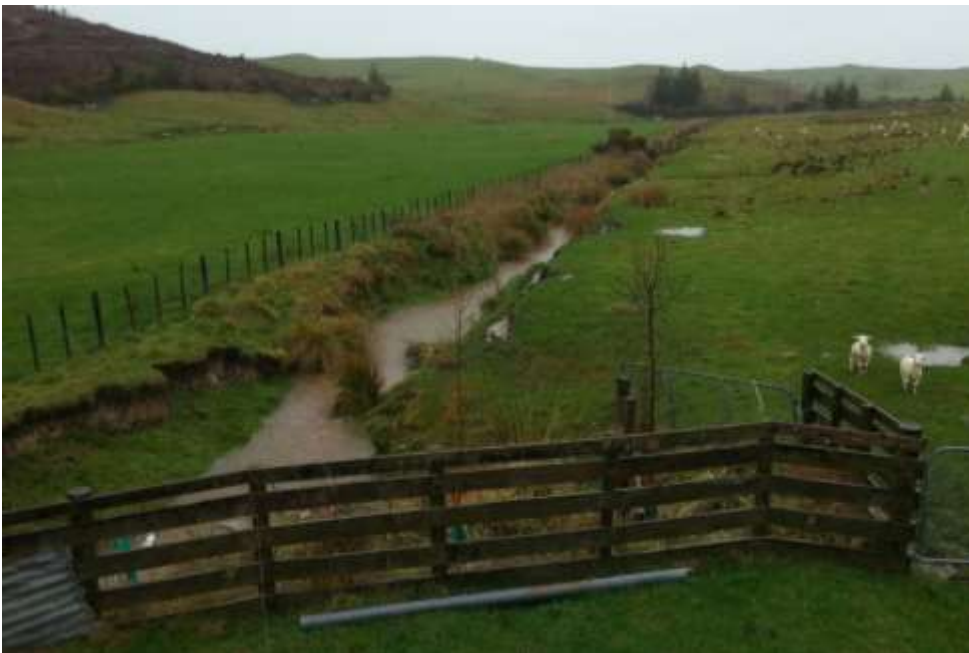
Left: 1.2km upstream of Moutere Highway looking upstream (E1601055 N5439376) as shown by the red arrow in the top photo.

Note: Riparian planting was carried out on the true left bank upstream of here but there was a poor survival rate due to inadequate releasing.

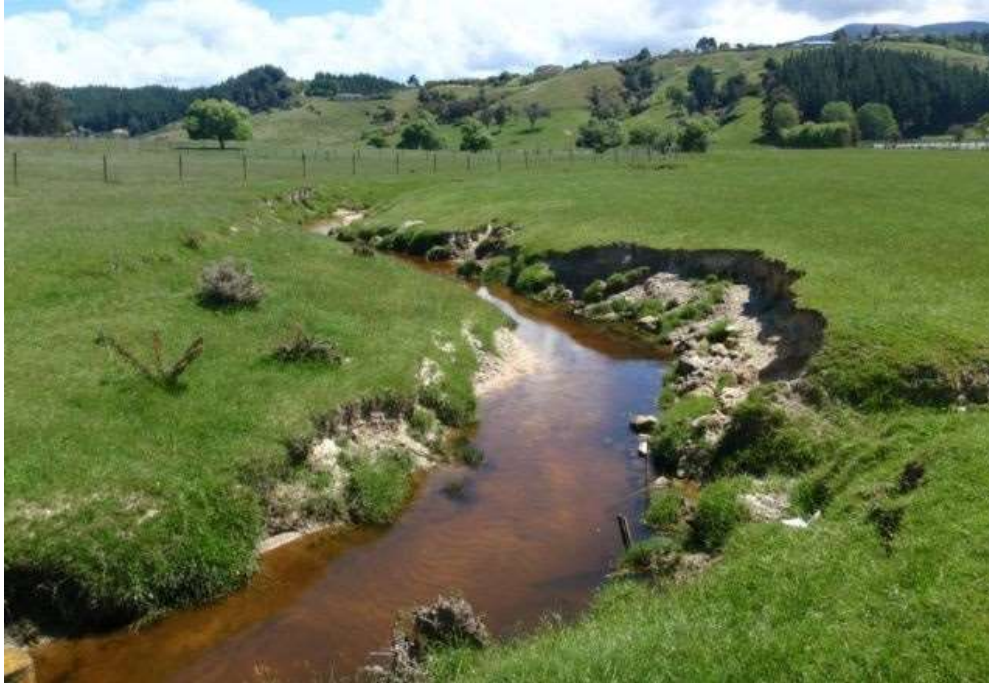
Below: **Powely Creek upstream Starnes Road** (view upstream). Note the **erosion and sediment discharge** caused by deer. Note the brown staining of the water showing that this is **fed by a wetland**. With a wetland in the hinterland and a reasonable amount of natural meander, this creek has a “head start” for restoration. The lowest reaches (600m) have good riparian tree cover and habitat.

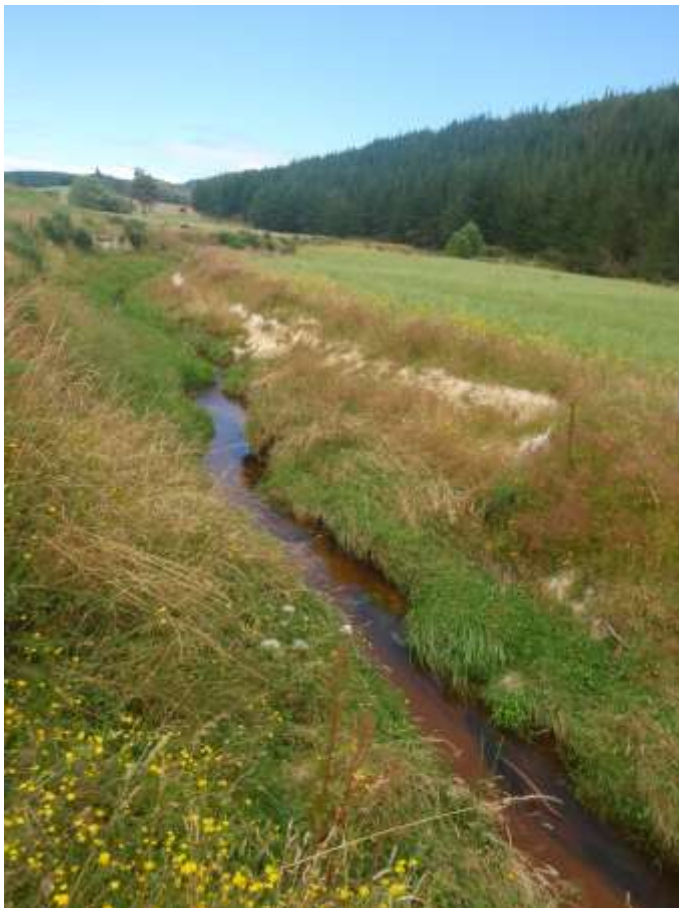
Left: **Powely Creek about 1.8km upstream of Starnes Road**. While this section has been straightened in the past (and a bit more meander would be good) the small meanders in this small creek still provide reasonable hydraulic diversity. It is mainly riparian tree planting that would be required.

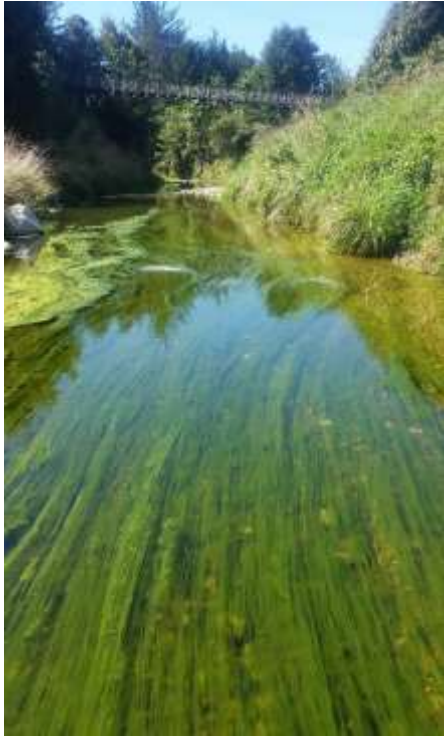
Left: **Moutere Rv looking downstream to Wilson Road** (E1599733 N5439178). Note >90% cover of filamentous green algae.

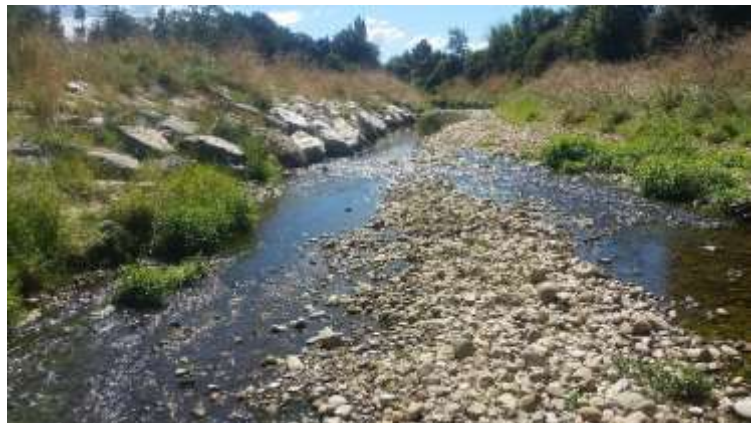
Below: **Moutere River at 400m upstream Wilson Road** looking downstream (E1599752 N5438457). Rock rip-rap on the left bank is relatively short and does not appear to have an adverse effect on water depth or hydraulics. However, this relatively unshaded section of the waterway led to a significant increase in water temperatures. Planting trees near the top of the rip-rap bank in this situation would have a large beneficial effect for stream shading.

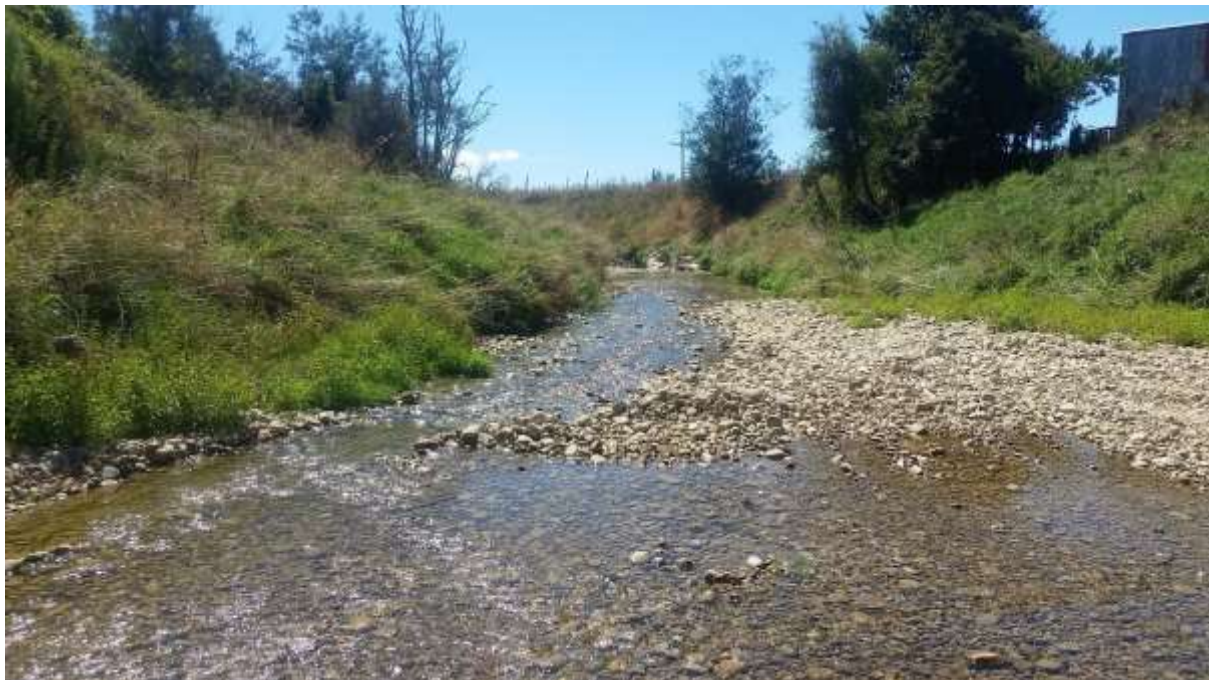
Below: **Moutere River at Wills Road** viewed downstream (E1599985 N5437635). This habitat is reasonably typical of sections in the mid reaches of this river showing the limited shading.

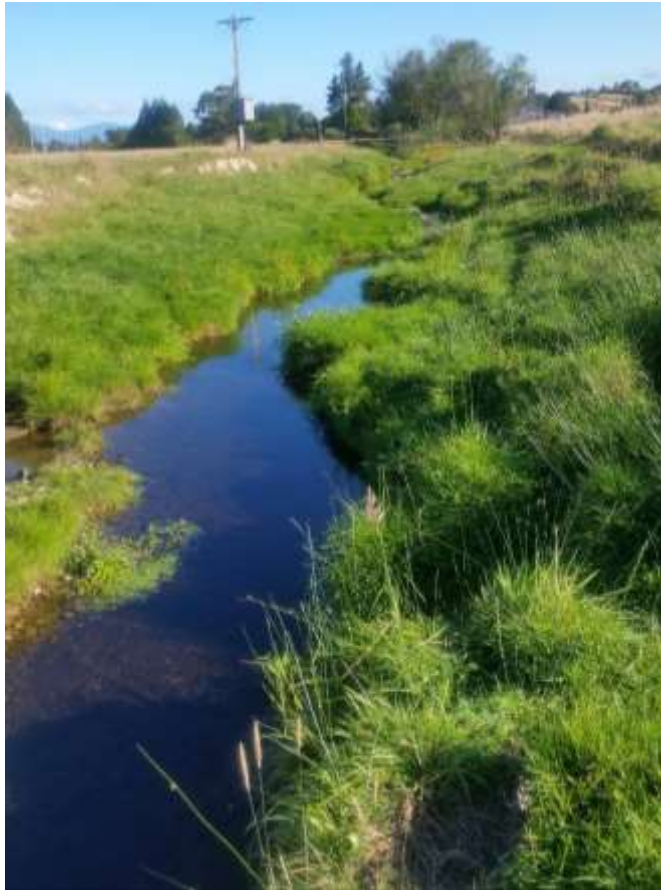
Left: **Company Ditch No1 at 220m downstream Davey Road (E1600728 N5436205)** and ~400m downstream of the photo below. A real opportunity exists to plant trees at the top of the bank along this part of the stream. Cattle are grazed in this area occasionally.

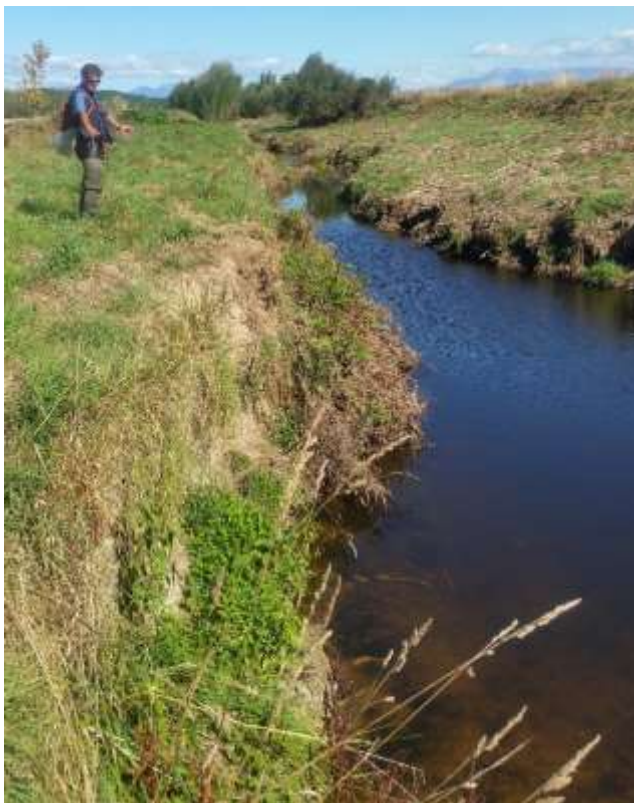
Left: **Company Ditch No1 approximately 300m upstream of Wilson Road.** Shows the removal of shrubby willow. Replanting in mixed natives and shrubby willow would achieve good shading through this section.

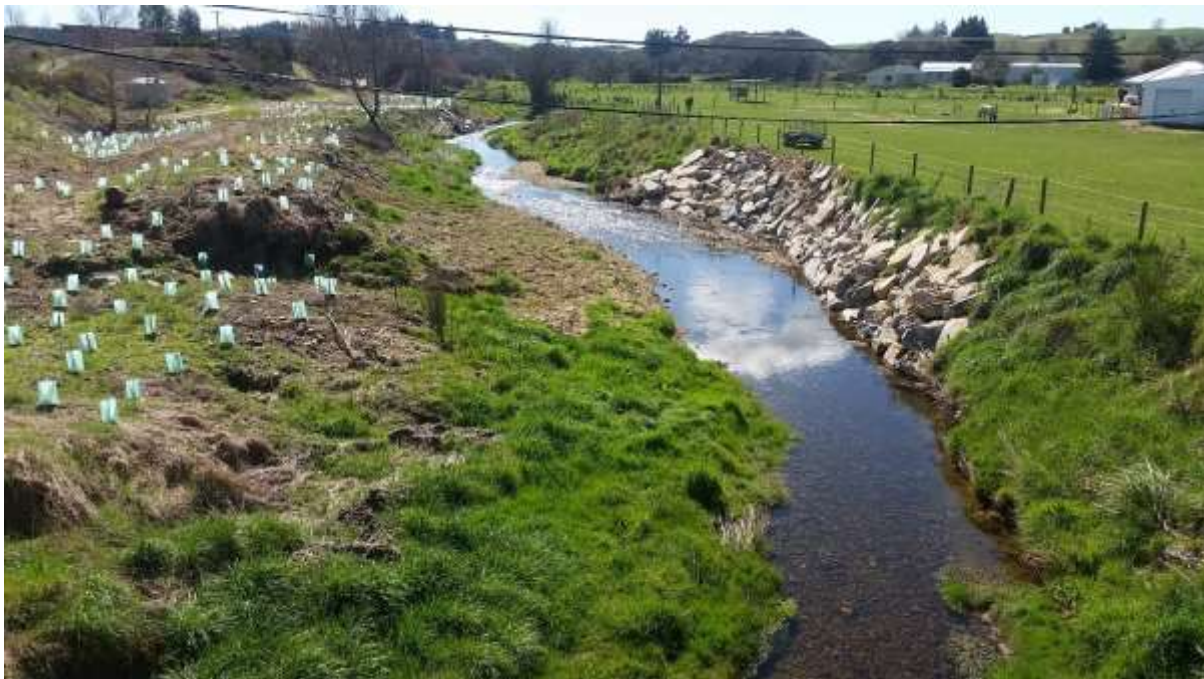
Below: **Moutere River downstream Kelling Road**. Unfortunately the trees (mostly smaller trees such as tarata (Pittosporum) estimated to be 10-12m) planted to the left of the photo will be limited in the amount they can shade the stream. Trees planted strategically at the top of steeper banks such as on the right above the rock rip rap would be effective at shading and feeding the stream. Small amounts of rock rip rap such as this are curved and are not adversely affecting the in-stream morphology.

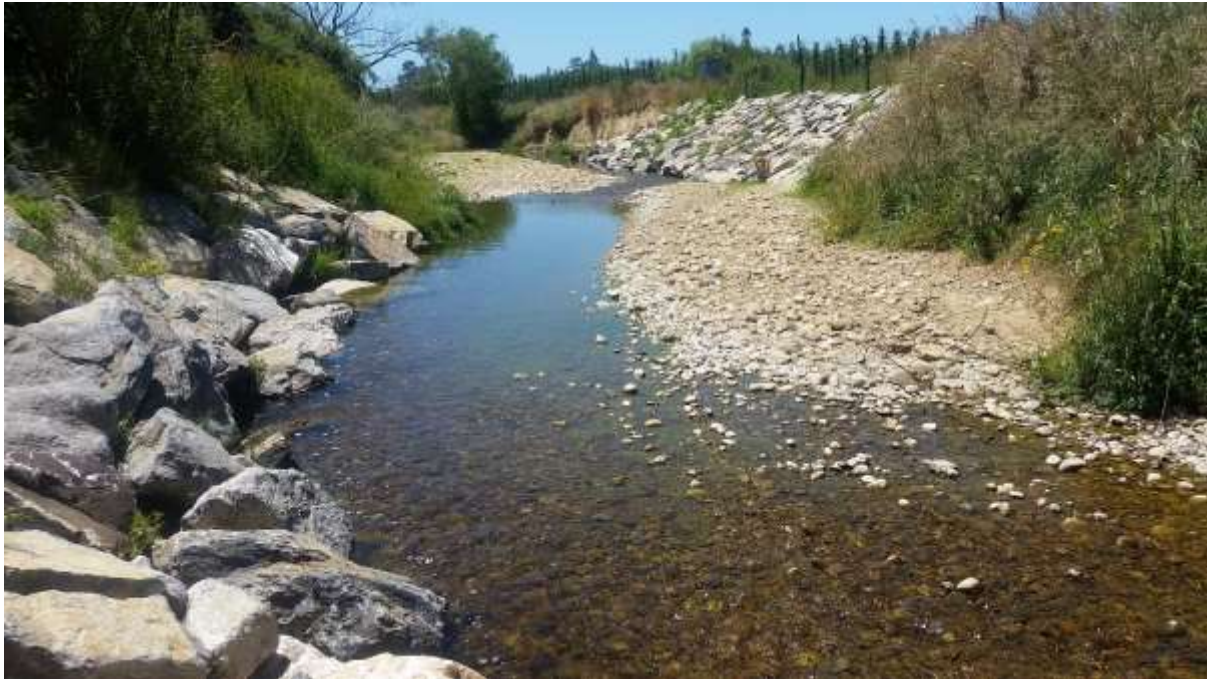
Below: This section of rip-rap retains a lot of the original meander. However, planting of the downstream (furthest away) section of battered rock 91h:1v) would be beneficial. **Moutere River ~600m upstream Old House Road (E1600012 N5434364).**

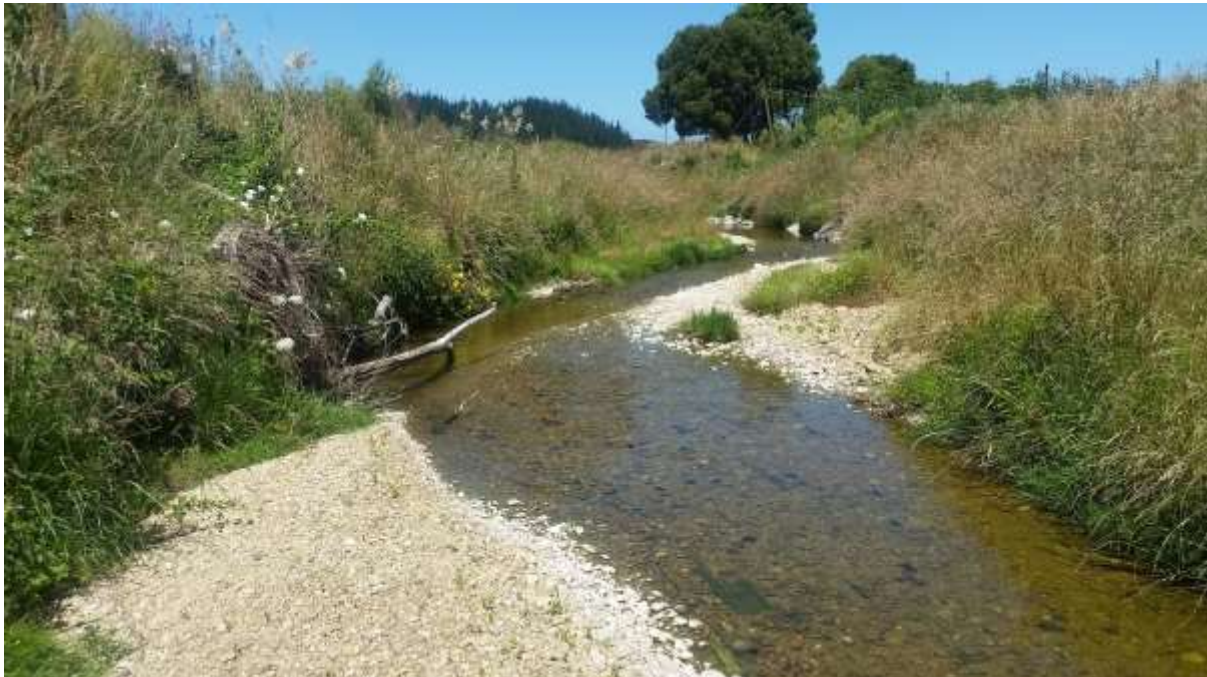
Below: More typical unshaded sections of the Moutere River but with good meander and water depth variety. **Moutere River ~360m upstream Old House Road.**

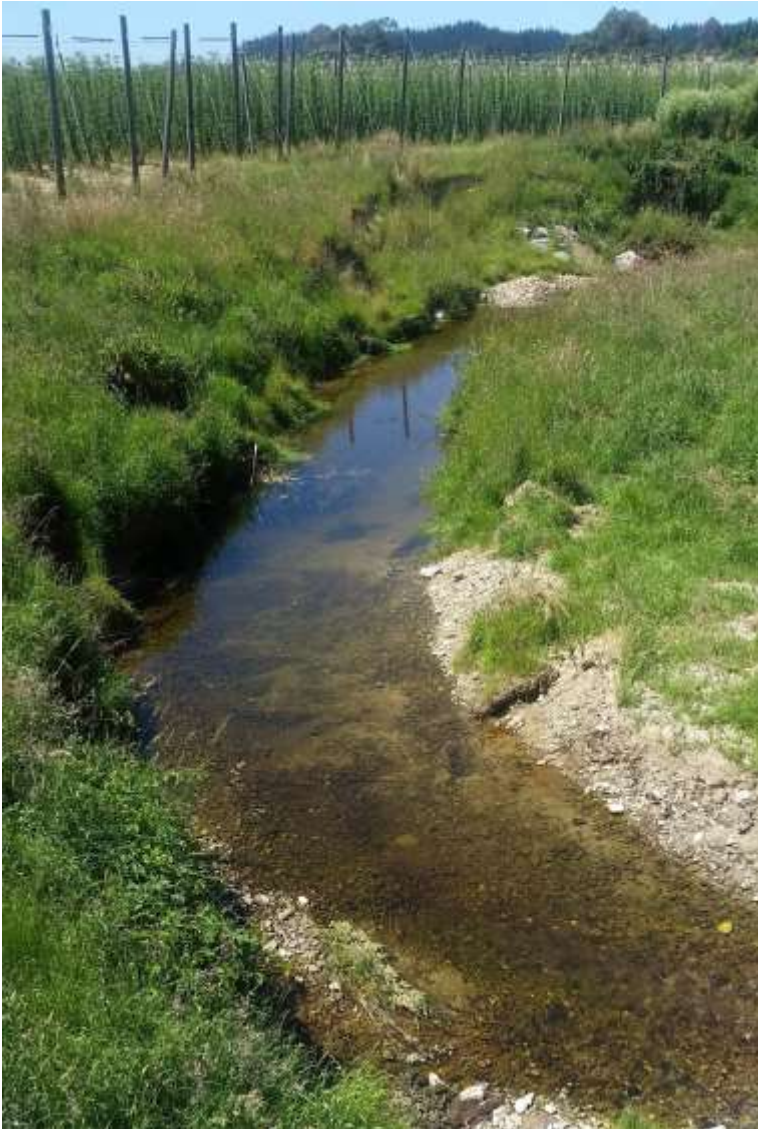
Left: This shows the proximity of the waterway to hop orchards and the limitation for the river to move and be protected by soft engineering approaches. **'Bosselmann Stream' looking downstream from Old House Road (E1600123 N5434800).**

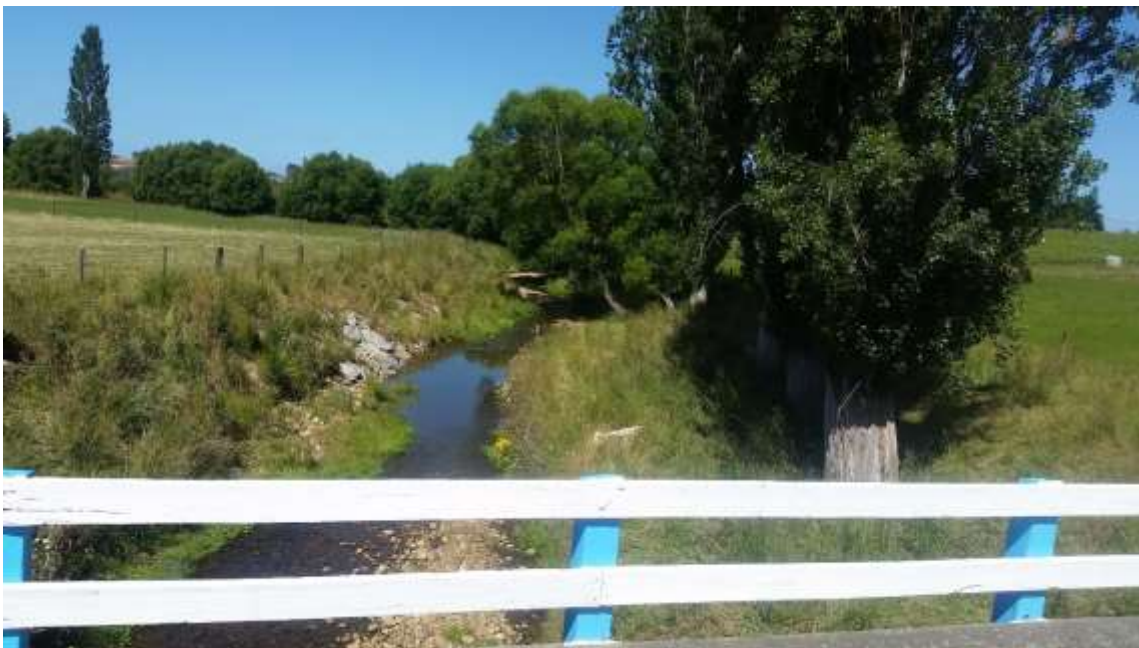
Below: **'Bosselmann Stream' at Rosedale Road** showing willows and poplars providing good shade. A mix of natives and exotics would be much better for our native freshwater fauna.
