# **GEOTECHNICAL INVESTIGATION REPORT**

## **PROPOSED NEW SLEEPOUT & GARAGE**

## **38 KAITERITERI-SANDY BEACH ROAD**

Reference: CN367

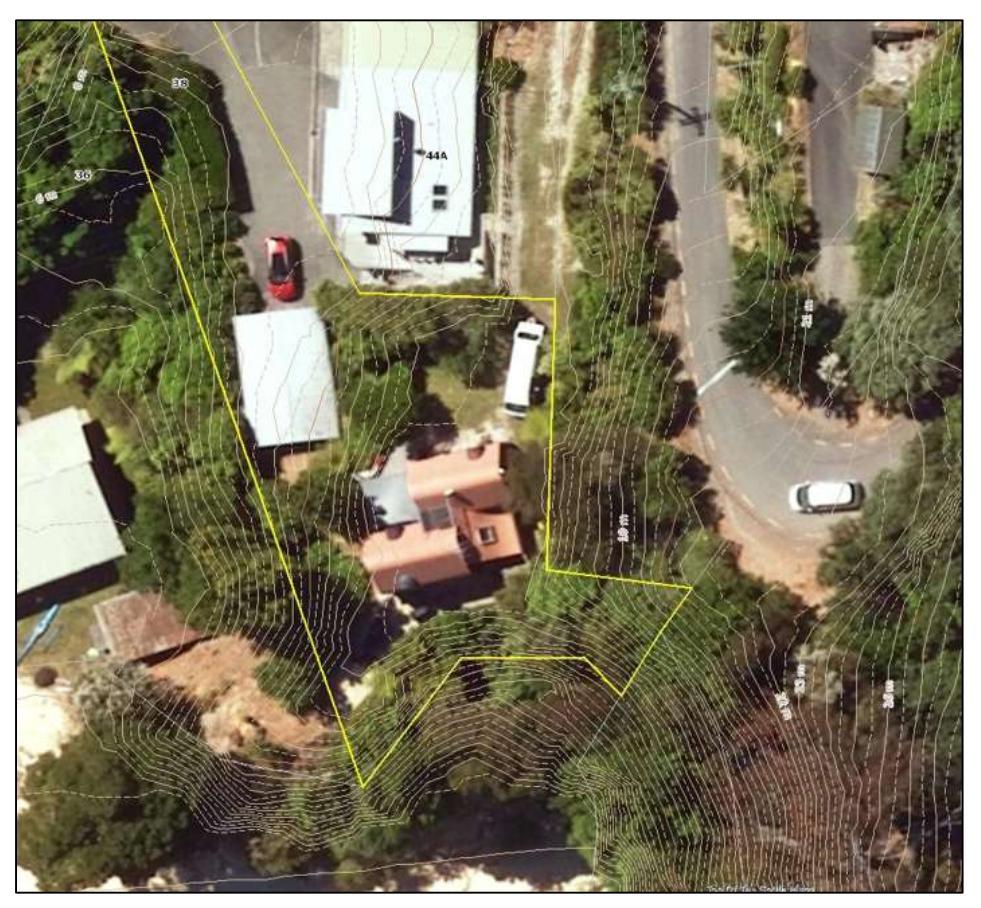
See image 1 below for an aerial image of the property and its approximate boundaries and topography outlined in yellow.

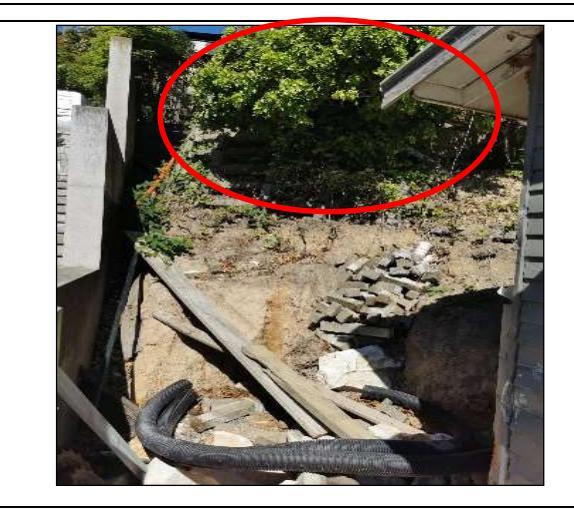
Photo 1:

Looking to the east at the steeply sloping area adjacent to block wall boundary with 44A. Note the crib wall above the unsupported slope (circled).

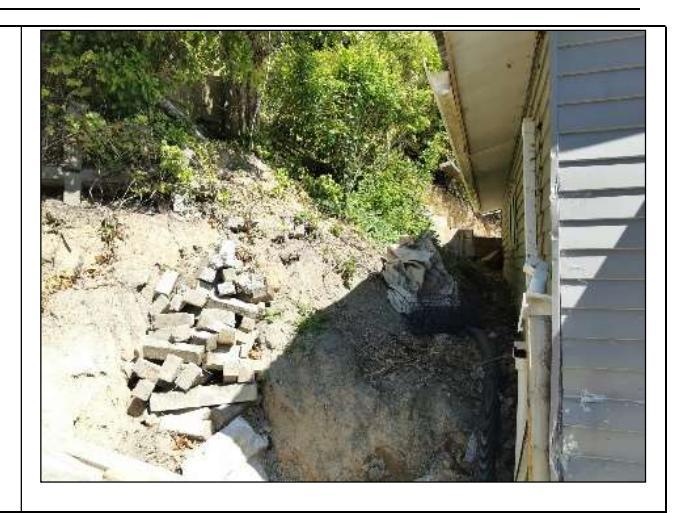
Looking south-east adjacent to the existing garage that is to be removed. The formation of a cut of up to approximately 4.0m is proposed in this area to form the eastern wall of the sleepout.

Where required the cut faces of the building platform excavation should be supported by retaining walls specifically designed to support the proposed cut face prior to bulk excavation. A soldier pile wall is recommended for this.

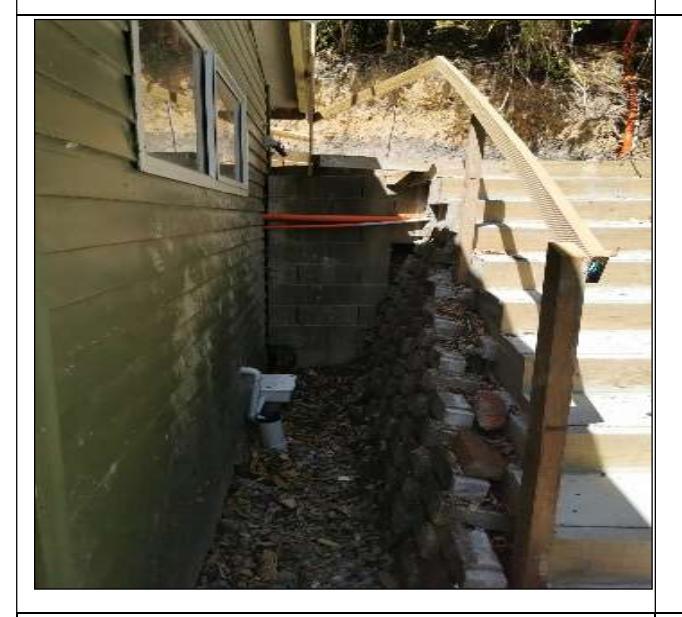
Looking east at the 1.2 m high garden retaining wall with a further exposed cut above this adjacent of the steps of approximately 1.7 m.

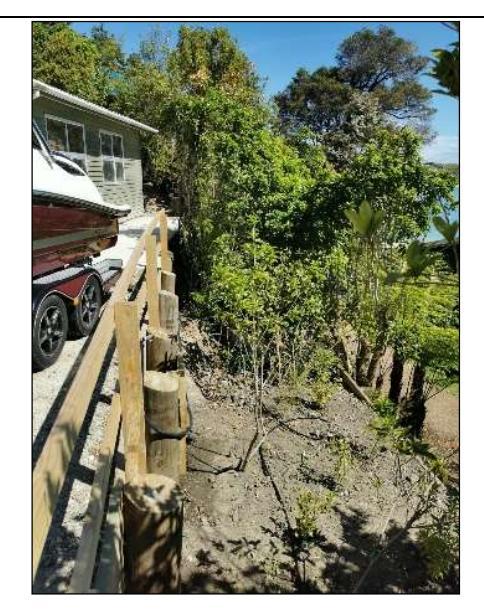
Photo 4:

Looking south at the western site boundary and the adjacent tiered timber pole retaining wall.

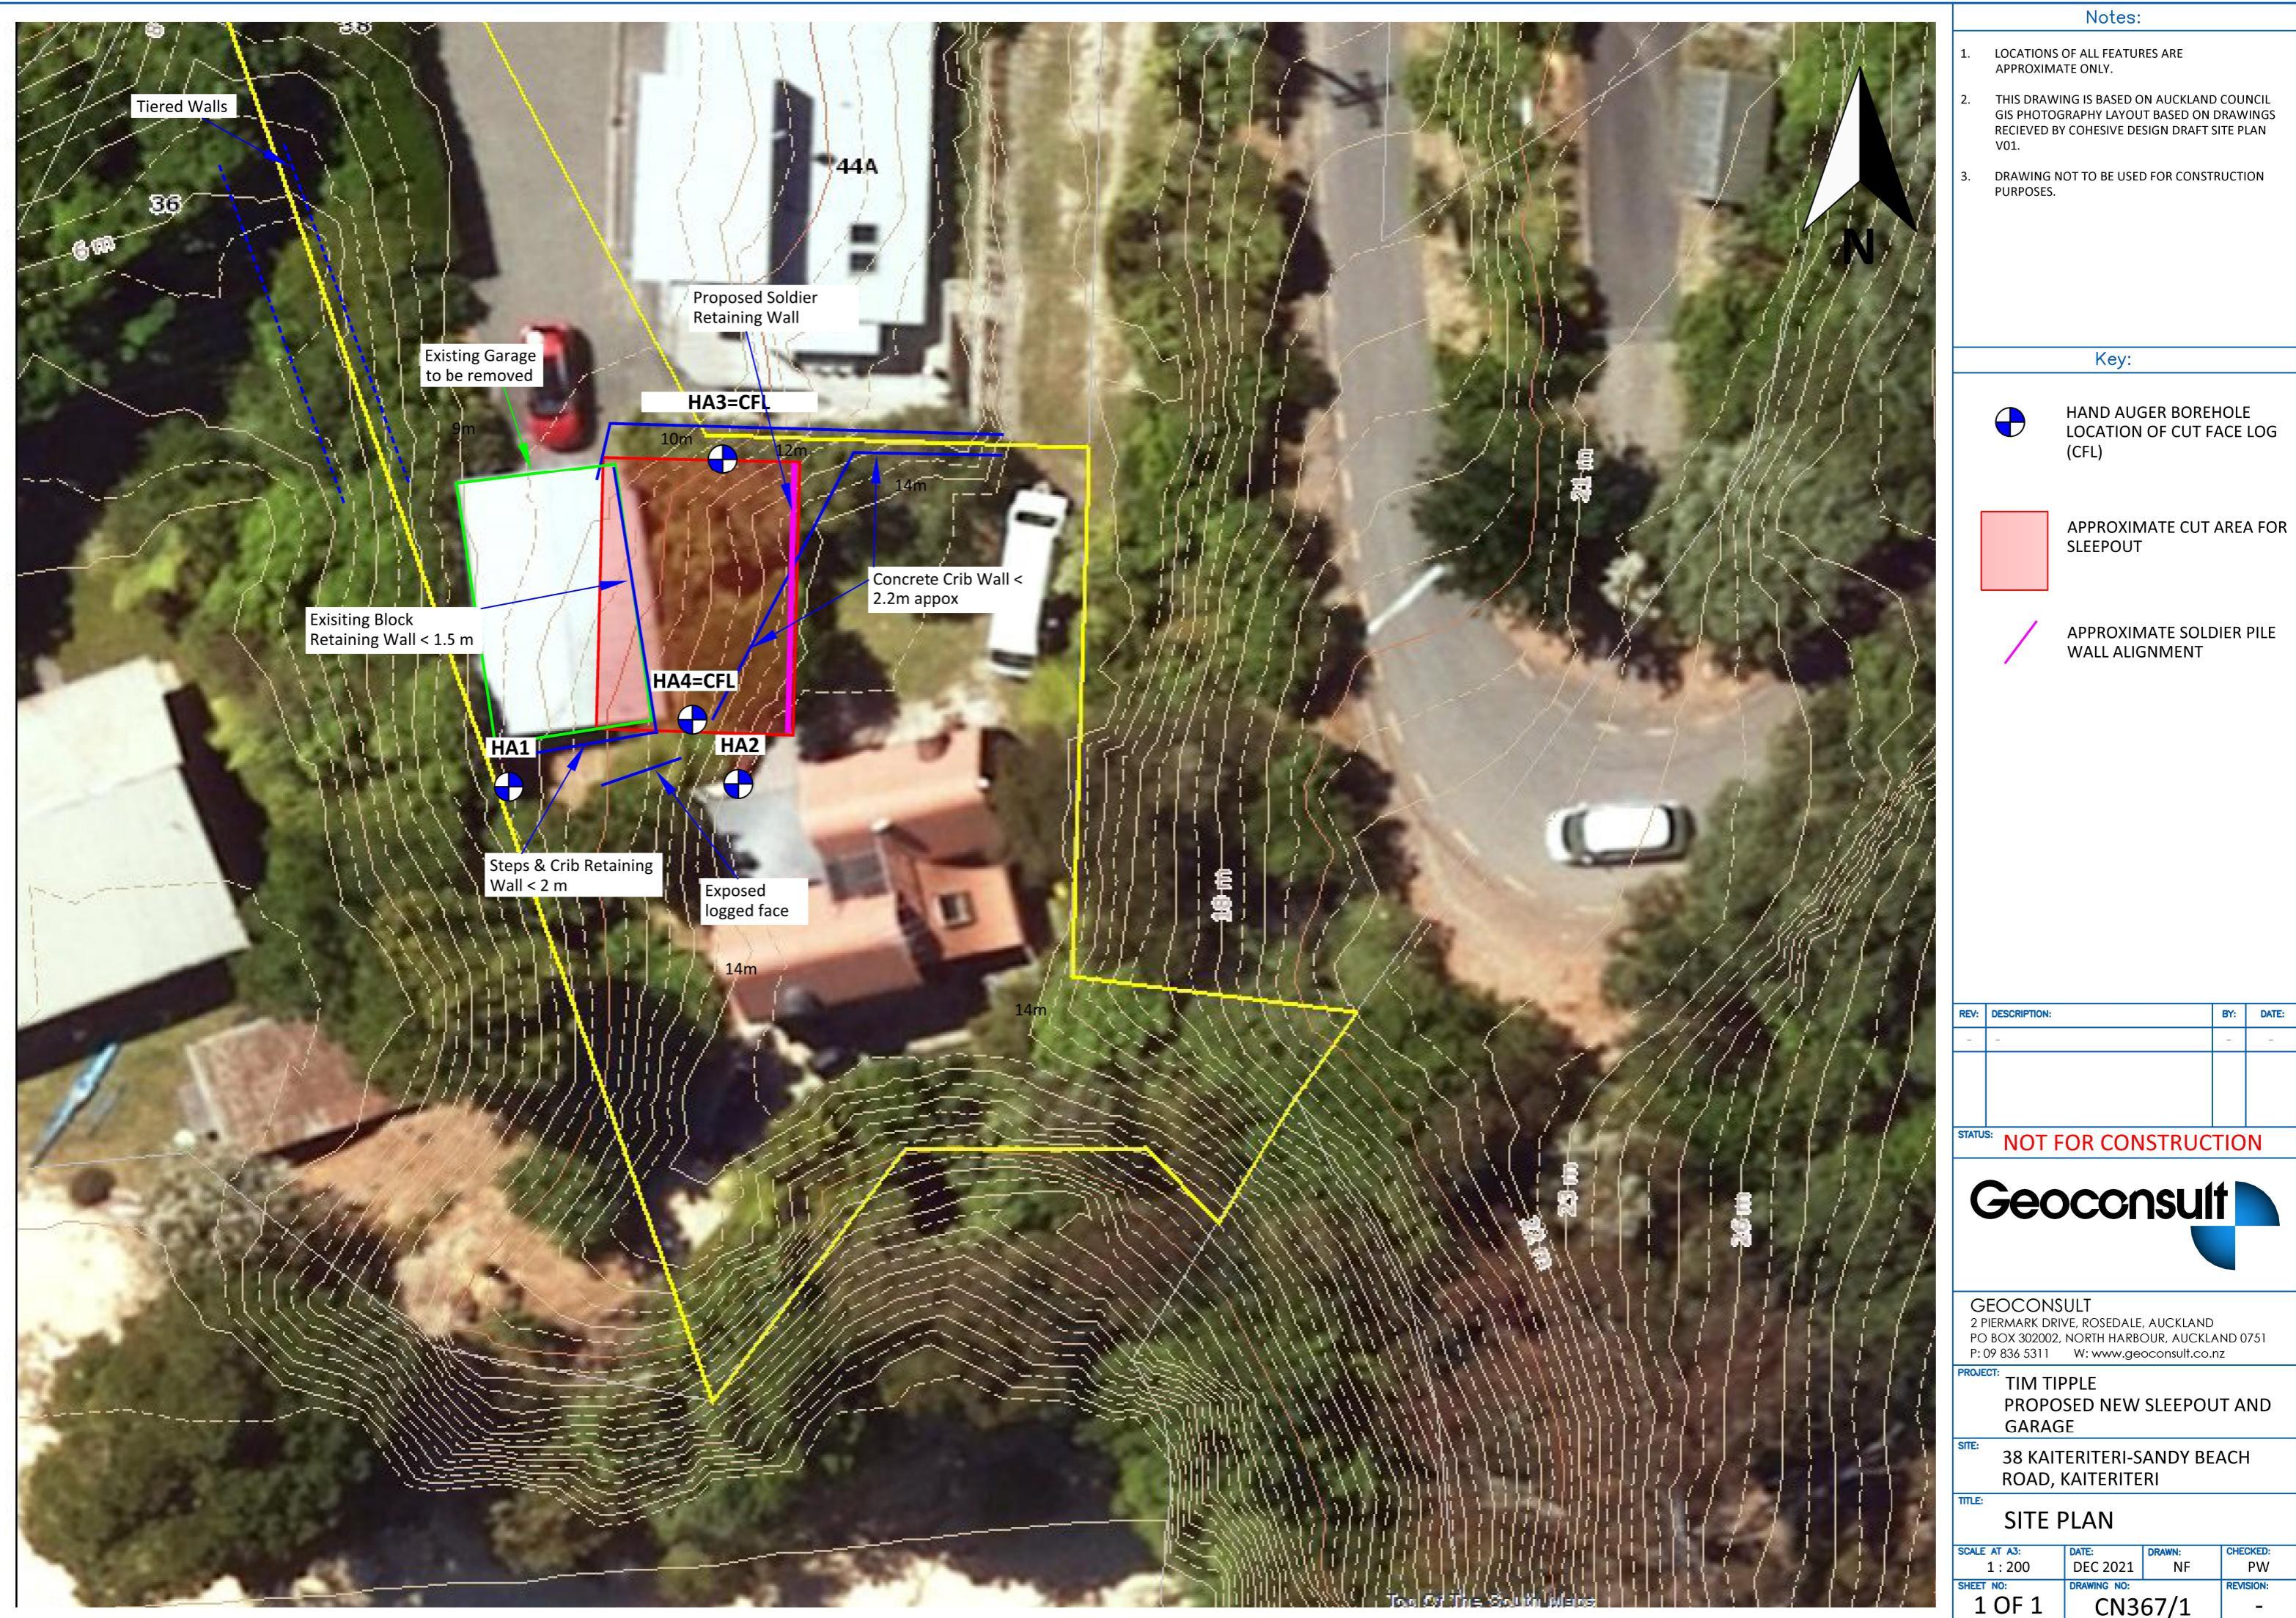
SCALE AT A3:	DATE:	DRAWN:	CHECKED:
1:200	DEC 2021	NF	PW
SHEET NO:	DRAWING NO:		REVISION:
1 OF 1	CN367/1		-

The approximate locations of the boreholes or exposure logs are shown on our attached site plan drawing number CN367/1; the borehole logs and exposure log are also attached. The soil descriptions given on the logs are in general accordance with the New Zealand Geotechnical Society's 'Field Description of Soil and Rock'.
