Ref RM200488 and RM200489

RE: Further Information Request for Resource Consent Applications – RM200488 – To disturb land and rehabilitate for the purpose of gravel extraction. RM200489 – To erect signage and use an unformed legal road for traffic purposes.

CJ Industries Ltd has engaged Tonkin & Taylor Ltd (T+T) to provide advice on the implications of gravel extraction at Peach Island, Motueka on flooding (e.g., peak water depth, velocity) and geotechnical (e.g. scour, seepage) risk to the Peach Island stopbanks. This letter report outlines our findings in relation to the geotechnical and flood hazard investigations T+T have undertaken on your behalf. The purpose of these investigations is to support the resource consent application for gravel extraction at Peach Island, Motueka. Our full scope of assessment is detailed in our letter of engagement dated 8 October 2020 (T+T reference #1015514).

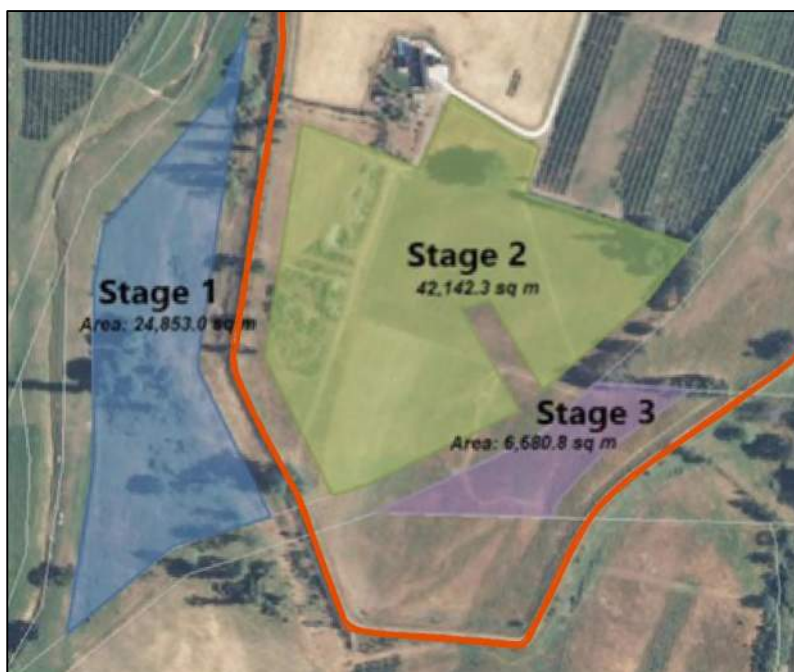
Figure 2: Peach Island Gravel Extraction Staging. Figure shows maximum operational extent of each stage. Stopbank crest shown (red). Modified from AEE prepared by Planscapes (2015)

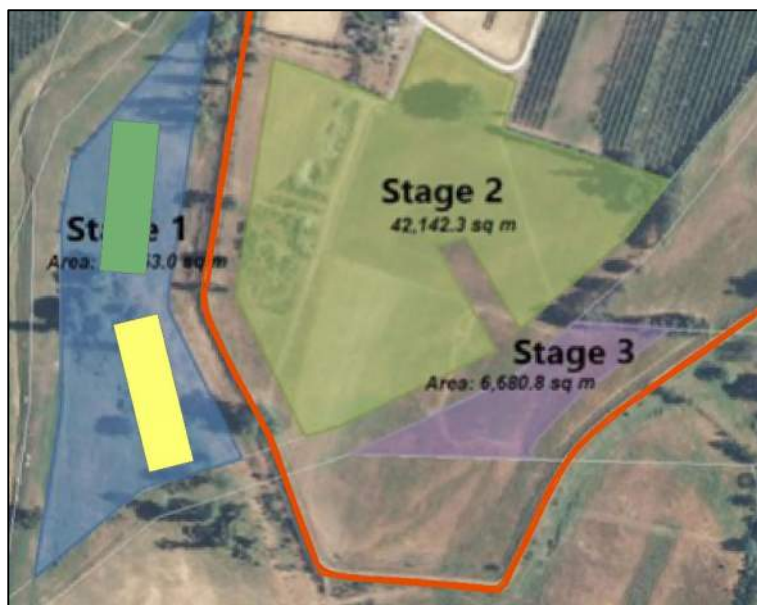
surface) were prepared, one each for the north and south of the stage 1 extent (see Figure 3). Each borrow is 30 m x 100 m and extends 5 m below the existing LiDAR ground level. These borrows are offset approximately 20 m from the toe of the stop banks and orientated parallel to the direction of flow. No further changes to the model have been made.

Figure 3: Modelled Borrow locations

Due to the proximity to the stopbanks these two locations are considered representative of the potential risk to the stopbanks as a result of the proposed activity. The run matrix below identifies the flood scenarios assessed, due to the relatively short consent duration (<15 years) no allowance for climate change or any additional upstream development has been allowed for.

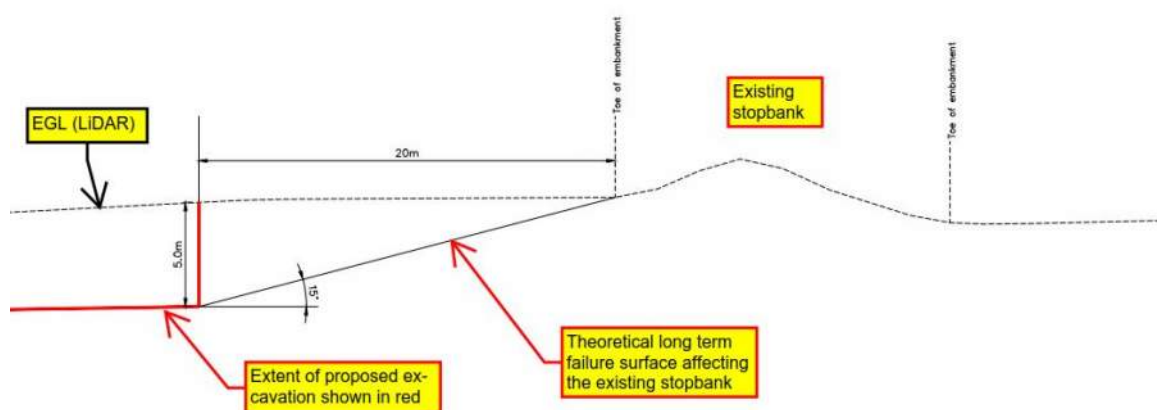
Figure 7: Design Section 3

Three typical design sections were produced based on the design assumptions in Section 2 above. The existing ground level is based on TDC LiDAR. These sections are shown in Figures 5 to 7 below.

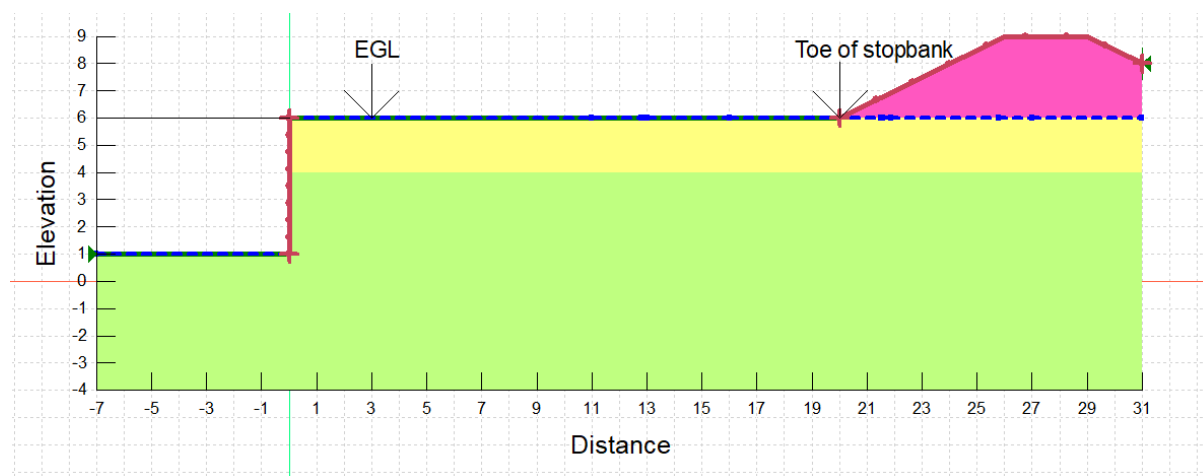
The assumed ground model is represented in Figure 8 below:

Figure 8: Ground Model – Elevated groundwater design case

- § 0-2 m depth below existing ground level – Alluvial Silts/Sands (loose to medium dense)
- § 2 m – 10 m+ below existing ground level – Alluvial Gravel (dense to very dense)
- § Stopbank filling assumed to be 3.0 m deep. A typical stopbank profile was used for the purposes of this analysis. Stopbank fill generally consists of silts and sands or a mixture thereof, based on test pit investigations carried out through the crest of the stopbank.
- § During excavation works for the borrow pit, the water level is expected to drawdown locally to the base of the borrow pit.

This ground model was applied to the critical design section 2. Industry accepted limit state stability software (Slope/W) was used to check the stability of this maximum theoretical long-term failure surface under fully saturated conditions for an elevated groundwater design case. A theoretical groundwater profile was adopted for static and seismic conditions, based on groundwater levels

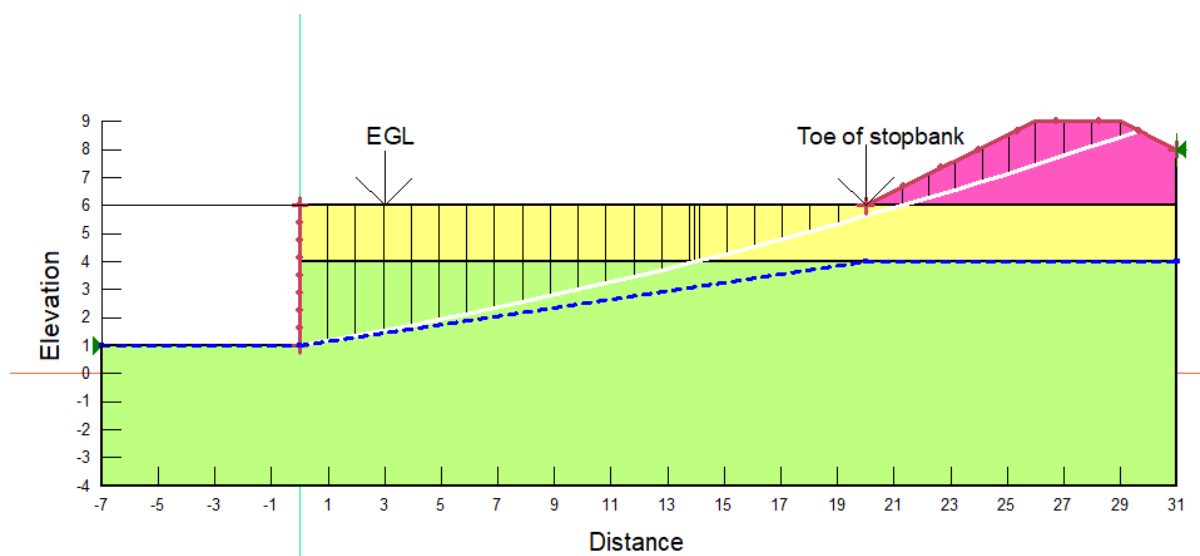
Figure 10: Static ground conditions. FoS exceeds 2.0

The results have shown that for the critical failure surface which affects the stopbank, the slope stability exceeds design requirements and the expected seismic displacements during a (1/500 year seismic event) are within acceptable tolerances.

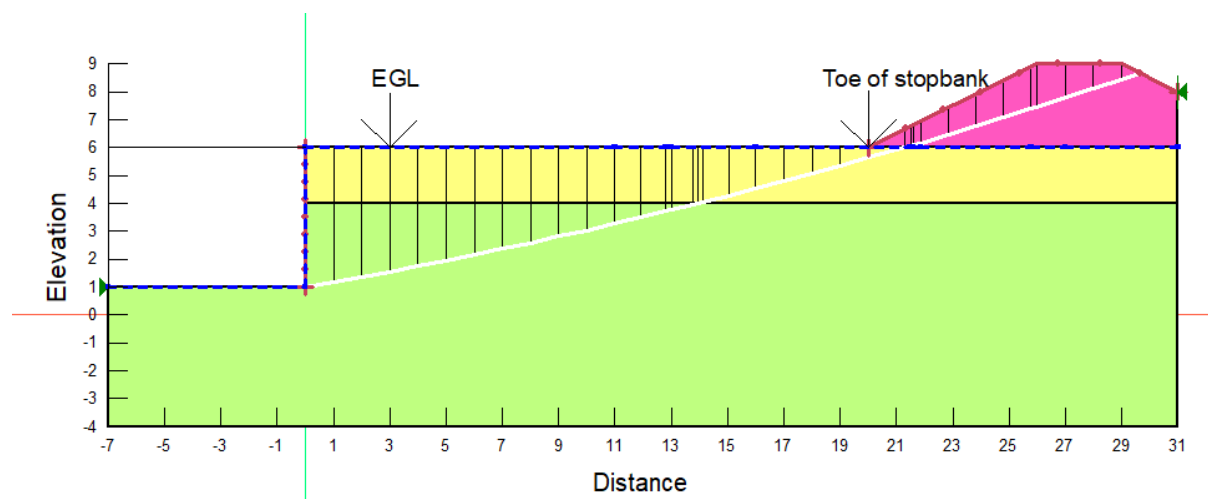
Figure 11: Fully saturated ground conditions. $FoS = 1.73$

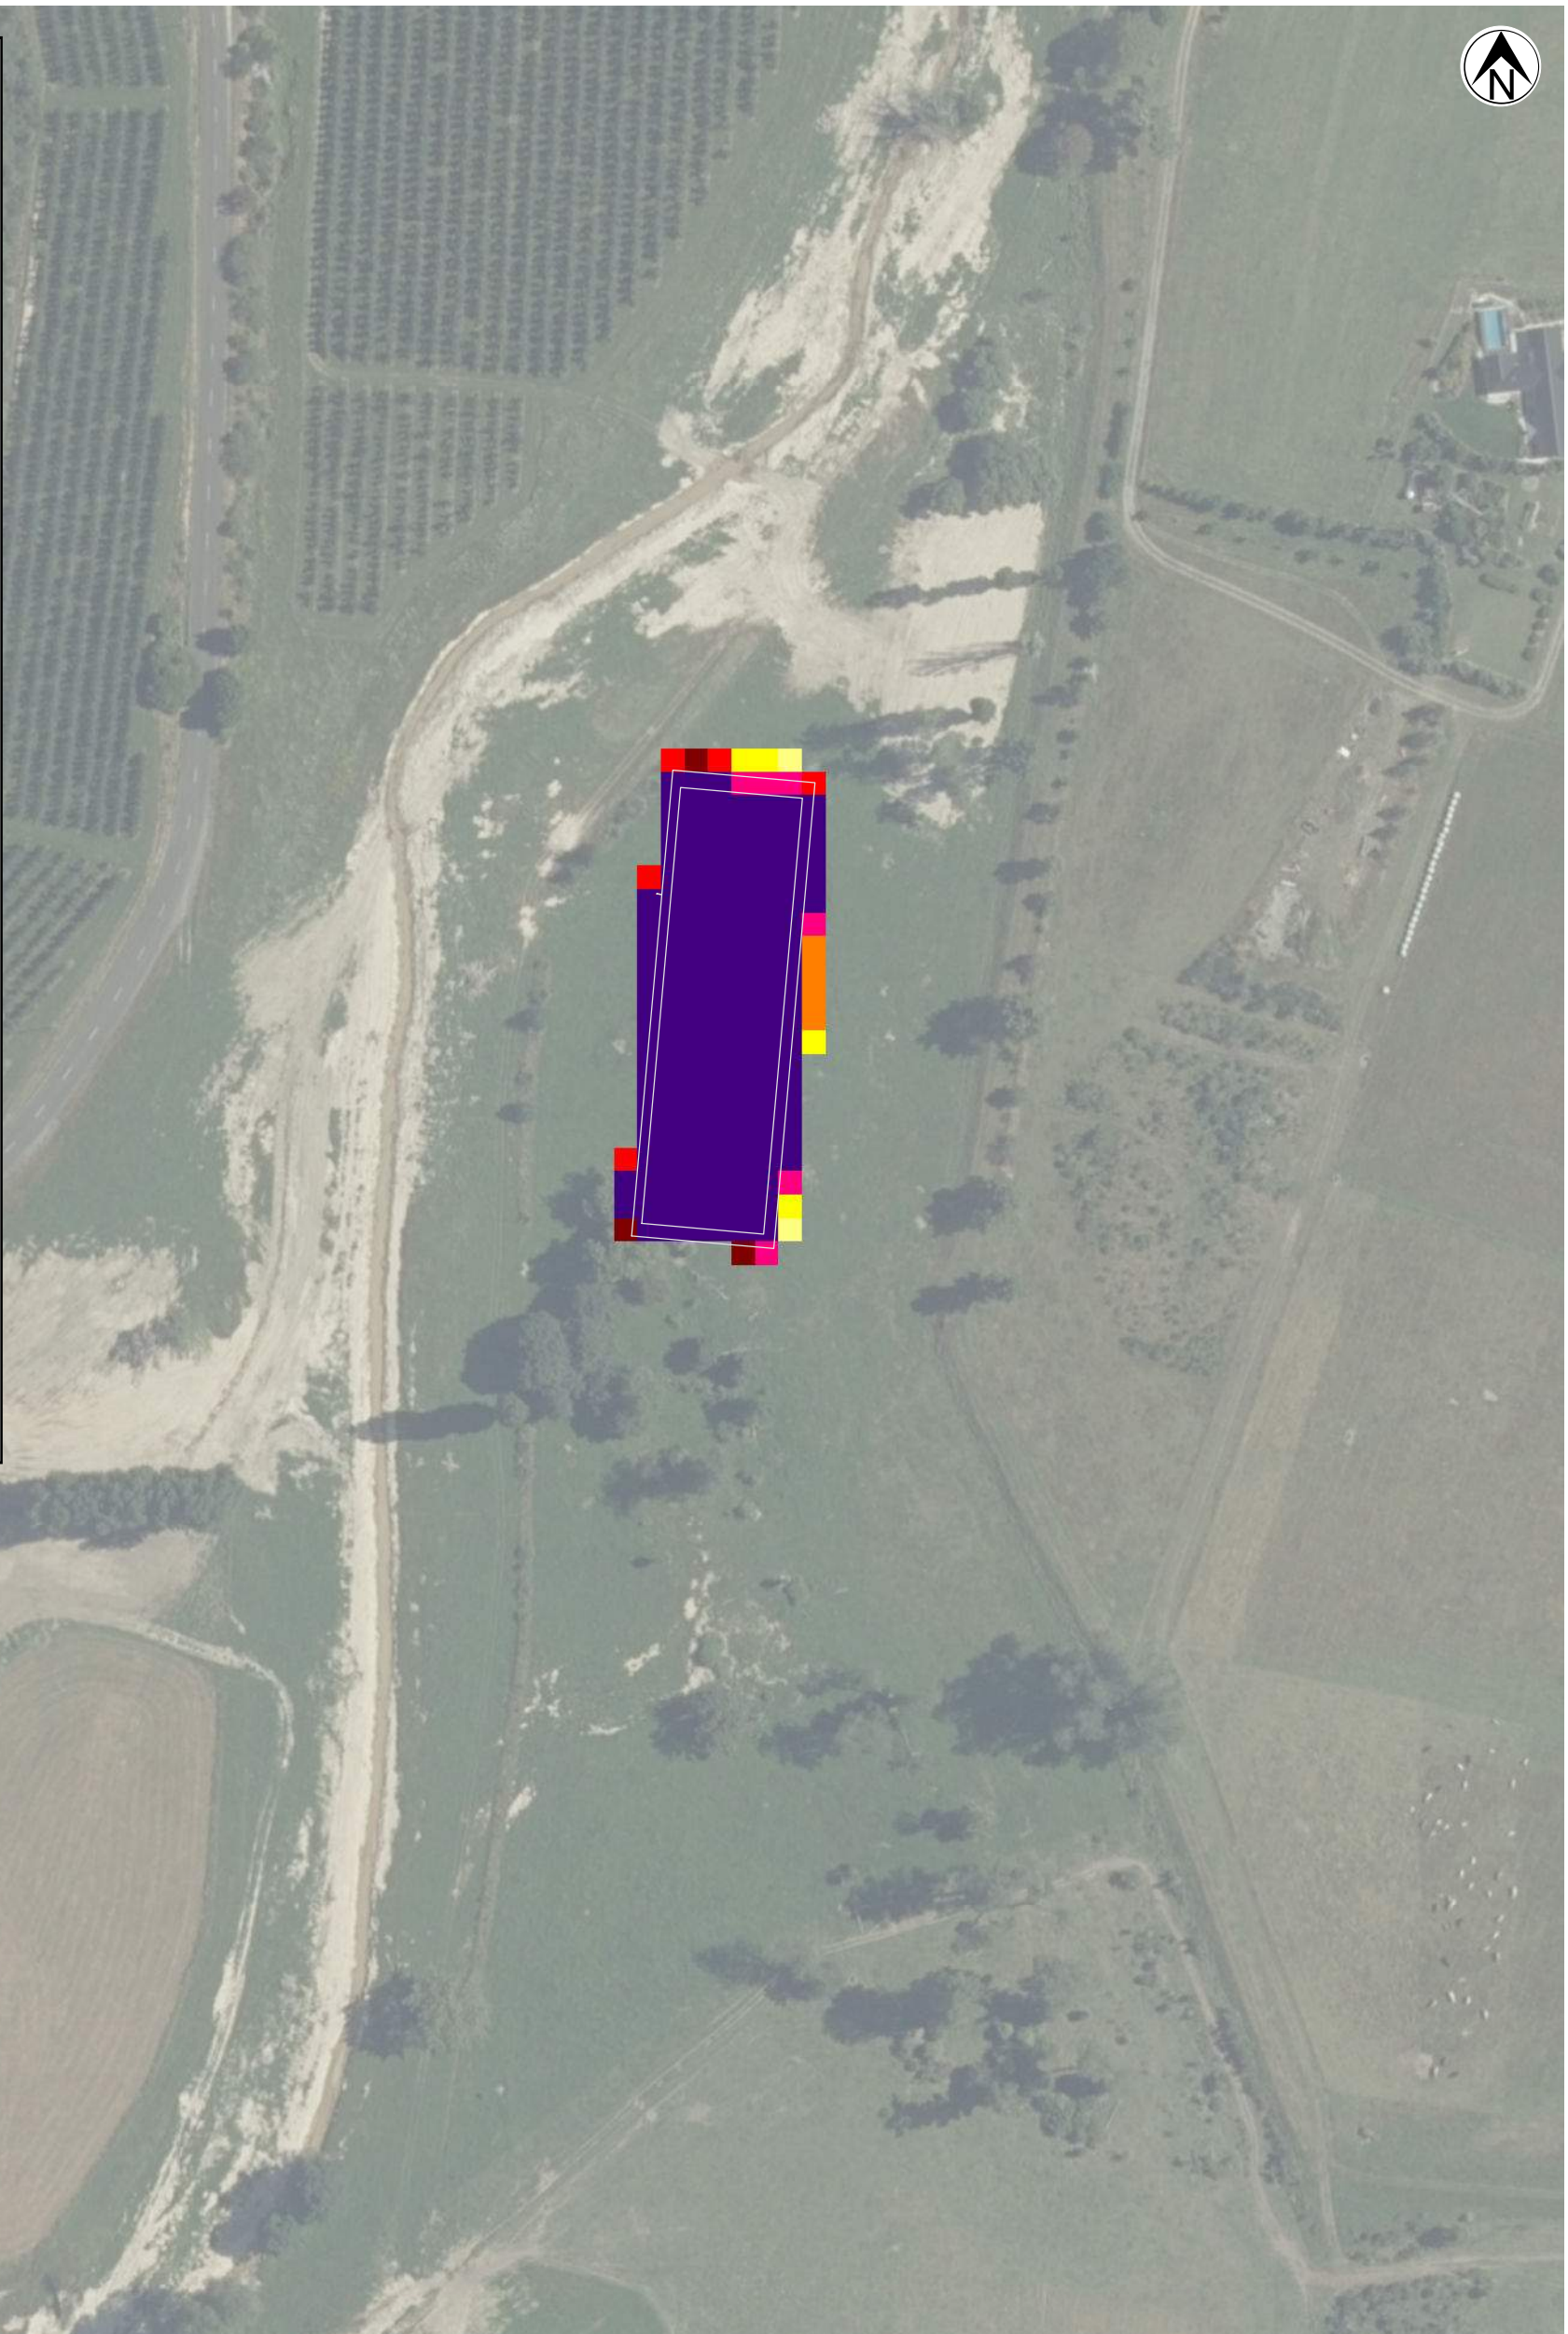
Cells with no value (i.e. no difference pre-and-post development) are not shown.

Figures are pre minus post development

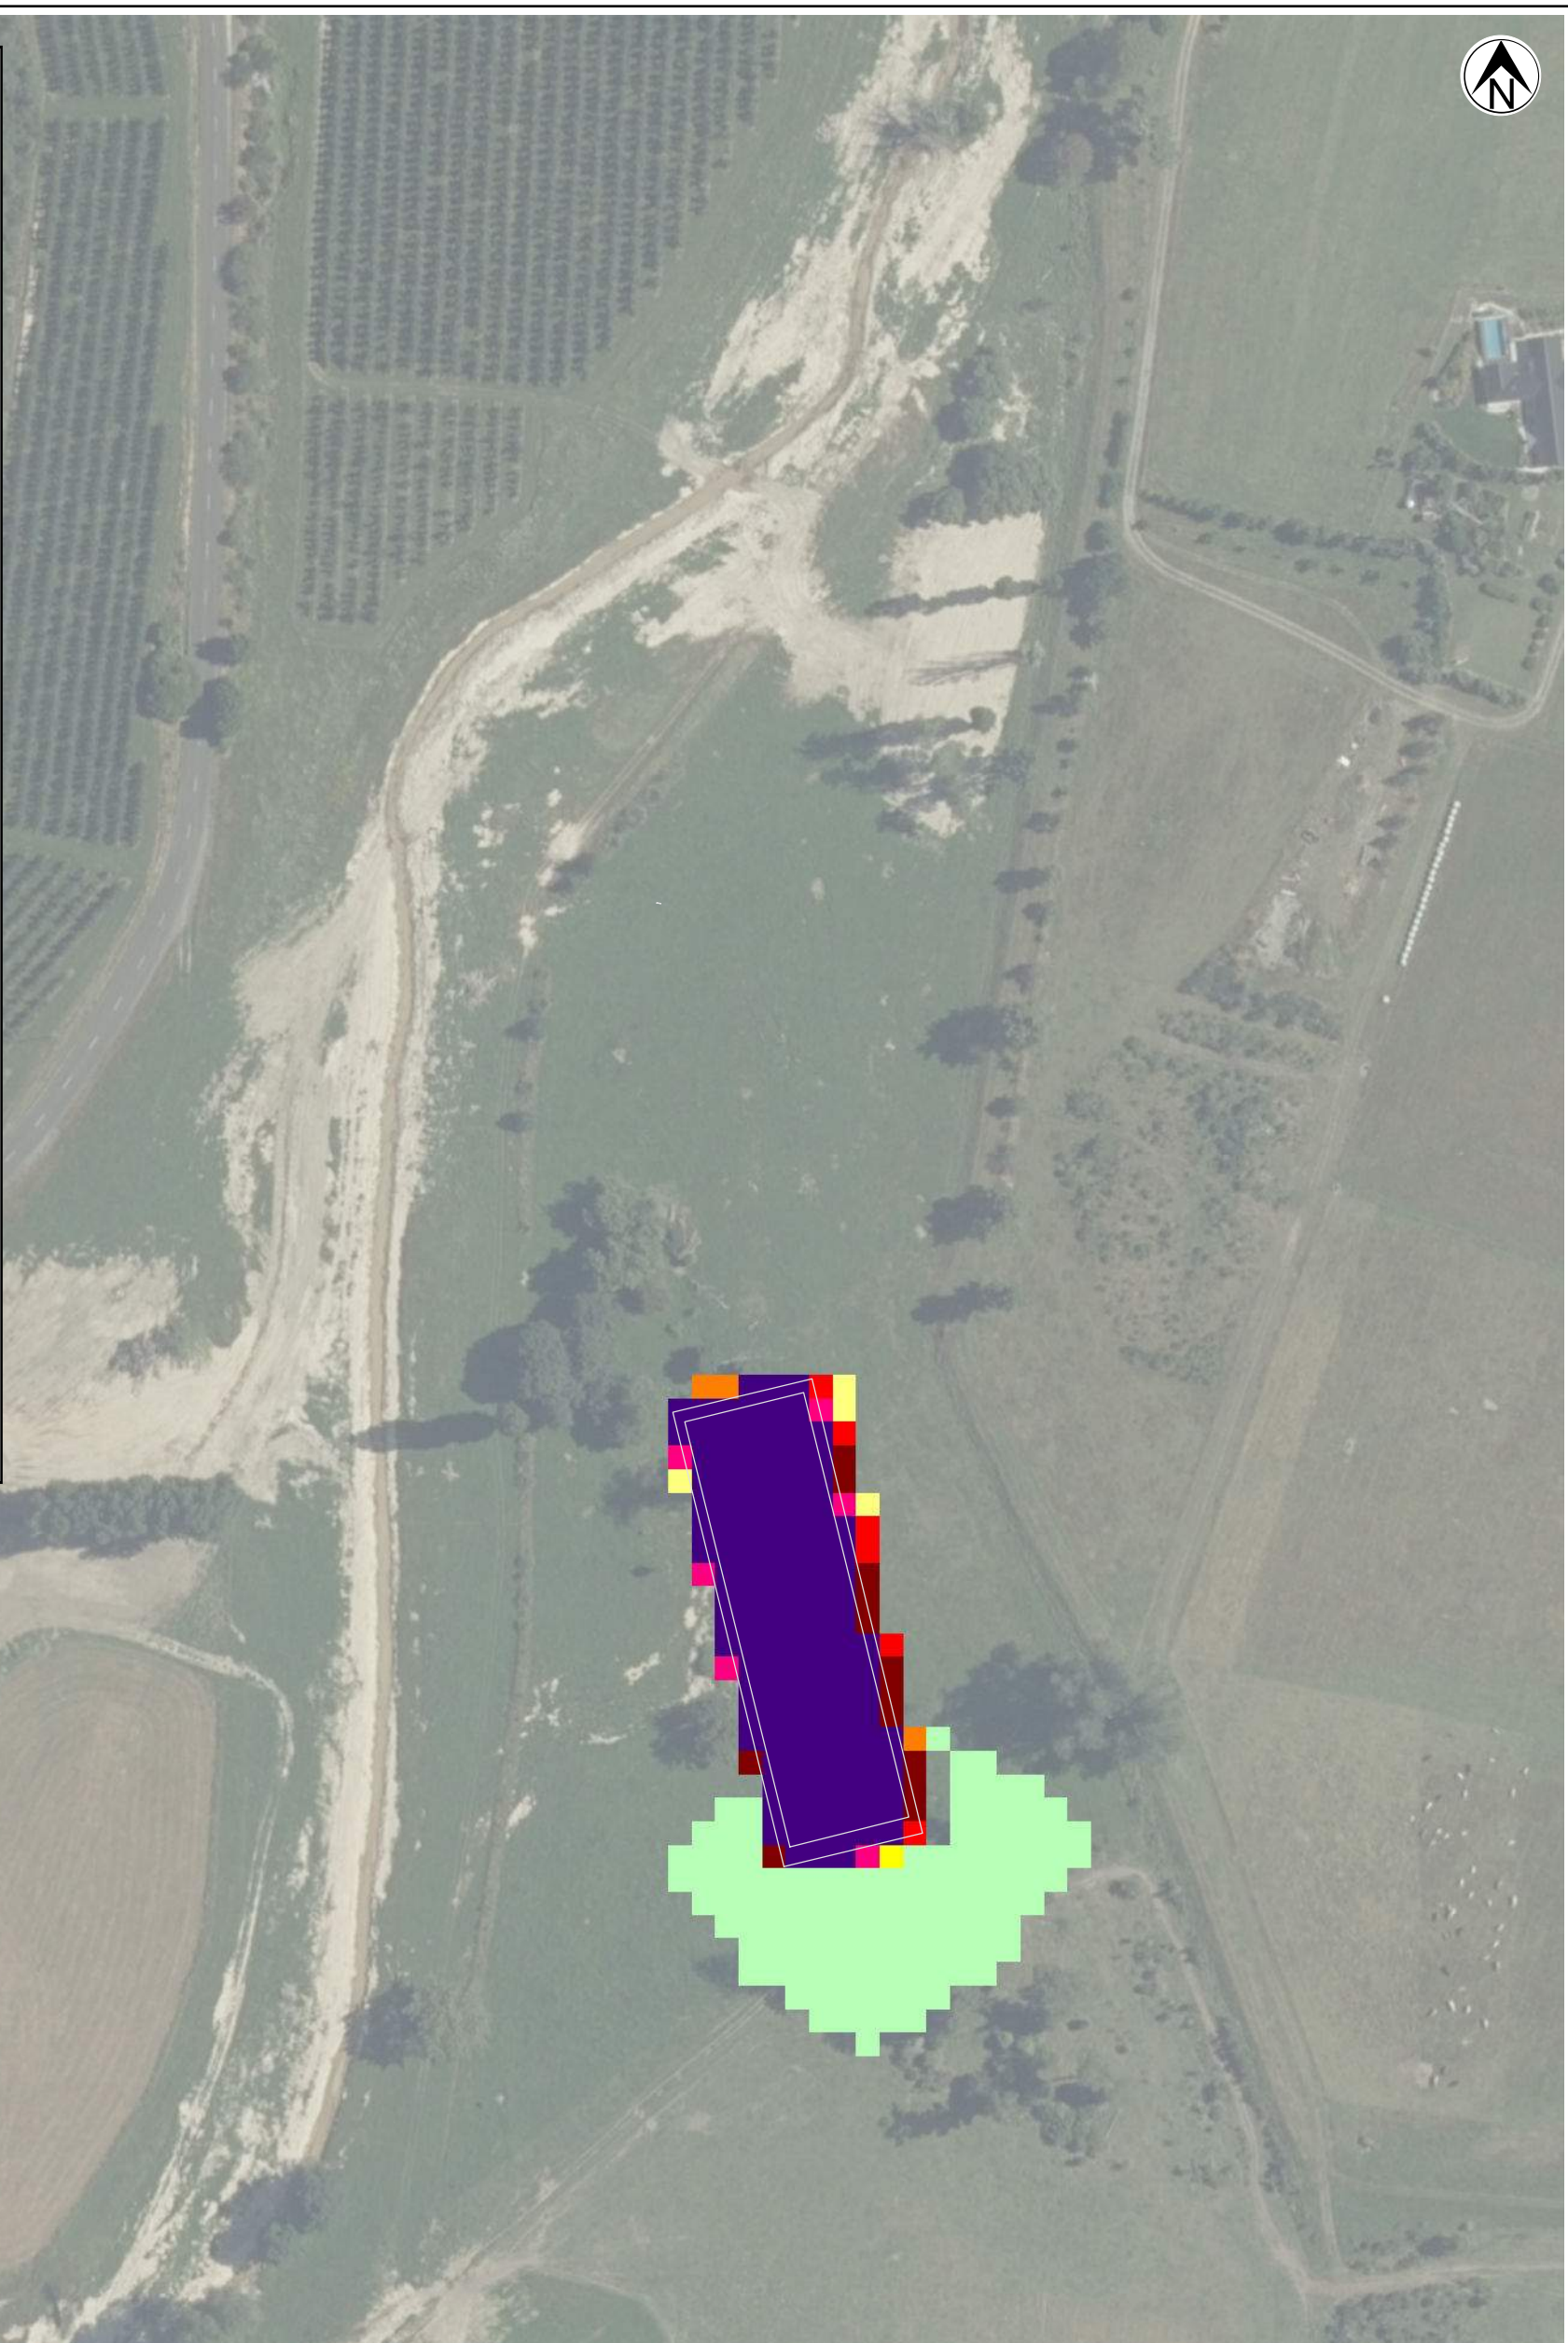
Cells with no value (i.e. no difference pre-and-post development) are not shown.

Figures are pre minus post development

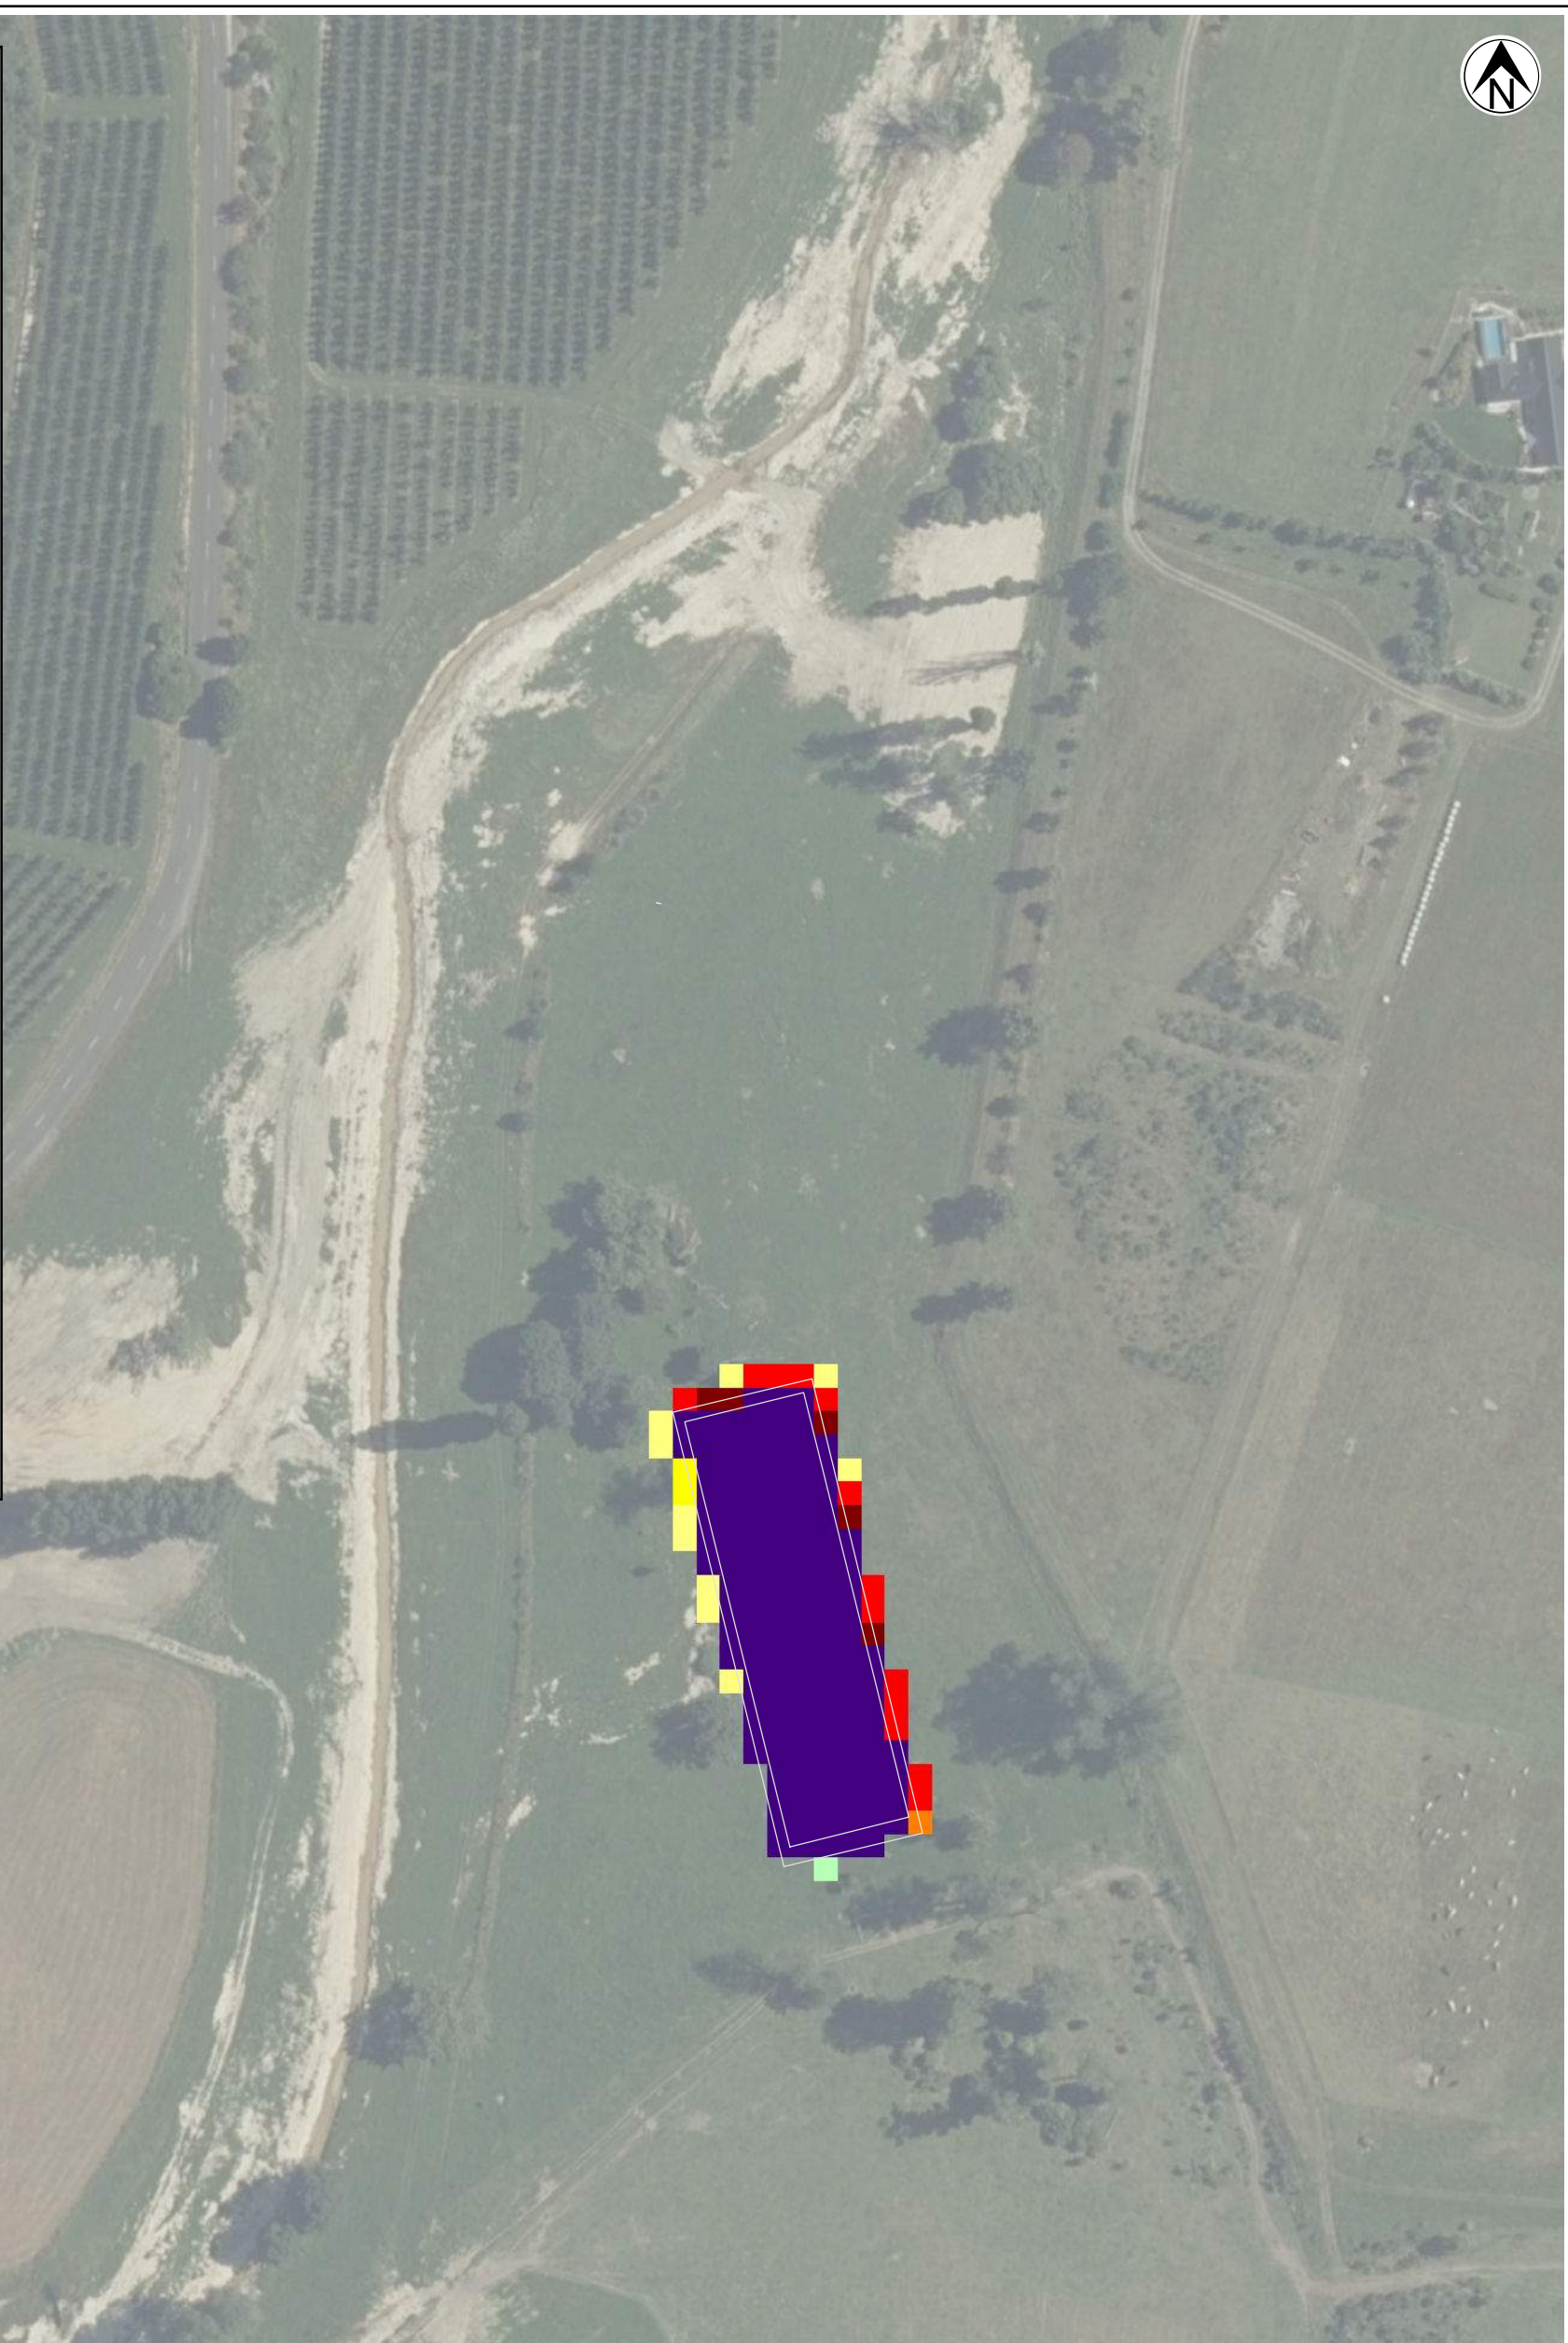
SCALE (A3) 1:1,500 FIG No. 1015514.000 - F4 REV 0

Cells with no value (i.e. no difference pre-and-post development) are not shown.

Figures are pre minus post development

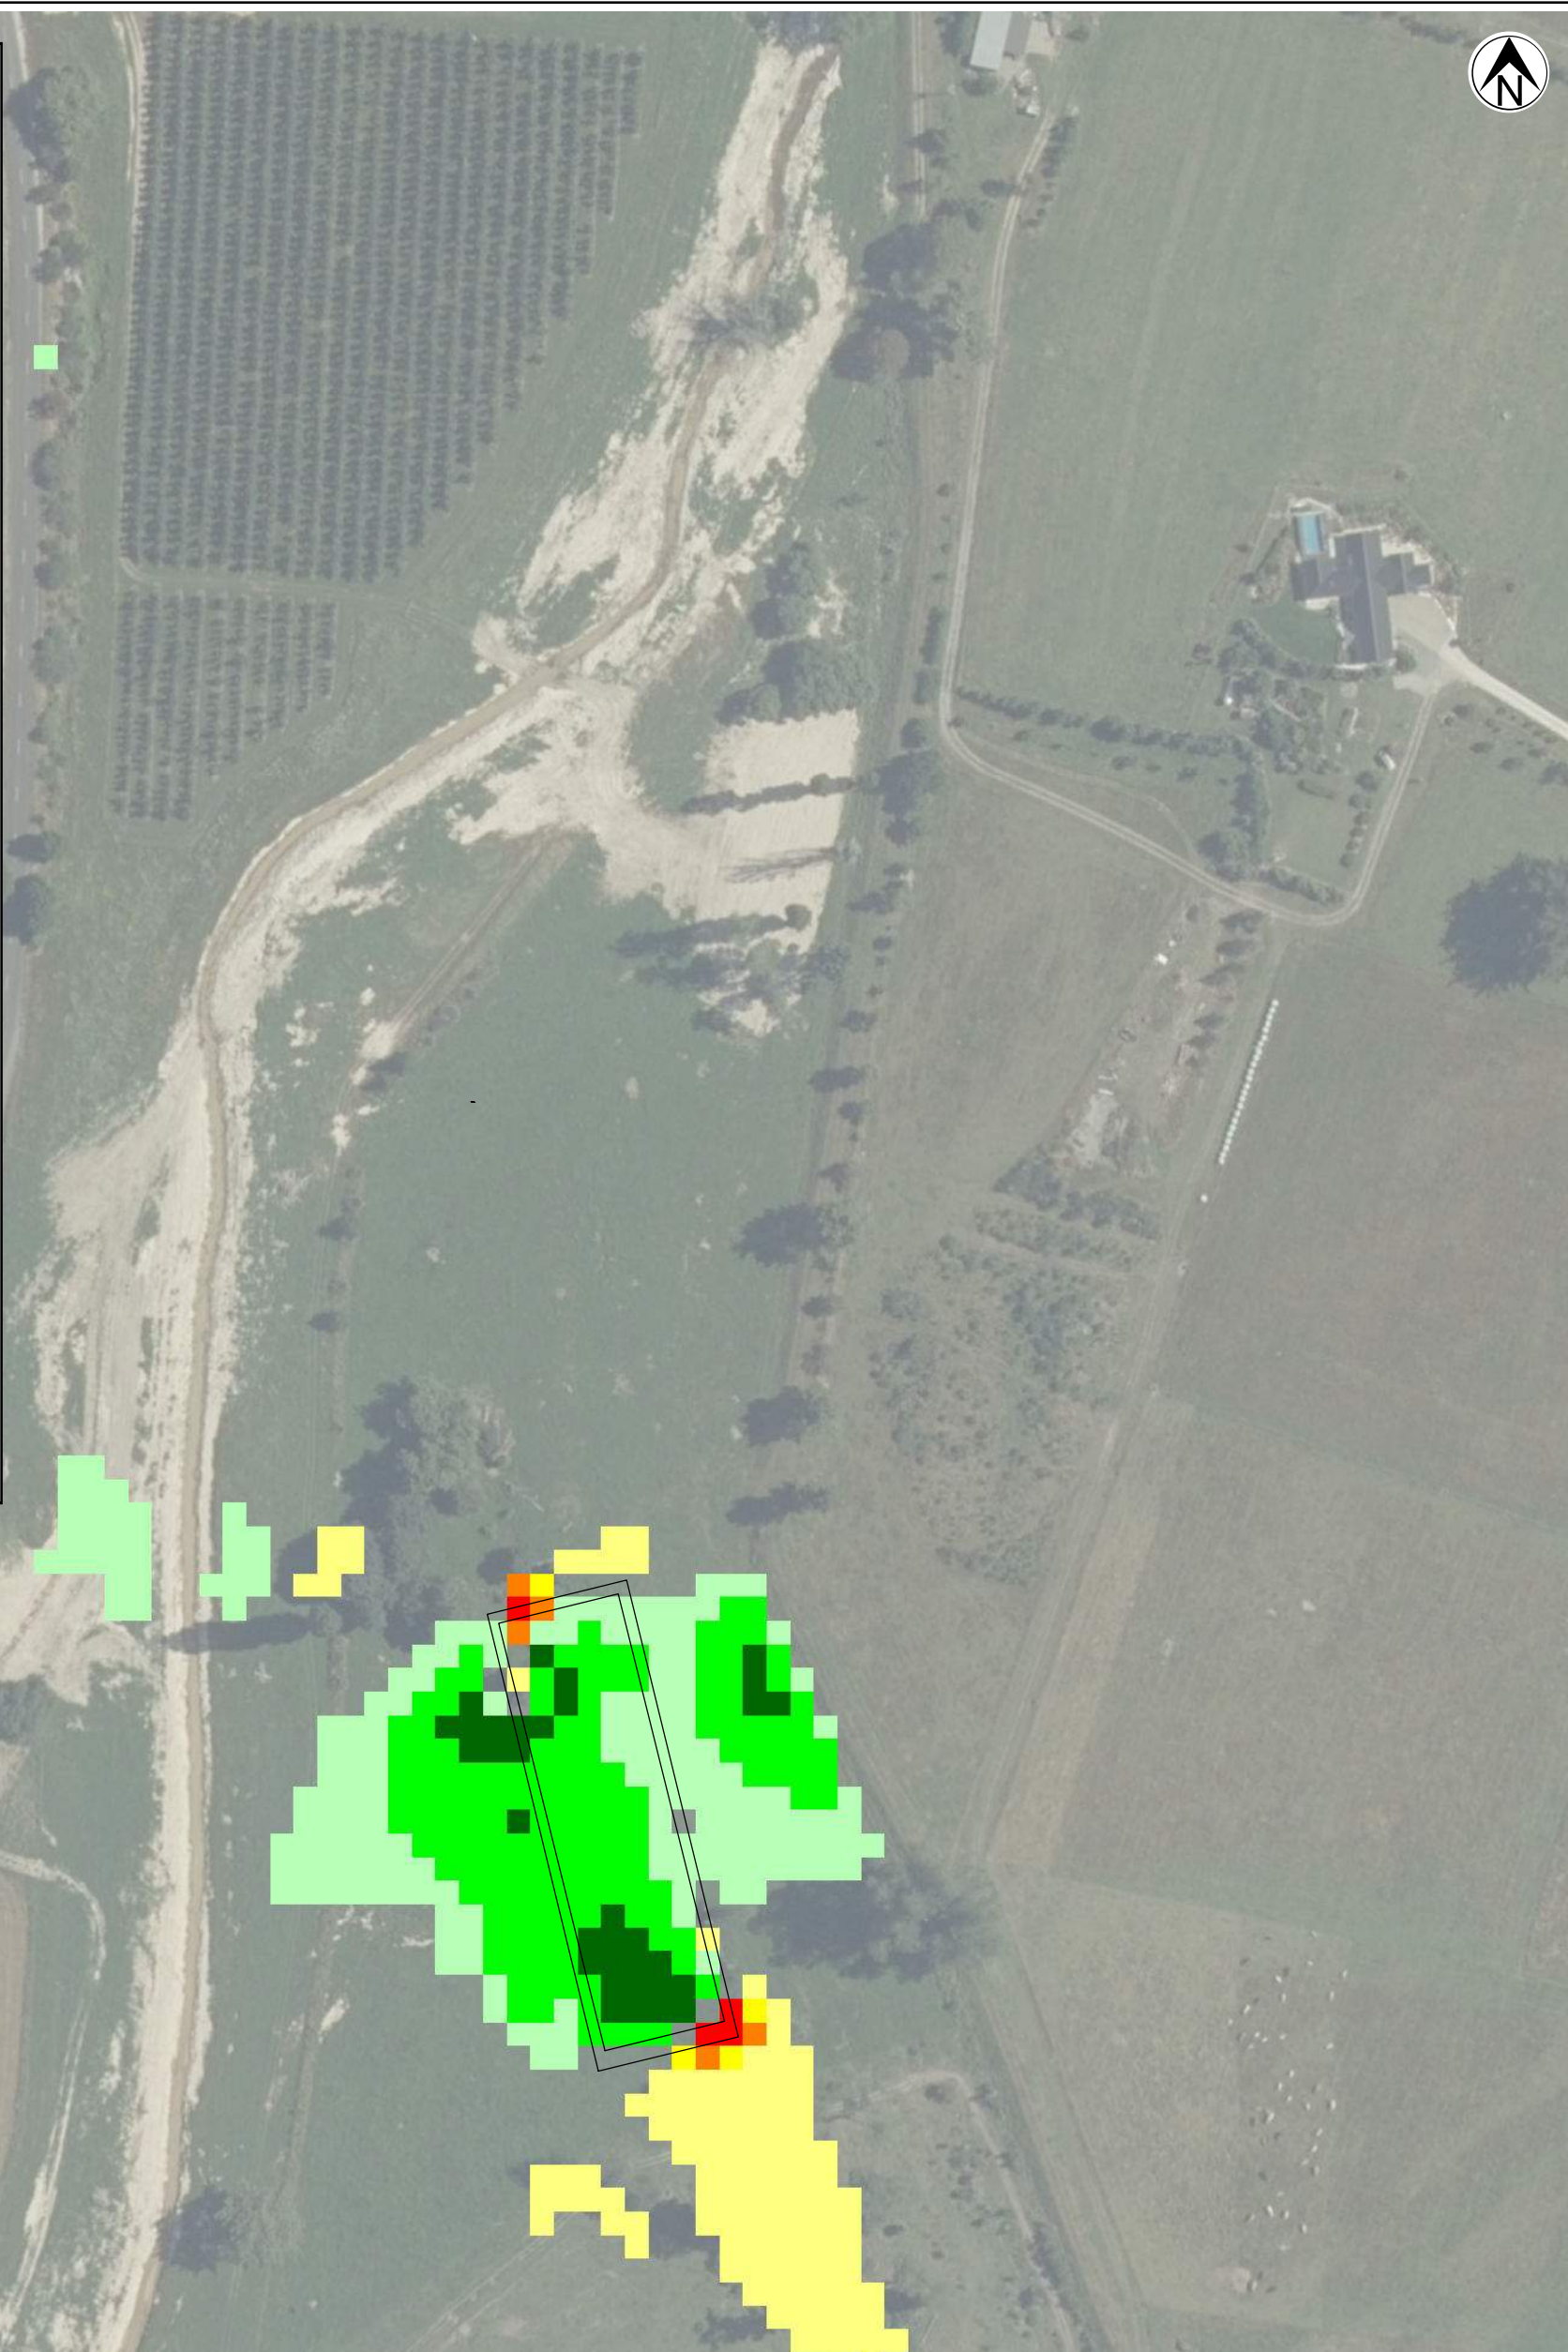
Max difference (m)

Cells with no value (i.e. no difference pre-and-post development) are not shown.

Figures are pre minus post development

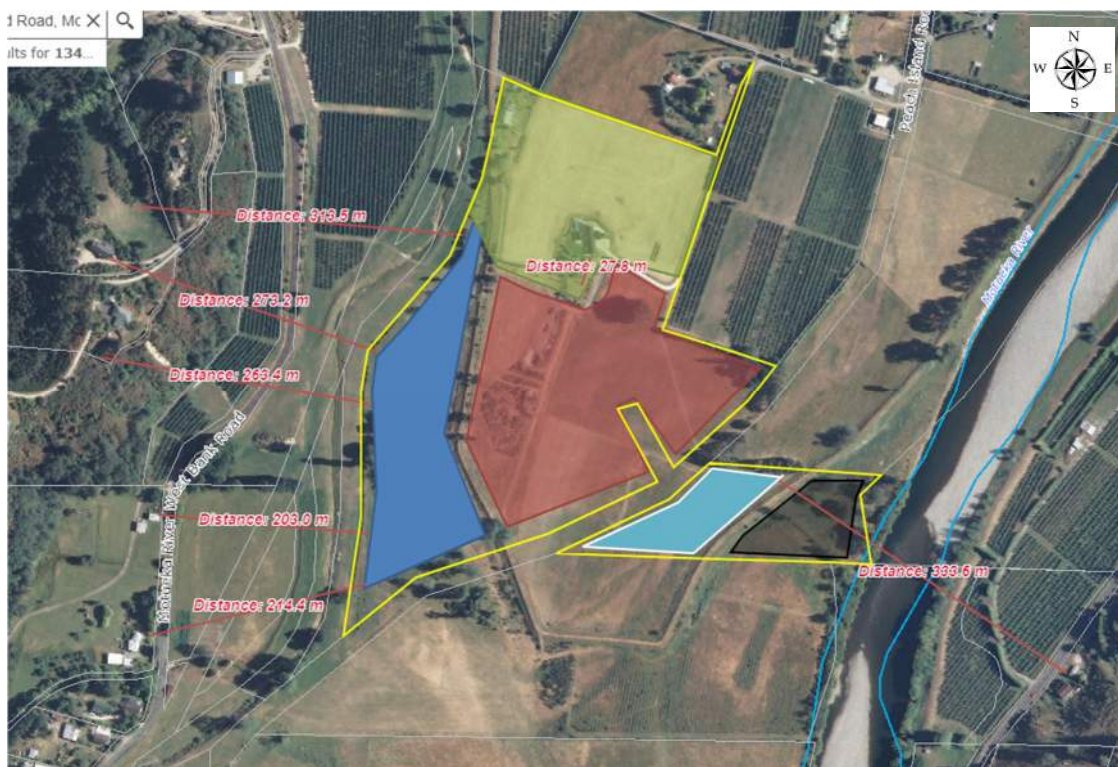
Figure 2 below shows the various parts of the sites (in yellow, blue and orange) and the surrounding, noise sensitive dwellings.

Figure 2. Neighbouring Properties

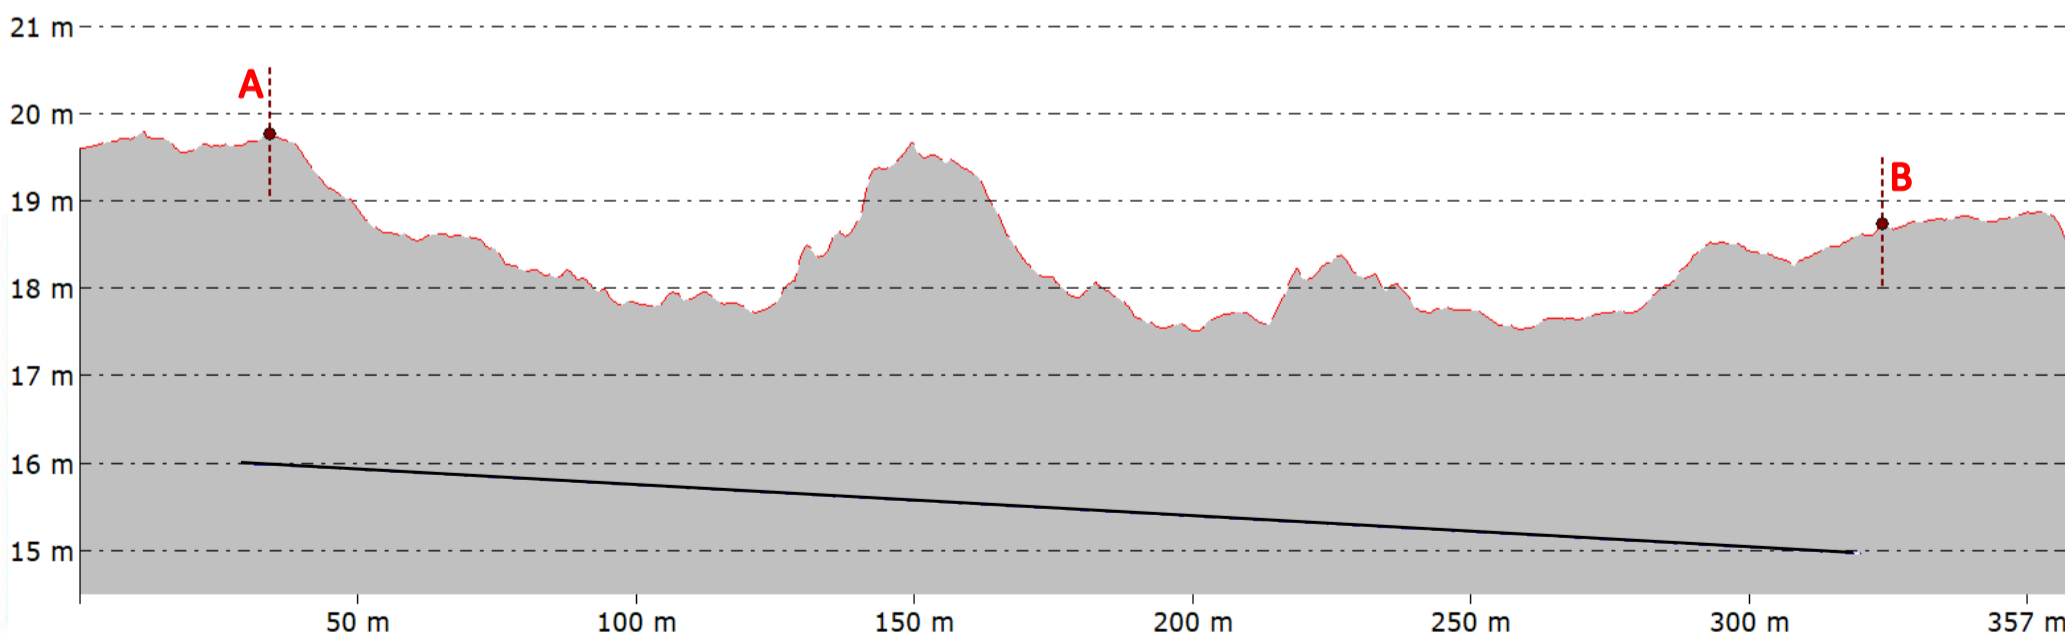
#2002 CJ Industries - Peach Island
Mean winter groundwater level, 2015 Lidar DEM

The Mapazzo plan includes a section through the proposed Stage 1 extraction area showing ground surface levels and mean winter groundwater levels. These are both referenced to the NZVD (2016) datum. It is envisaged that conditions of consent will require excavations to be regularly surveyed to ensure that they do not extend below the mean winter groundwater levels that have been established. This information will be recorded and provided to Council at agreed intervals.

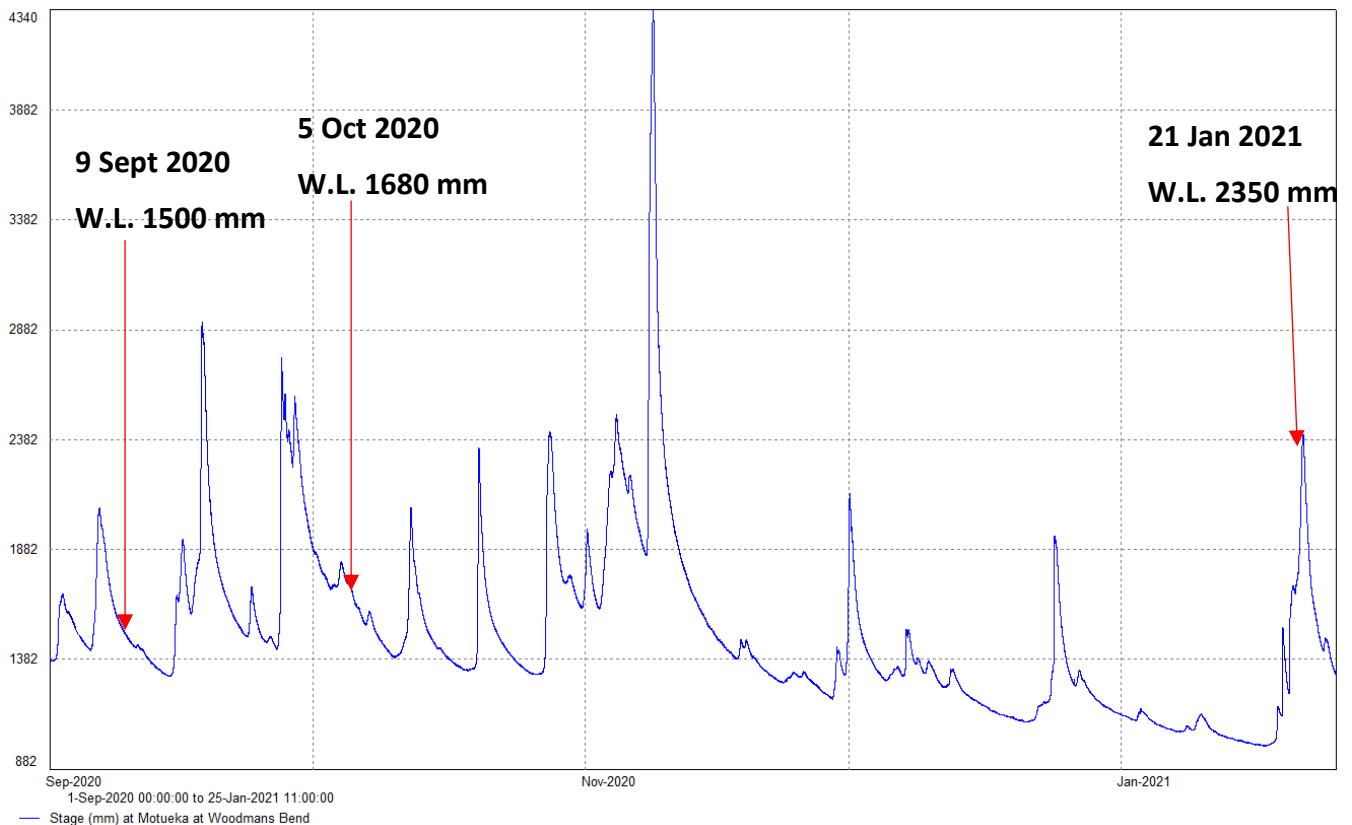
The bore at Douglas Road and Piezo 4 were sampled on three occasions between September 2020 and January 2021. The dates of sampling are shown against water level for the Motueka River at Woodmans Bend in Figure 3.

Figure 3: Water level for the Motueka River as measured at Woodmans Bend

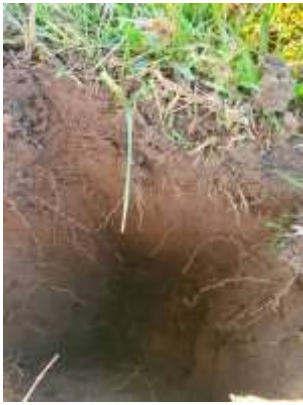
<p>Name: Soil 1 LUC map symbol: 1 Parent material: Alluvium over sands over gravels. Drainage status: Well drained. Soil consistence: Friable when moist Degree of topsoil development: Weakly developed. Profile description: 20 cm brown (10YR 4/3) weakly developed nutty sandy loam; on 80 cm dark greyish brown (2.5YR 4/2) weakly developed blocky to structureless sandy loam and becoming a loamy sand with depth; on yellowish brown (10YR 5/4) loose single grain sand.</p>
