Ref RM200488 and RM200489

RE: Further Information Request for Resource Consent Applications – RM200488 – To disturb land and rehabilitate for the purpose of gravel extraction. RM200489 – To erect signage and use an unformed legal road for traffic purposes.

CJ Industries Ltd has engaged Tonkin & Taylor Ltd (T+T) to provide advice on the implications of gravel extraction at Peach Island, Motueka on flooding (e.g., peak water depth, velocity) and geotechnical (e.g. scour, seepage) risk to the Peach Island stopbanks. This letter report outlines our findings in relation to the geotechnical and flood hazard investigations T+T have undertaken on your behalf. The purpose of these investigations is to support the resource consent application for gravel extraction at Peach Island, Motueka. Our full scope of assessment is detailed in our letter of engagement dated 8 October 2020 (T+T reference #1015514).

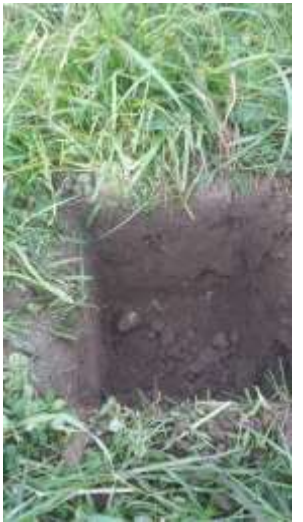
<p>Name: Soil 2 Soil map symbol: 2 Parent material: Alluvial gravels. Drainage status: Well drained to excessively well drained. Soil consistence: with stones removed, friable when moist, plastic when wet. . Degree of topsoil development: Weakly to moderately developed. Profile description. 15 cm weakly developed fine nutty crumb silt loam to silty clay loam, friable when moist and plastic when wet. Can be sticky when wet. On 15 cm weakly developed fine nutty crumb sandy silt loam. On alluvial gravels.</p>

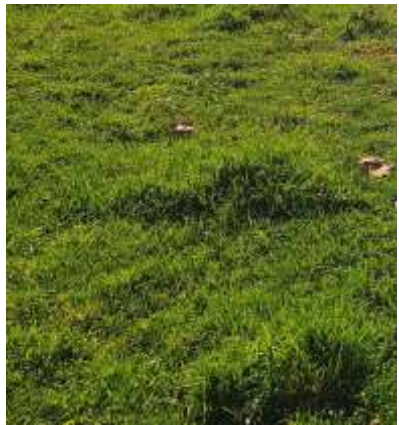
IIIw1 Flat to undulating floodplains and low terraces with moderately deep sandy loam to clay loam textured soils where the depth to the low chroma colours, gleying or mottling is greater than 45cm, and/or a moderately high watertable for part of the year.	2.19	Finer alluvium and alluvial sands.	3, 3+4	The soils are reasonably well developed finer material with good structure but have a moderate wetness limitation during the winter and spring periods. They are prone to pugging and treading damage when wet. The moderate wetness limitation makes this unit class III land.

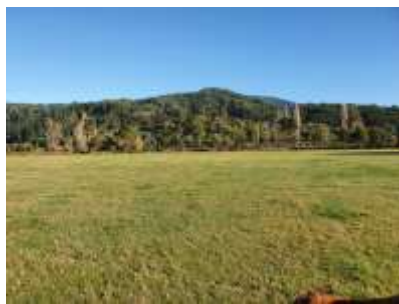
IIIsl Flat to undulating floodplains with moderately shallow (30-45cm) and stony silt loam or sandy loam textured recent soils in mild moderate rainfall areas.	1.45	Alluvial sands over gravels.	1	Generally well drained soils with gravels below the plough layer. Top soil development is very weak and as a consequence this unit will not handle repeated cultivation. There is the potential for wind erosion under cultivation or if the vegetative cover is removed. There is often a fine to coarse sand horizon (with no structure) at about 25-30 cm over the gravels. The depth to the gravels can vary. The moderate limitations to arable use make this unit a LUC class III unit.

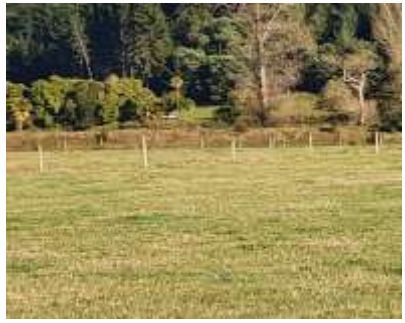
<p>IVs1 Flat to undulating floodplains, low terraces and fans with moderately shallow (15-30cm) and stony silt loam or sandy loam textured recent soils in mild moderate rainfall areas.</p>	<p>3.89</p>	<p>Alluvial gravels.</p>	<p>2 4 4+5 4+3</p>	<p>The gravels are closer to the surface and can influence the cultivation techniques undertaken. The topsoil is very weakly developed indicating the soil is not suited to repeated cultivation and also prone to wind erosion when the vegetation cover is removed. The stone content and depth is a severe limitation to arable use.</p>

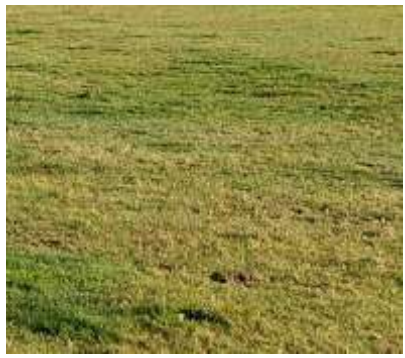
<p>Vs1 Flat to gently rolling floodplains and fans with recent silt loam to sandy loam textured soils. The gravels are at or near the surface which makes them unsuitable for cultivation.</p>	<p>1.49</p>	<p>Alluvial gravels.</p>	<p>5</p>	<p>Low natural fertility and prone to drying out during the summer months. Reasonably resistant to pugging and treading damage by heavy cattle and on this property they make an excellent standoff area for heavy cattle.</p>

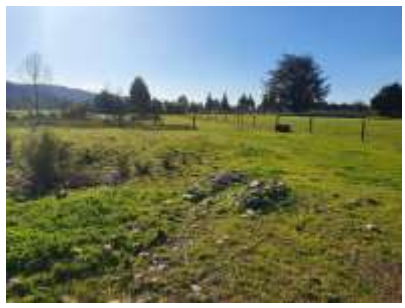
<p>VIs1 Flat to gently rolling floodplains and fans with recent silt loam to sandy loam textured soils with boulders on the surface.</p>	<p>0.6</p>	<p>Alluvial gravels and boulders.</p>	<p>6, 6+5,</p>	<p>Boulders on the surface inhibit cultivation.</p>
