**BEFORE AN INDEPENDENT HEARINGS COMMISSIONER  
AT NELSON**

**COUNCIL REF: RM200488,  
RM200489 AND RM220578**

**STATEMENT OF EVIDENCE OF DR MICHAEL HARVEY ON BEHALF OF VALLEY RESIDENTS  
AGAINST GRAVEL EXTRACTION (FLOOD PLAIN, STOPBANK AND EROSION IMPACTS)**

Dated 11 November 2022

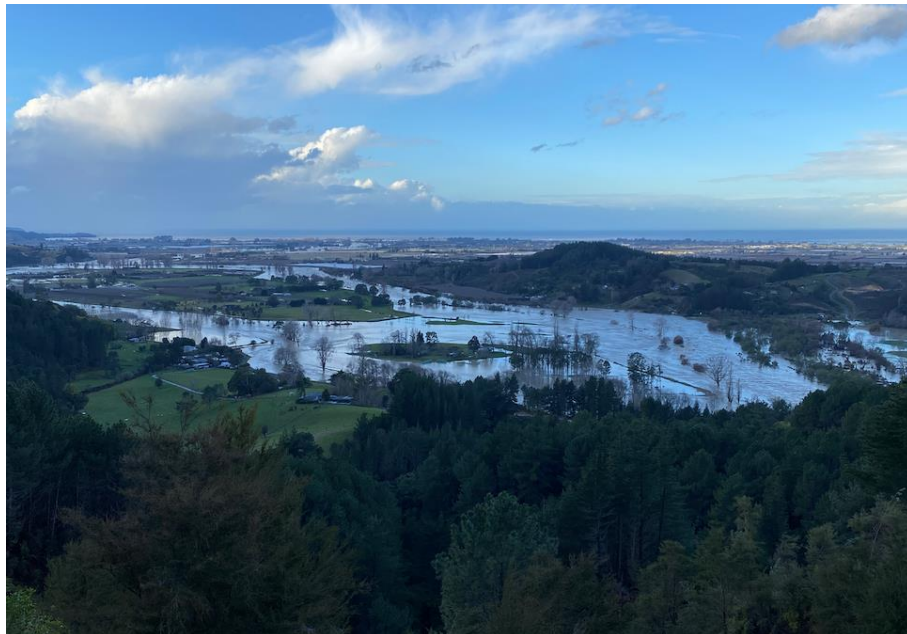
Figure 2. View downstream of the Peach Island reach of the Motueka River during the July 2021 floods (Photo provided by Ollie Langridge).

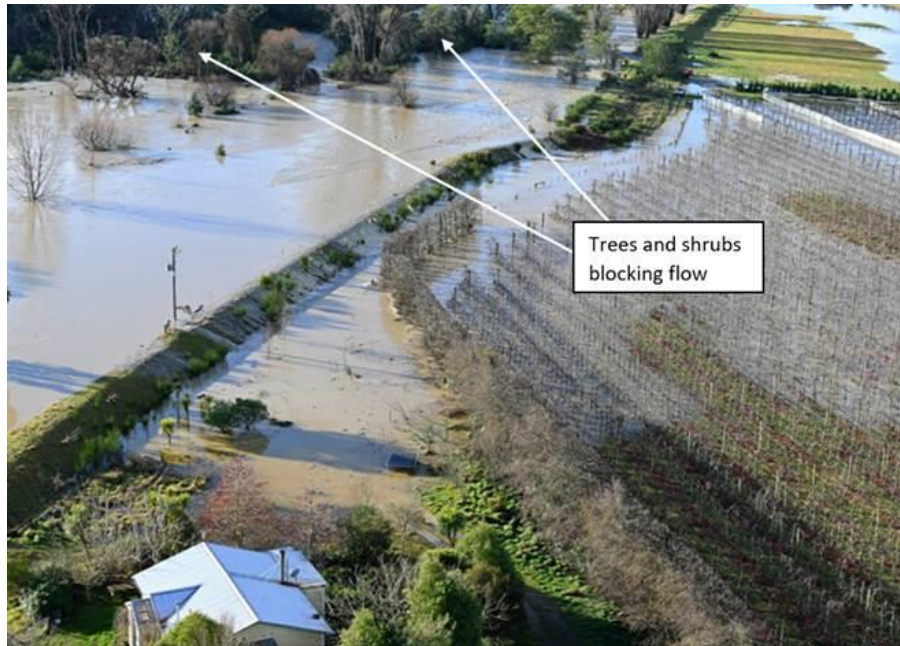
Figure 3. Overtopping of the west Peach Island stopbank during the July 2021 flood. The backchannel is located to the left of the stopbank. (Photo provided by Rob O'Grady, TDC, 2 November 2021).

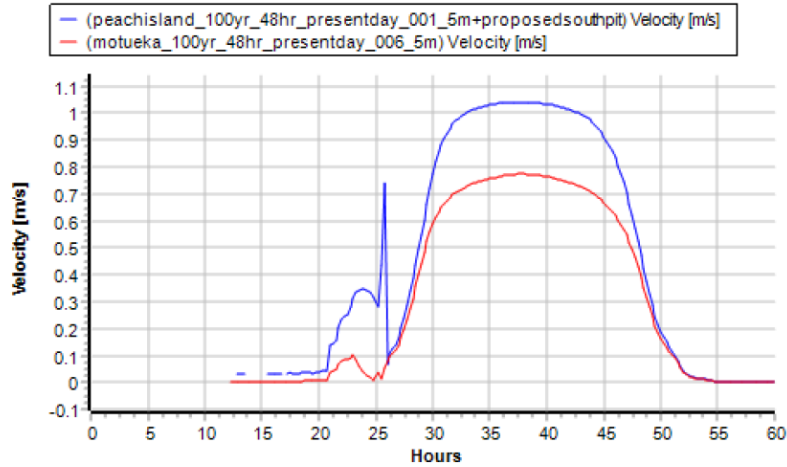
Figure 4. Time series of velocity for model cell immediately adjacent to modelled borrow pit for the 1% AEP flood event (Aiken, 2022, Figure 6)

25. Acceleration of flood flows into both the upstream and downstream margins of a modelled pit (Figures 4 and 5; Aiken 2022) prior to the pit filling clearly indicate that erosion of the pit headwalls (headcutting) will occur during a flood event (Kondolf, 1997). This will release fine sediments (sands, silts and clays) from floodplain storage (topsoil and subsoil thickness varies from 0.5m to 1.0; Corrie-Johnson, 2022 3.7) into the flows thereby increasing the suspended sediment load that ultimately will be transported downstream to the Motueka River and then into Tasman Bay. The potential for this mode of erosion was not evaluated by Tonkin & Taylor even though its omission had been identified in my previous submission (27 January 2022). Visual evidence of the headcutting process on the Motueka River floodplain can be seen in Figures 6 and 7 which were taken at the head of the Douglas Road pit following the 17-18 July 2021 flood.

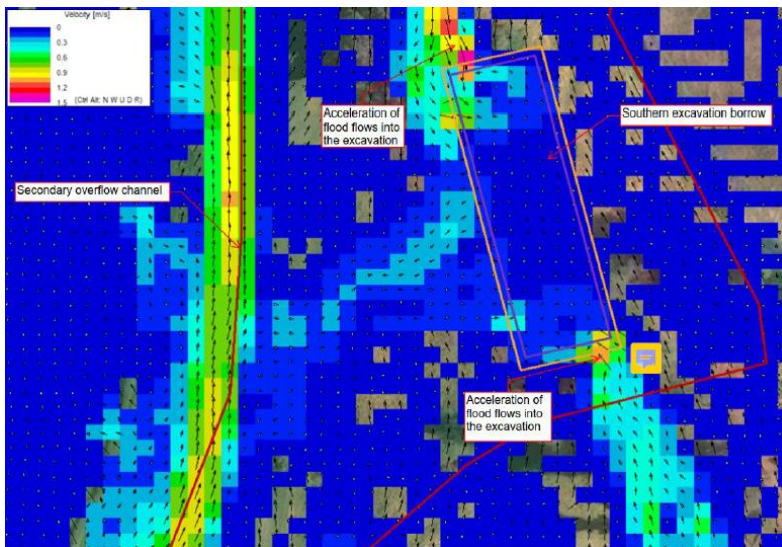
Figure 5. Flood flows accelerating into the excavation pit at the 25 hr timestep for the modelled 1% AEP event (Aiken, 2022, Figure 7).

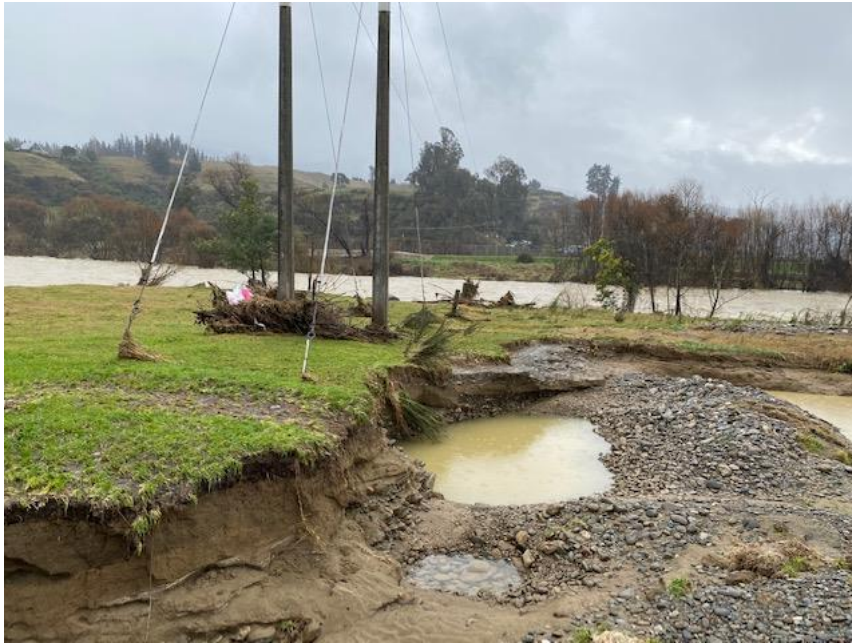
Figure 6. View west of headcut erosion of fine-grained floodplain sediments at the upstream end of the northern pit at Douglas Road following the 17-18 July 2021 flood. The Motueka River is in the background. (Photo provided by Pete Taia)

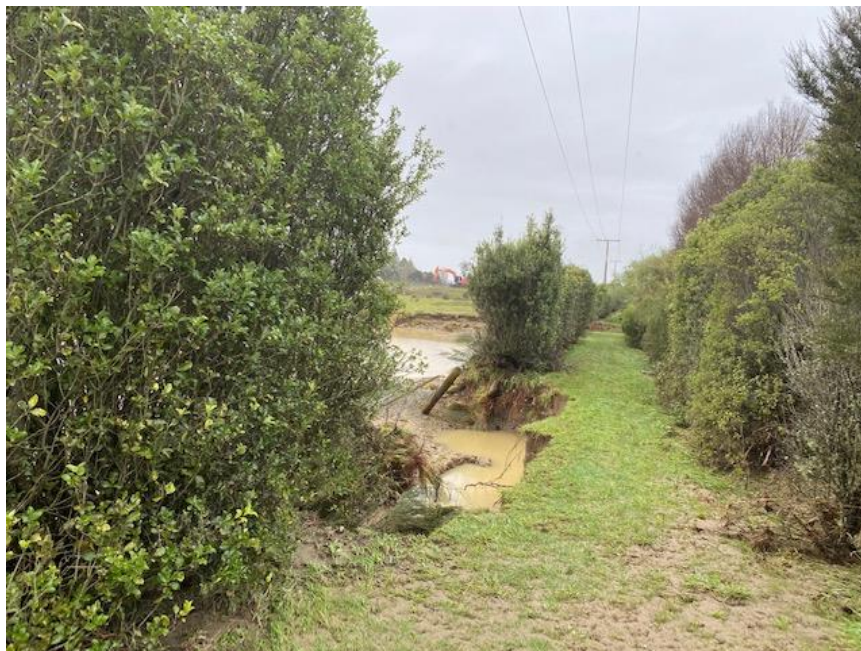
Figure 7. View east of the headcut erosion of fine-grained sediments at the upstream end of the northern pit at Douglas Road following the 17-18 July 2021 flood (Photo provided by Pete Taia)

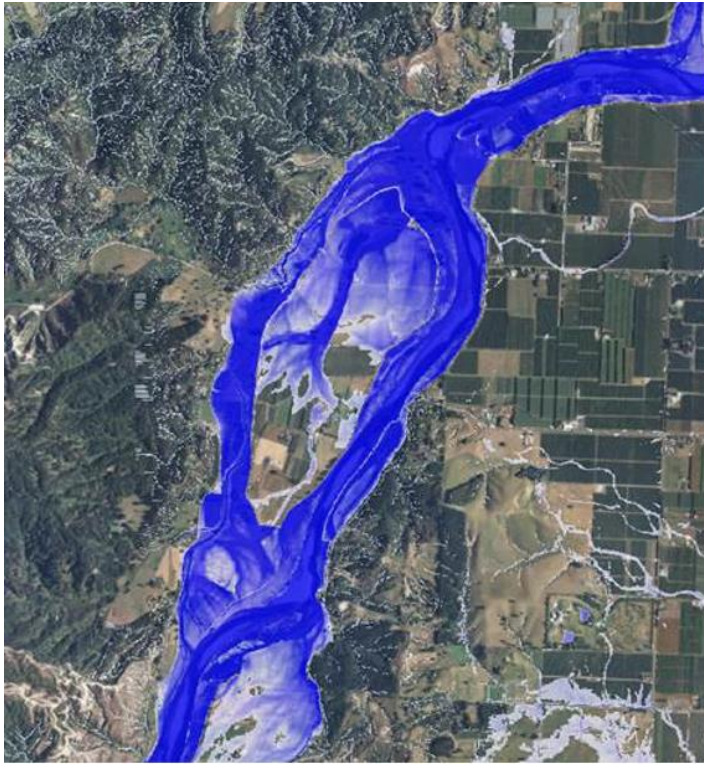
Figure 8. Modelled flow distribution of the 1% AEP event showing the hydraulic connection of the backchannel and the Motueka River in the vicinity of Peach Island. (Image provided by R. O'Grady, TDC, from Peach Island Flood Response and Mitigation Public Meeting 2 November 2021)

of downstream backwater caused by flow constriction below Peach Island (refer to Figure 8).

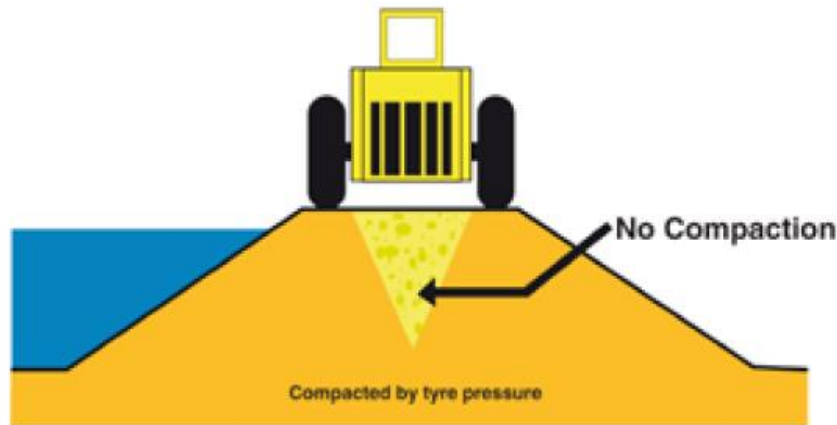
Figure 11. Schematic of Motueka River stopbank construction methods during construction in the 1950's showing lack of compaction in the stopbank core (TDC, 2010; Motueka Flood Control Project, Newsletter Issue 01, July 2010)

30. I agree with Mr Averill that the proposed mining, provided that the 20m setback from the levee toe is maintained, is unlikely to adversely affect the stability of the existing Peach Island stopbanks (Averill, 2022; 2.3). However, because the stopbanks were constructed in the 1950's from local floodplain materials with methods that are unacceptable today (Figure 11) there is a risk that there will be failure (Figure 12), primarily as a result of seepage or sloughing of a saturated embankment during a flood event with an undetermined ARI (Tonkin and Taylor, 2020, p.4). Maintenance activity on the Peach Island stopbanks is intermittent and there is evidence of stock tracking and rabbit burrowing, both of which compromise the integrity of the stopbanks (TDC, Rob O'Grady meeting notes, 2 November 2021.) If the stopbanks were to fail, stockpiles of overburden material, topsoil and backfill material stored between the stopbanks at all 3 stages of the mine life would be at risk of erosion and
