Stormwater Monitoring Report 2023/24

Stormwater Monitoring Report

1. Introduction/Summary

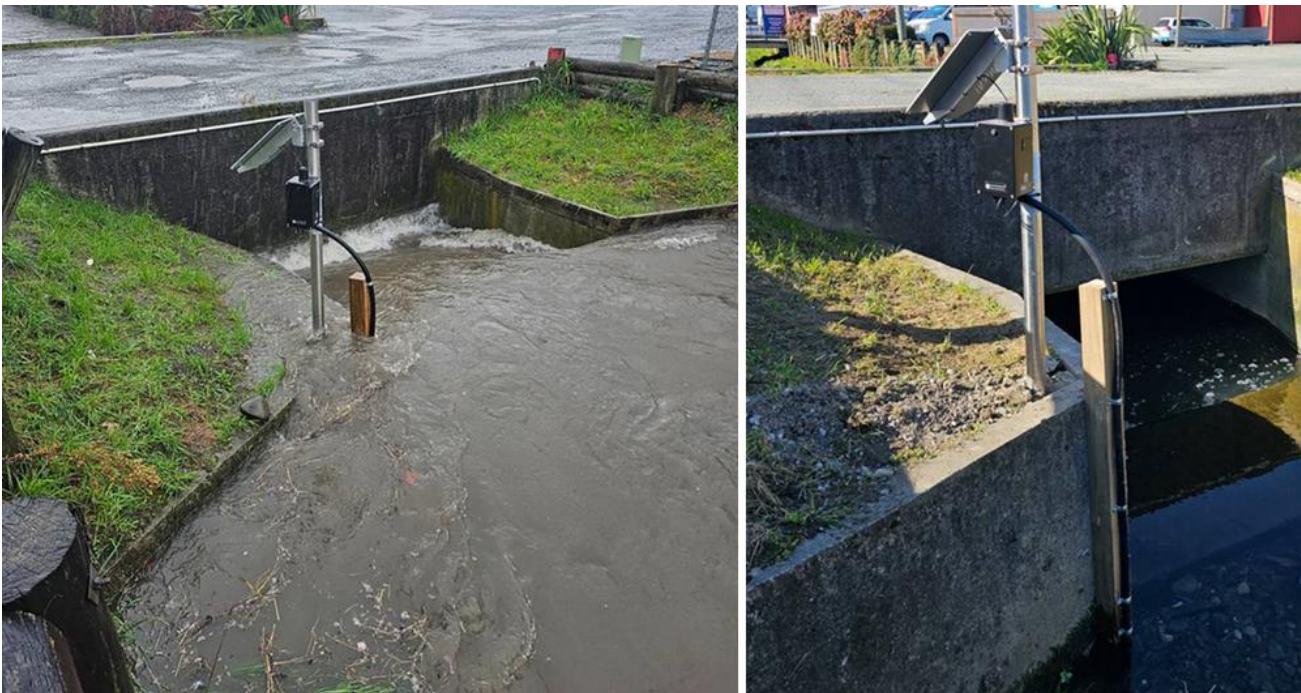
Figure 2 Beach Rd continuous monitoring site

Two continuous monitoring stations which broadcast the data every 15 minutes have been set up in Jimmy Lee creek and have been gathering information since September 2023 (Figure 2). This data has given us some good insights in understanding how flow and conductivity are affected during rain events, but also in detecting illegal discharges. So far, these monitoring sites have alerted the council to a range of contaminated water discharges including swimming pool water containing chlorine or salt, cleaning agents and food processing waste. Due to having some alerts set up at the monitoring stations, some of these could be detected and then traced back to the source. Conductivity has been the main parameter that is used to create these alerts. Conductivity in a waterway is relatively stable at a given location but many discharges do increase the conductivity in water significantly.

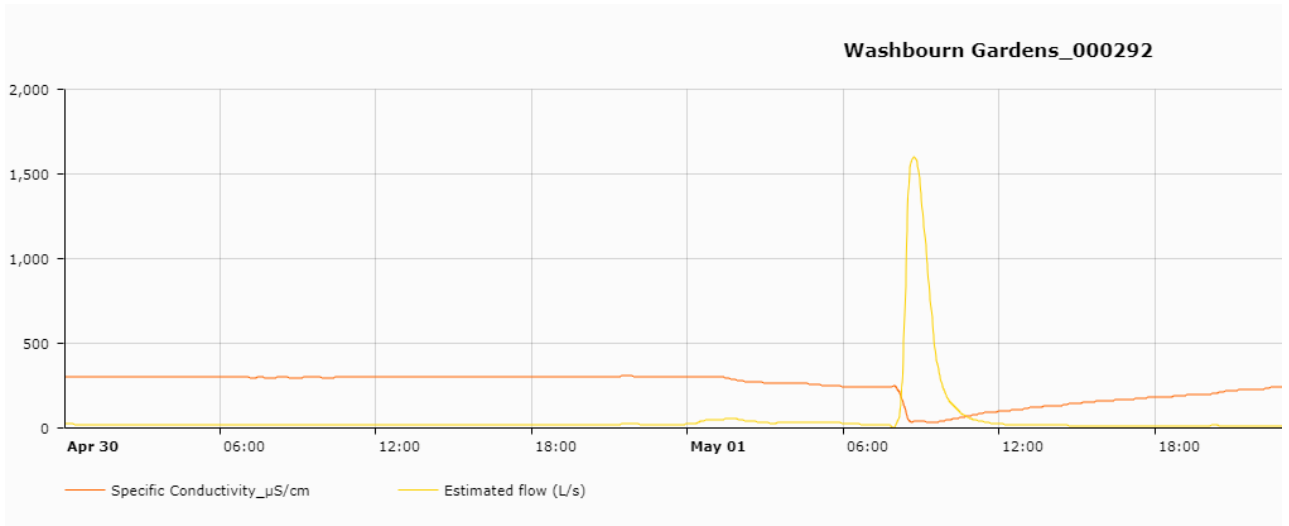
It was observed that conductivity drops when flows increase due to rainfall:

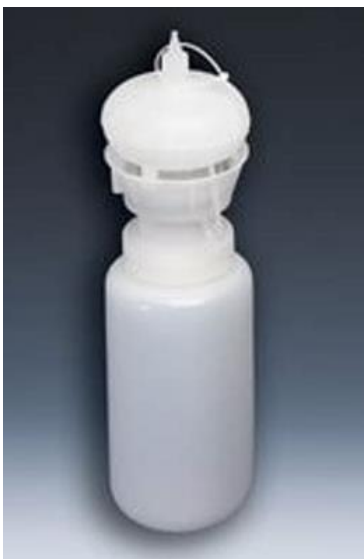
Figure 3: Nalgene Stormwater Sampling Bottle (self-sealing)

First flush samples were collected using Nalgene stormwater sampling bottles. See Figure 3 Figure 4. They were placed 2cm above the current water level in a water body or suspended from the grill in a sump as pictured in Figure 4 and Figure 5, Once they filled up they self-sealed and then were collected following the rain event, or when the water subsided so that it was safe to collect them.

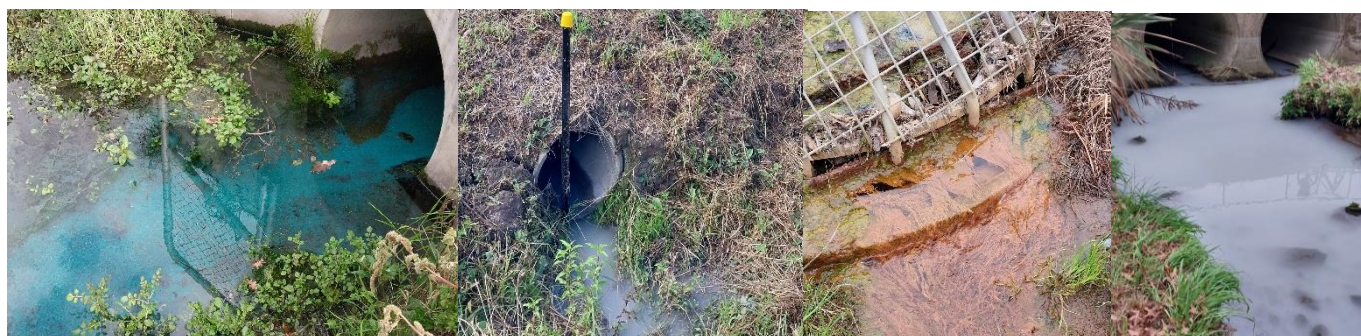
Figure 6: A range of possible discharges that have been investigated as part of our monitoring programme in 2023/24

Areas of investigation focused on road runoff, industrial sites runoff, and wastewater contamination due to leaks.

Three rounds of road runoff sampling have been carried out. As expected, Zn & Cu levels were high as well as TSS. Visually the sump water samples were grey black.

Stormwater outlets from a concrete manufacturer and a car mechanic workshop led to some further environmental compliance team led investigations. This was also the case for multiple discharges that had been observed in our stormwater network either by the public or our stormwater maintenance team from Downers.
