## NOR – Richmond South Water Supply Reservoir

## Richmond South Reservoir

Short-Term Discharges Ecological Impact Assessment

For Tasman District Council

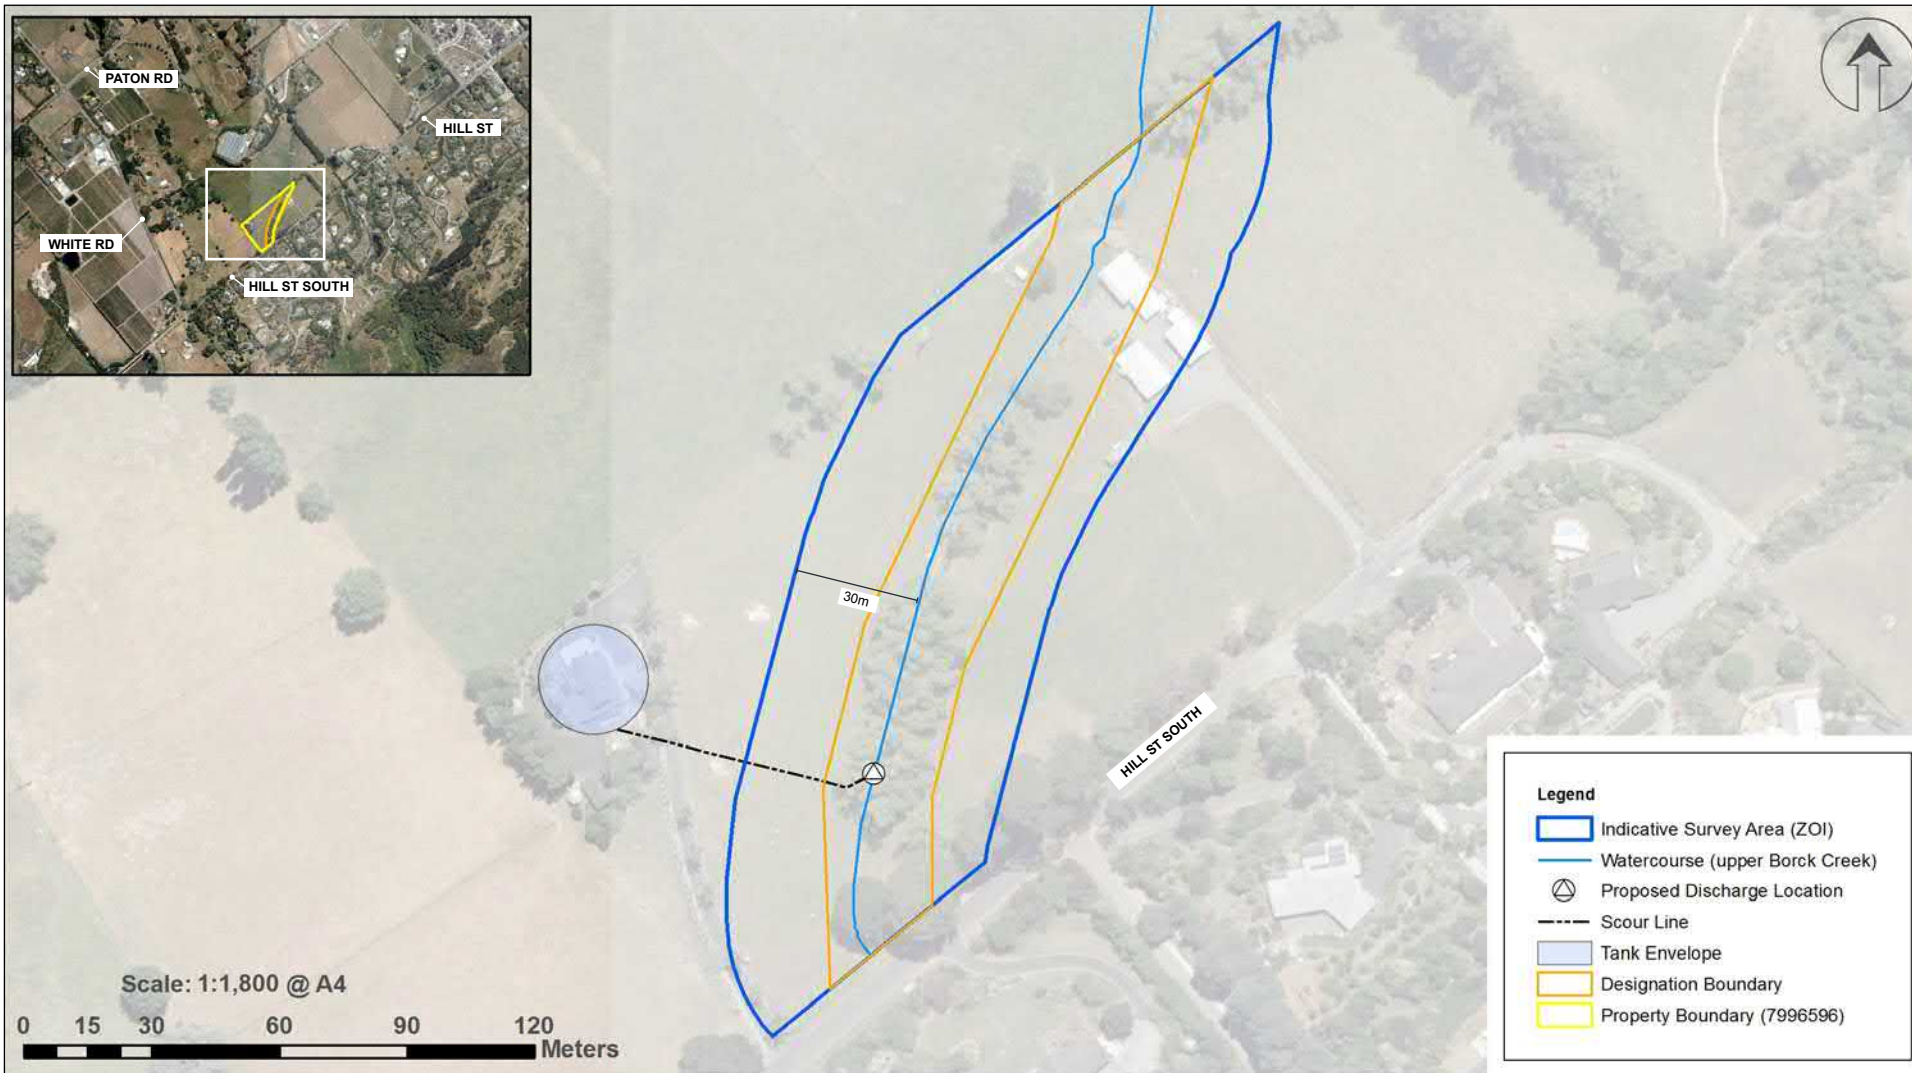
**Figure 1.1.** Survey reach (or Zone of Influence) and proposed discharge location, upper Borck Creek. Designation boundary and proposed discharge location as per site plans by WSP and Stantec.

The location of the proposed discharge outfall within the designation footprint and subject survey area is shown in Figure 1.1. The overflow pipes (scour line) will lead to upper Borck Creek with controlled discharges during commissioning of tanks, maintenance and emergency situations. Based on information from WSP, for tank commissioning, the following steps are proposed:

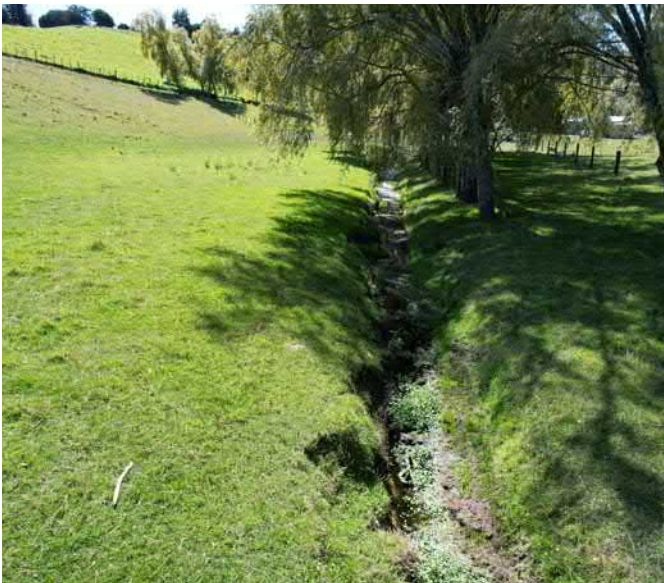
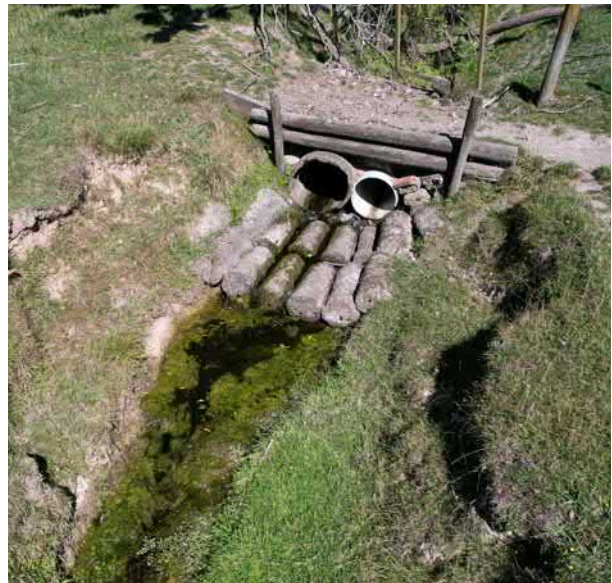
**Figure 3.1.** Borck Creek upper reach contiguous with grazed pasture cover down to the wetted stream edge and exotic shrubs/trees on low relief gully floor within the survey area, at the proposed site, March 2022.

The survey area encompassing Borck Creek upper reach, a small, narrow, first order (most likely ephemeral) stream, is within low topography<sup>3</sup>, gully floor environment situated to the immediate east of the proposed tank reservoir and discharge site at 520 Hill Street South. The area is surrounded by High Producing Exotic Grassland (LCDB5) with a height above sea level of around 58 meters. Predominantly landuse cover across the wider catchment area is one of high producing pasture grasses and urban development, with areas of indigenous (deciduous and broadleaf hardwoods) and plantation forest occupying land on steeper hillslope flanks to the south.

Riparian margins consisted of grazed pasture grass with isolated non-native large shrubs and/or trees (mostly weeping willow) confined to an area along the true right bank top. The latter provide some shading of the streambed. The open pasture area provided no protection from stock access to the stream. The lower banks on both sides of this reach were incised and relatively steep with some areas of bare exposed ground. With evidence of bank slumping observed, both banks appear to have a high potential for erosion, especially during higher flow events.

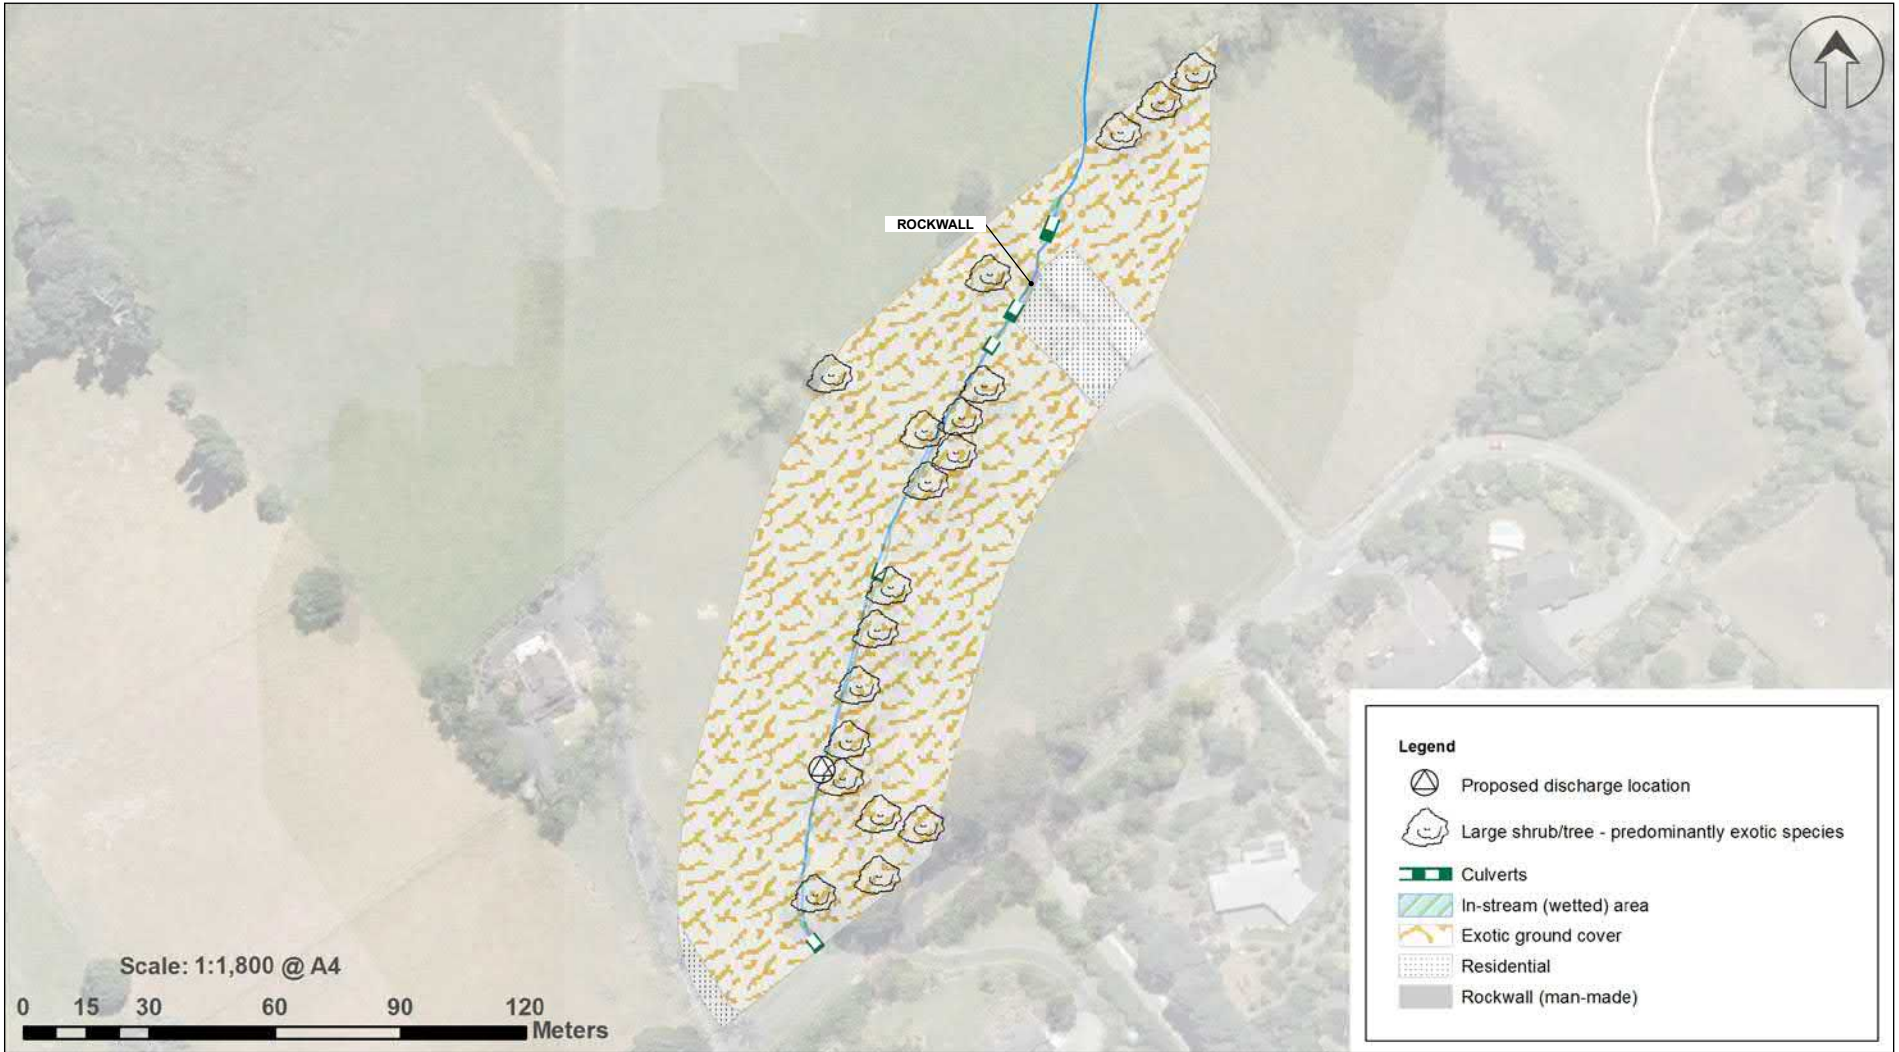
**Figure 3.3.** Broad scale (indicative) map of existing habitats, including proposed discharge location within the upper Borck Creek study area.

An example, looking north (downstream) across the site, of how habitat margins were delineated is provided in Figure 3.2. A GIS-based habitat map of the study area is provided in Figure 3.3.

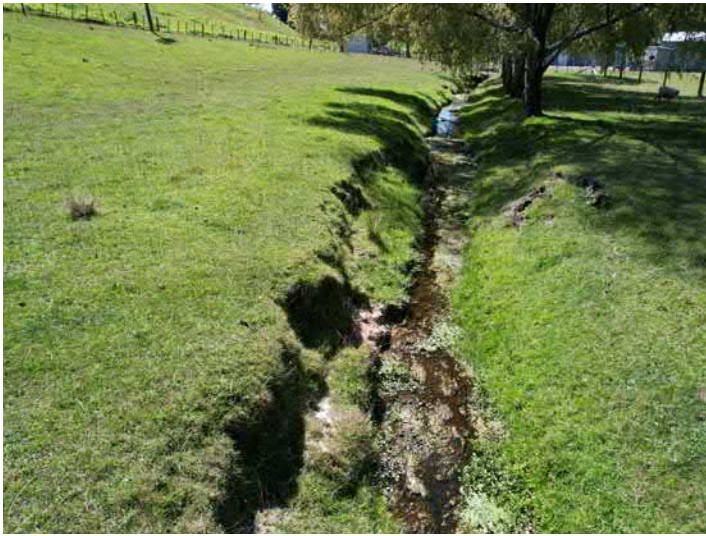
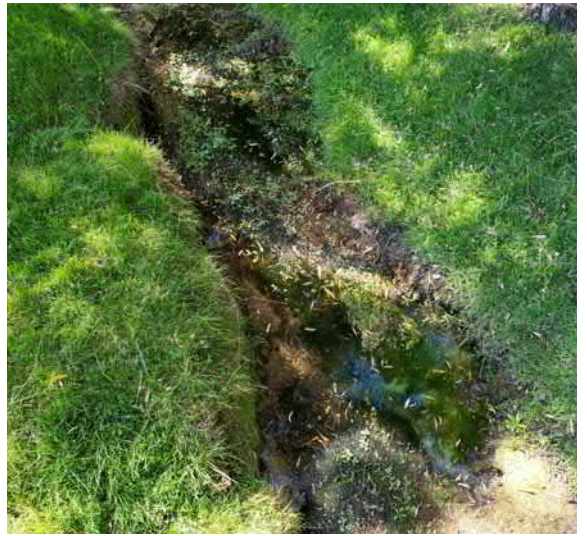
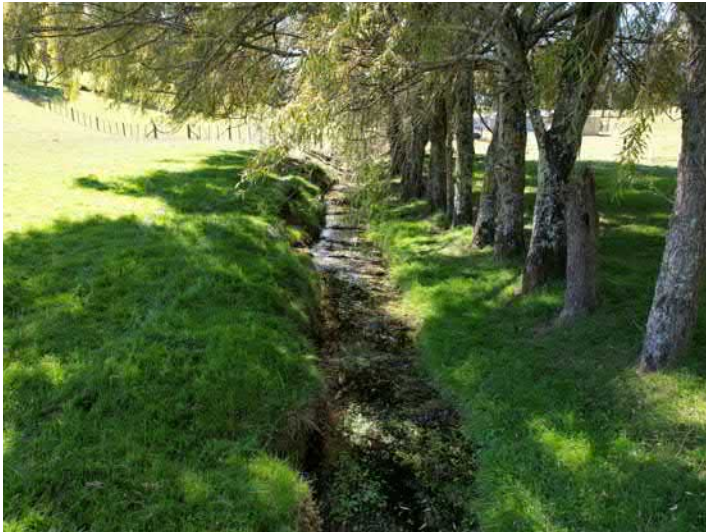
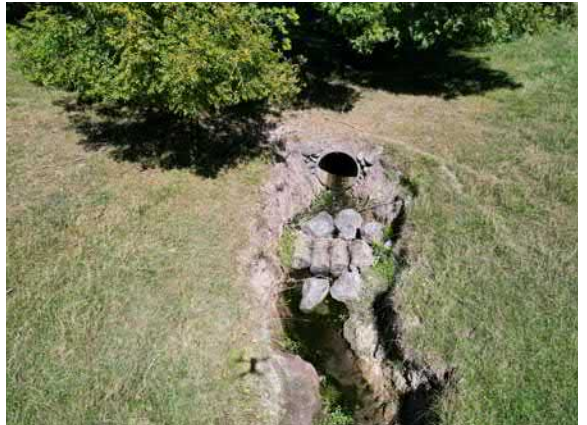
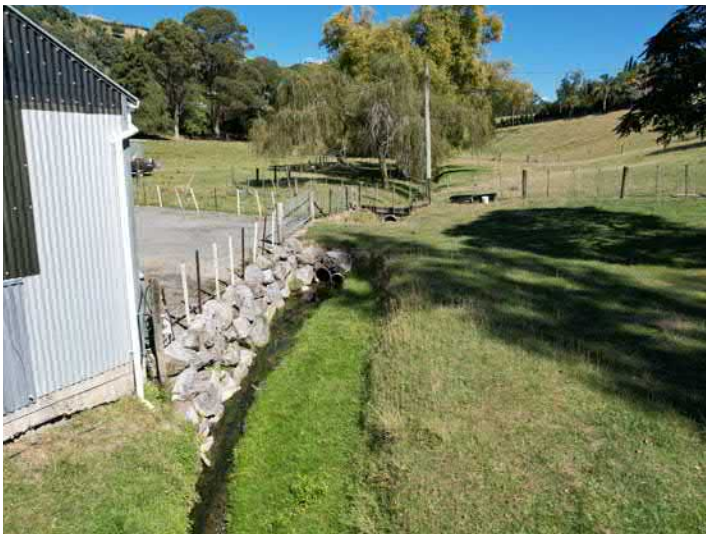
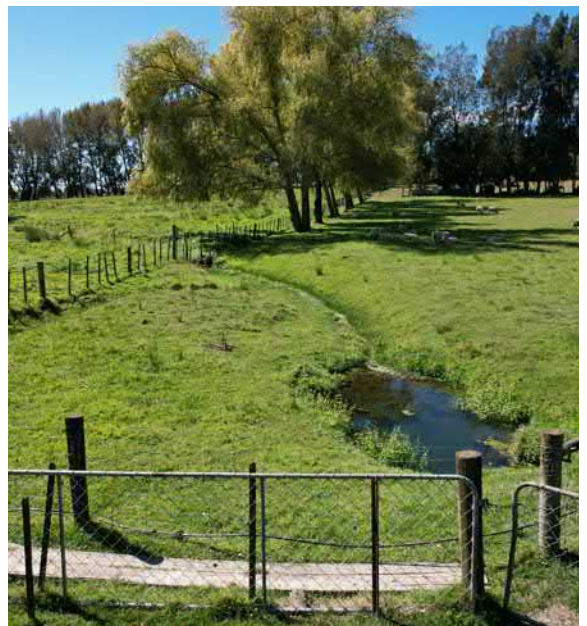
Photo 1-6: Overview of existing (modified) conditions within the subject reach, upper Borck Creek, where discharges will be received.
