An archaeological assessment of the construction of a boat ramp at Waterfront Park, Mapua, Tasman District

For
Tasman District Council

April 2022

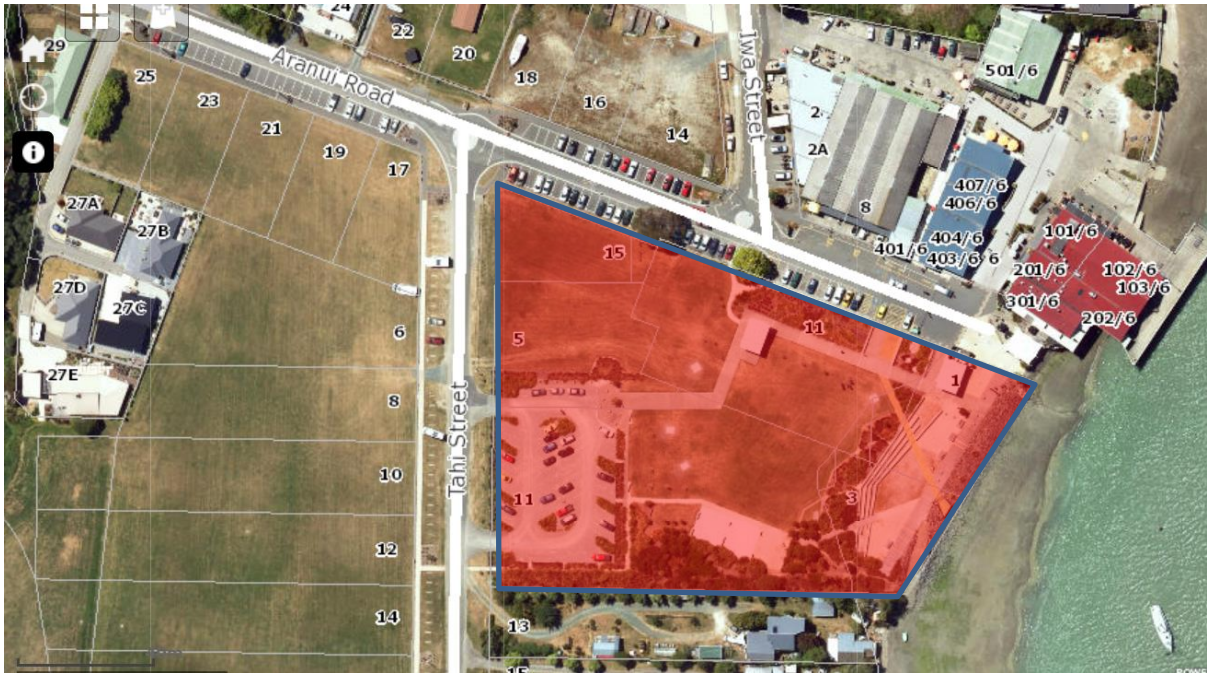
Figure 1 The shaded area is Waterfront Park, where the remediation took place. The boat ramp is proposed to go along the southern boundary of the park (retrieved from topofthesouthmaps.co.nz)

The physical addresses of the affected land are Nos 1 and 3 Tahi Street. The legal descriptions of both parcels are Lot 6 DP 11502.

The ramp structure will be sited 3m north of the boundary shared with 13 Tahi Street. It will protrude into the sea by about 20m.

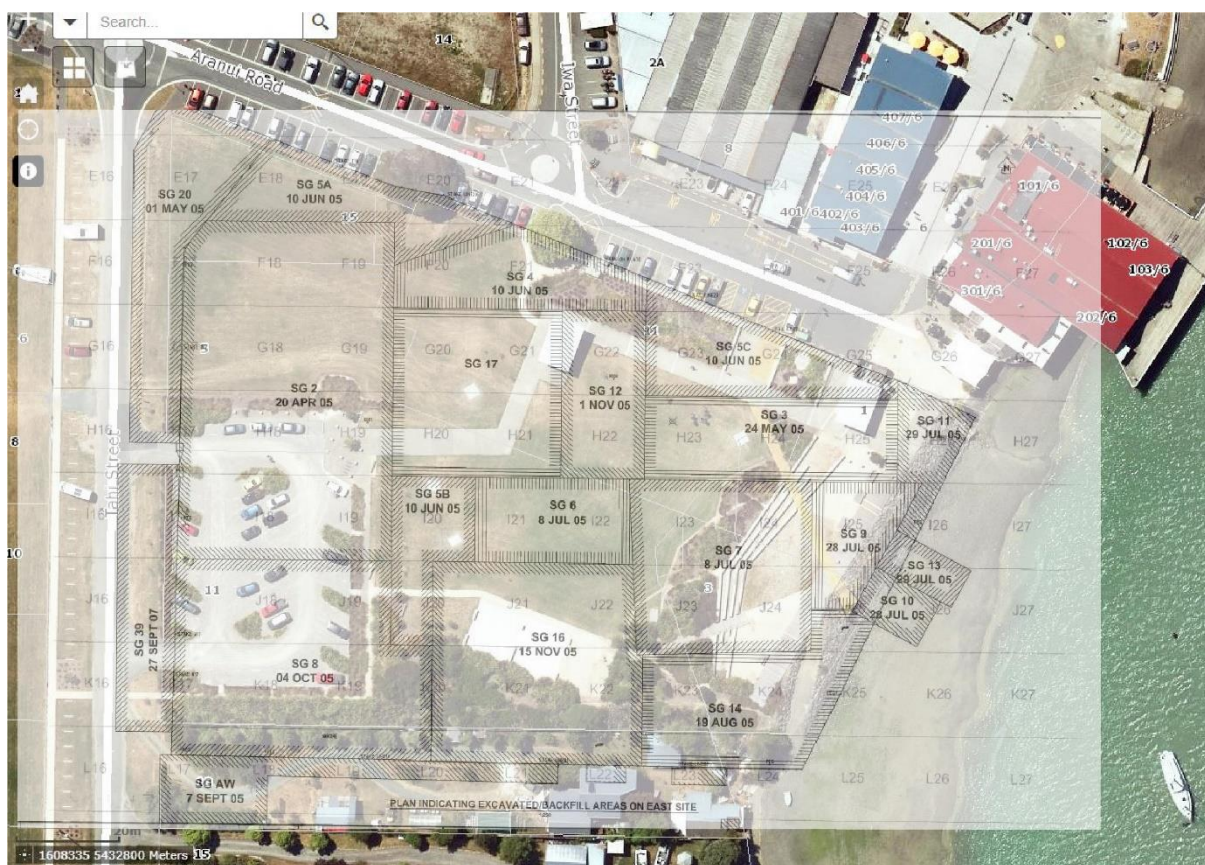
Figure 4 Overlay of remediation plan onto modern aerial (overlay by Hamish Williams)

A supplied plan of the remediated area was overlaid onto a modern aerial to check the extent of works along the boundary with 13 Tahi Street (Figure 4). An area at the western end of this property was evidently excavated for remediation, as well as a strip along the boundary. This was backed up in conversation with the property owner, Annette Walker, who confirmed that a strip of land on her property was excavated as part of the work package. Depths of excavation varied across the site, but it is understood they were up to 3 m deep. The plan shows that remediation extended well into the foreshore beach gravels.

At this depth and extent, it is highly unlikely that any excavation involved in constructing the boat ramp will affect any intact archaeological deposits.
