Motupipi Estuary 2007

Broad Scale Habitat Mapping

**March
2008**

**Prepared for
Tasman District Council**

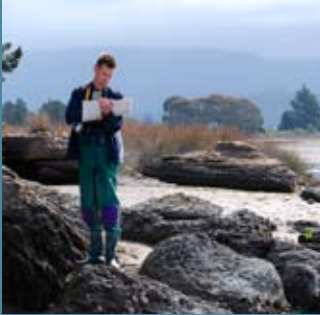
Bands of percentage cover used to classify macroalgae and seagrass.

>1 %
1-5%
5-10 %
10-20 %
20-50 %
50-80 %
80-100 %

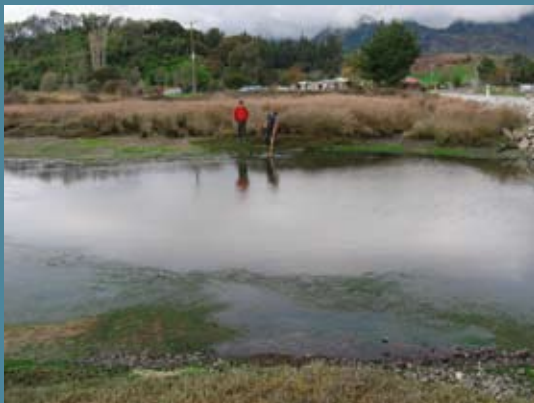
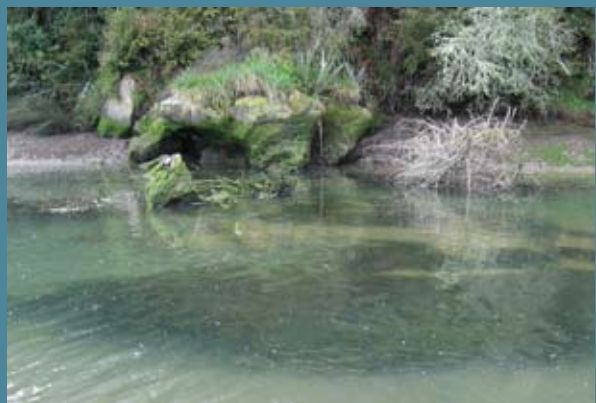
Uncommon for the upper reaches of NZ estuaries, extensive subtidal beds were present (see photos below). This is likely to be due to the largely spring fed Motupipi River providing relatively clear and stable flows enabling the seagrass to thrive in the upper estuary.

Examples of *Zostera* in the upper Motupipi Estuary

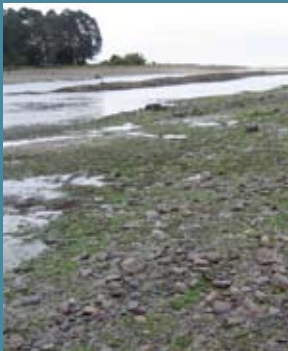
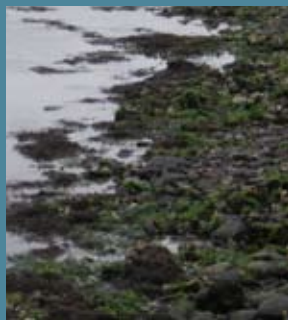
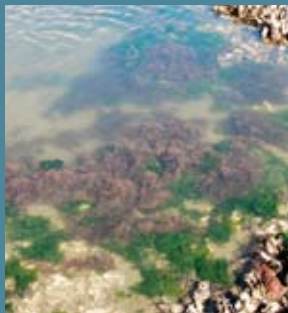
Gracilaria and *Enteromorpha* in the lower Motupipi Estuary.

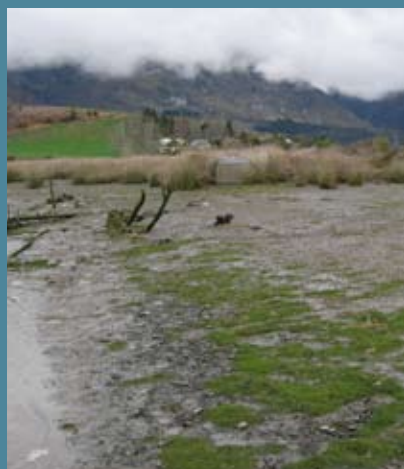
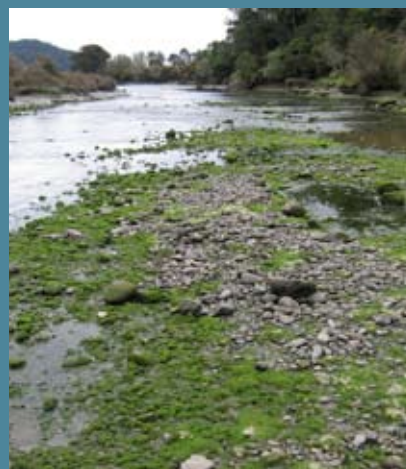
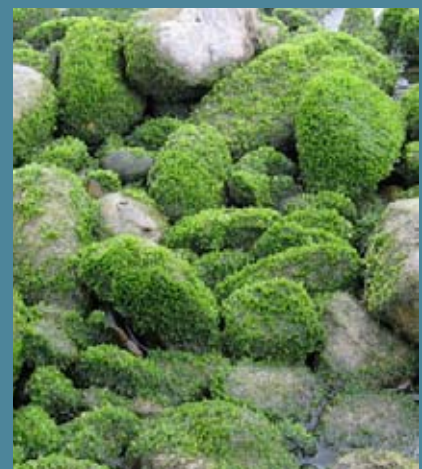
In the upper estuary *Enteromorpha* dominated and was present in high densities (50-80% cover), commonly covering rocks and cobbles in riffle zones, and elsewhere in narrow bands along the edge of the river (see photos below).

Enteromorpha in the middle and upper reaches of the western arm of the Motupipi Estuary.

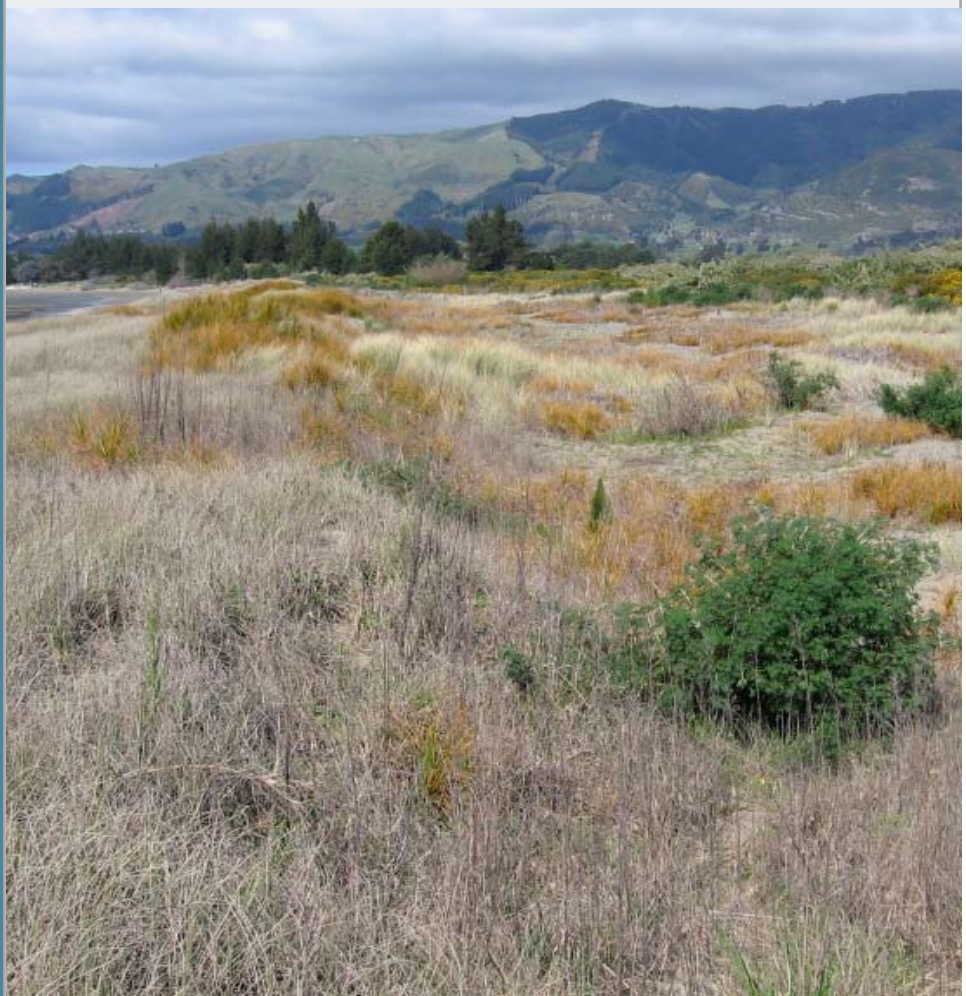
The dune also supports a range of native and introduced scrub/shrub/forest species evident in discrete bands of vegetation present across the dune (see photo below and Figure 12.), with parts of the inland dune now very much terrestrial in nature.

Dune vegetation is dominated by the introduced sand binding marram grass (*Ammophila arenaria*), although native sand binders pingao (*Desmoschoenus spiralis*) and kowhangatara (*Spinifex sericeus*) have been reintroduced to the dune.

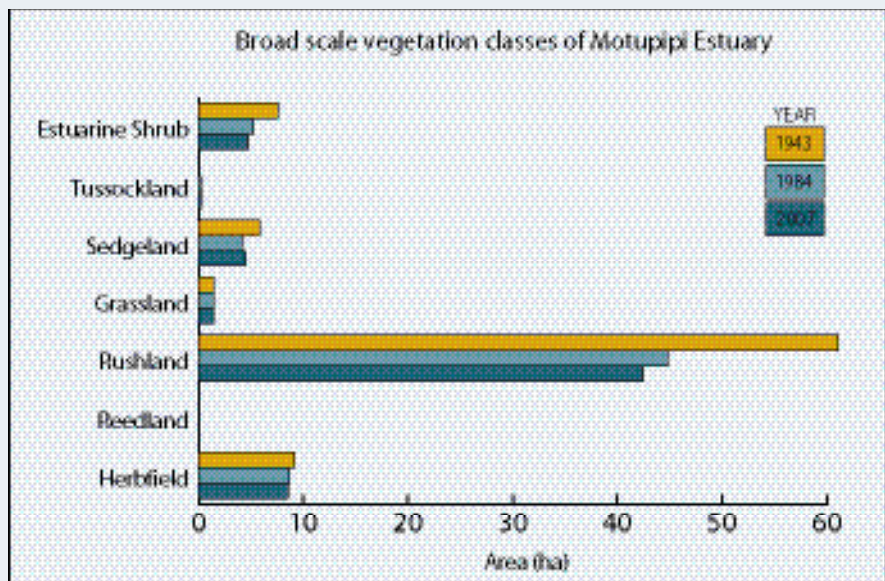
The biggest decrease has been saltmarsh vegetation (23ha, 27%), predominantly through losses of rushland (18.6ha, 31% reduction) and estuarine shrub (3.1ha, 41% reduction), and small losses of sedgeland and herbfield. Most of the change (21ha) occurred between 1943 and 1984, with only small overall loss of saltmarsh (2.5ha) since 1984 (Figure 9). While rushland beds generally appear very stable (1943 beds are still clearly distinguishable in 2007), some seaward expansion of rushland is evident. Consequently, the loss of rushland along the terrestrial margin will be larger than the overall figures indicate.

Figure 9. Change in broad scale vegetation class (ha): 1943, 1984, 2007.

Broad scale vegetation present in 1943, 1984, and 2007 is summarised in Table 8 and in Figures 7, 8, and 9, while Figures 10 and 11 show the historical photographs used to map features from 1943 and 1984, along with habitat maps of the dominant vegetation classes.

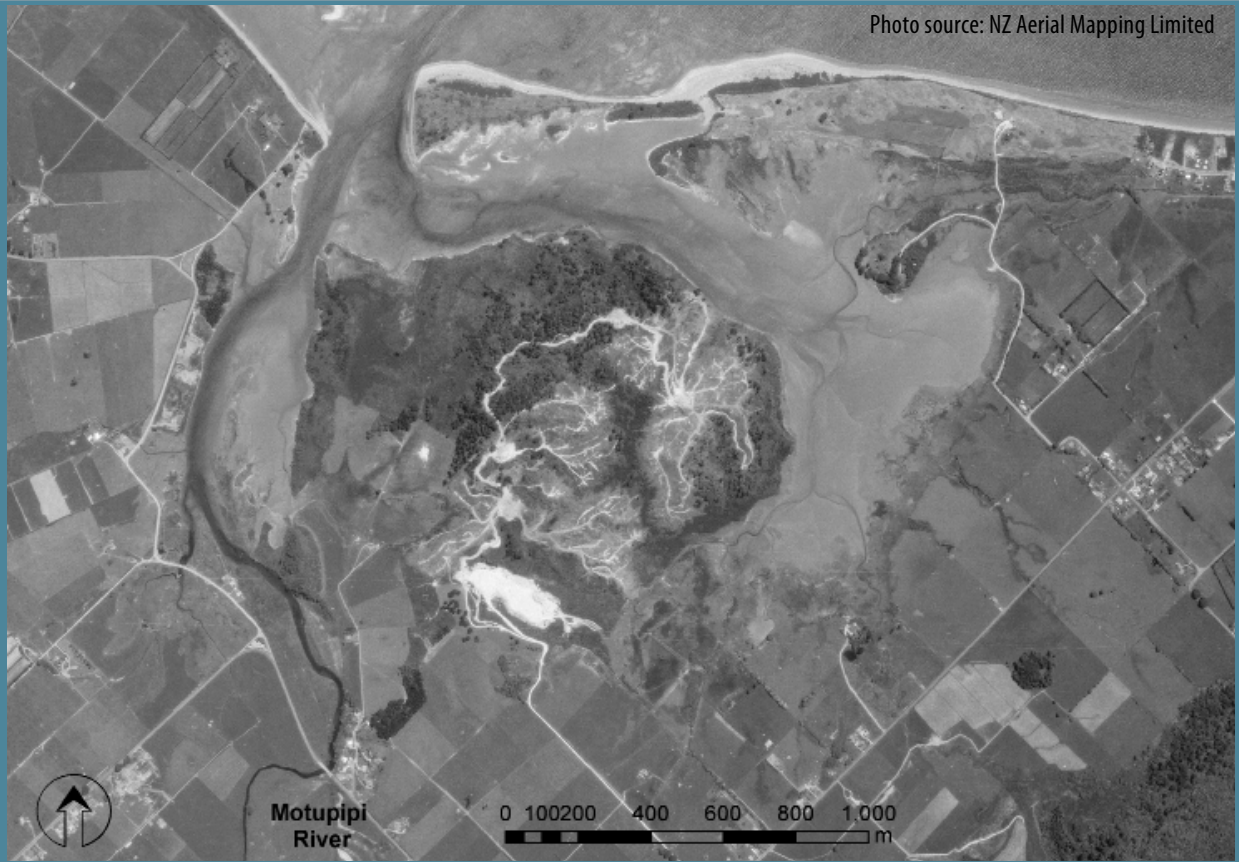
Figure 11. 1984 aerial photograph of Motupipi Estuary (top) and broad scale estuary vegetation (bottom).

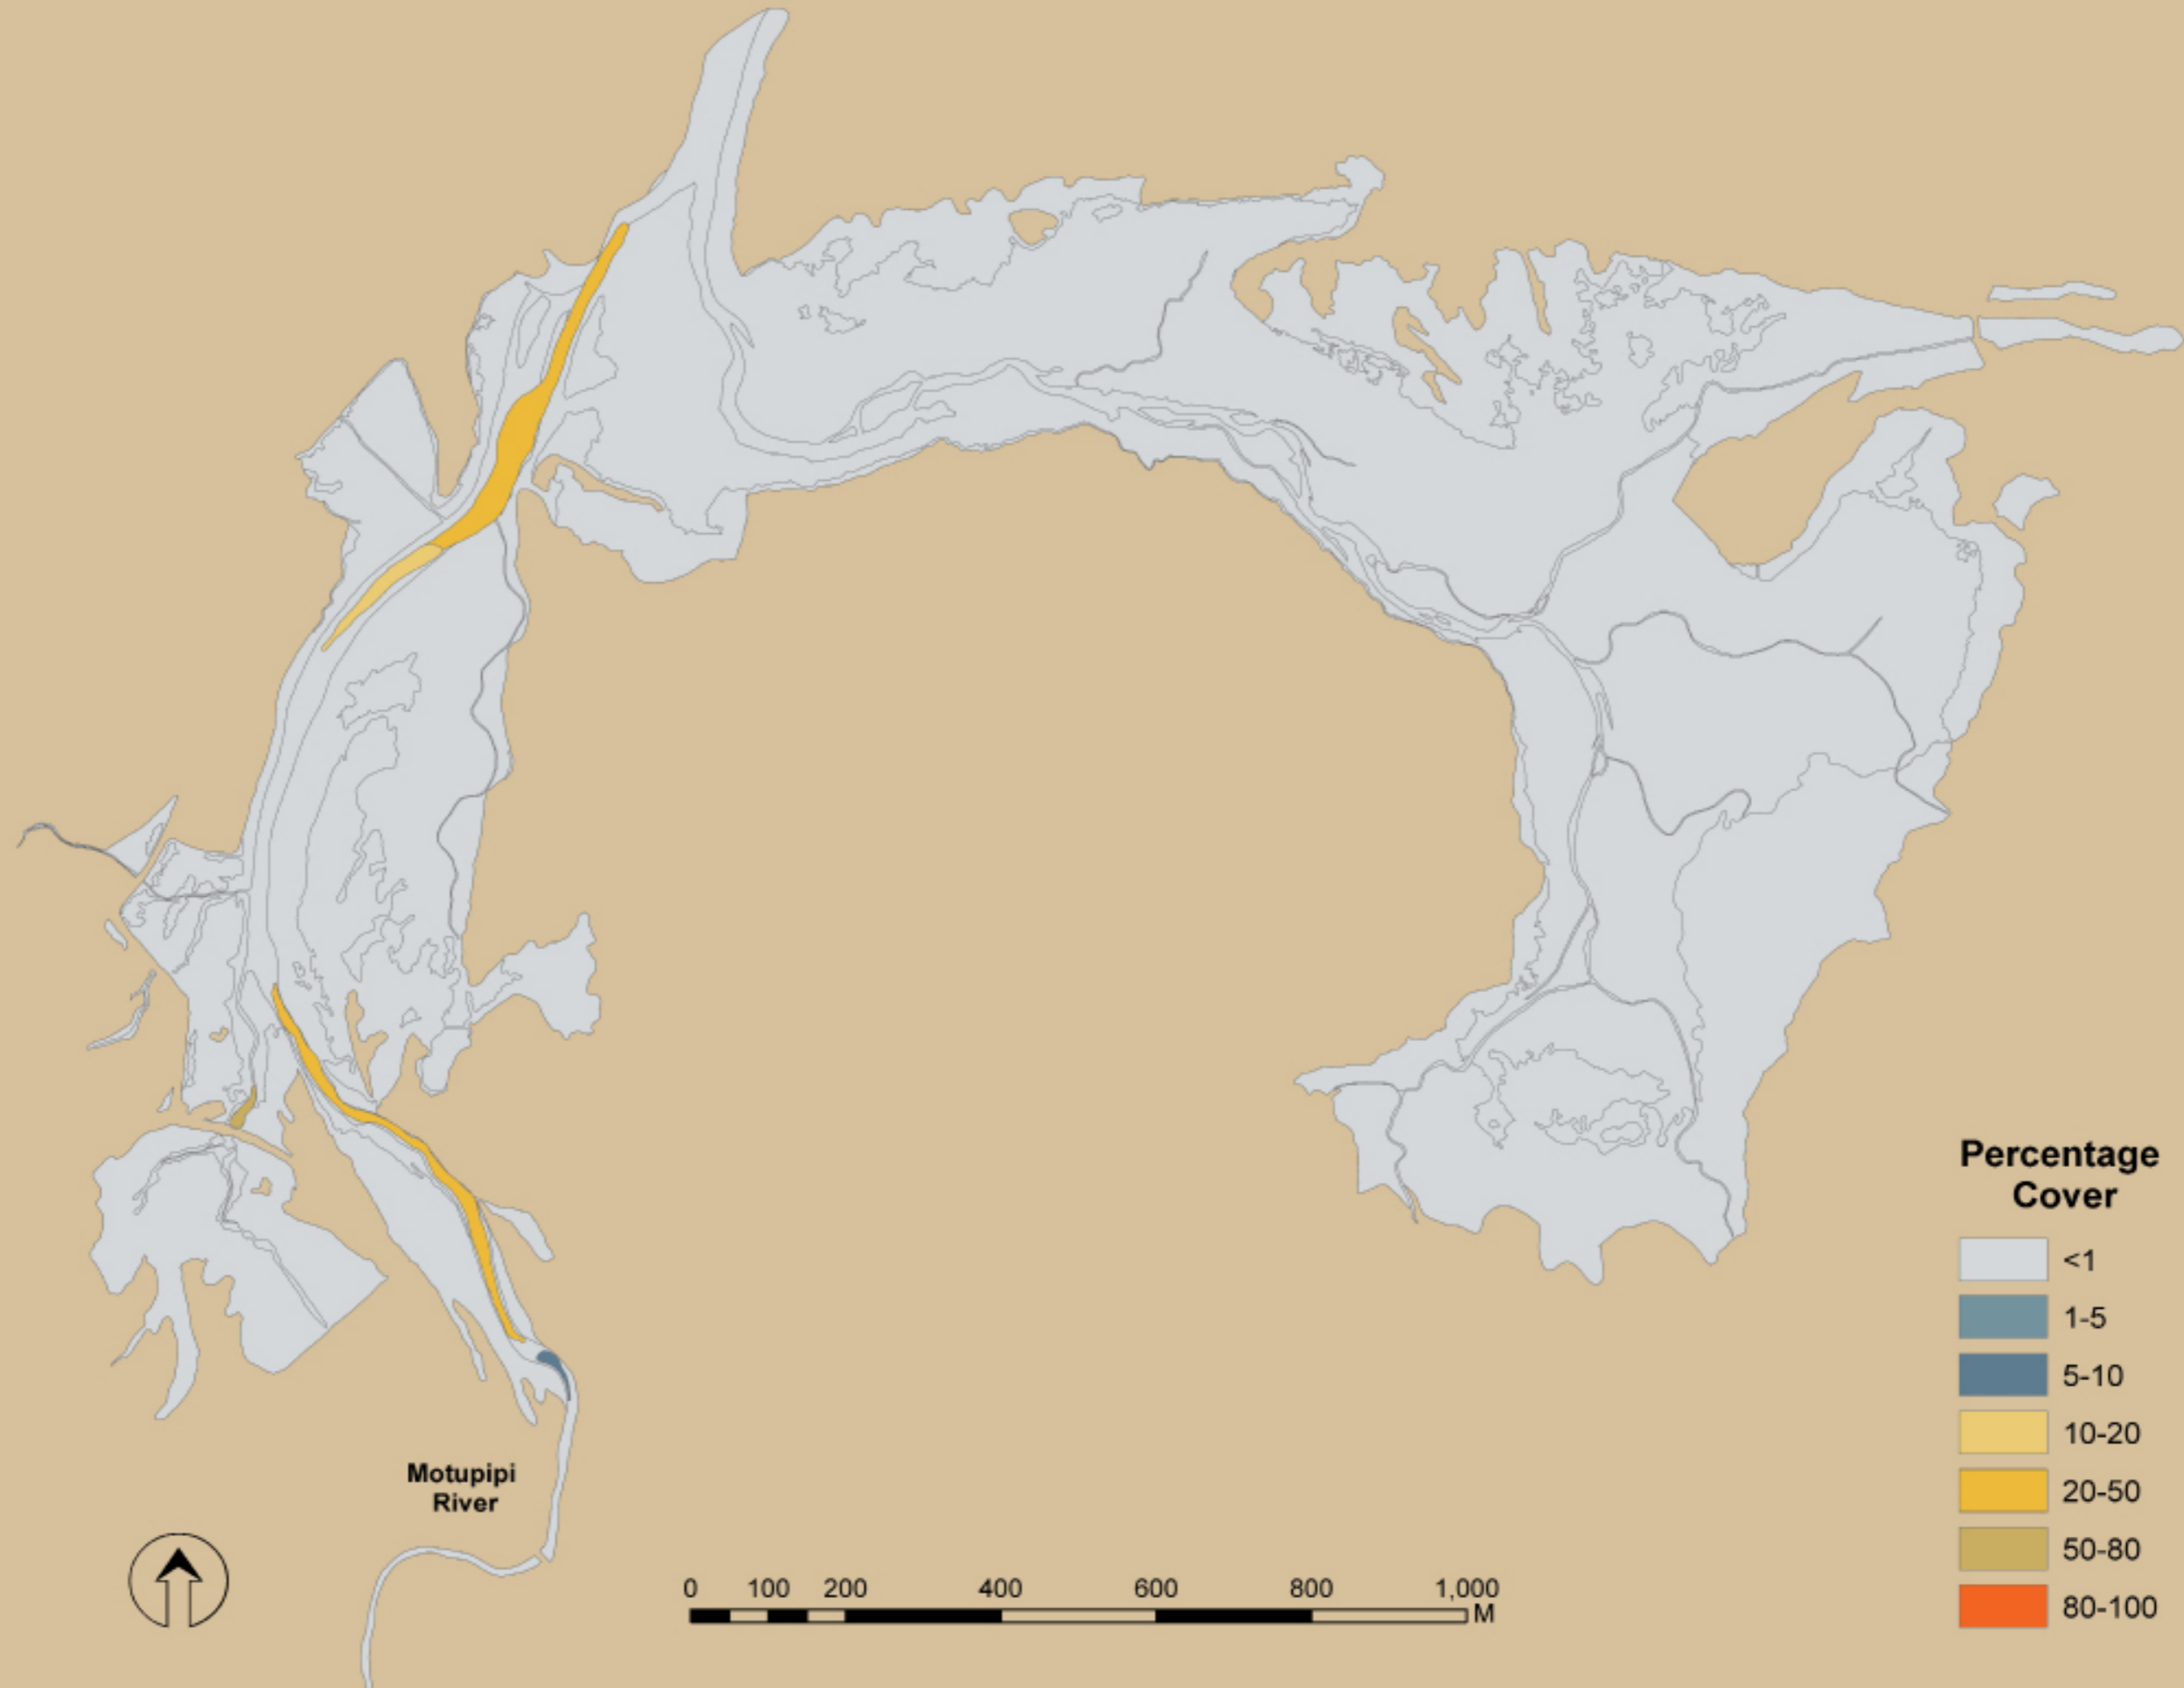
Motupipi Estuary 2007 Seagrass Percentage Cover

Percentage Cover

Table 5 and Figure 3 summarise the results of seagrass mapping within Motupipi Estuary and provide a baseline for comparing future changes using the Condition Ratings proposed in Section 2.
