# GROUNDWATER QUALITY IN THE MOTUPIPI RIVER HEADWATERS

**Document Status: Final Report**

September 2008

Tasman District Council Report Ref: 07004

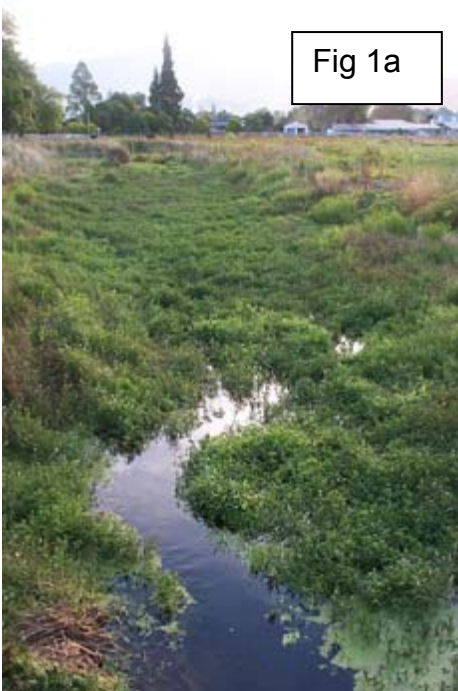
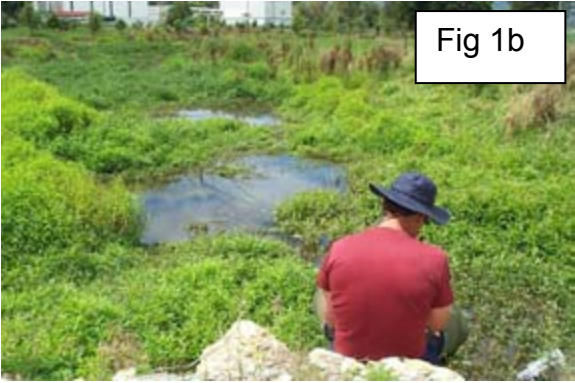
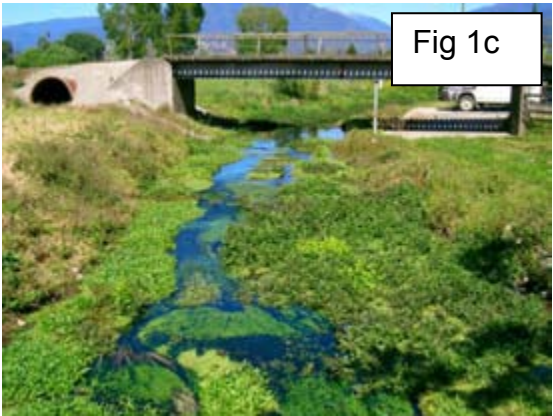
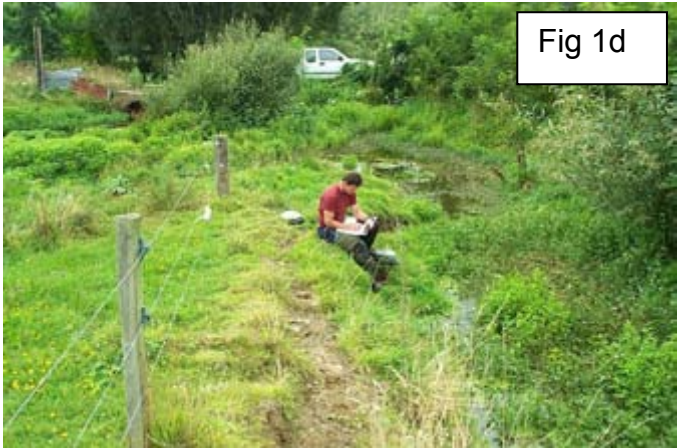
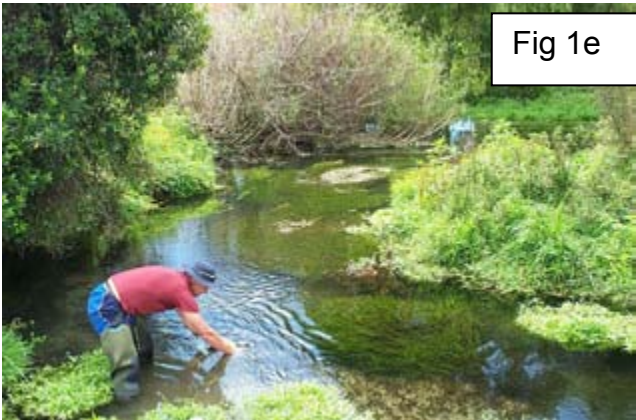
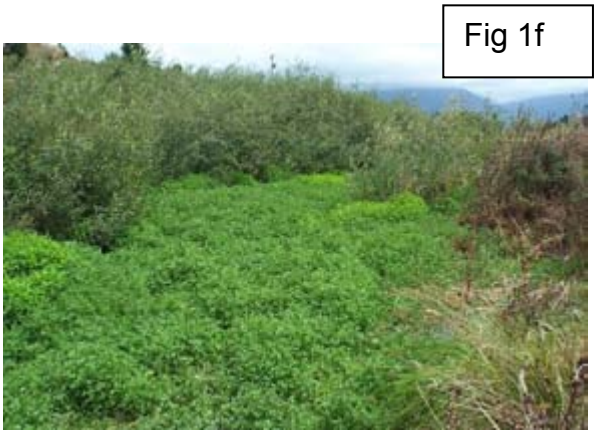
**Figure 1:** The spring sources of the Motupipi River. \_\_**Fig 1a** Watercress Ck u-s dairy factory **Fig 1b** Watercress Ck Spring source, **Fig 1c** Motupipi Rv u-s Watercress Ck, **Fig 1d** Motupipi trib 10m u-s Factory Farm Br, **Fig 1e** Motupipi trib 310m d-s Factory Farm Br (near Motupipi confluence), **Fig 1f** Motupipi trib 310m d-s Factory Farm Br source (170m upstream Fig 1e)

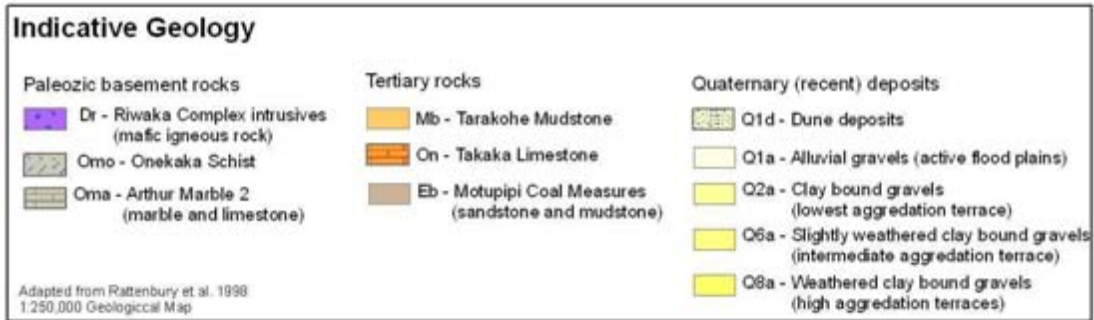
**Figure 2:** Indicative geology of the Motupipi River headwaters area.

Figure 2 shows the generalised geology of the Motupipi River headwaters area. It is adapted from the 1:250,000 scale geological map (Rattenbury *et al.* 1998) and the boundaries of the rock units are approximate only.

The Motupipi River headwaters are located immediately to the west and southwest of the Takaka township (see Figure 2)

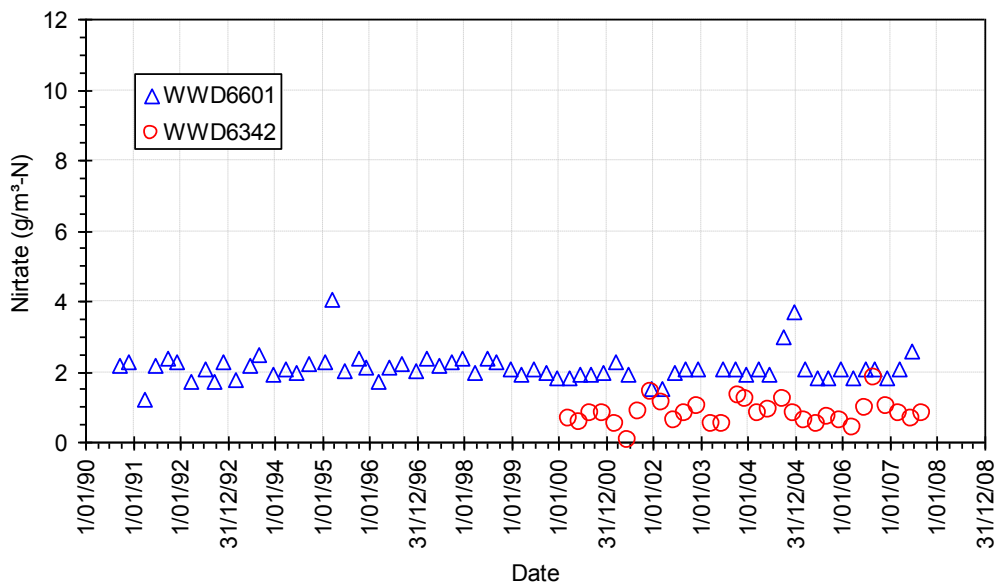
**Figure 10:** Nitrate-nitrogen concentrations, WWD6601 and WWD6342.

0.8 g/m<sup>3</sup>-N and a maximum concentration of 1.8 g/m<sup>3</sup>-N (Figure 10). Surface water nitrate concentrations in the Takaka River (measured at Kotinga Bridge) are typically less than 0.5 g/m<sup>3</sup>-N.

Where the groundwater has a karst source the expected background nitrate concentrations are less certain. As shown in Figure 9, nitrate concentrations in groundwaters with a significant karst component to their source (i.e. have hardness' greater than 80 g/m<sup>3</sup> as CaCO<sub>3</sub>) showed considerable variation. Significantly, almost all of these sites had nitrate concentrations greater than 1 g/m<sup>3</sup>-N. Long term groundwater quality data for the Takaka Limestone is available from WWD6601. Quarterly monitoring since 1991 (17 years) has shown a stable nitrate concentration with a median value of 2.1 g/m<sup>3</sup>-N (Figure 10).

The relative stability of the observed nitrate concentrations in WWD6601, coupled with the absence of obvious seasonal variations, give the appearance stable background nitrate concentrations. However this is unlikely to be the case.
