# Moutere Inlet 2013

## Broad Scale Habitat Mapping

Tasman  
District  
Council

September  
2013

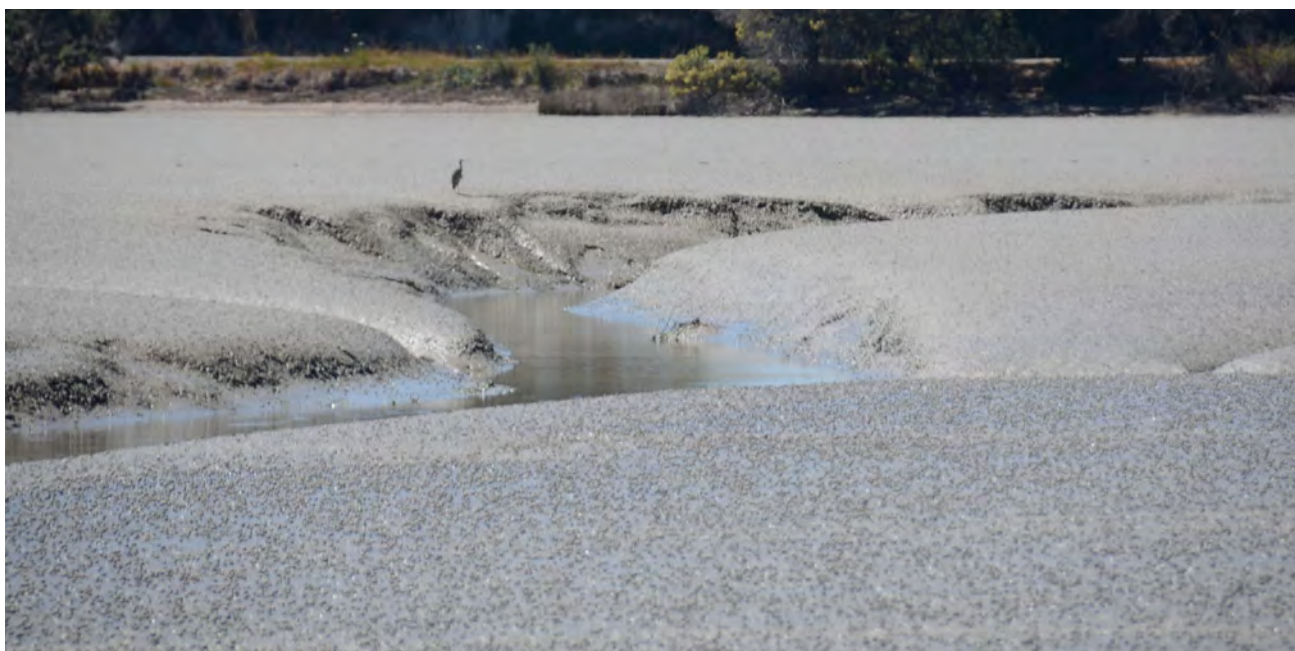
Perched tidal flats in the southern end of Moutere Inlet.

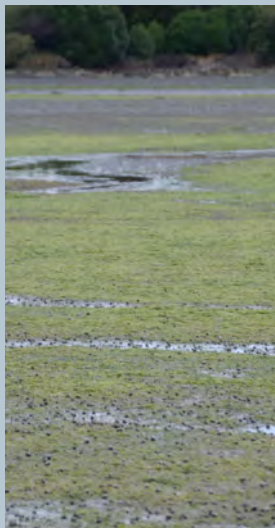
Extensive macroalgal (*Ulva*) cover near the western side of Jackett Island.

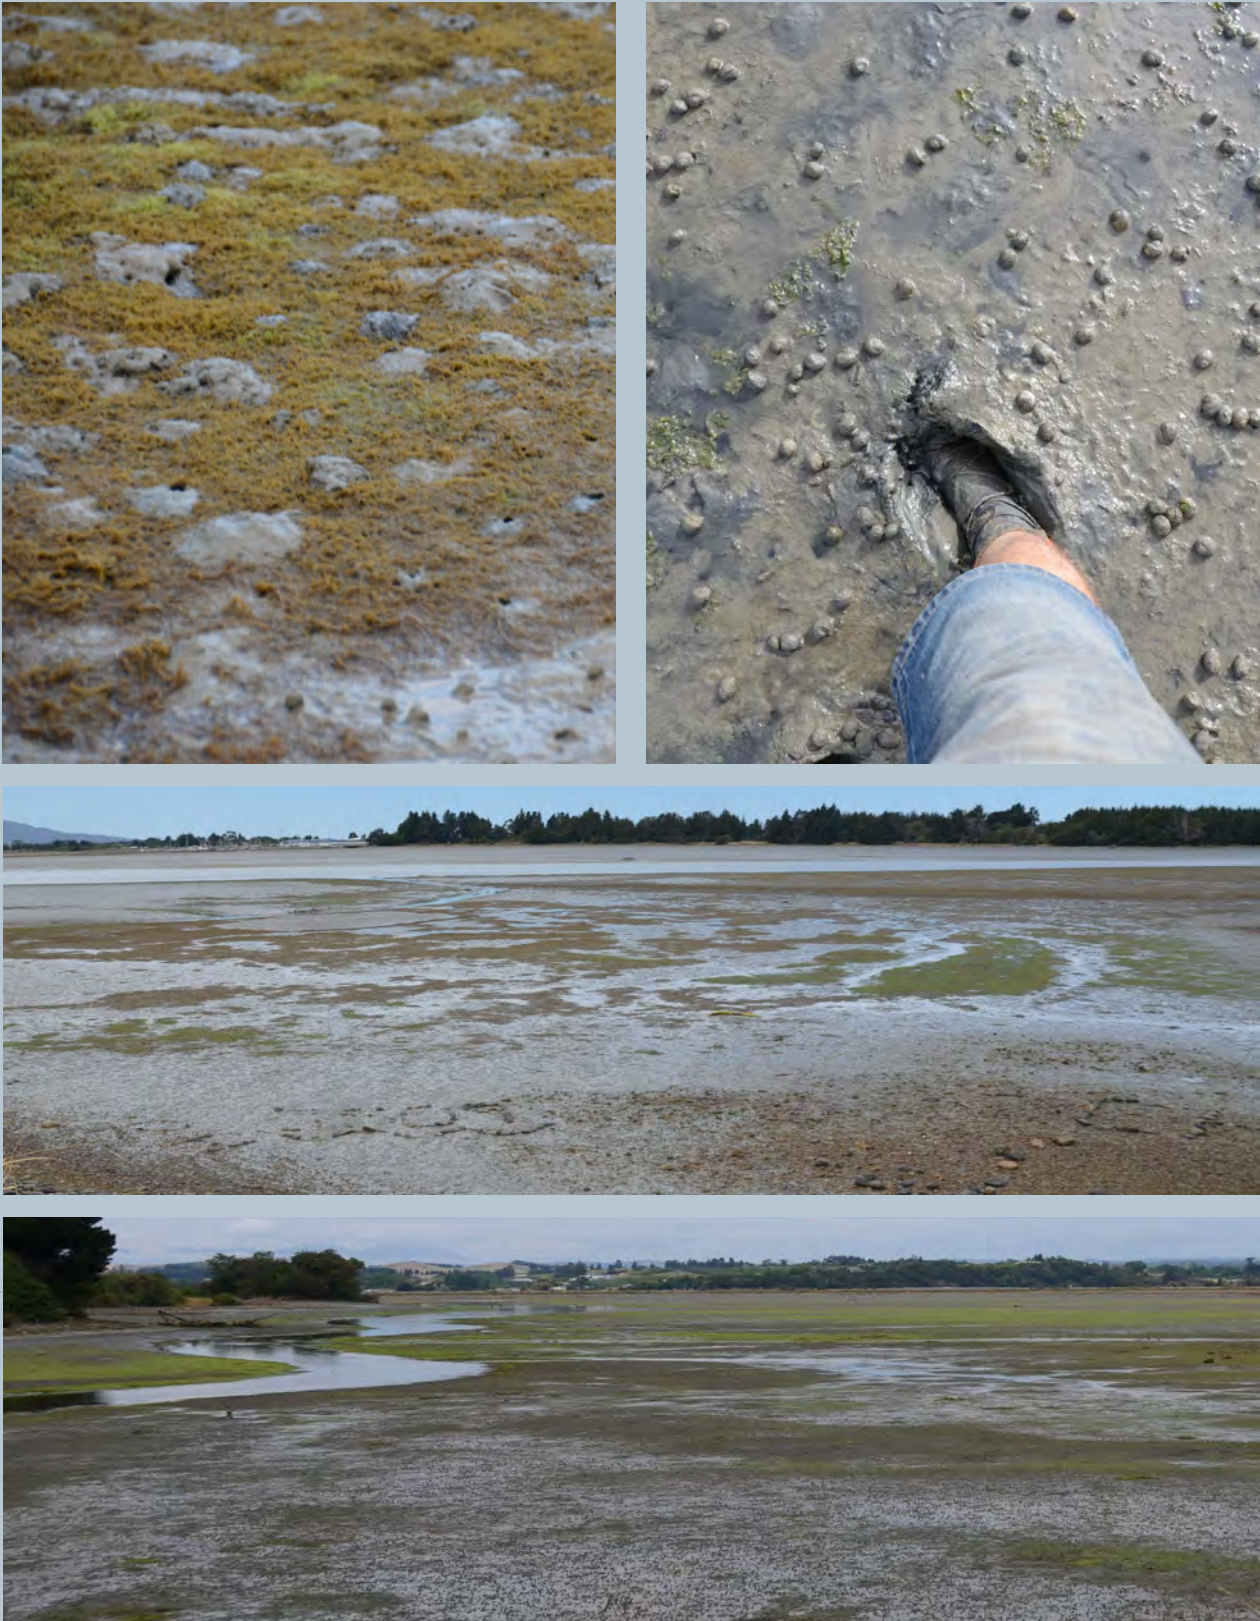
Figure 6. Examples of gross eutrophic zones within Moutere Inlet showing smothering by dense macroalgal growth (top left), excessive muddiness and high sulphide/low oxygen sediment conditions (top right), and extensive cover in the central estuary (middle photo) and Wharf Road embayment (lower photo).

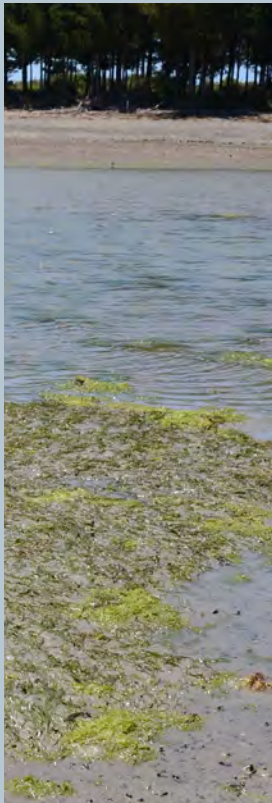
Seagrass beds near low tide channels by the Kina entrance.

The current location of seagrass appears restricted to well flushed lower channel areas near the estuary mouth which are largely free of mud and regularly bathed with clean seawater. Seagrass appears unable to establish on the perched intertidal flats of the estuary, most likely due to a combination of dessication (long periods of exposure between tides), excessive muddiness, and poor water clarity.

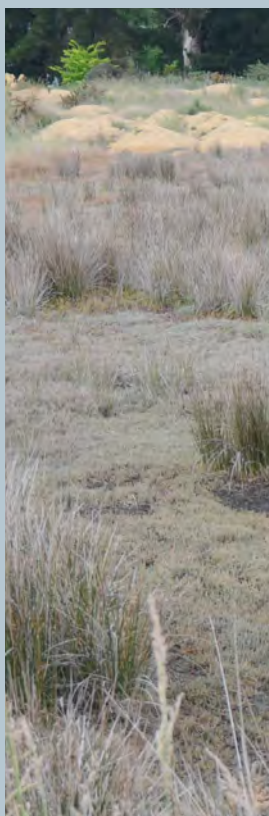
Saltmarsh reclamation on private land near Batchelor Ford Road.

Saltmarsh restoration at Tasman following causeway removal and realignment of the State Highway.

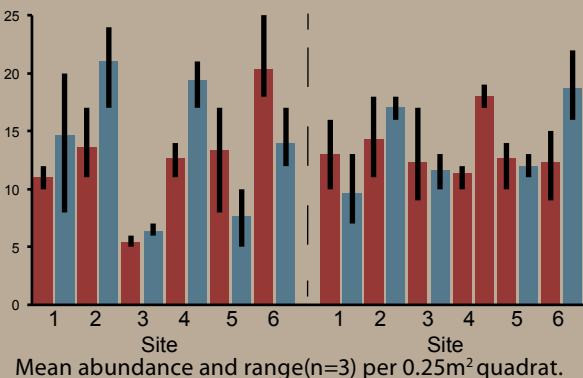
Mean abundance and range (n=3) per 0.25m² quadrat.

Crab hole counts showed a more rapid return to pre-impact levels with little evidence of impact after 6 months (see lower inset graph).

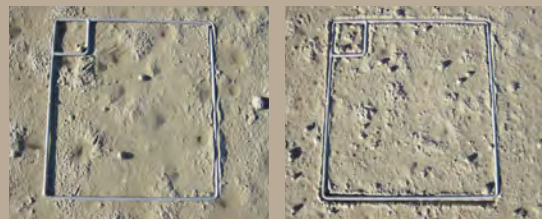
Site 1 quadrats: 6 week impact (left) and reference (right).

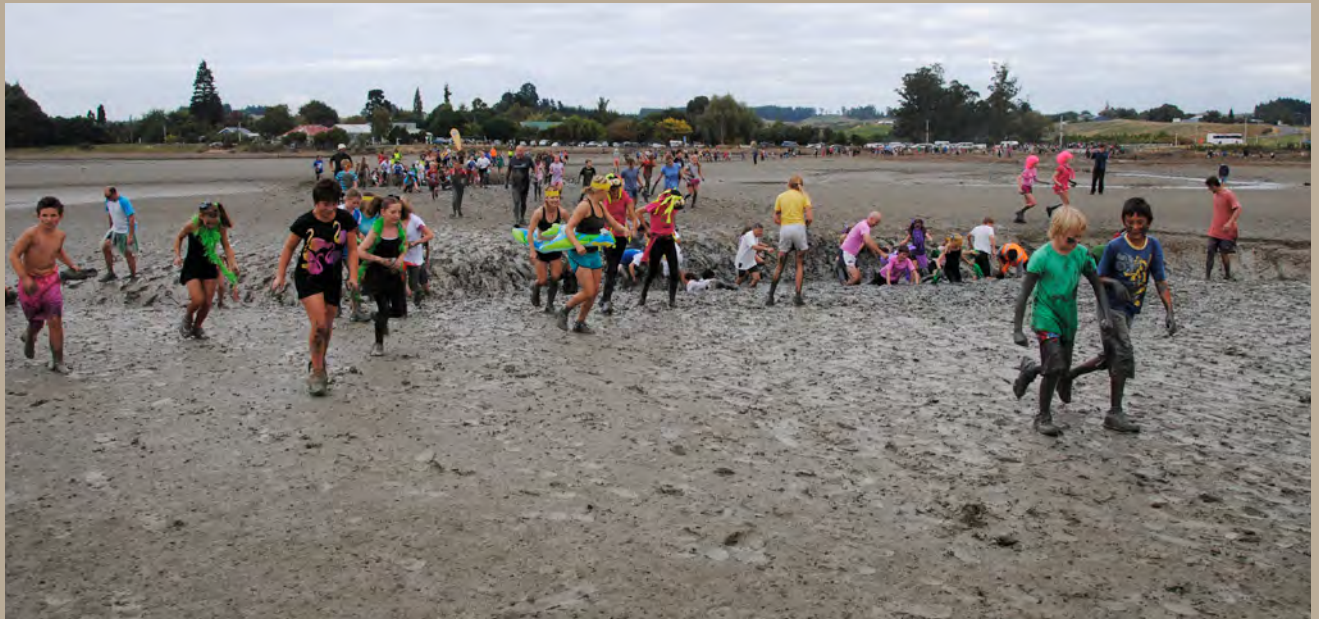
Sport Tasman **MUDDY BUDDY** Adventure Fun Run - March 18th 2012  
Yasman School - 10am

BEFORE	DURING	+1 HOUR	+ 6 WEEKS	+6 MONTHS
a					
b					
c					
d					
e

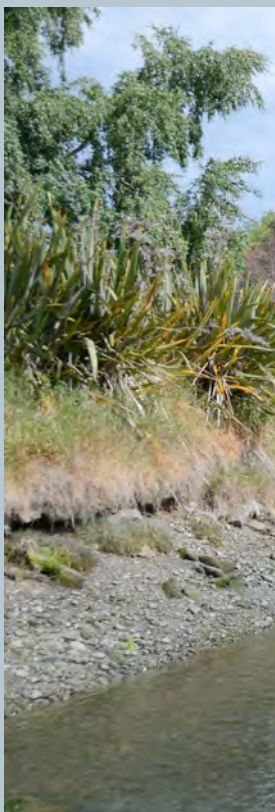
Margin areas in the Wharf Road embayment (above) and by SH60 (right).
