# LEE RIVER DAM VEGETATION UPDATE

**Philip Simpson**

**Uruwhenua Botanicals, Pohara**

**November, 2013**

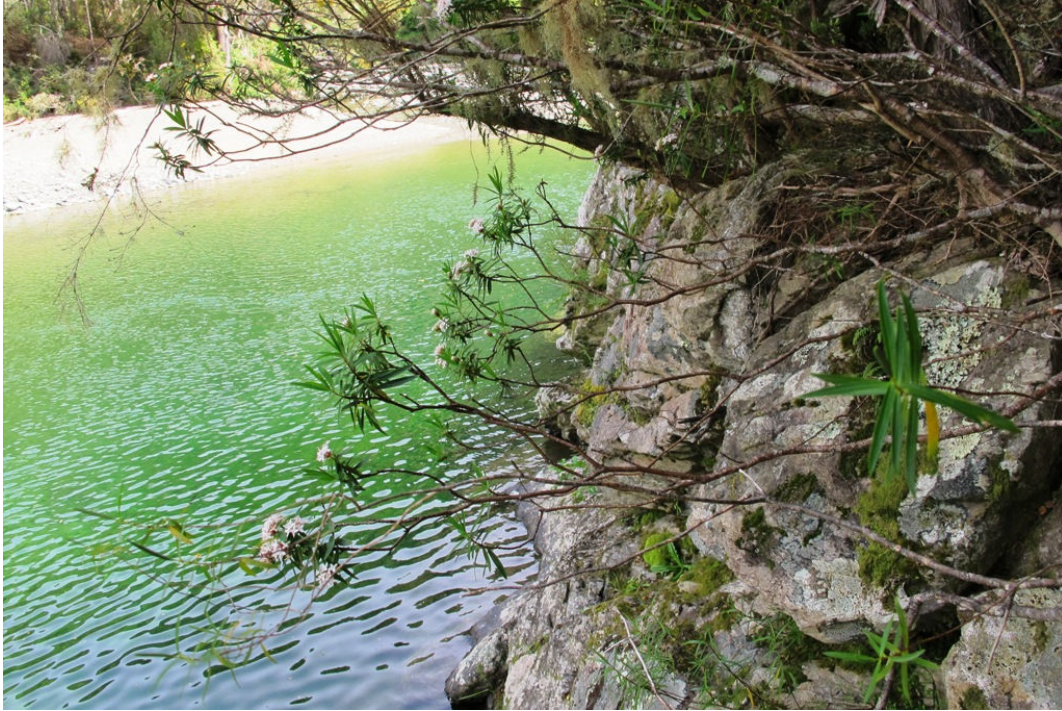
Site 1. A bed-rock induced curve in the river protects a turf habitat from flood damage, and the only *Pimelea longifolia* (NZ Daphne) known from the footprint area, a grove of several plants and seedlings, has survived.

Site 1. With the relocation of the dam upstream Site 1 will not be inundated, but may well be modified by construction activity if such activity extends that far downstream. This is a unique part of the footprint because the river follows an S-shaped course caused by a reef of hard rock, and this means that there is a set of uncommon habitats. The very important kanuka strip with regenerating podocarps and some *Scutellaria* recorded previously is still present. An additional species was found protected by a rock outcrop, namely *Pimelea longifolia*, NZ Daphne, which has not been seen before in the footprint area or downstream. It is growing with turf species including the liverwort (hornwort) *Anthoceros* as well as *Thelymitra* ground orchids, neither of which has been recorded from previous surveys. Site 1 is confirmed as a place of ecological significance. There was more pig rooting observed than previously, but no apparent loss of ecological values.

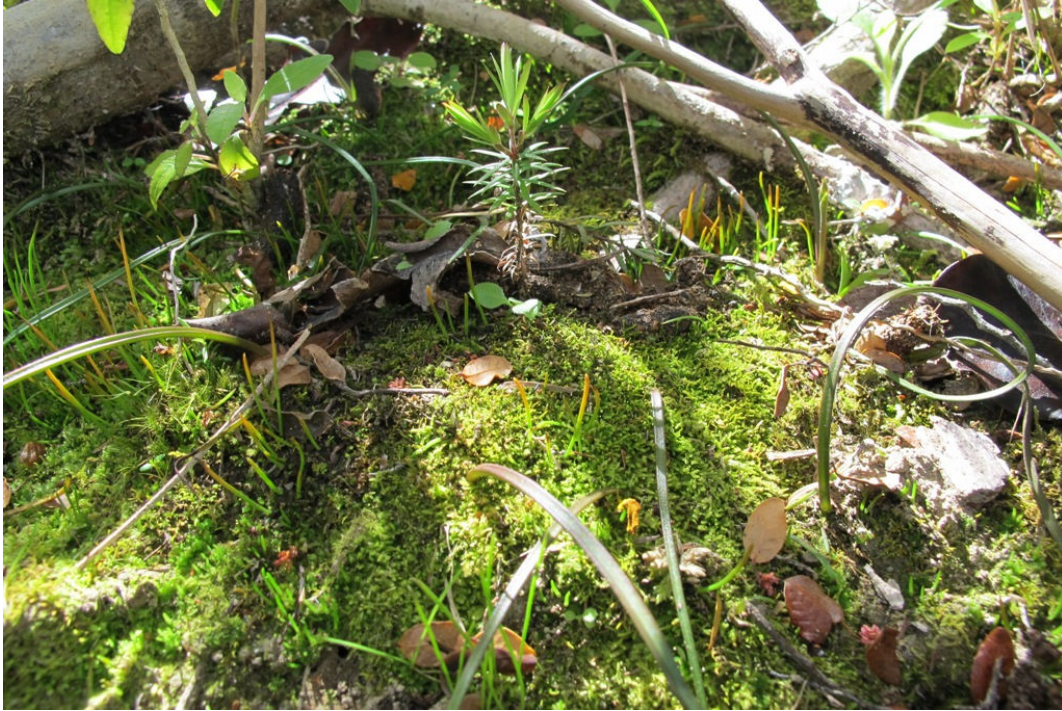
Site 1. Two species growing in the bedrock flood-induced turf are *Anthoceros* sp. (one of 13 'hornworts' in New Zealand), showing as yellow-tipped spore capsules, and a ground orchid (dark grassy single leaves), possibly a *Thelymitre* sp: neither has been seen on previous surveys.

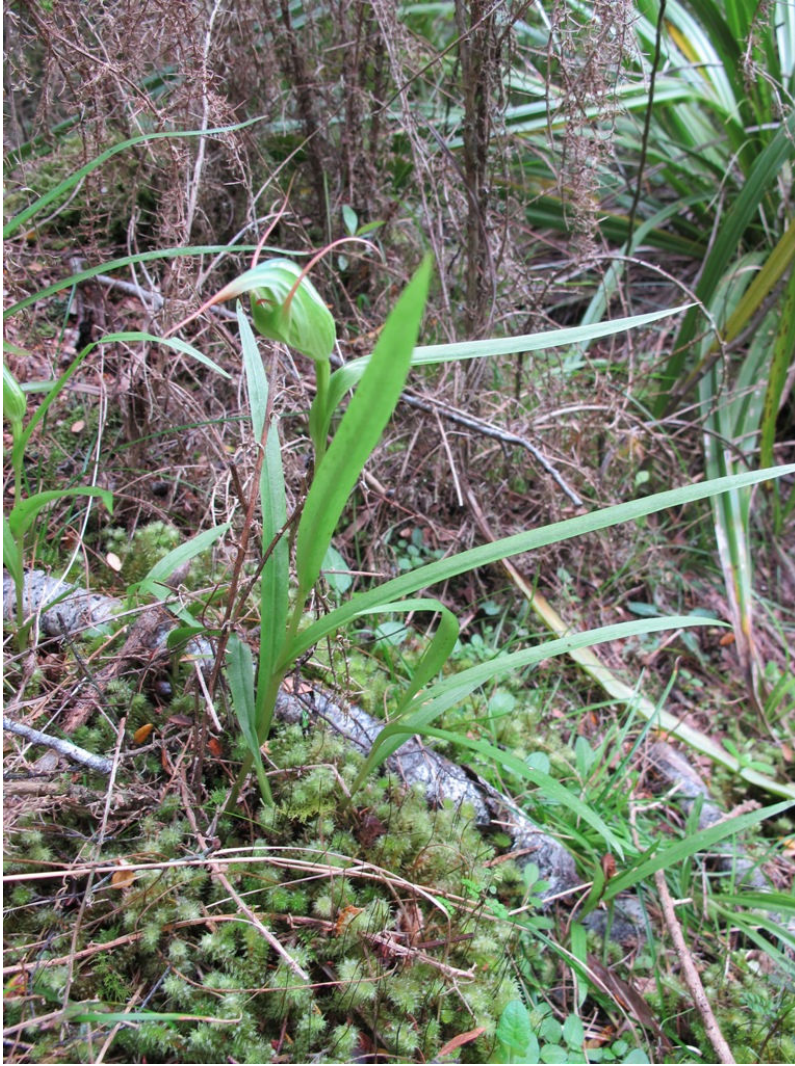
Site 3, pole kahikatea forest. The greenhood orchid *Pterostylus banksii*.

This species occurs in several forms in the Lee bush. Seeing it in flower illustrates the importance of undertaking surveys in different seasons of the year.

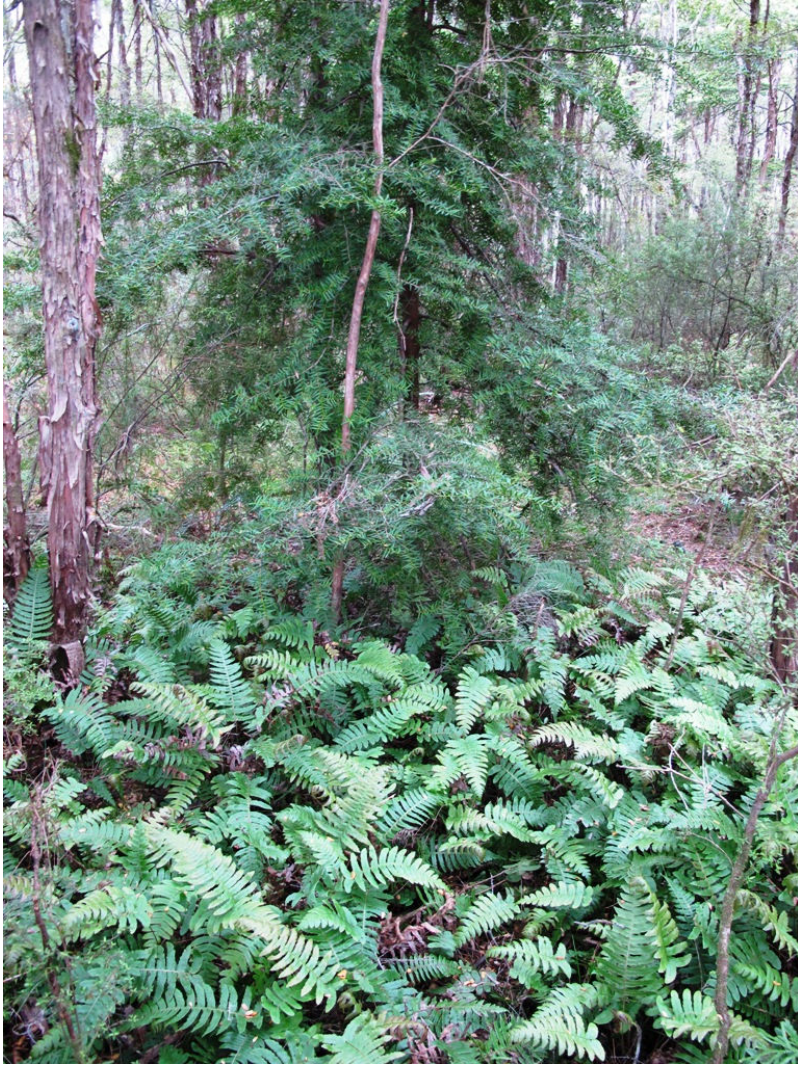
Site 3. Waterfall Flat kanuka forest. The fern *Blechnum vulcanicum*, which is well developed throughout the footprint area, shares an alluvial habitat with a vigorous young Hall's totara (*Podocarpus cunninghamii*). Nationally this is an unusual alliance and reflects the montane component of the flora.

Site 3. The mature kahikatea forest (10-3-1, in 2008 report) on the left bank was not visited but was observed from across the river, and the upstream boundary was located, indicating that it is a defined river flat, separate from the pole kahikatea forest (10-3-3) upstream. The kanuka forest on Waterfall Flat (10-3-2) was visited and confirmed as a future, very dense matai forest of

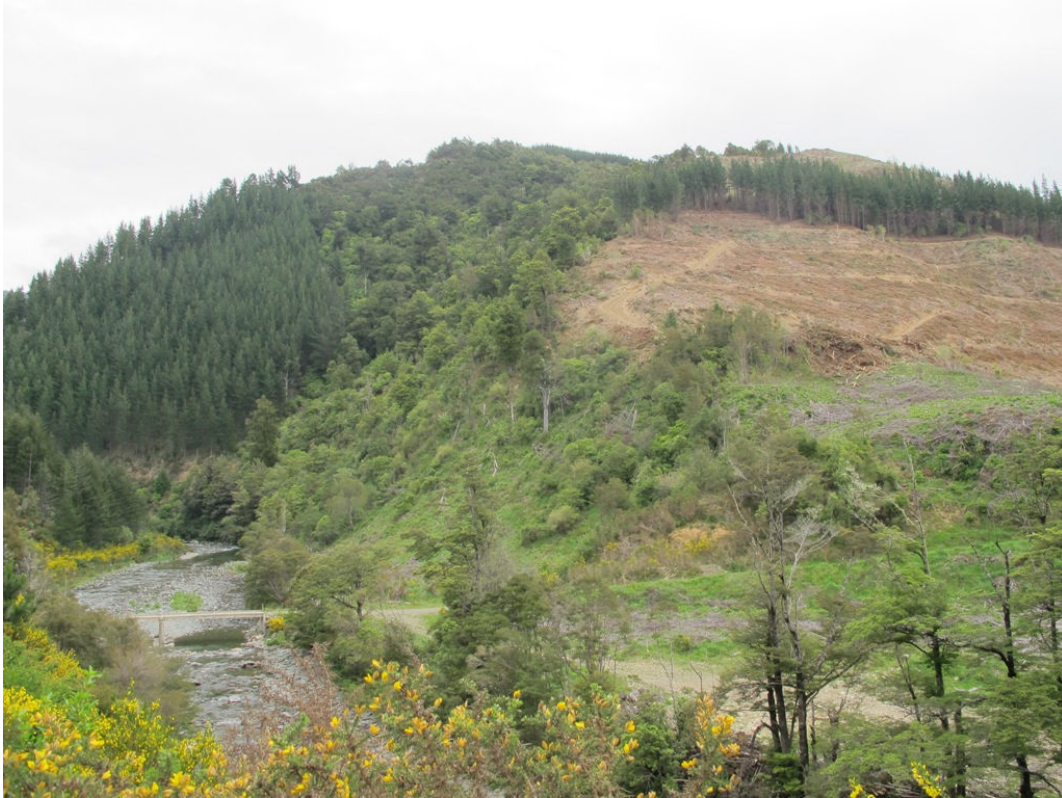
Site 3, Matai forest. Recent logging has defined the boundary to the remnant matai forest.

In future it may be possible to establish a buffer zone without pine trees and reduce subsequent disturbance around this important lowland forest remnant.

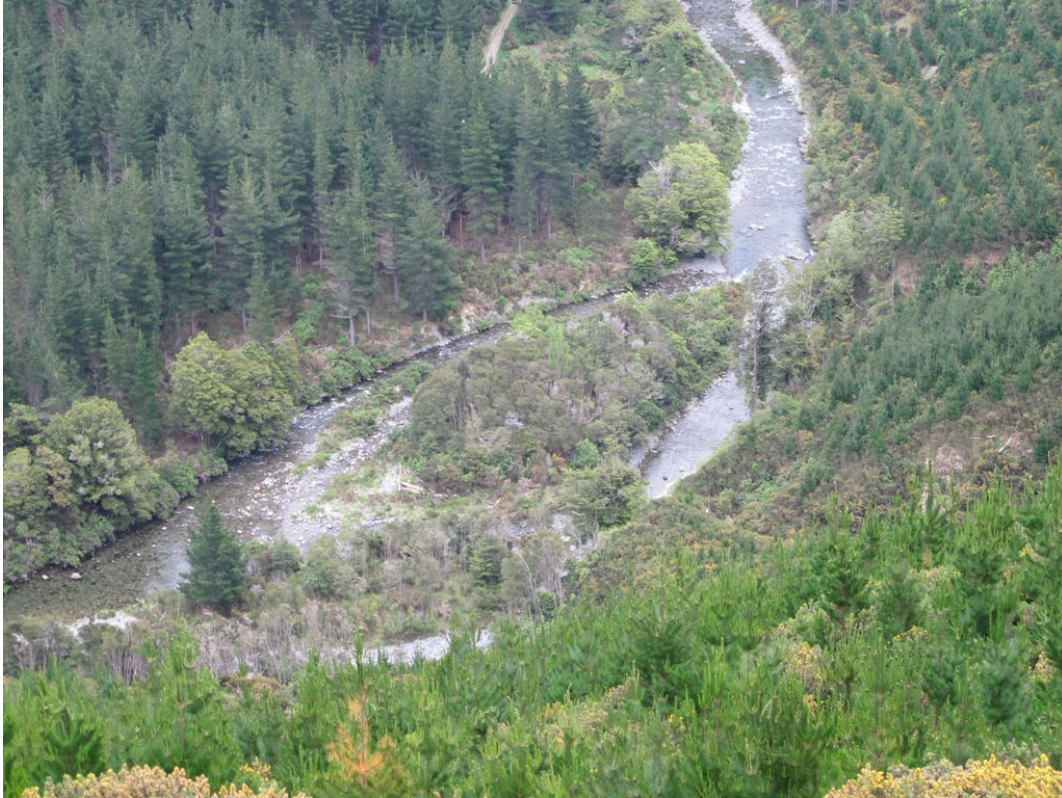
Site 4. Kanuka Island. Seen from above the precarious stability of this site is apparent. In this unusually cold, damp habitat, the young vegetation is dominated by grasses and sedges beneath the kanuka canopy.

Site 4. I did not visit this complex site, but did observe the kanuka island and the matai forest from high on the right bank forestry roads. An interesting feature is that the pines have been milled from adjacent to the matai. This gives a clearer picture of the boundary and of the level of disturbance that has occurred due to logging of pines adjoining the matai area. The lack of a buffer between the matai block and pine plantation may contribute to incidental damage of native trees along the edge of the matai block. Natural slope instability is a feature of the site.

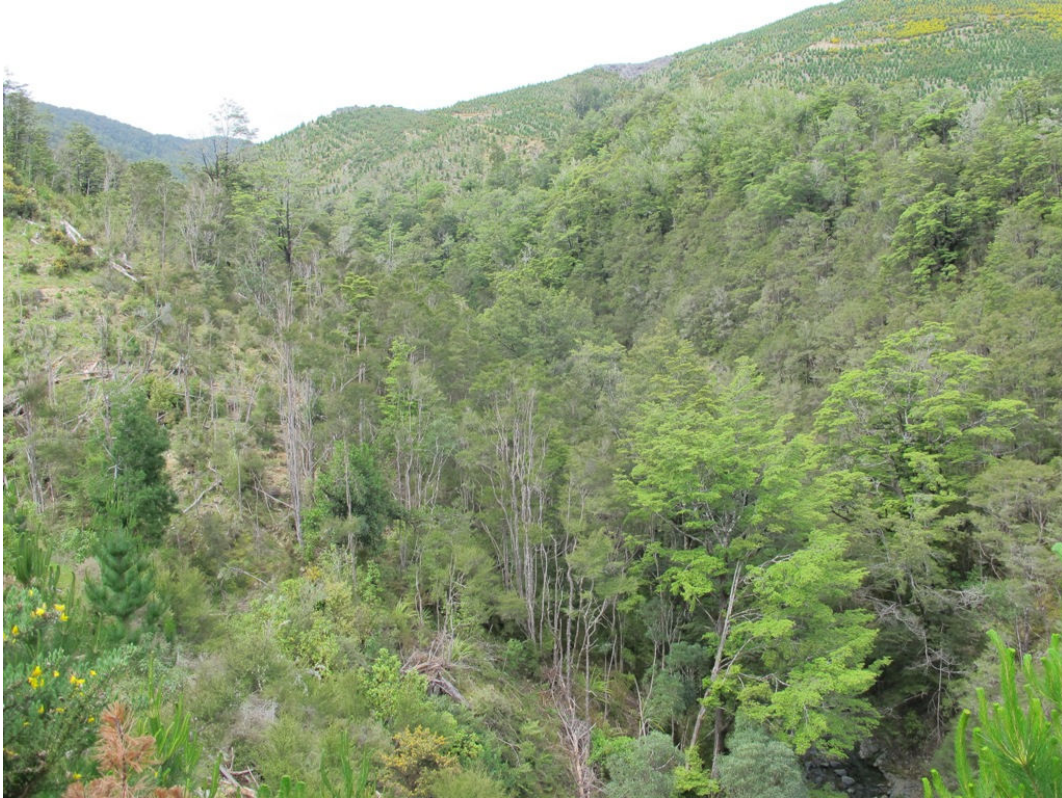
Site 6, Waterfall Creek beech forest. This bush is linked by continuous beech forest to the hinterland (far left). This is where the waterfall that names the creek is located and is likely to be inundated by the Waterfall Creek arm of the reservoir.

Site 6. Waterfall Creek. This is a new site. I was able to visit two areas of bush at Waterfall Creek. The reservoir map indicates that the reservoir will extend to the 'forks'. This is where a tongue of beech forest extends down the true right branch from the highlands (Mt Starveall). This is a geologically complex place and is where the waterfall that names the creek is located. It appears that the reservoir may inundate this waterfall. The bush is dominated by black beech at this altitude but there is some red and silver beech, as well as rimu, matai, tanekaha and kahikatea. However, overall the bush here is more montane than lowland, with kamahi, lancewood and broadleaf prominent.

I would rank this site as having Medium ecological significance.

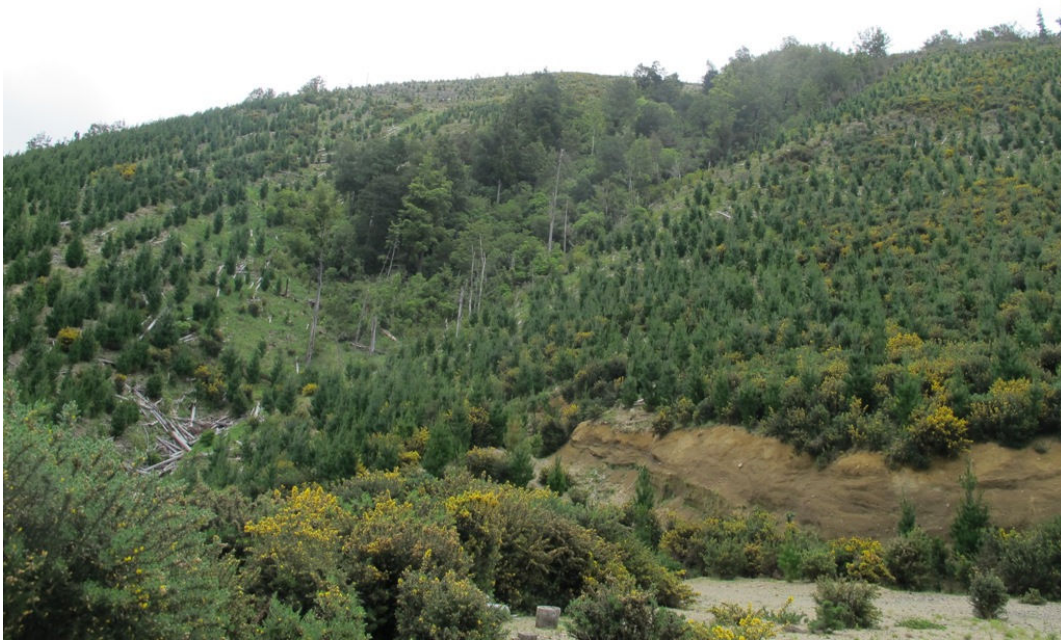
Site 6. A gully dominated by matai on Waterfall Creek. This gully is linked along the top ridge to another gully remnant, and ultimately to the Waterfall Creek beech forest hinterland.

Just a little way downstream on the right bank of Waterfall Creek there is a steep gully (hidden by a ridge from view from the Lee River) with mature matai forest. I would rank this site as medium as it is only about 1ha in size. However, I did not have time for a detailed look.
