Report No:	RESC11-06-07
File No:	
Date:	13 June 2011
<b><i>Information Only – no decision required</i></b>

**Report to:** Engineering Services Committee  
**Meeting Date:** 23 June 2011  
**Report Author:** Jeff Cuthbertson, Utilities Asset Manager  
**Subject:** **FLOODING IN SOUTH RICHMOND – 26 MAY 2011**

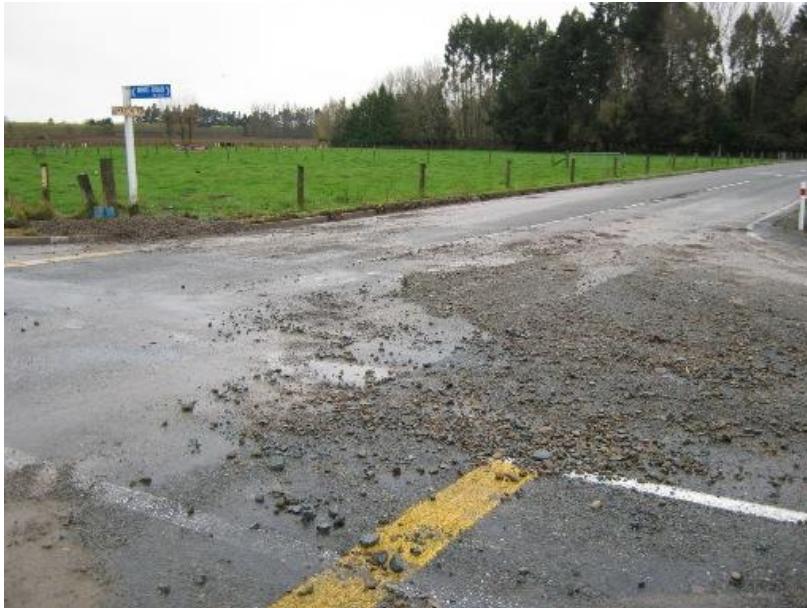
3.6 Approximately 670 metres along White Road from Hill Street it would appear that a lot of the flood water left the confines of the roadside drainage and progressed through the property at 125 White Road (see attached plan and photos).

- 3.7 Water caused damage to the landowner's driveway and lawns and flowed into their swimming pool before appearing to re-enter the White Road/Paton Road side drainage.
- 3.8 Almost all of the water receded and simply spilled through the intersection and down White Road. At the peak of the flood it would appear that the water moving down White Road was a sheet flow from boundary to boundary.

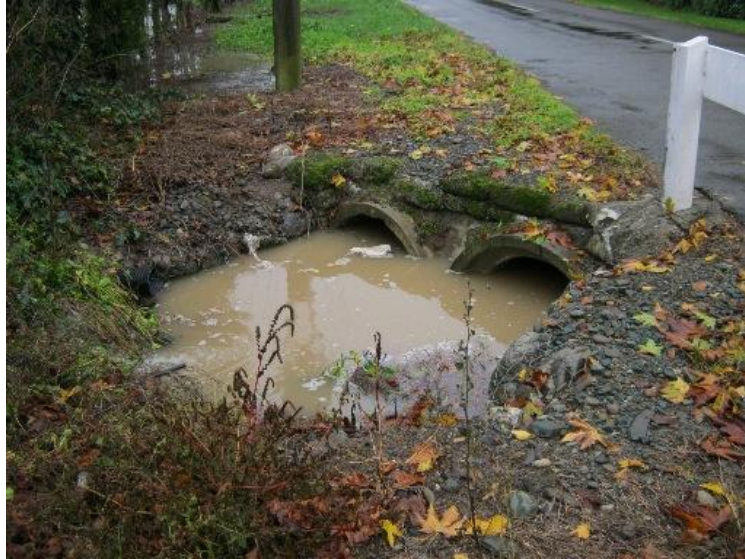
- 3.9 In a normal situation the stormwater that would flow down White Road would be directed along a water course about midway between Paton Road and State Highway 6 to the Reed Andrews Drain. In the situation that occurred in the early hours of 26 May 2011, the flood water could not be directed along the normal discharge course and just kept travelling down White Road.
- 3.10 There are a number of private dwellings on the south side of White Road. Overnight on 26 May 2011 the Fire Service recommended to nine of the residents to self-evacuate their property.
- 3.11 By 9.00 am on 26 May 2011 virtually no flood waters were visible but the resulting gravel and debris within culverts was very clear to see.

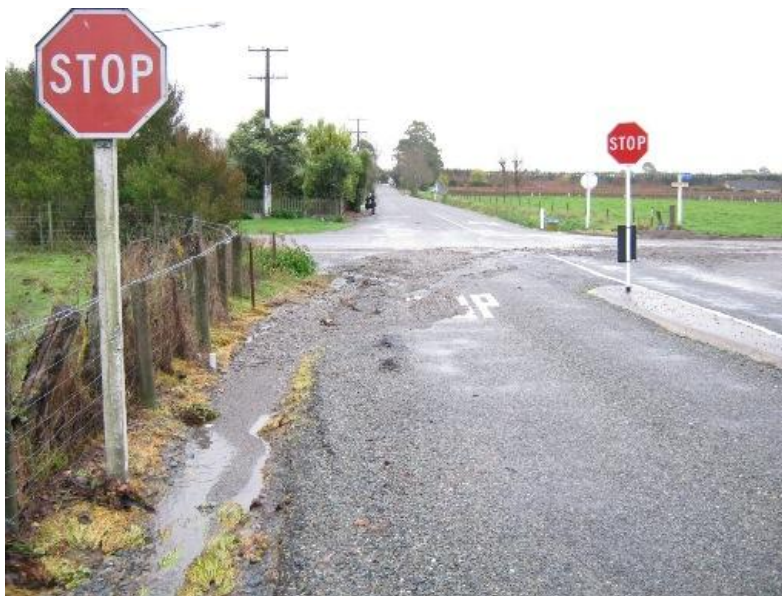
3.14 At the intersection of Paton Road and Ranzau Road two main water catchments converge. The volume of water for these two catchments basically inundated the culverts at the intersection resulting in very high volumes of water filling the two roadside drains with excess water spilling into the adjacent paddocks and then following old drainage routes.

3.15 As a result the dwelling at 293 Ranzau Road was evacuated.

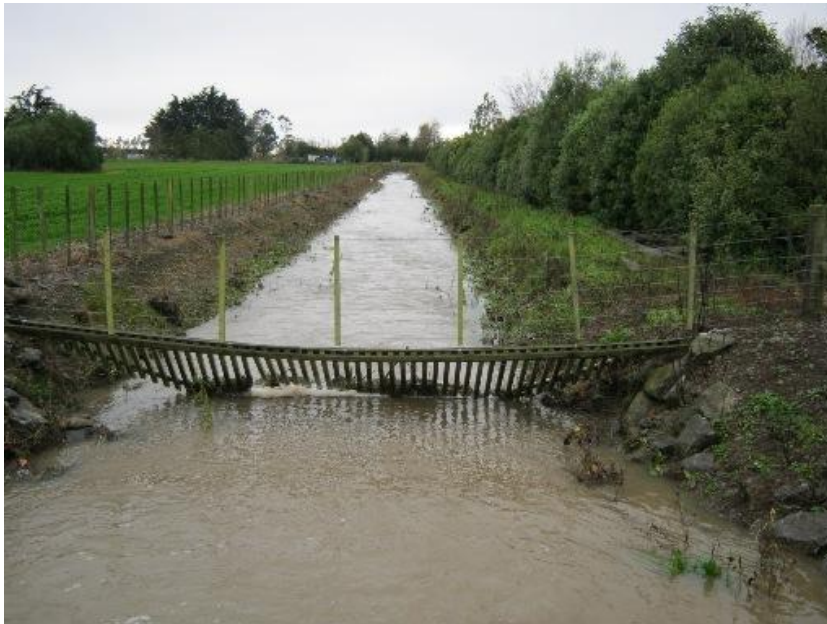
3.16 The water that flows down Ranzau Road from Paton Road then enters Borck Creek. Borck Creek below Ranzau Road is maintained by Council and appears to have worked effectively. It should be noted that the capacity of Borck Creek at Ranzau Road was at its maximum but appears not to have overtopped.

3.17 There was some minor flooding below the Borck Creek/Ranzau Road confluence but this appeared to be contained.
