Report to: Engineering Services
Meeting Date: 15 September 2011
Report Author: Jeff Cuthbertson, Utilities Asset Manager
Subject: **Paton's Rock – Stormwater Improvements**

- 1.1 The purpose of this report is to inform the Engineering Services Committee of the proposed stormwater improvements at Paton's Rock community.

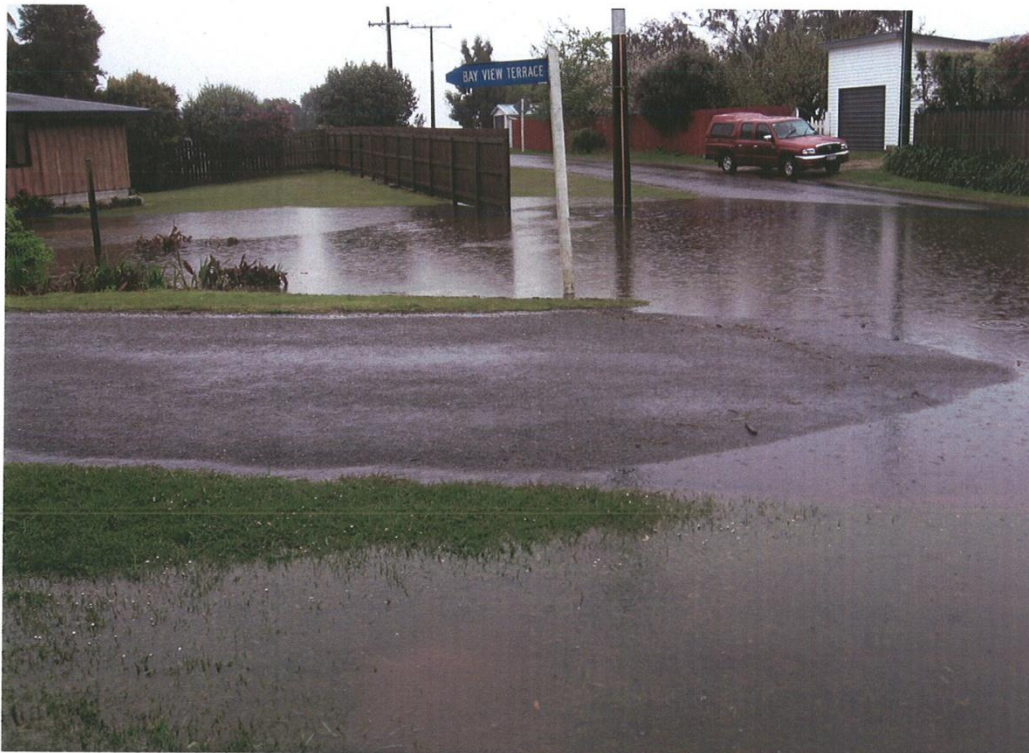
DRUMMOND PROPERTY SEPT 29

- The main problem was at the Drummond property (bottom of Bay View Terrace).
- The drains (outlets to beach) were not open before the storm.
- They have been in Paton's Rock since 1966.

6.5 It is proposed to remedy this ponding issue by the installation of two sumps and piping stormwater south along Paton's Rock Road to the water course.

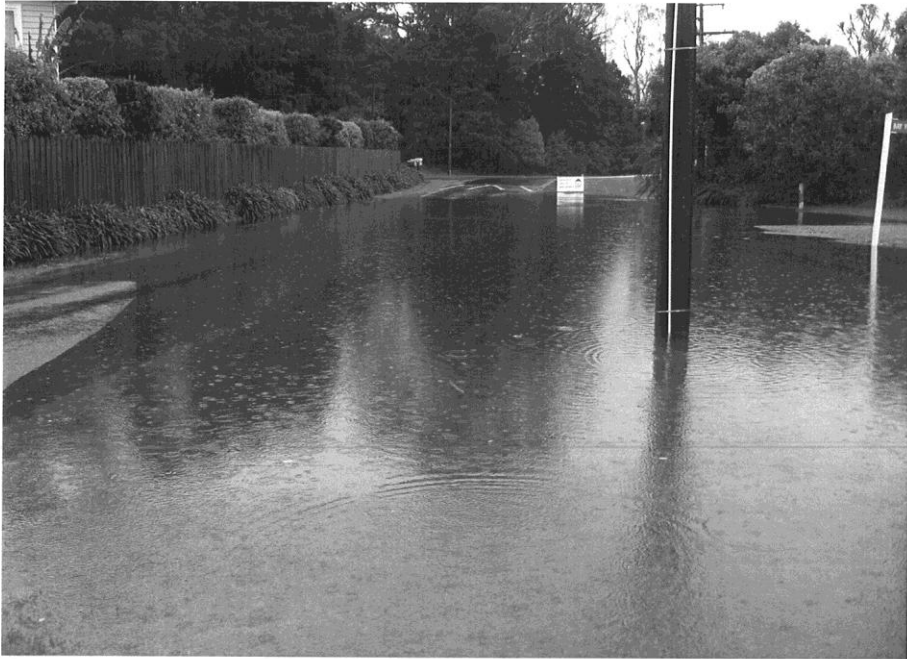
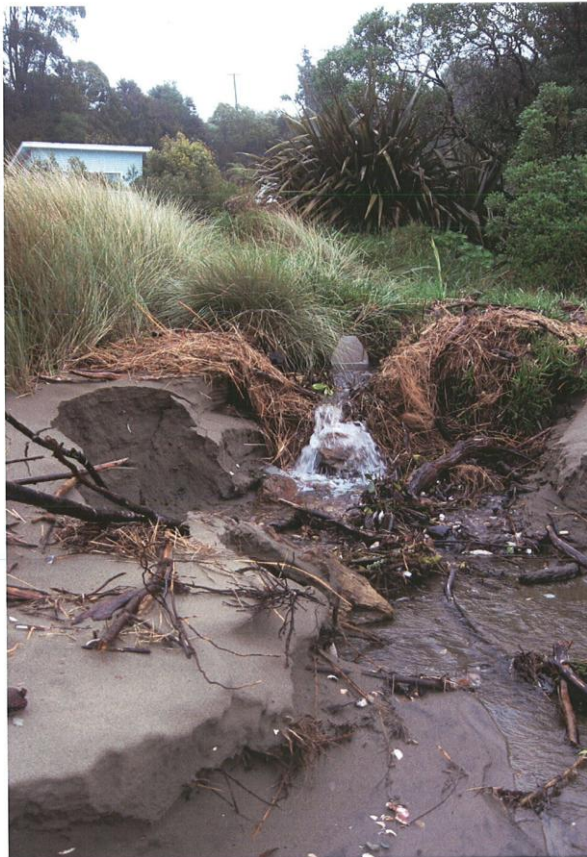
DRUMMOND'S SEPT 29

- 6.2 It is proposed to modify the stormwater outlet at the beach face by removing the existing flap gates and installing rubber tide-flex valves. We would then raise the outlet and reinstall the flap gate valves (see attached plan).
- 6.3 This will result in the flap gate being located at a level similar to the kerb and channel on Paton's Rock Road and thus maximise the ability for some stormwater to discharge.
- 6.4 At present there is a soak hole located at the Paton's Rock Road and Bay View Terrace intersection which, over time, does allow water to finally soak into the ground. There are two issues with this flooding that cause concern:
- The flooding covers a majority of the carriageway (see photos below). Vehicles driving through the water cause waves that could potentially cause damages to houses.

- The septic tank located at the dwelling is inundated with stormwater. This raises the issue of septic tank effluent overflowing and contaminating the property, the waterway and the beach.
