BEFORE THE ENVIRONMENT COURT

Decision No. [2011] NZEnvC 374

## **Jackett Island - Action Plan for Interim Works**

TASMAN DISTRICT COUNCIL  
ACTION PLAN FOR INTERIM WORKS  
JACKETT ISLAND  
New Geofabric Bag with 30 Degree Return Layout Plan and Details  
Figure 2

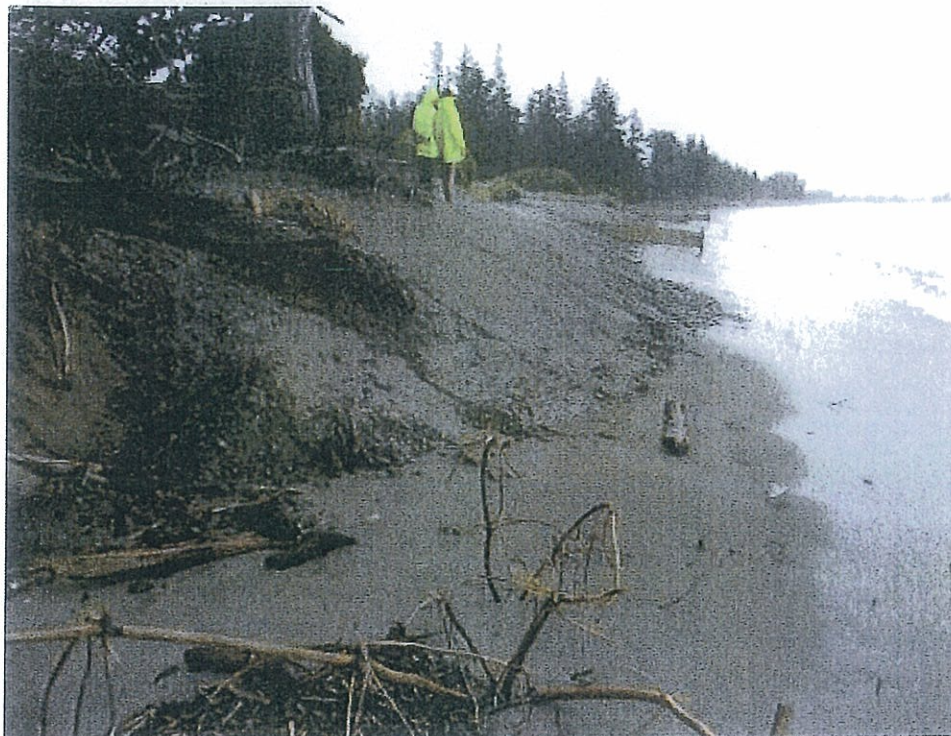
*Photograph 1 Completed emergency works as at 6 July 2011*

The resulting placement has resulted in a combined gravel/sand/silt bund along the southern half of the property protecting the bank and wool bales (refer Photograph 1) that appears to be providing reasonable wave protection and a volume of material on the upper beach and should provide sufficient protection while the geo bag option is progressed.

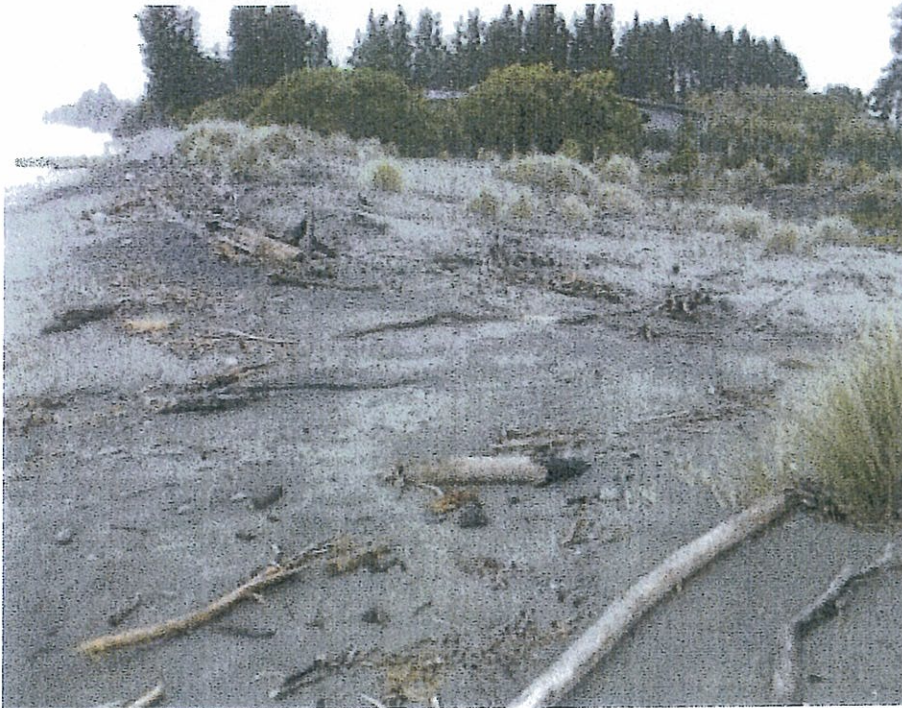
*Photograph 2 Sand over wash at northern end of the property as at 6 July 2011*

At the northern end of the property where sand had been excavated along the backshore by the Van Dykes to provide increased sand elevation in front of their dwelling, the low beach crest has been overtopped and sand infilling by wave overtopping was evident (refer Photograph 2).

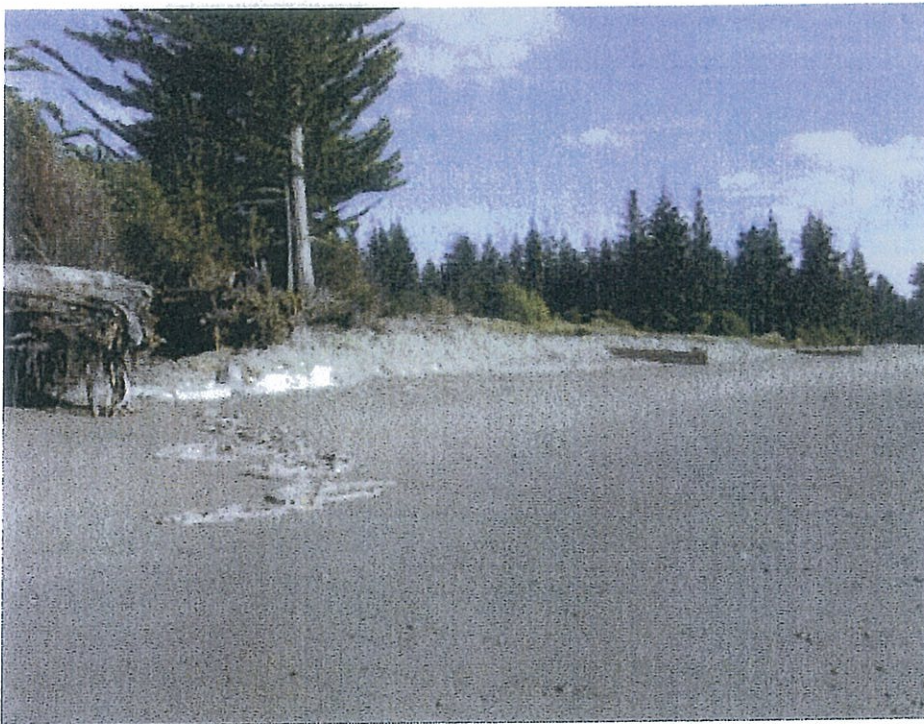
*Photograph 3 - existing shoreline showing two timber groynes (8 April 2011)*

The geotextile bags will be placed along some 104.4 m. For context, the bags will extend from the southern boundary to around 20 m to the north of the second groyne shown in Photograph 3. The bags will be placed over a geotextile filter fabric that overlies a formed subgrade of beach sediments. The geotextile filter fabric will assist in reducing the loss of fines through the gaps between the bags.
