Report No:	RESC12-04-09
File No:	C351
Date:	16 April 2012
<b>Information Only – no decision required</b>

**Report to:** Engineering Services Committee  
**Meeting Date:** 26 April 2012  
**Report Author:** Sarah Downs, Transportation Planning Officer  
**Subject:** Port Motueka Groyne – Jakkett Island Erosion Project

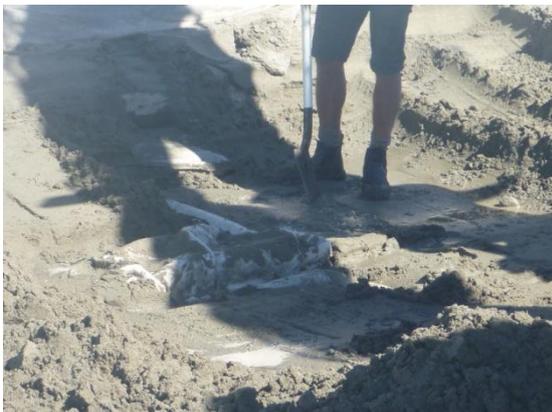
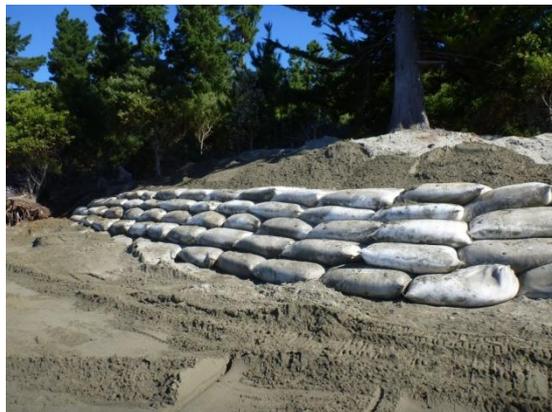
- 5.1 On the weekend of 24 and 25 March 2012, high winds (30kmh) accompanied by high tides saw a partial collapse at the southern end of the geotextile sand bag wall on the Van Dyke property at Jackett Island.
- 5.2 Previous damage had occurred at some point in February. Photographic evidence is shown in the status report (Appendix A).
- 5.3 Staff undertook some surveying of the sand bag wall and the beach profile. It was found that considerable erosion of the beach was taking place at the southern end of the wall close to the macrocarpa tree.
- 5.4 Maintenance work was carried out on the wall between 3 and 5 April 2012. A further 70 geotextile sand bags (which had been stored on the Van Dyke property) were utilised. This resulted in a further three rows being added at the toe of the wall close to the macrocarpa tree at the southern end of the Van Dyke property.

- 5.5 A further 40 geotextile bags are being ordered and will be stored (with sand) on the Van Dyke property for ongoing maintenance work. Another 40 geotextile bags are also being ordered. These will be stored at Council and not filled with sand.
