Jackett Island Erosion Study

Progress Report June 2012

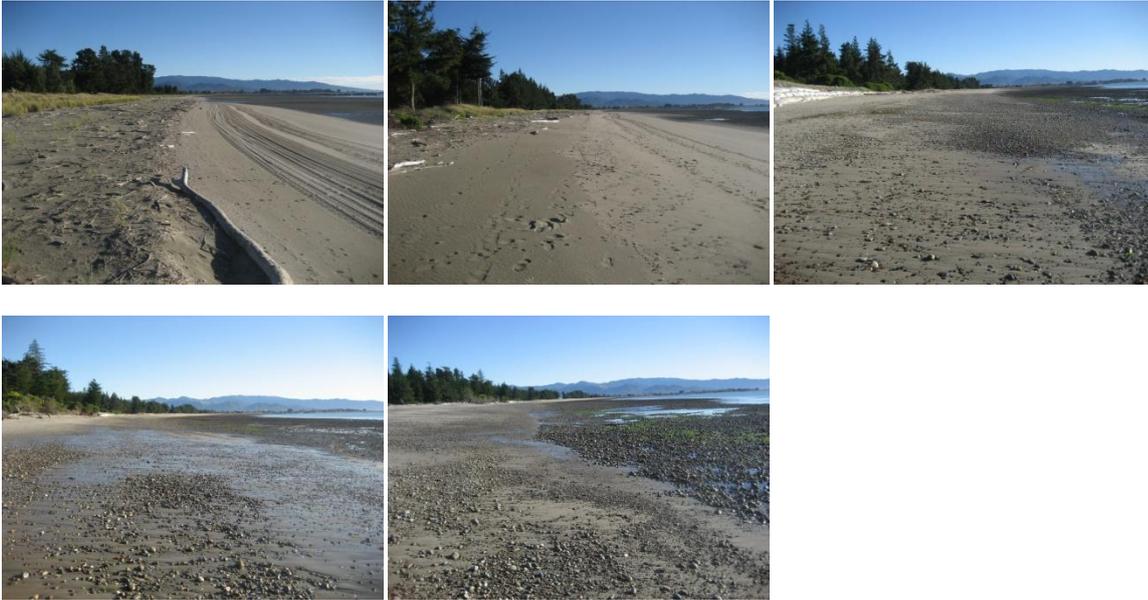
Photographic monitoring was completed under the management of Council on 29 May 2012. These photographs were taken as part of the general monitoring process. The photographs (1-5) at the end of this document display that there is sand accretion at the northern end of the wall as well as that end of the island. There is also evidence that there are high levels of erosion beyond the southern return of the wall and to the southern tip of Jackett Island (see photos 6-12). At low tide there is a significant amount of gravel exposed and also clay, which can be seen in the photos 12,13 and 14.

Photos 1-5 looking north from survey points along the beach

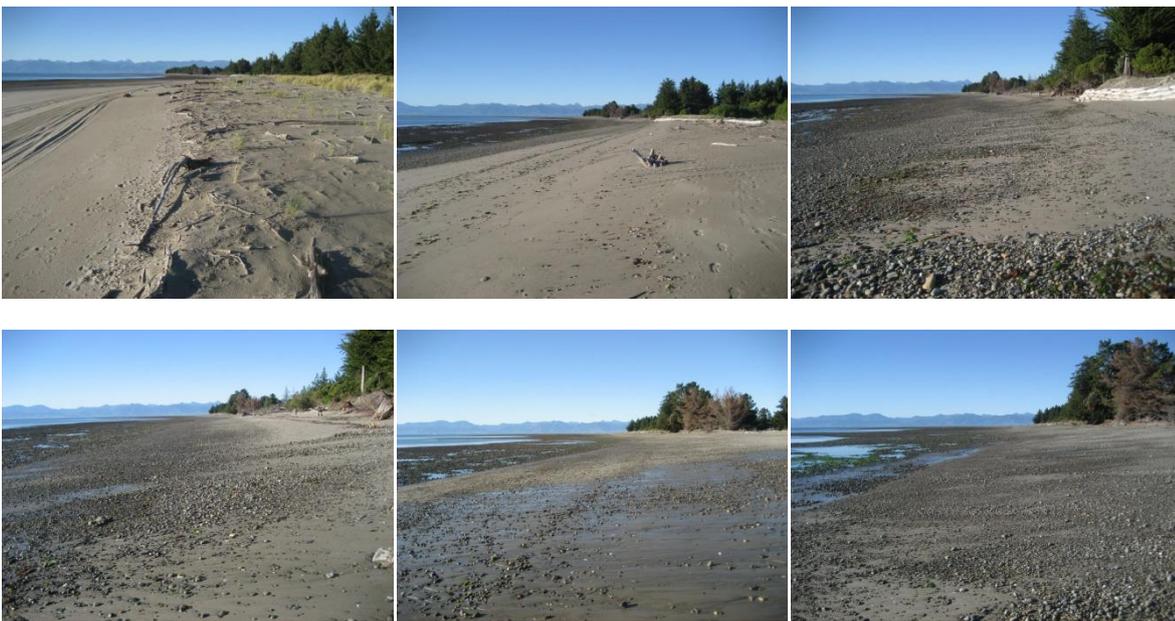
Photos 6 - 11 looking south from survey points along the beach

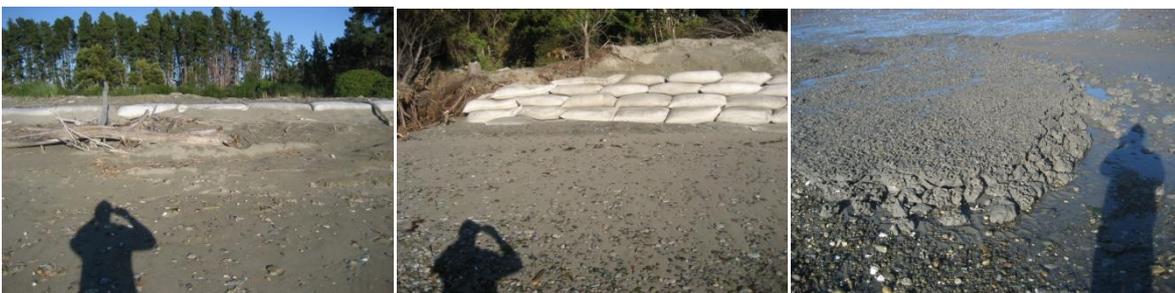
Photos 12, 13 and 14 show the sand bag wall and exposed clays near the Van Dyke property

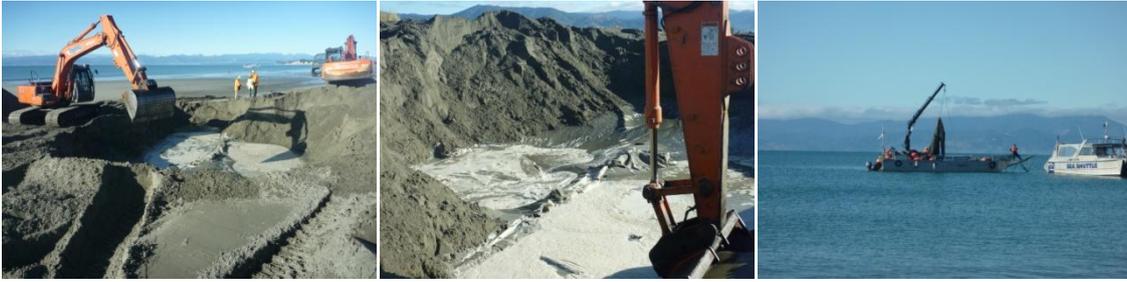
To date, the removal of the groyne is going well. The progress can be seen in photos 15-17.

Photos 15 – 17 show the removal of the groyne

Taylor's Contracting has been awarded a short-form contract to remove the groyne. Work on the removal of the groyne began in mid June 2012. It was delayed owing to damage from the storm event to Jackett Island works which took place on 5-6 June 2012, plus further poor weather restricting access to the groyne site. A variation to the resource consent also had to be undertaken so that the contractors were able to refuel on site. The Department of Conservation agreed to this variation. Philip Drummond is the Engineer to the Contract and is making regular visits to the site.
