Report No:	RESC12-07-04
File No:	
Date:	2 July 2012
<b>Information Only – no decision required</b>

**Report to:** Engineering Services Committee  
**Meeting Date:** 19 July 2012  
**Report Author:** Sarah Downs – Transportation Planning Officer  
**Subject:** **Port Motueka-Jackett Island Erosion Project**

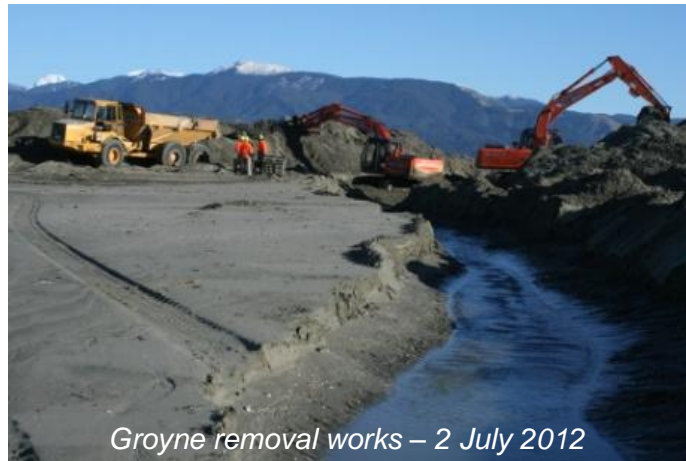
- 4.1 Resource consent for the full removal of the groyne was granted on 12 March 2012. Conditions of the consent stipulated that the groyne had to be removed in full before August.

- 4.4 The physical work on the removal of the groyne began on 25 June 2012. The contractors experienced delays because of the previous poor weather conditions.

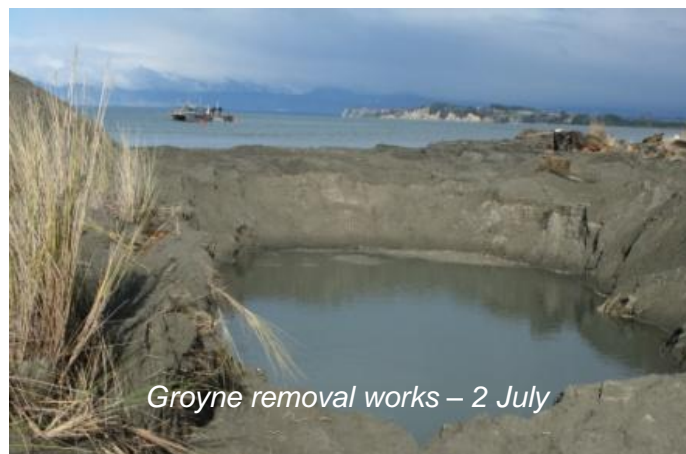
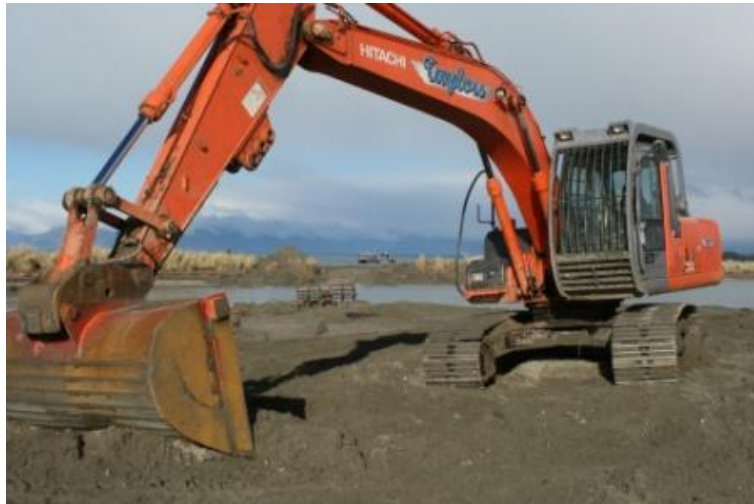
- 4.5 To date, the exposed parts of the groyne have been successfully removed. The contractors are experiencing some difficulties in reaching the parts of the land-based groyne which are covered in sand. This is due to water filling the excavated areas in the tidal zones.

- 4.6 The photographs above (taken on 2 July 2012) show the material associated with the geotextile groyne; the issue about water filling up the excavated hole; and digger carrying out the work.

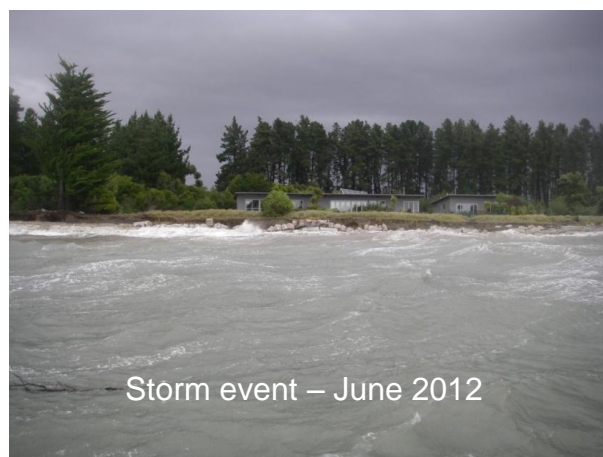
- 5.3 On 6 June 2012, Tonkin and Taylor reported that a mid section of approximately 30 metres had been washed away. The first set of waves came from a northerly direction and came straight over the spit. This caused the fill behind the wall to get washed away. The wave direction then came from the east which directly attacked the loosened sand bag wall.

- 5.5 The contractors worked through to 10.00 pm on 6 June 2012 patching up the wall to prevent further damage with the king tide that was expected that evening.

- 5.6 Tonkin and Taylor developed an action plan to deal with the emergency remedial work required to repair the wall in the interim. This work continued until 8 June 2012. The bags that we had recently taken over to Jackett Island were fully utilised and a good number of the bags that had been swept away by the waves were able to be recovered.

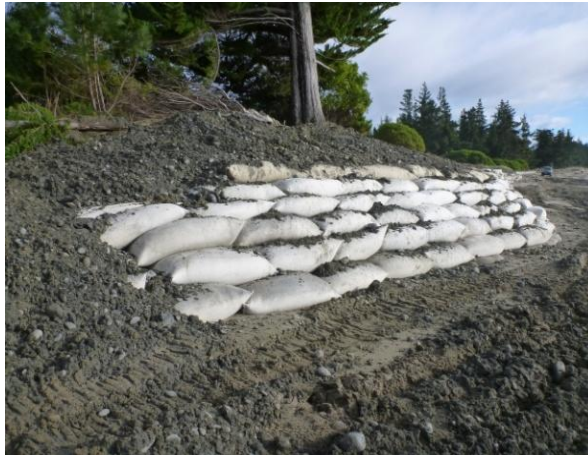
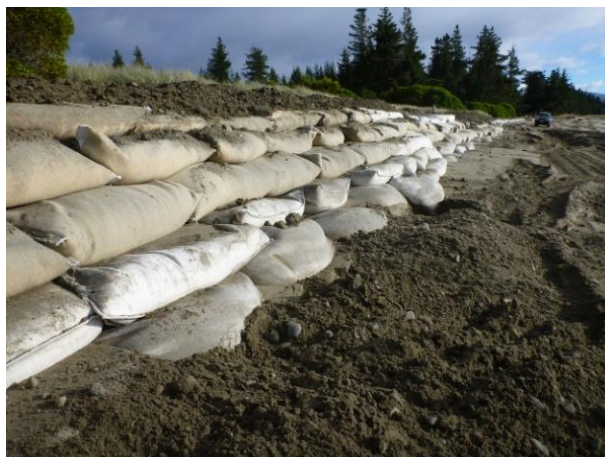
Sandbag wall after the storm event – June 2012

- 5.4 The area where previous remedial work had taken place around the macrocarpa tree at the southern end of Van Dykes property stood strong as well as the northern end of the wall where sand accretion is occurring.

- 5.7 The sand material that had also been washed away from the overtopping wave action was reclaimed at low tide to fill in behind the new wall. This material was easily identified as it contained considerable levels of gravel which was consistent with the material that had been originally used when the geotextile sand bag wall was built.

- 5.8 The beach profile was surveyed in full on 27 June 2012. The results from this will help Tonkin and Taylor develop an action plan to repair the wall. The intention is to use bigger bags supplied by Maccaferri. Resource consent is required to attain more sand to fill these geotextile sand bags. A supply site for sand has been identified and an application is currently being prepared.
- 5.9 In the poor weather conditions since the storm event of 5-6 June 2012 the geotextile sand bag wall has been 'holding the line' as expected.

7.6 Tonkin and Taylor will prepare a work programme for the repairs to the geotextile sand bag wall on the Van Dyke property.
