Jackett Island Erosion Study

Progress Report July 2012

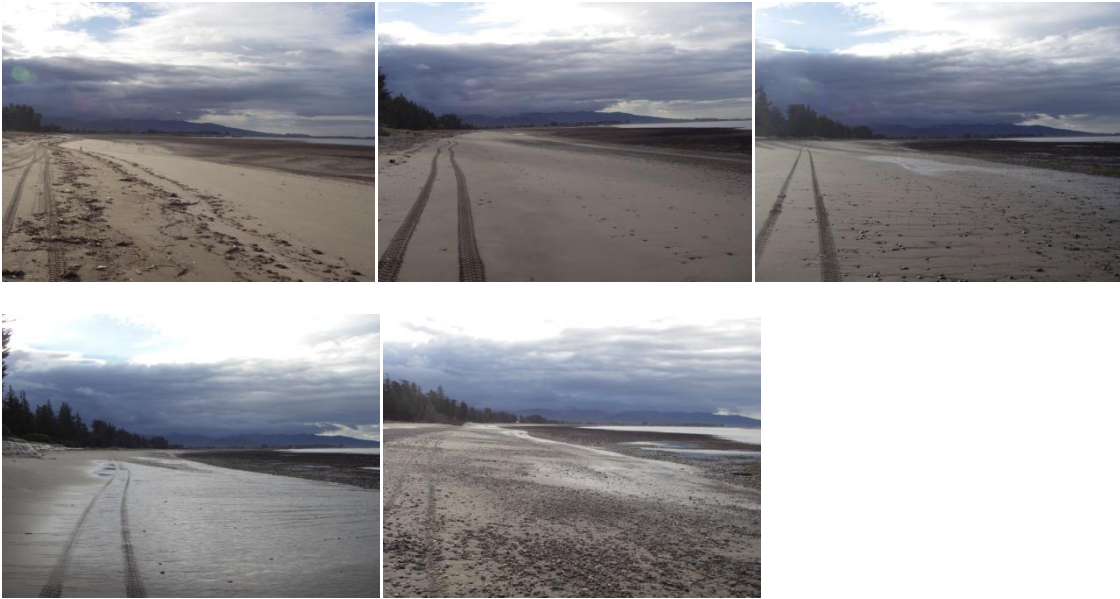
Photographic monitoring was completed under the management of Council on 27 July 2012. These photographs were taken as part of the general monitoring process. The photographs (1-5) at the end of this document display that there is sand accretion at the northern end of the wall as well as that end of the island. There is also evidence that there are high levels of erosion beyond the southern return of the wall and to the southern tip of Jackett Island (see photos 6-11). At low tide there is a significant amount of gravel exposed and also clay, which can be seen in the photos 12-16. The last photographs (17 – 20) show the geotextile sand bag and erosion inland.

Photos 1-5 (below) looking north from survey points along the beach

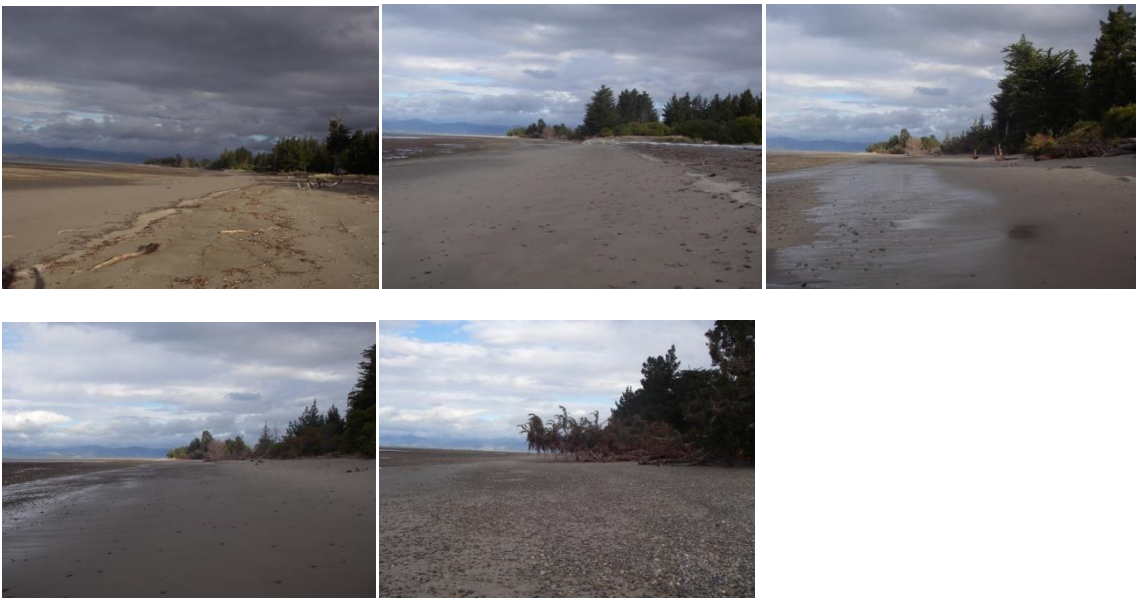
Photos 6 – 11(below) looking south from survey points along the beach

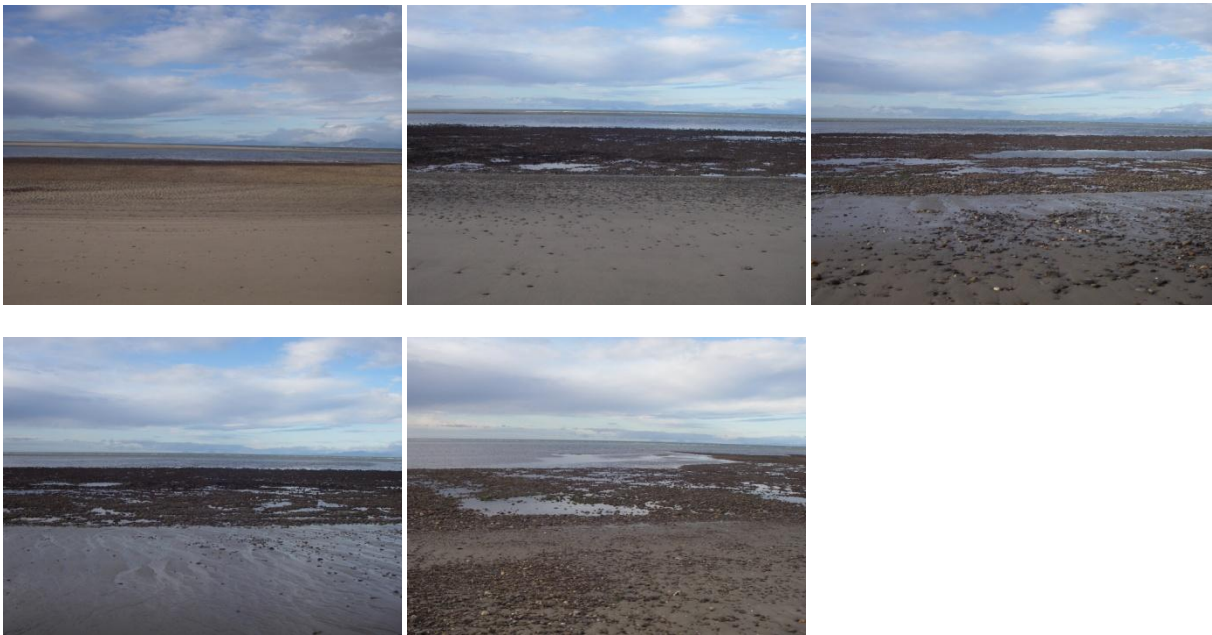
Photos 12-16 (below) looking east from the survey points along the beach (these photos indicate the level of erosion at low tide and the exposure of the Moutere clays)

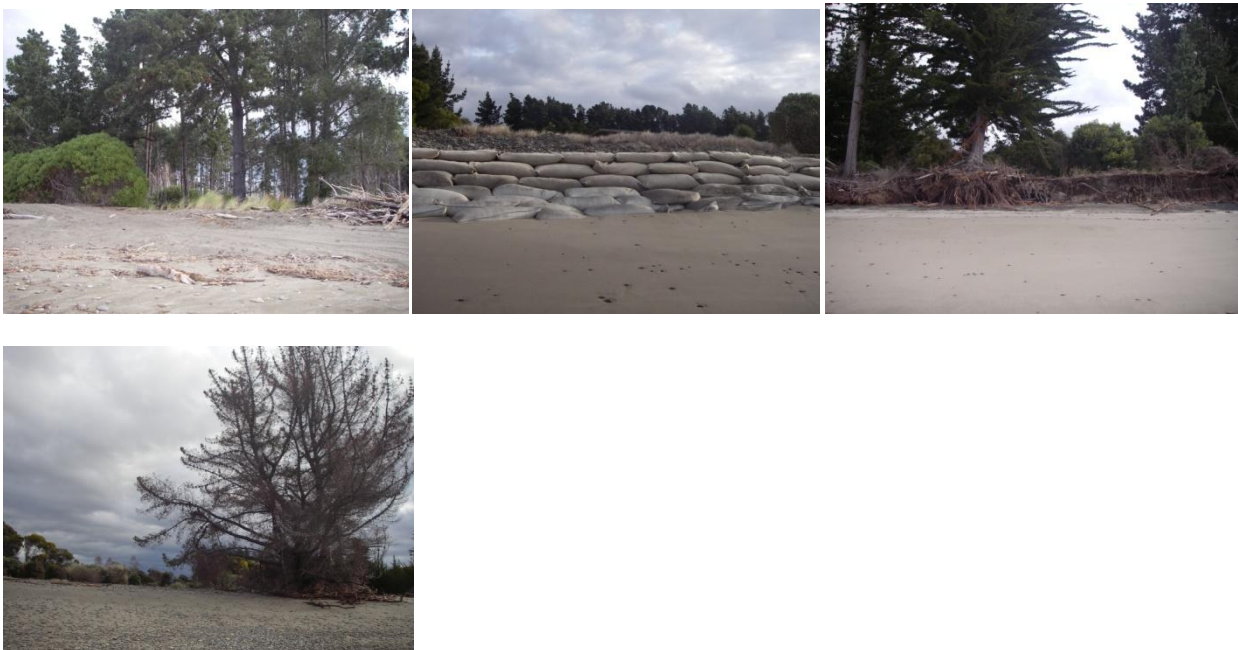
Photos 17 – 20 (below) looking west from the survey points along the beach (including the geotextile sand bag wall).
