## STAFF REPORT

**SUBJECT:** **IMPACT OF DISCHARGES FROM STORMWATER SYSTEMS ON STREAMS AND ESTUARY MARGINS IN RICHMOND: 2010 REPORT - REPORT REP10-07-07** - Report prepared for meeting of 1 July 2010

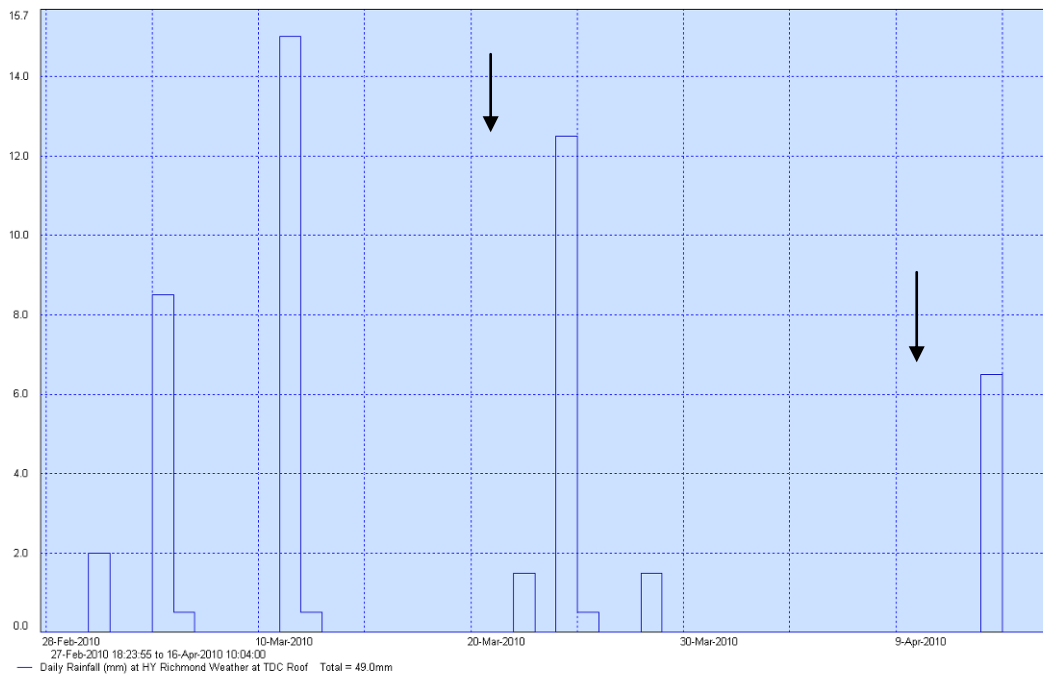
**Figure 1: Rainfall records at Richmond (Council Offices) prior to stormwater sampling. Arrows indicate sampling events.**

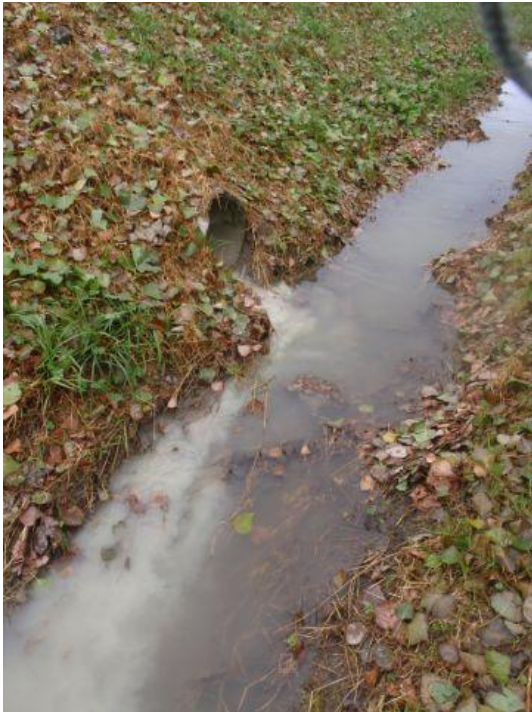
While sampling during the March storm event two particularly conspicuous discharges from industrial areas were evident. One discharge was moderately alkaline bright, white-coloured appeared to originate from a cement fabricator on Gladstone Road discharging to Borck Creek (see Figure 5a). The other discharge was a petroleum slick from a coolstore on Beach Road to Jimmy-Lee Creek. Both these discharges were followed up by Council's compliance team (see Figure 5b).

Figure 5a Discharge to Borck Creek downstream Gladstone Road on the Railway Reserve

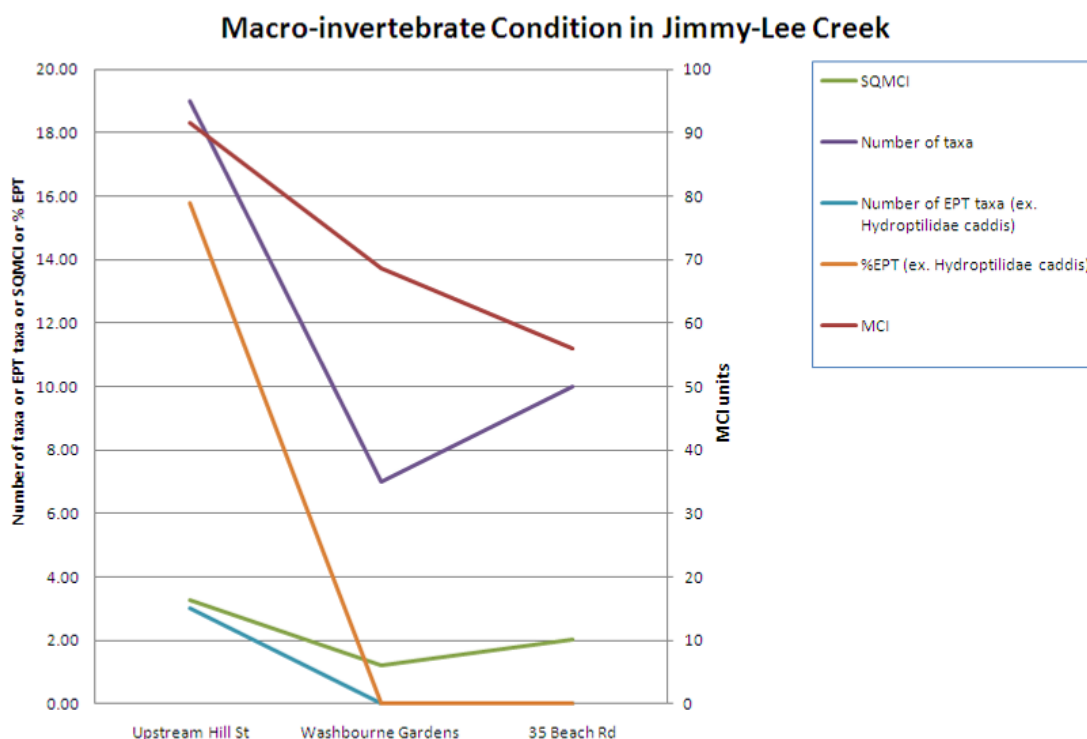
The middle and lower part (downstream Washbourne Drive and along Beach Road respectively) of Jimmy-Lee Creek had very poor macro-invertebrate condition compared to the upper part (upstream Hill Street)(see Figure 6). The habitat at the Washbourne Gardens was characterised by a high fine-sediment load and high turbidity.

**Figure 6** Five metrics of macro-invertebrate condition along a longitudinal transect of Jimmy-Lee Creek.

The macro-invertebrate condition at the Washbourne Gardens and Beach Road sites could be due to high fine sediment inputs from poor sediment retention devices on a subdivision within 1km upstream of this site. Fine sediment deposits on the stream bed upstream of Washbourne Drive averaged between 100-200mm thick. Ducks in Washbourne Gardens are likely to keep a lot of the fine sediment in suspension which results in high turbidity. Macro-invertebrate Community index (MCI) values for the Beach Road site is amongst the lowest recorded for any sample in the Council's database.

While the fine sediment deposits on the surface of the bed along the Beach Road section were minor (only a thin 1mm layer near the banks), there was a considerable amount in the bed matrix. This, and the contaminant concentrations experienced in this section, are the likely cause of the poor condition of the macro-invertebrate community.

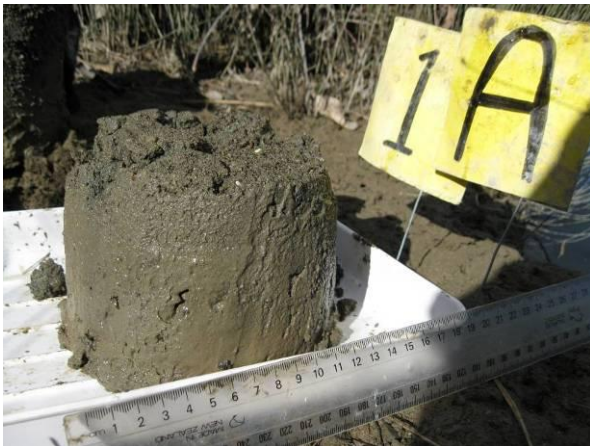
Sediment core from urban stream (Reservoir Creek)

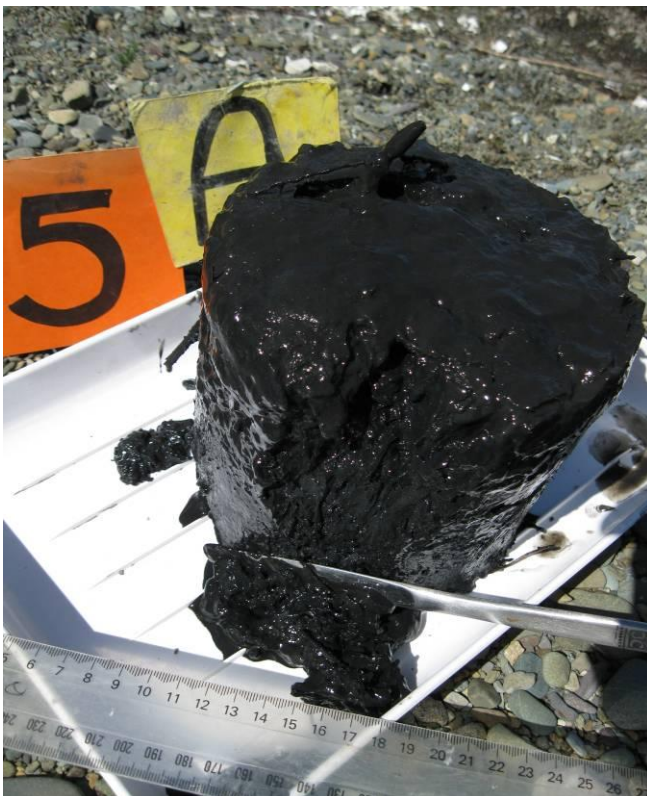
Anoxic sediment core from Nth RTS

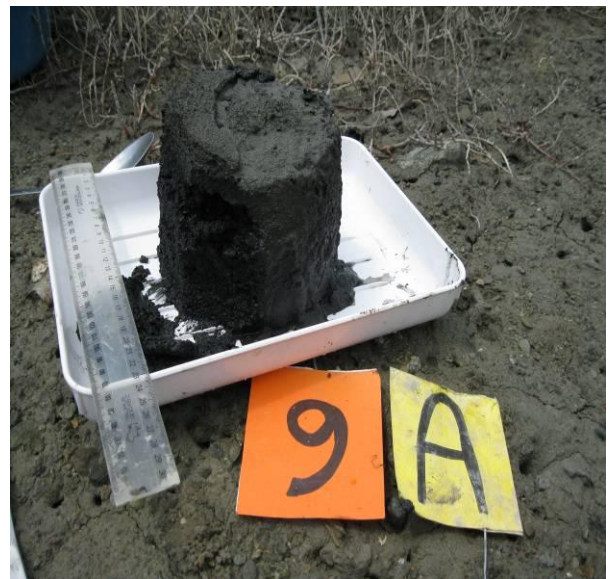
Anoxic core from Dynea culvert

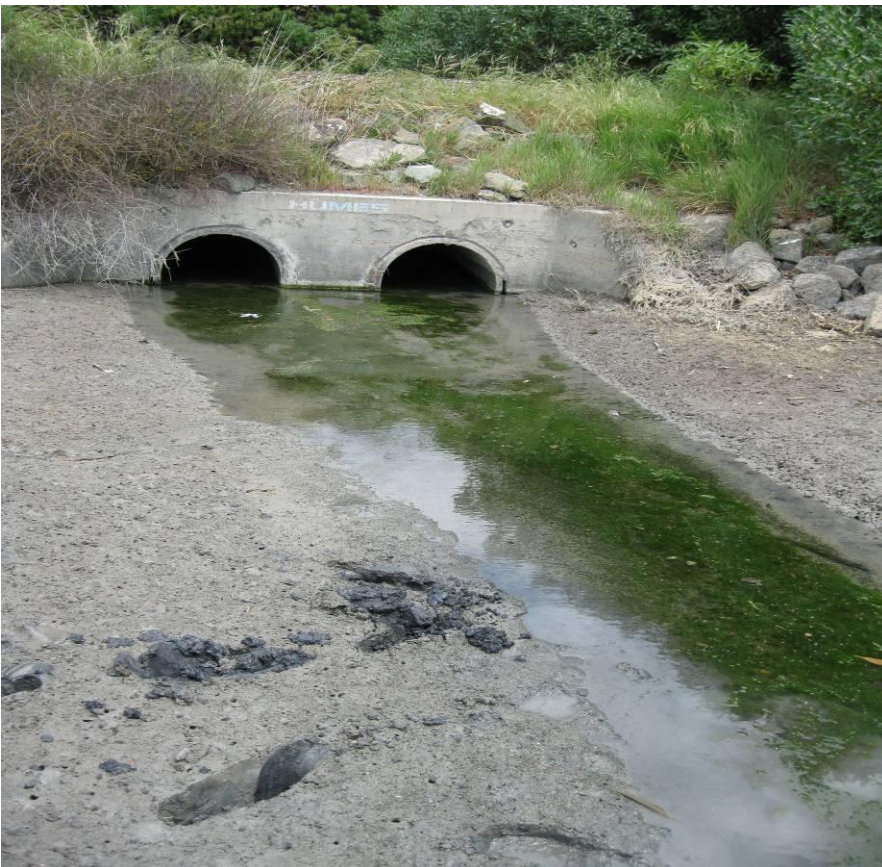
Soft mud at Dynea culvert sample site
