River Water Quality in Tasman District

State of the Environment Report

A technical report presenting results of the Tasman District Council's 'State of the Environment' River Water Quality Monitoring Programme and additional data from the National River Water Quality Network. Indicators measured include: physical, chemical, and bacteriological characteristics of the water, macroinvertebrate indices and periphyton cover. The report highlights water quality condition and trends, from the Waimea, Motueka, Takaka, Aorere and Buller water management areas.

Tasman District Council Ref: 15001

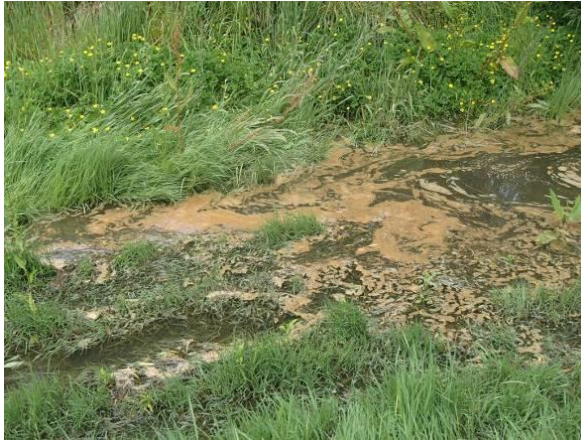
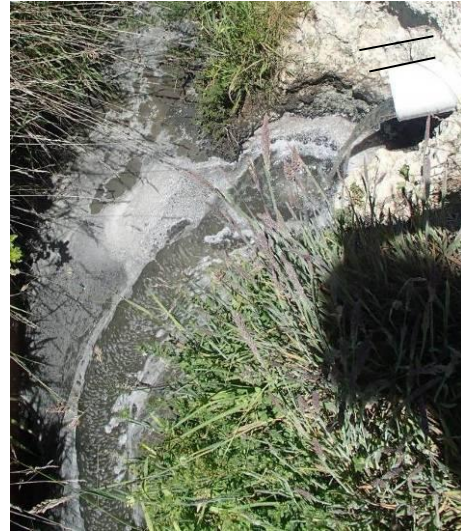
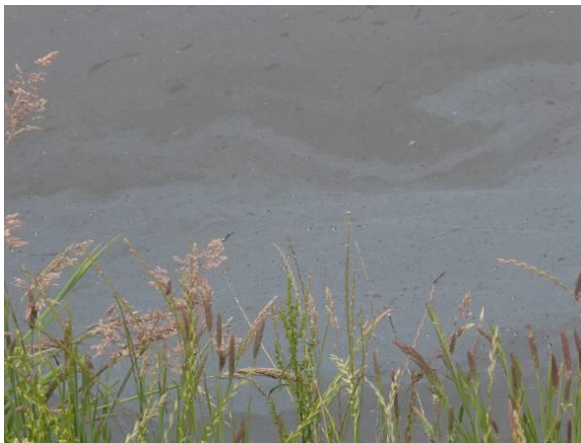
Discharges to Old Moutere Creek upstream Edwards Rd (December 2014). Lower right: methane bubbles and sheen on water surface.

Dissolved oxygen was recorded at near zero over several days in the summers of 2010 and 2014 (Figure 20). In 2014 there was little daily fluctuation (below 1% for over 3 days) compared to 2010 when dissolved oxygen fluctuated between just above zero to about 30%. The cause of this low dissolved oxygen was found in late 2014; two discharges direct to the stream from two fruit processing industries (Figure 19). These discharges have since been removed and it is hoped that future monitoring will show an improvement.

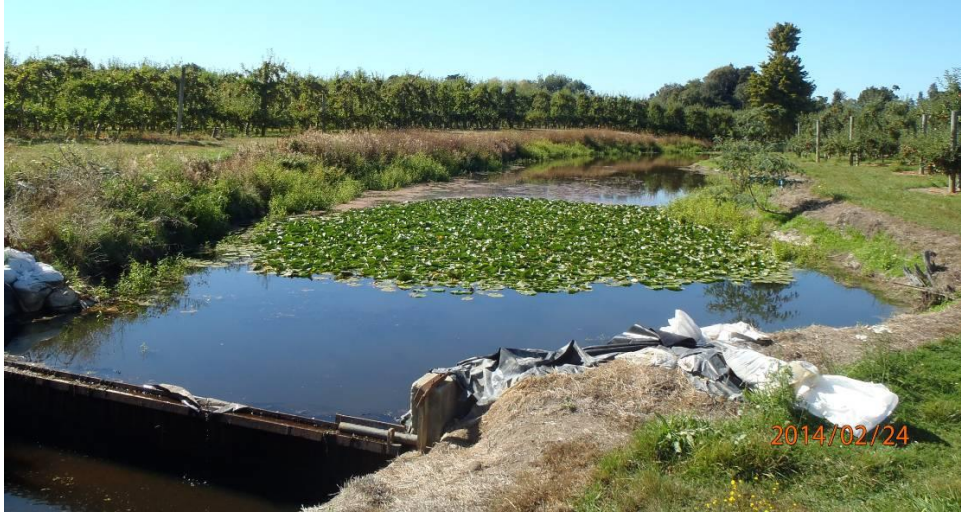
Old Moutere River at Wratten Weir looking upstream (sonde installed on the left of the photo).

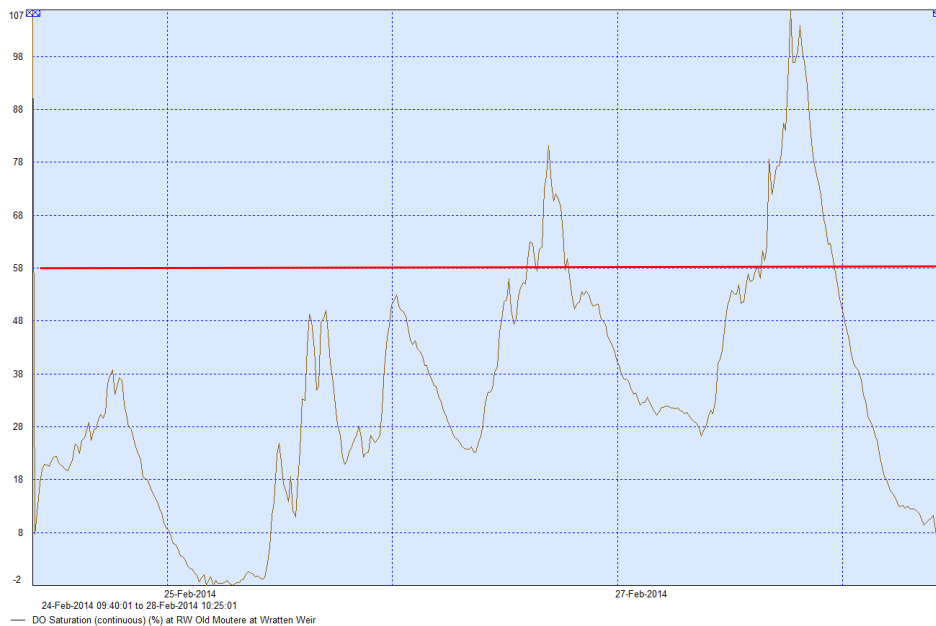
Figure Dissolved oxygen at Old Moutere River at Wratten Weir sampled continuously from 24-28 February, 2014). The national proposed bottom line for the daily 1-day minimum is shown by the red line.

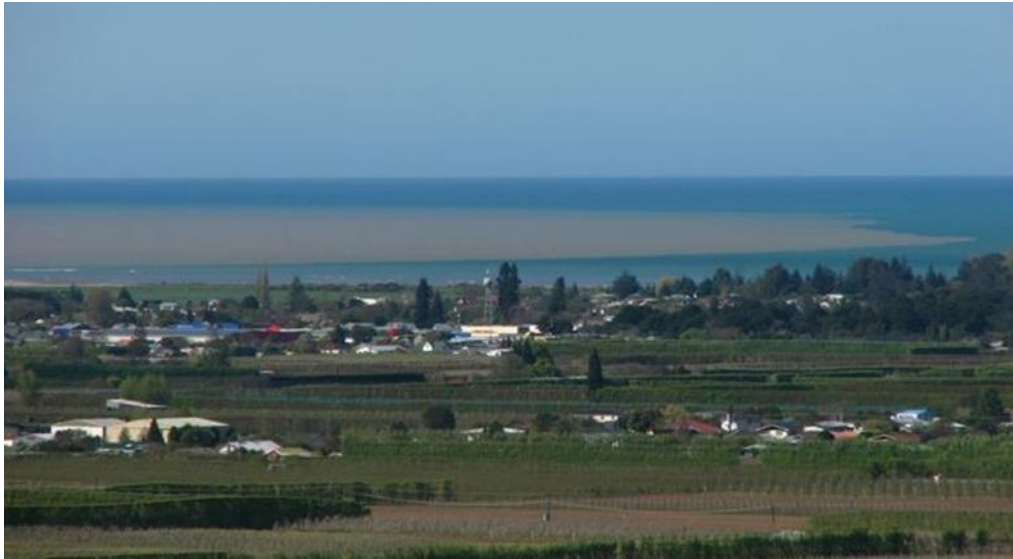
Motueka River plume from the Motueka Plains after a moderate flood event (6 October 2007; view NE).

Base-flow levels of faecal indicator bacteria are low, but at high-flows levels almost always exceed guidelines. Faecal indicator bacteria were found in elevated concentrations after a rainfall event in the Motueka River plume 6 km out into Tasman Bay. This contamination was linked to ruminant animal sources using genetic markers (Cornelisen *et al.* 2010). No human markers were found in this study, indicating that the influence of sewage treatment plants, such as the one at the Motueka River mouth, are not having a widespread impact.

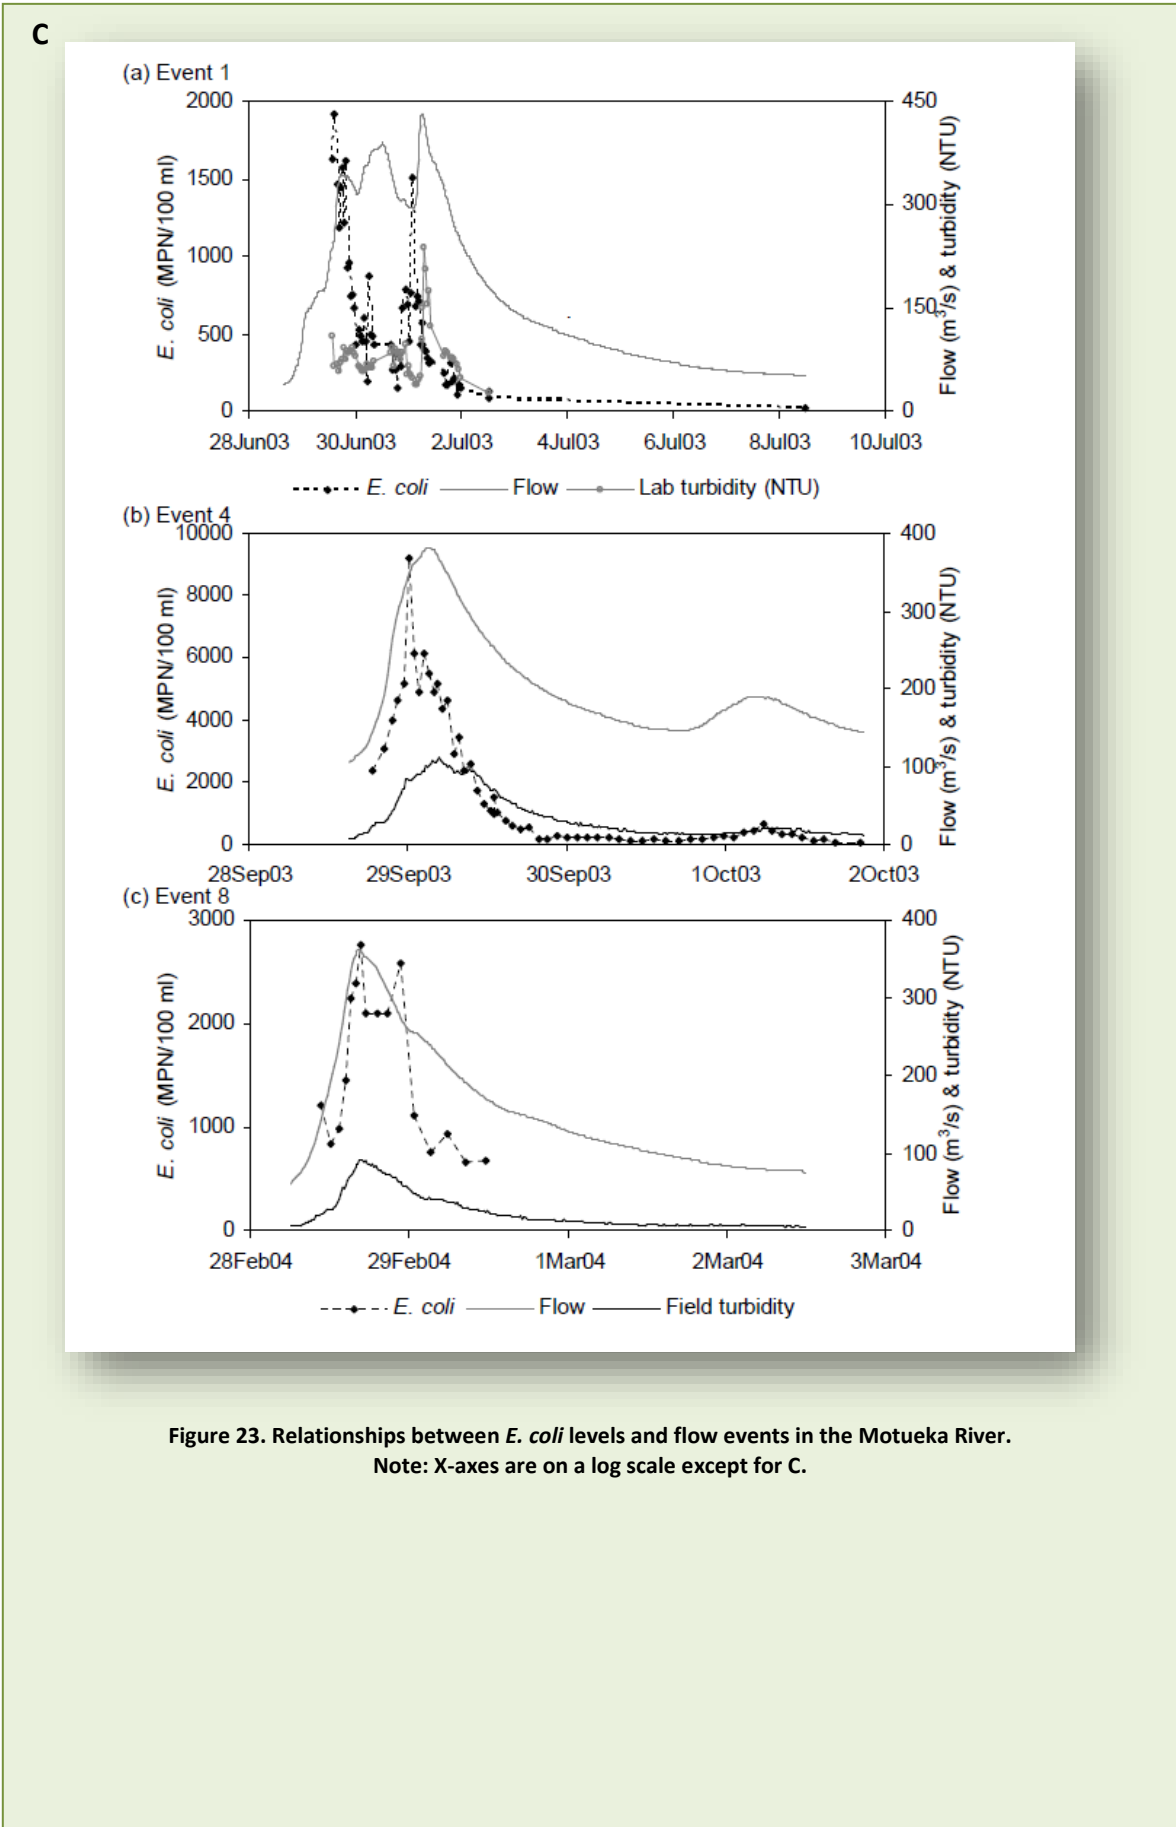
Figure 23. Relationships between *E. coli* levels and flow events in the Motueka River.
 Note: X-axes are on a log scale except for C.

In an extensive study carried out in the **Motueka River**, annual exports of disease-causing organisms (*E. coli*) were predicted to be in the order of 10^{16} *E. coli*/year, which is equivalent to an average annual specific yield of about 10^{12} *E. coli*/km²/year (McKergow & Davies-Colley 2010). This is an order of magnitude lower than catchments dominated by intensive dairy farming land use in the Waikato. The concentration of disease-causing organisms during rain events is typically 10-30 times higher than in base flow conditions (Figure 23A), and most (>98%) of the annual load of *E. coli* is exported to the lower river and coast during flood events (McKergow & Davies-Colley 2010). All peak *E. coli* concentrations occurred on the rising limb of the hydrograph (Figure 23B and C). Knowing this information, people who like to swim or get immersed in rivers can avoid the risky periods during and after rain. The river flow rate was found to be the best surrogate for disease-causing organisms in the Motueka catchment, rather than turbidity, which has been found to be more useful in smaller catchments. **Run-off from grazed pasture and direct deposition from livestock** are the most likely sources of disease-causing organisms in this catchment. Average *E. coli* concentrations for flood events where rainfall was centered on the middle Motueka catchment were much higher than for rainfall that mainly occurred on the steep lands.

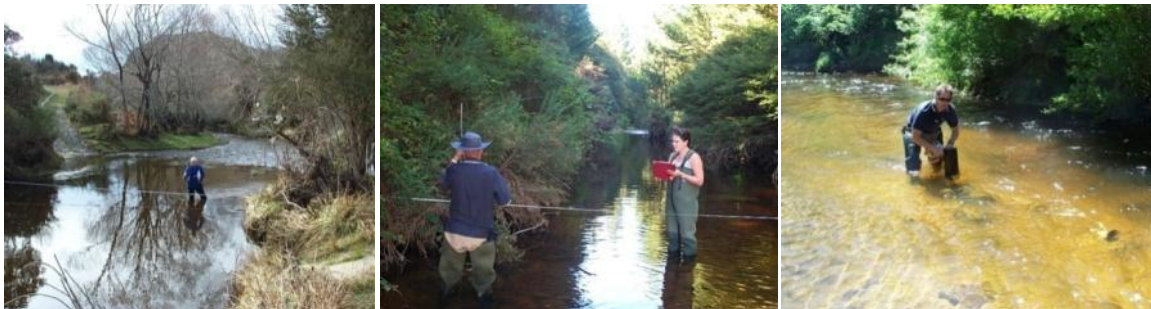
Sherry Rv at Blue Rock (July 2007, left), Upstream Cave Ck (January 2008, middle), Reading the black disc water clarity at Matariki (right).

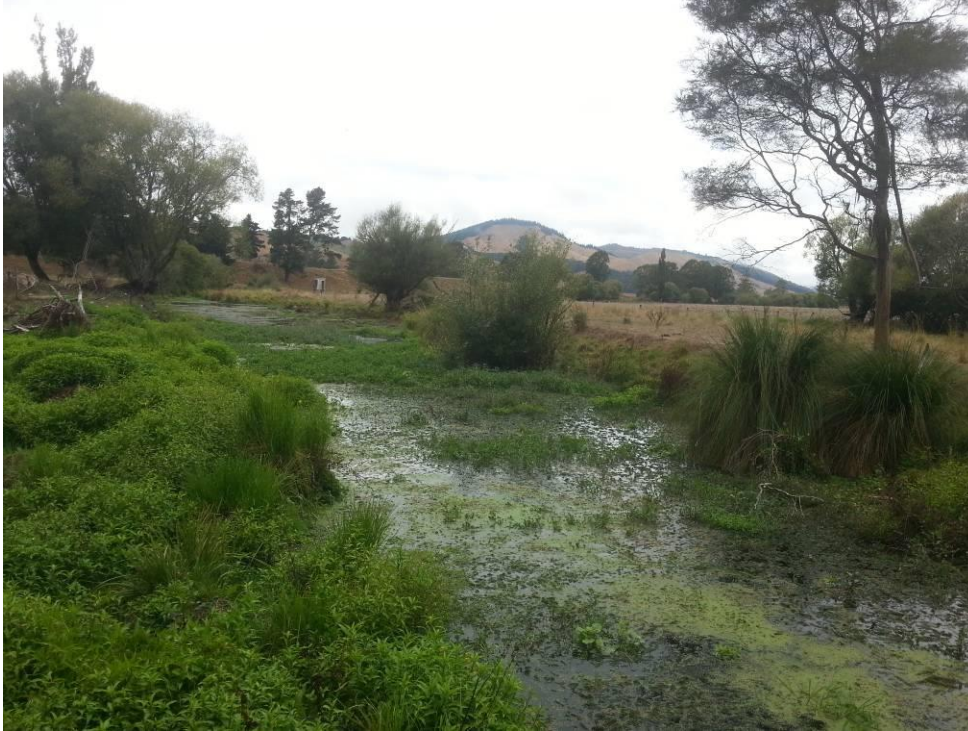
'Hinetai Creek' approx 720 m upstream Motueka River (February 2015)

Dissolved oxygen was very low (daily minimum of 25-35%) (Figure 36). This was probably due to the prolific growth of aquatic plants (including *Lagarosiphon major*) and limited shading of the creek for most of its length (although the meter was installed under willows in the lower reaches). Water temperatures were very acceptable for a healthy aquatic ecosystem (midpoint of daily mean and daily maximum of 19°C).

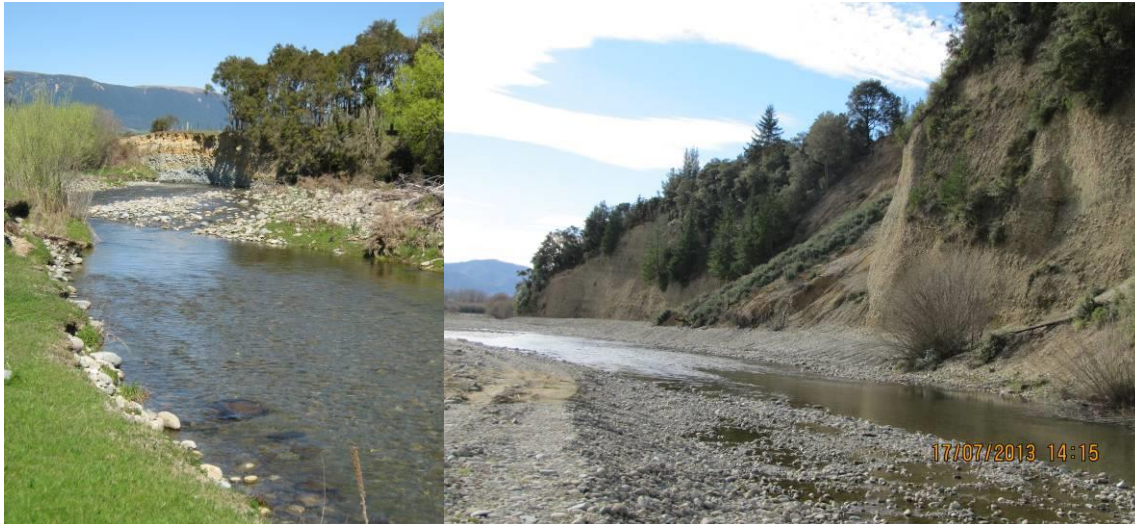
Above left: Motupiko River 300 m upstream Graham Ck showing a source of the catchment in the St Arnaud Range (October 2010). Above right: Erosion of Moutere gravels along cliffs. This is a relatively common occurrence between Korere and Quinneys Bush (2km downstream Korere Bridge, July 2013).

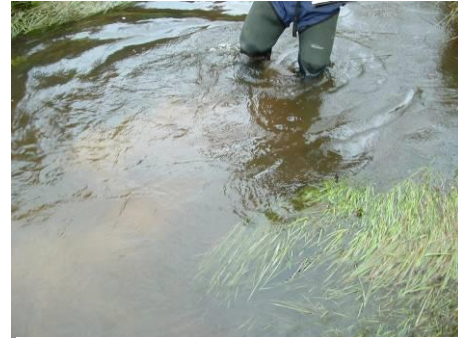
Doing the Suffle test in Waiwhero Ck

There is a lot of **fine sediment** in the bed of Waiwhero Creek (shuffle index regularly 4 and sometimes 5). A proportion of this sediment will be from bank erosion but unfenced riparian areas are also likely to contribute.

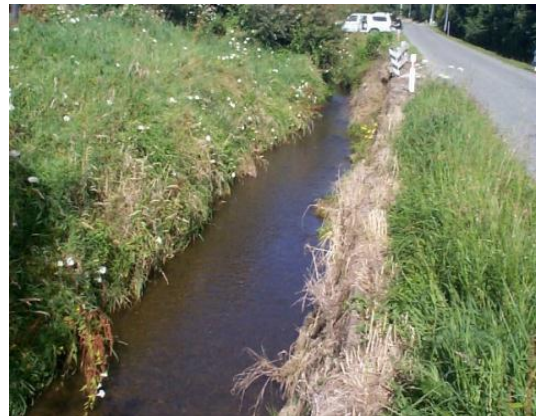
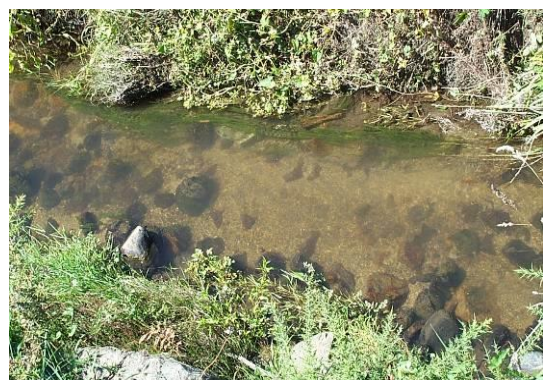
Above: Little Sydney Stm at Factory Rd (October 2008). Below: The stream bed showing the dominance of sand substrate.

The stream banks are sprayed periodically and dug out every 10-15 years releasing reasonable amounts of sediment into the waterway (see photo below). During the most recent digout spoil piles were searched for fish, but only a few eels were recovered for re-release.

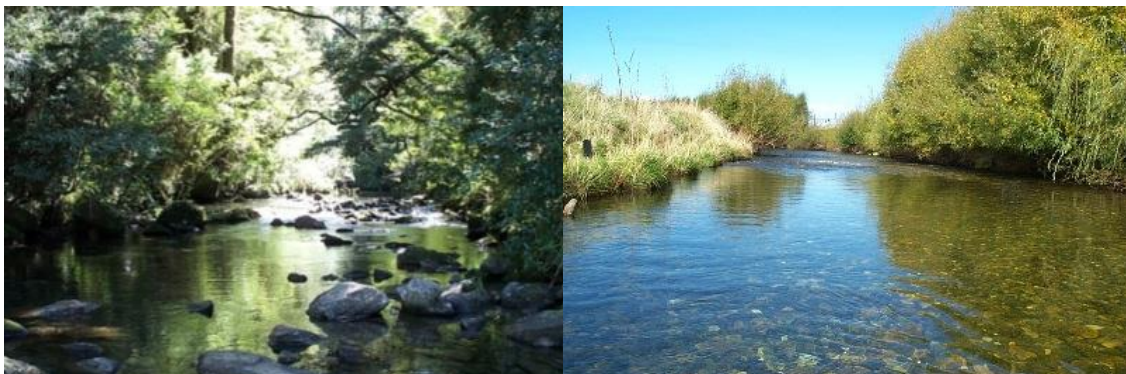
Riwaka Rv at North Branch Source (January 2008, left) and at Hickmotts (April 2005, right).

Macroinvertebrate condition at the north branch source indicates very good water quality. Unfortunately, this condition was on average 21 MCI units lower at the Hickmotts site compared to the north branch source site. MCI has also declined at the Hickmott site from >120 units (excellent) in 2002-2005 to 100-115 more recently.

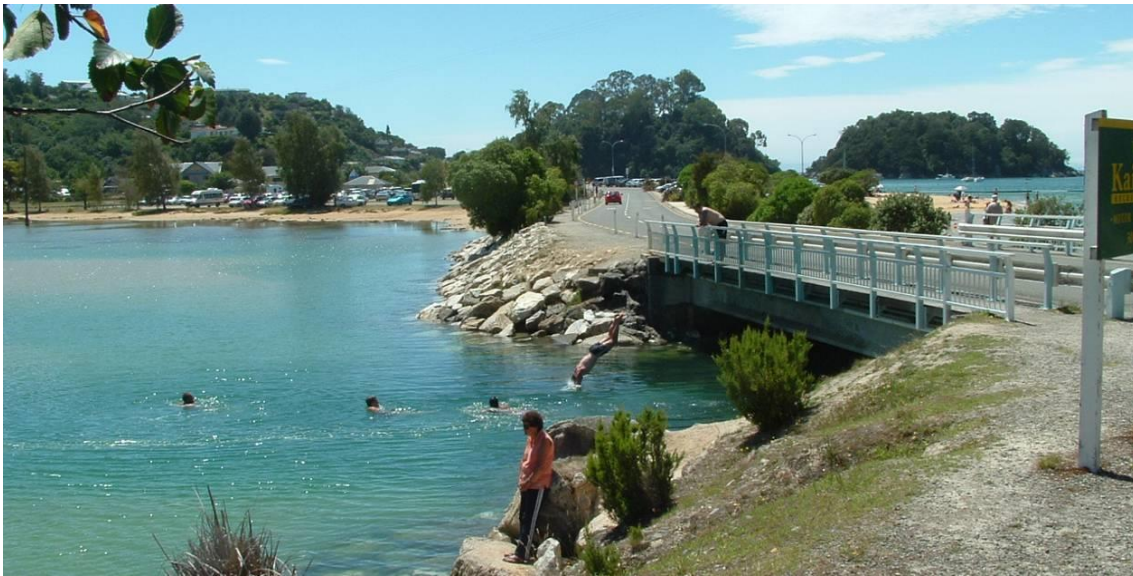
Like all streams draining catchments dominated by Separation Point geology these waterways have a bed dominated by coarse sand substrate.

The concentration of **disease-causing organisms** over a range of flows in both these streams was found to be **low** (based on 20 samples taken on an outgoing tide at each site as part of BWQMP; Kaiteriteri lagoon outlet median: 7.5 *Enterococci*/100 ml in 2012-13; Marahau River mouth median: 105 *Enterococci*/100 ml in 2011-12). A relatively low cover of periphyton was recorded at each of these sites.

Kaiteriteri Lagoon Outlet (February 2011)

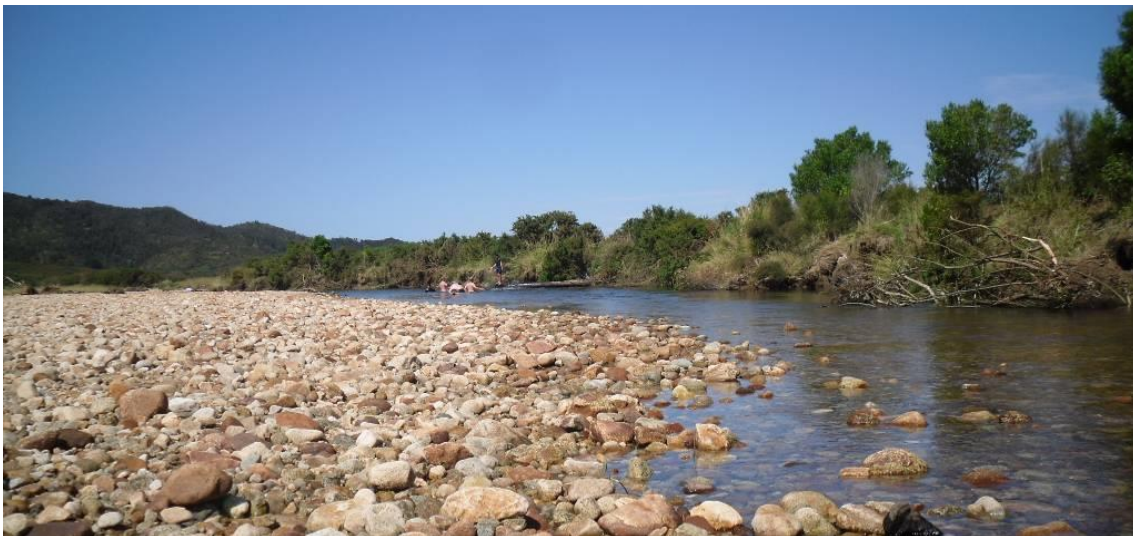
Marahau River downstream Sandy Bay Rd (January 2011)
