River Water Quality in Tasman District

State of the Environment Report

River Water Quality in Tasman District 2015

A technical report presenting results of the Tasman District Council's 'State of the Environment' River Water Quality Monitoring Programme and additional data from the National River Water Quality Network. Indicators measured include: physical, chemical, and bacteriological characteristics of the water, macroinvertebrate indices and periphyton cover. The report highlights water quality condition and trends, from the Waimea, Motueka, Takaka, Aorere and Buller water management areas.

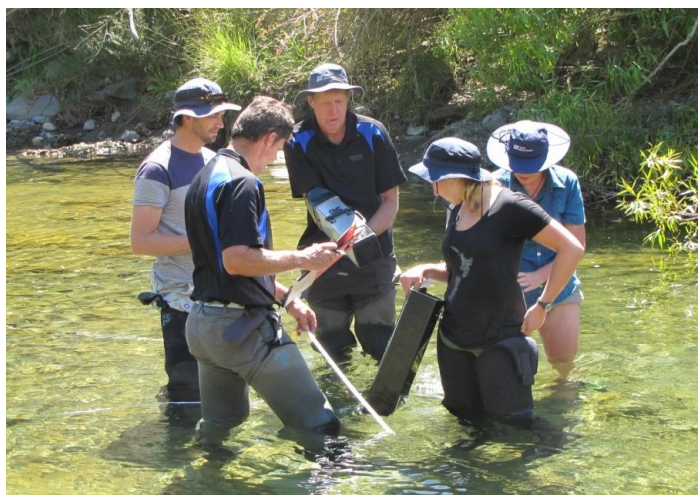
Monitoring staff at a training and quality control exercise. Here comparing black disc water clarity measurements to ensure inter-operator accuracy (Jan 2015).

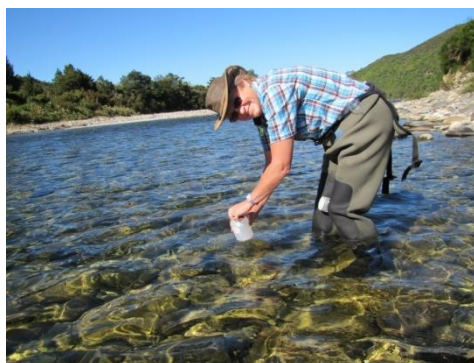
Collecting water samples at Aorere at Devils Boots (Feb 2015)

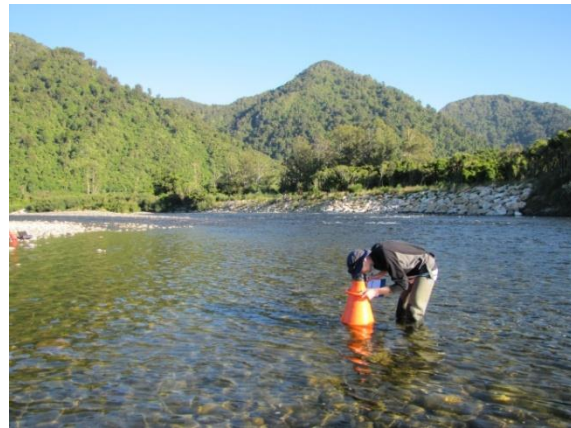
In the modified version used by our field teams, the percentage cover of the periphyton groups was recorded from views of approximately one square-metre of streambed, rather than from stones. Periphyton scores are recorded in spring, summer and autumn but not in winter.

Sampling periphyton using a bathyscope at Aorere at Le Comte (Feb 2015)

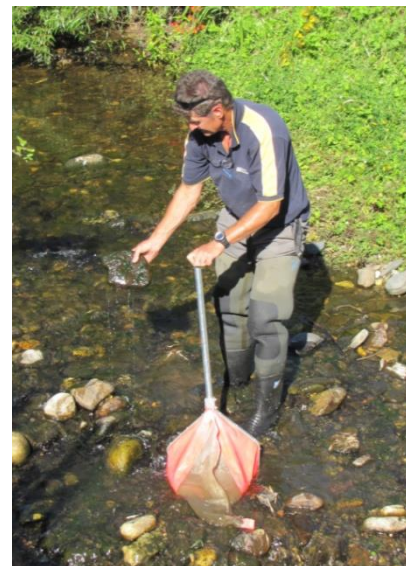
Macroinvertebrates (stream bugs) are generally sampled once per year using a kick-net, following national protocol C1 and samples were analysed according to Protocol P1 (Stark et al. 2001). The season in which samples were collected has changed over the record as follows: 2000-2005 in spring, 2005 in spring and autumn, 2007 to 2009 in autumn and 2012 onwards in summer. Sampling in summer has been settled on due to the higher rainfall in spring and autumn and the requirement for at least two weeks of base flows prior to sampling. Frequent flooding made it difficult to collect the samples with a timely manner. In 2006, 2010 and 2011 macroinvertebrate sampling was abandoned after almost 3 months of waiting for a two-week period of base flows (apart from sites in the Waimea area in 2010). The macroinvertebrate results for any particular site were only interpreted if there were at least three samples (over the 2000-2015 period).

Sampling macroinvertebrates using a kick net on the Onahau River (Feb 2015)

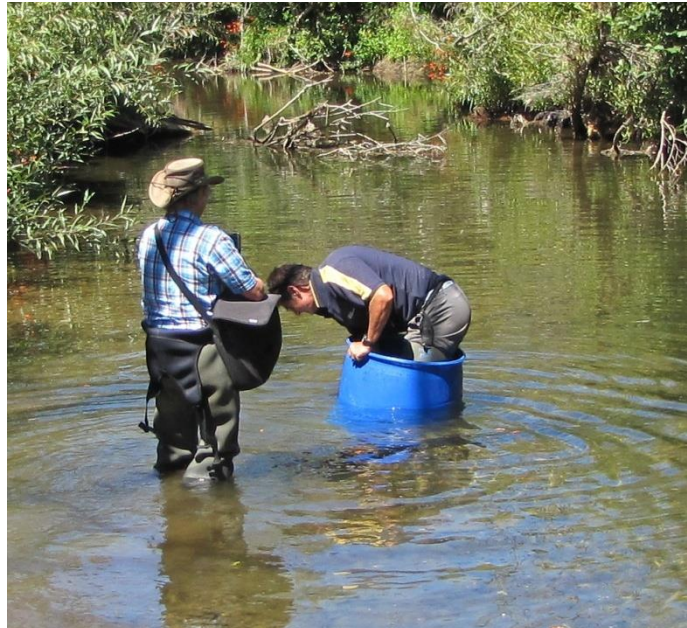
macroinvertebrate sampling occurs. This method is only used in streams with beds dominated by cobble-sized bed substrate. For this method a patch of streambed is isolated using a plastic barrel (400 or 500 mm diameter) and the sediment within the bed is stirred by working your boots vigorously into the bed to a depth of about 150-200 mm. A sample of the water and sediment mixture from the barrel was then collected. This procedure was repeated six times at each site. The volume of sediment in each sample was measured after settling for 1 hour in Imhoff cones. These raw measurements were then converted to Volumetric SBSV (litres of sediment per cubic metre of streambed).

Sampling re-suspendable fine sediment on the Onekaka River (Feb 2015)

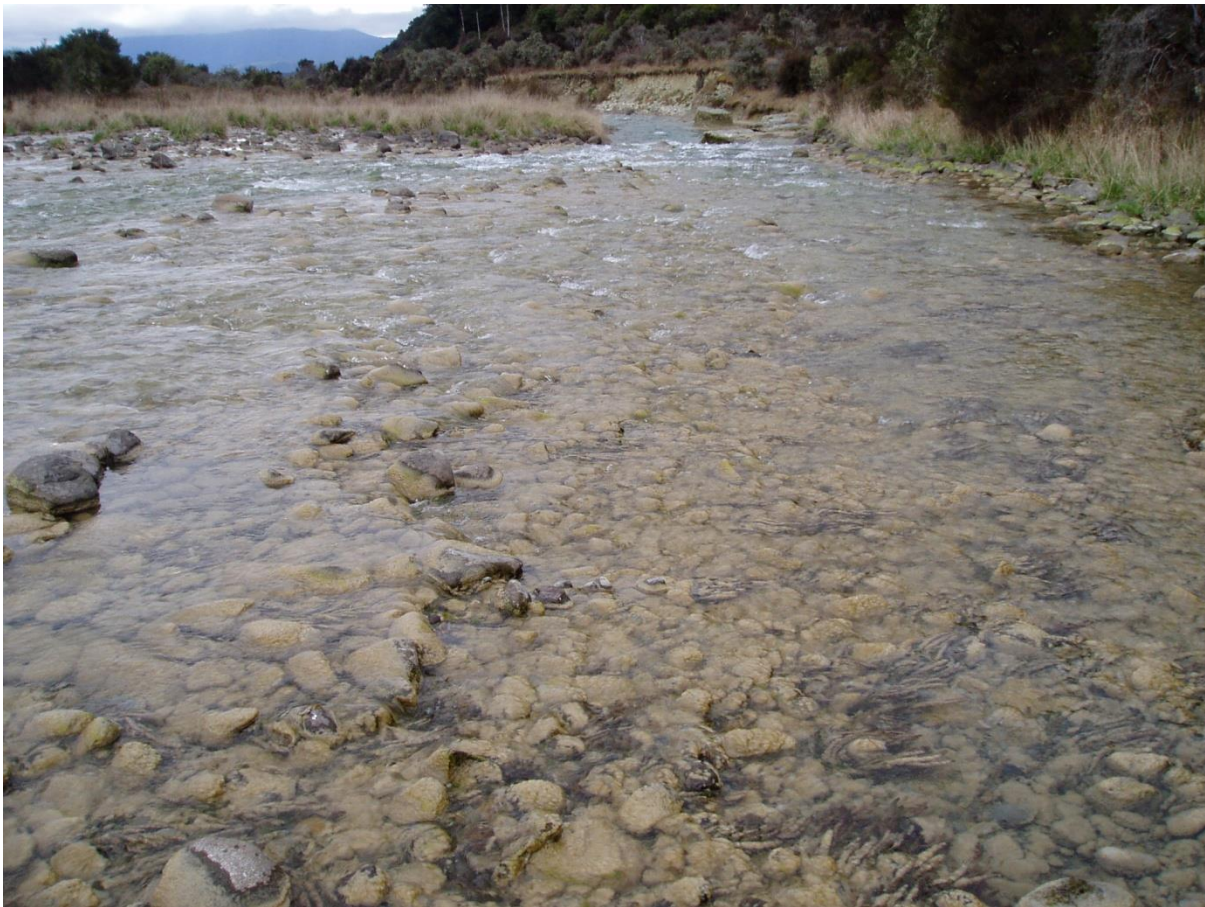
Didymo in the upper Buller River near SH73 (Sept 2005)

Didymosphenia geminata (didymo) is a freshwater diatom (a type of alga) that forms thick (up to 20 cm), brown, unsightly mats on the bottom of streams, rivers and lake edges. A single cell of didymo is microscopic; therefore it takes a large number of cells to be present in the water before it is visible to the human eye, so the risk of spread will not always be obvious. Didymo has often been confused with New Zealand native algae. One difference between didymo and native species is the way it feels. Native algae feel slimy and will break apart in your fingers, whereas didymo is strong and feels like wet cotton wool.

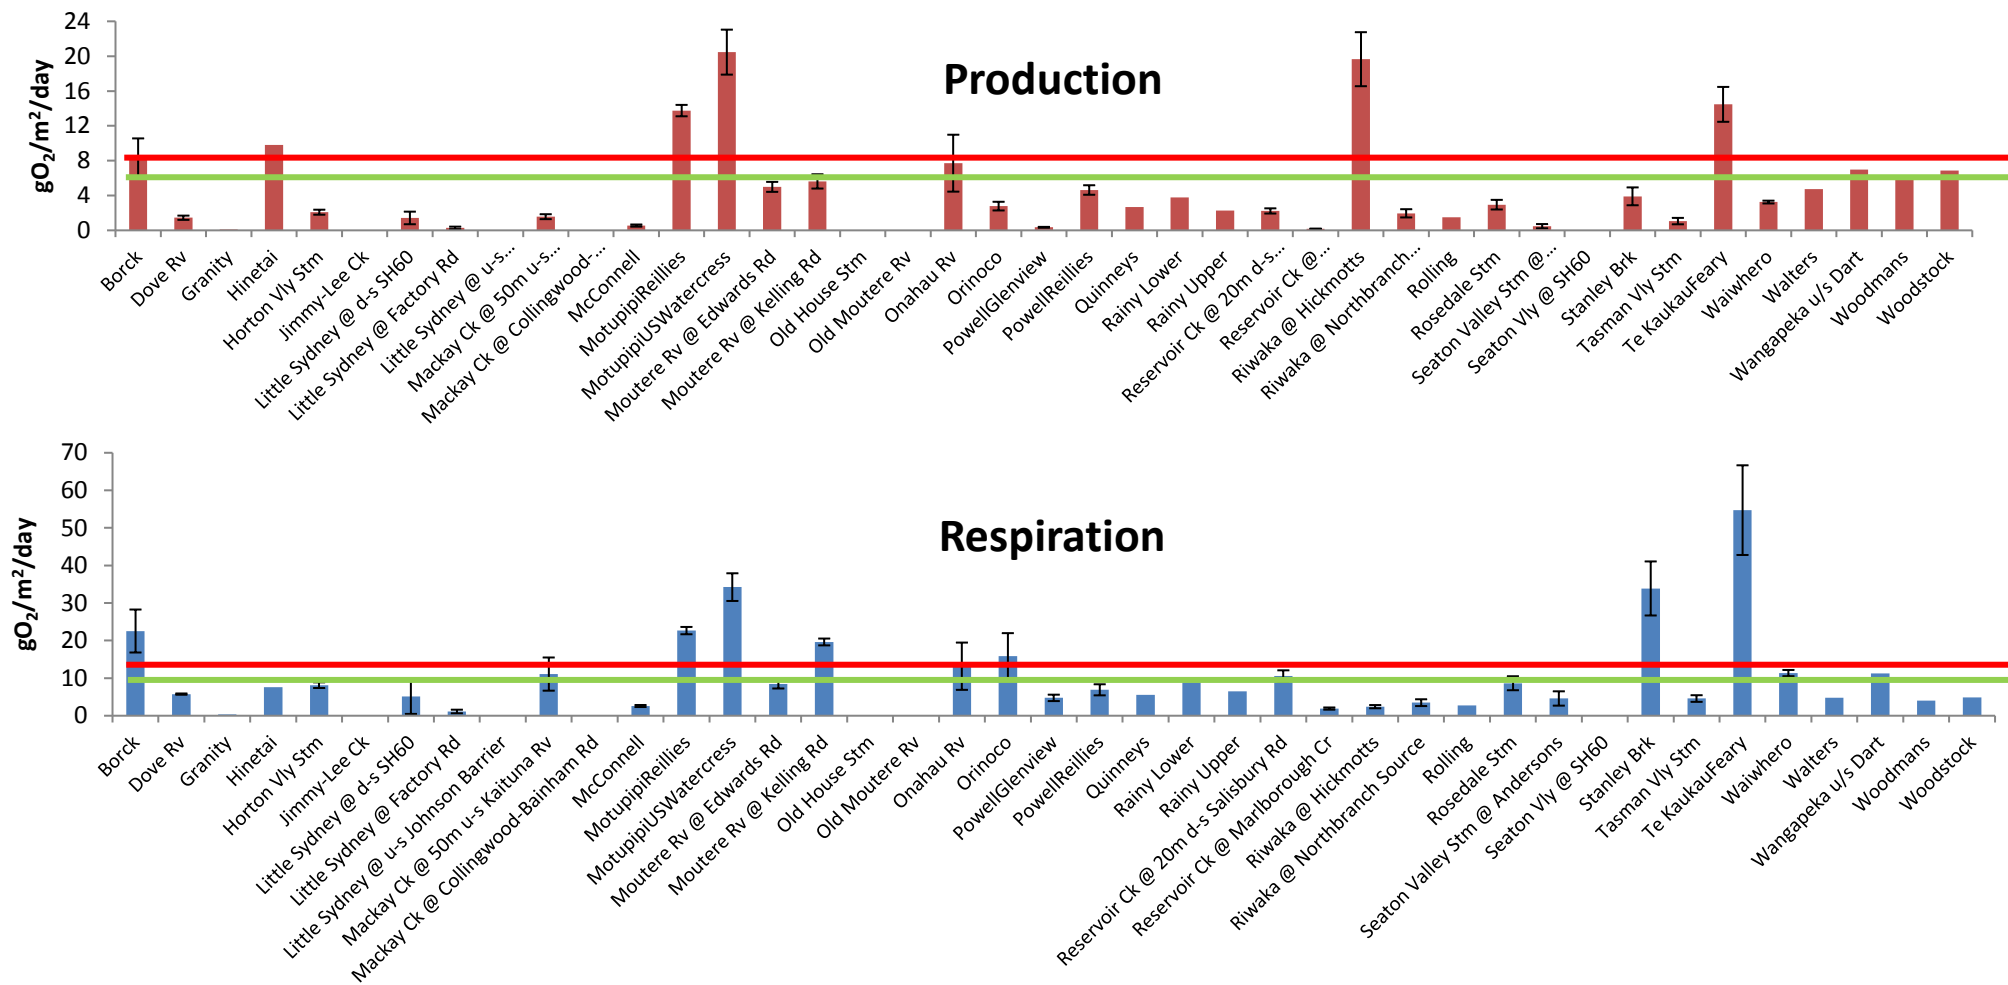
Figure 8. Average production and respiration for 41 sites in the TDC region. Gaps in the graph indicate a lack of data or data unsuitable for analysis. Standard error bars were calculated using the observed variation within the sampling period for each site.

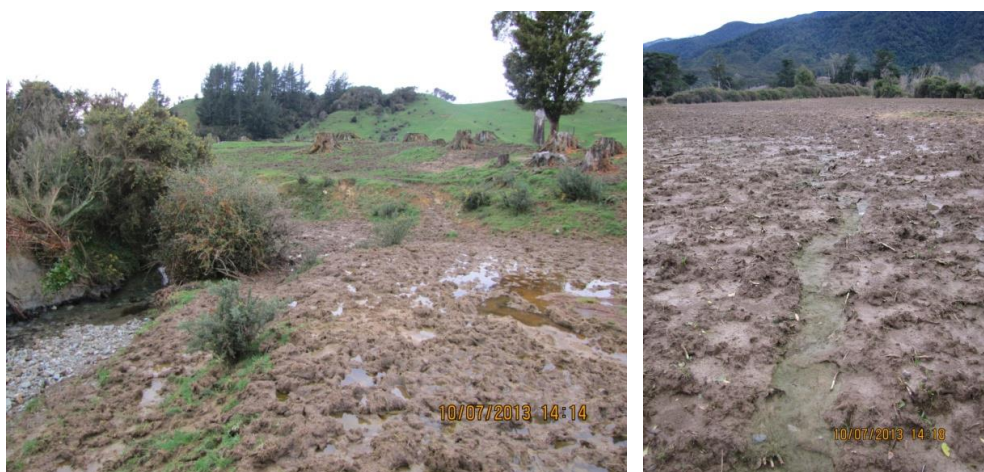
Several instances of discharge of topsoil to waterways from winter cropping and break-feeding as well as feeding out beside a waterway were evident in winter 2013. Prior to the 2014, winter Fonterra and Council teamed up to present good practice on this aspect of farm management to farmers. Such good practice is to begin grazing furthest away from the stream first and progressively graze (break fence) toward waterways. The reverse had been happening and there was no grassy sward for sediment to get trapped into.

Examples of risk of sediment discharge to waterways. Left: Feed out area next to a waterway. Right: Evidence of run-off (the waterway is 180° from this view).

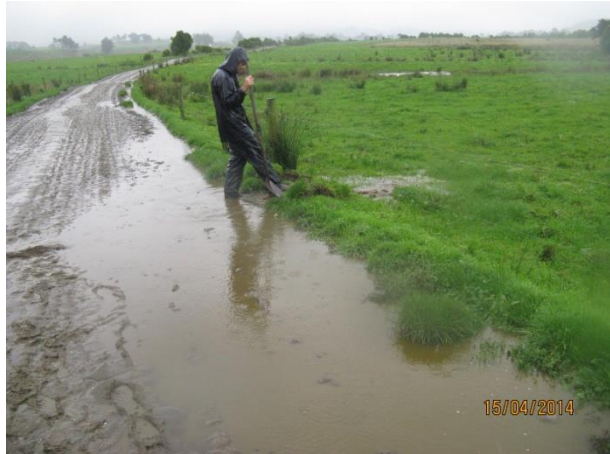
Discharges of sediment and faecal matter from dairy farm races are also a common issue in Tasman. The photo to the right shows the simple solution of ensuring the runoff from the race is diverted to the paddock and not the stream.

Discharges of sediment and disease-causing organisms from a lane-way. Note the berms on the raceway curbing the flow direct to the stream and the farmer breaching the curb to allow the discharge to pasture instead.

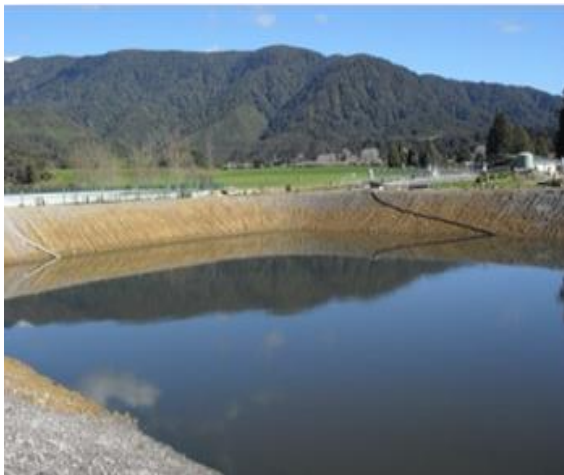
A dairy farm effluent pond; this pond has good storage and a weeping wall for solids removal

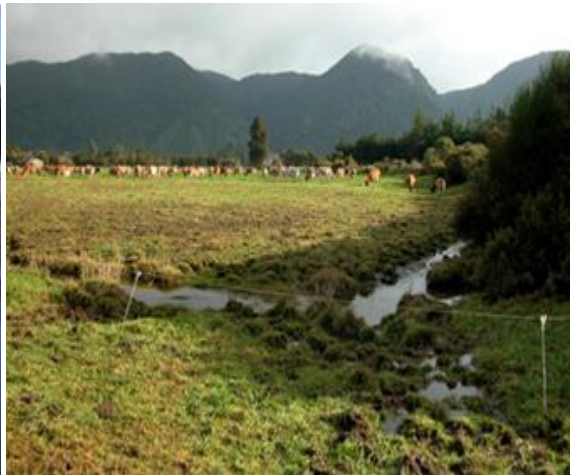
An ideal location for a constructed wetland to intercept runoff from pasture

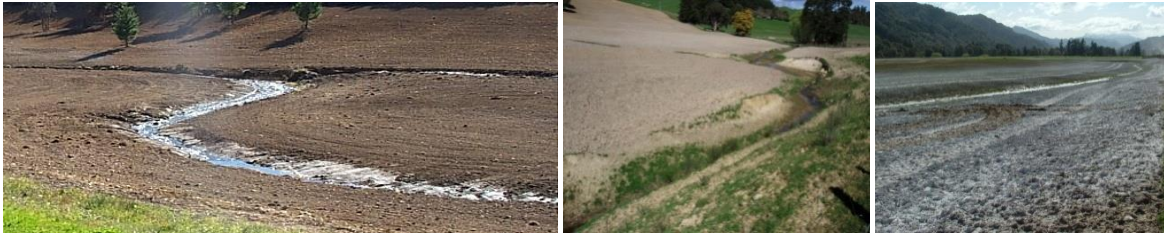
Examples of farming practice that have led to fine sediment run-off to waterways.

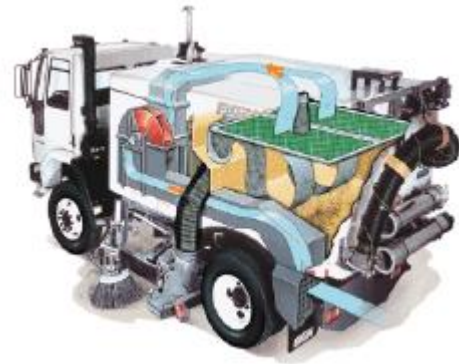
However, particular attention needs to be given to the type of street sweeping machine (vacuum sweepers were much better than mechanical broom and regenerative air sweepers at removing the fine particles from the road surface and then depositing them in the truck rather than re-emitting the dust). The timing and frequency of sweeping is also important. The frequency needed to remove road contaminants is higher than for aesthetic sweeping (it is estimated that there about double the yield of contaminants removed by increasing the frequency of sweeping from 2 to 12 times/year). Sweeping is best carried out prior to rainfall events after a longer dry spell as road contaminants build up over time and then get effectively washed into waterways during rain.

A vacuum sweep vehicle for removing road deposited sediment

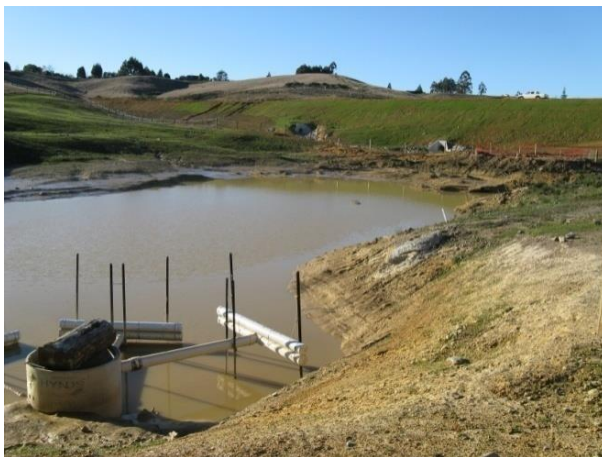
A sediment pond with decanter, Ruby Bay Bypass Gardner Valley Catchment, Moutere.

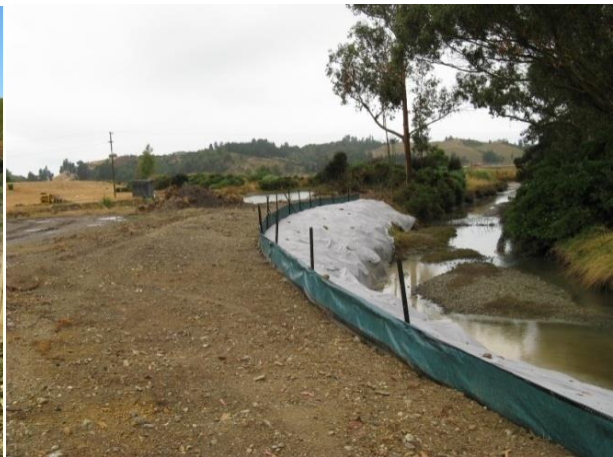
Silt fence for sediment control on flat terrain, Ford Creek, Tasman.

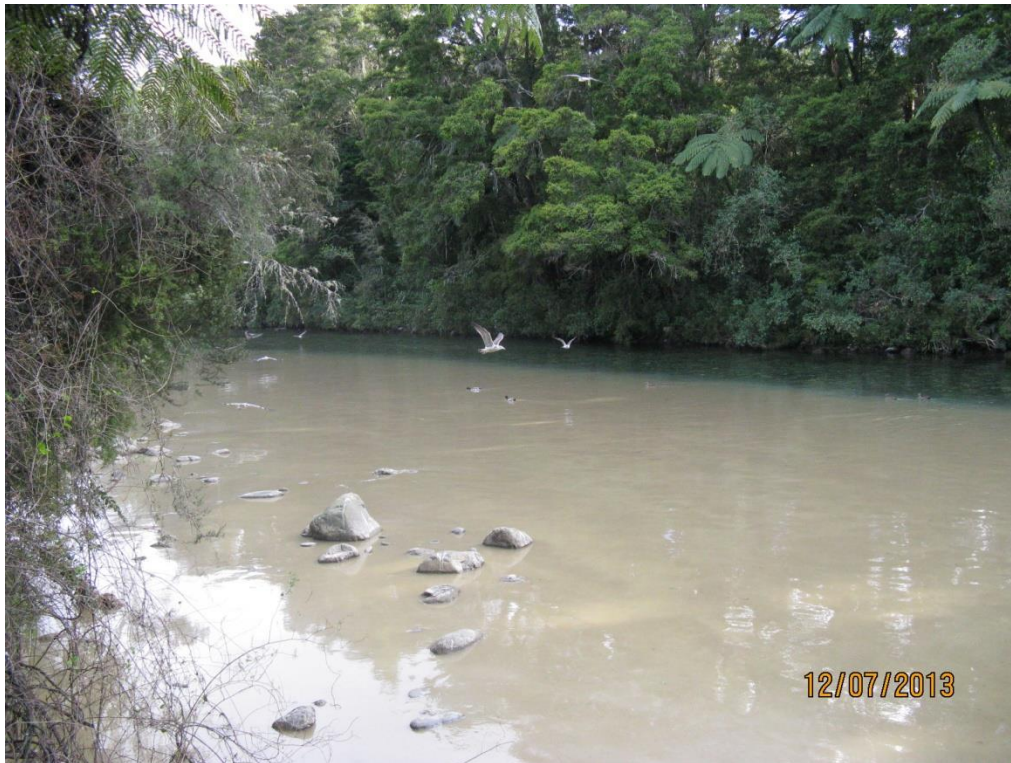
Heavy sediment load to the Anatoki River from discharges from works in a tributary (July 2013).

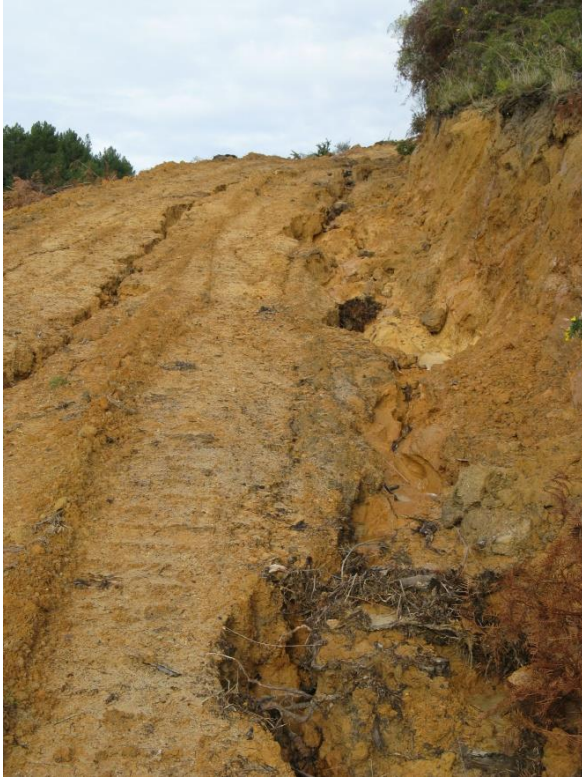
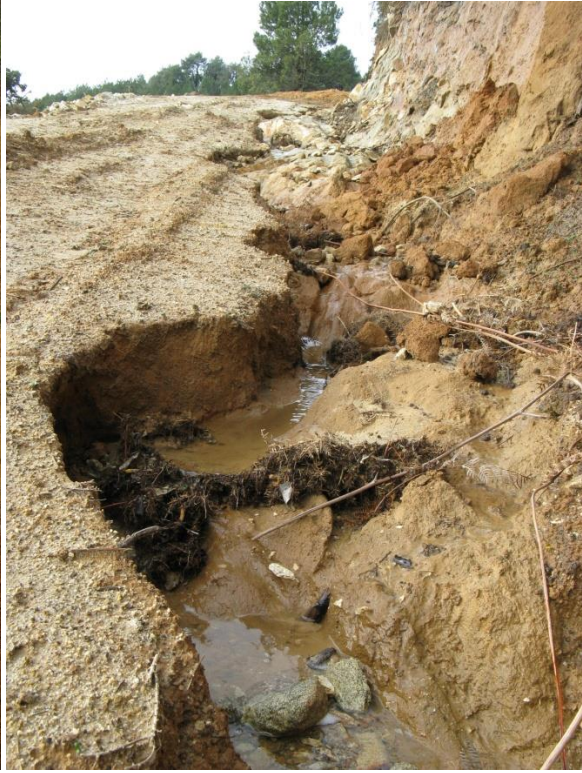
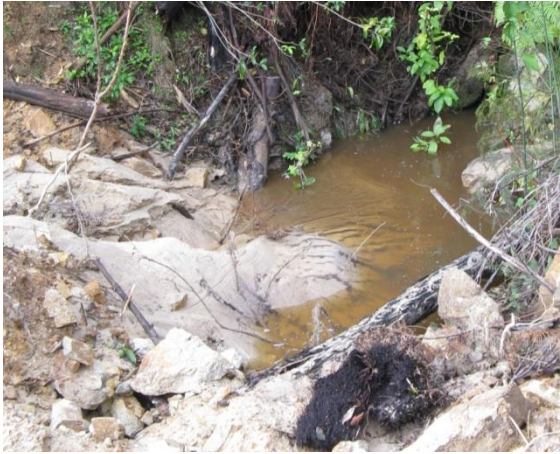
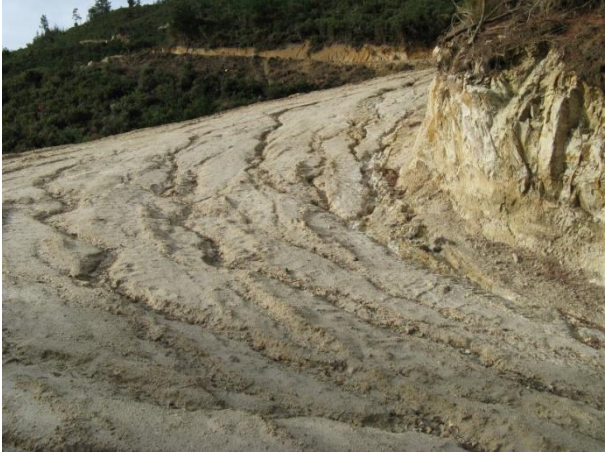
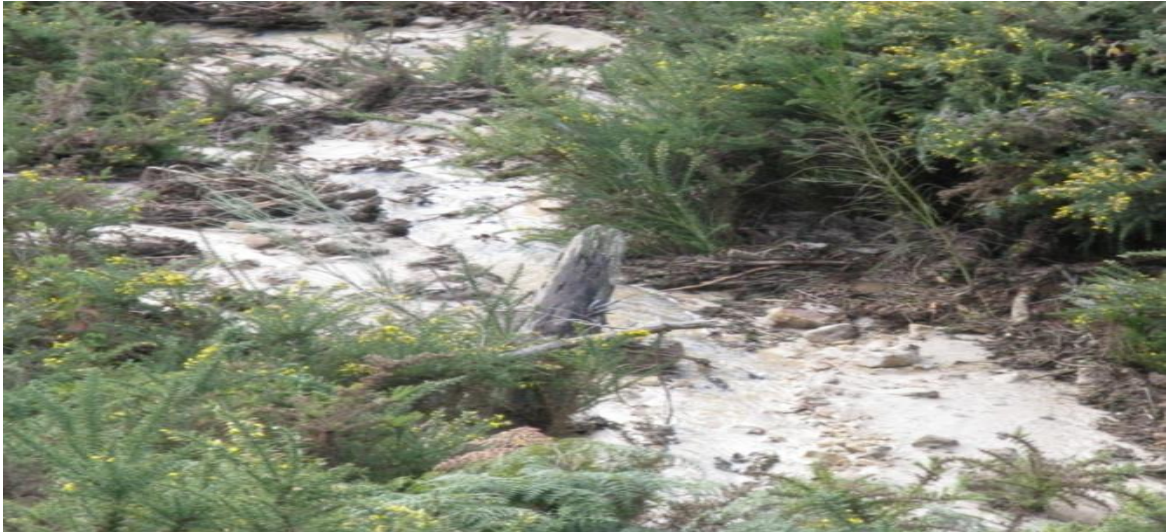
The risk of sediment generation from roading is particularly high in Separation Point Granite geology. An example is shown in the photos below. This occurred in 2011 at Pangatotara, Motueka Valley.

Erosion from poor sediment and erosion controls in road construction in granite geology.

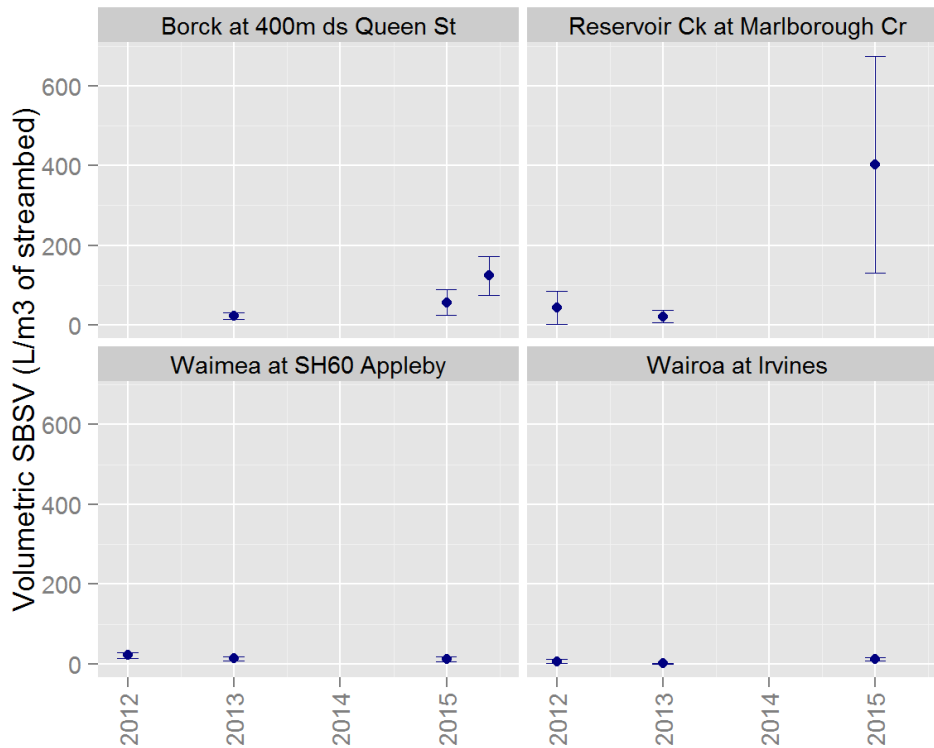
Figure 27. Mean volumetric suspendable benthic sediment volume (SBSV) from 2012 to 2015 (sampled during summer). The error bars show 95% confidence intervals.

Volumetric SBSV data were available for three sites (Figure 27). Despite the large variation in mean volumetric SBSV at Reservoir Ck at Marlborough Cr, there was evidence of an increase in this measure between 2012 and 2015 maybe as a result of the reconstruction of the Reservoir dam in 2013 or sediment from forestry activity still making its way down the stream. The 2015 result for this site was one of the highest in the district (the mean SBSV across all 27 sites in 2015 was 70 L/m³, SD = 78).

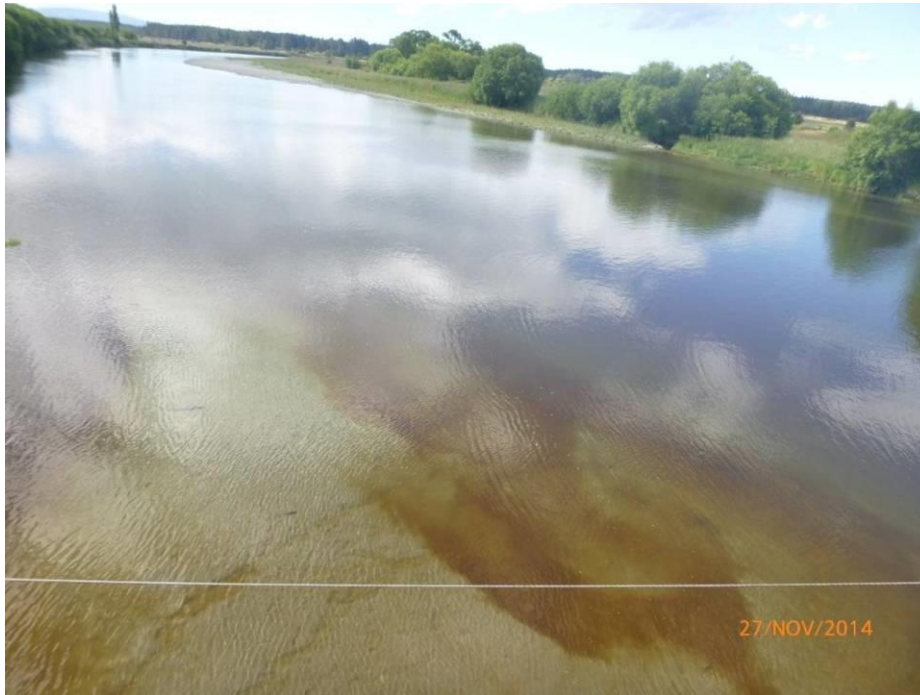
A Cryptomonad algal bloom in the lower Waimea River (November, 2014).

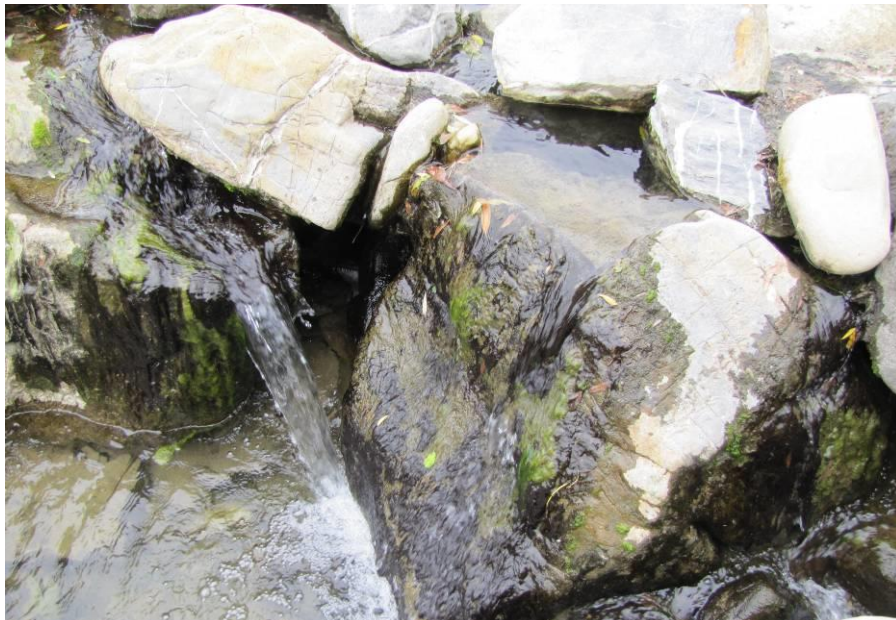
***Phormidium* (the black growth) on the Wai-iti River weir downstream Waimea West Rd.**

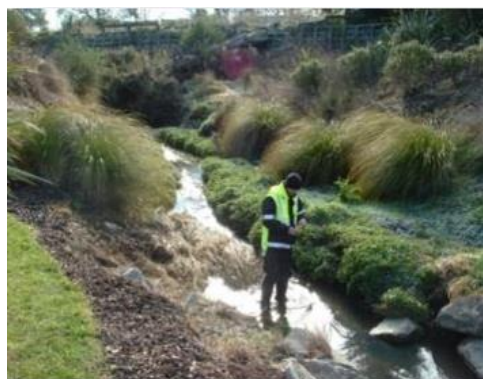
Reservoir Ck at Marlborough Cres (January 2002, left) and downstream Salisbury Rd (July 2009, right).

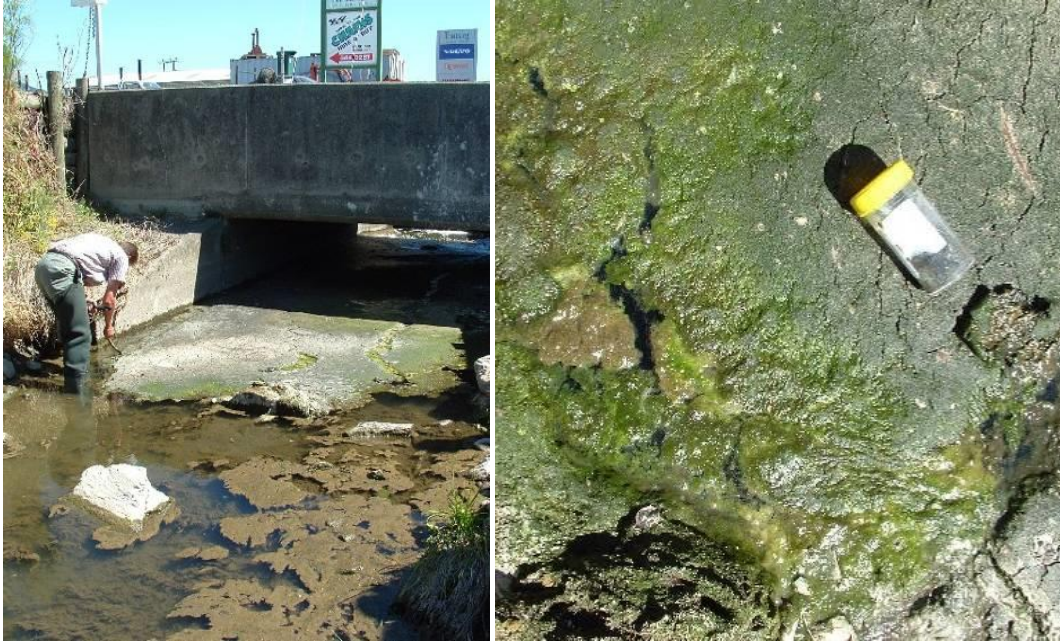
At a site adjacent to 40 Beach Rd a scum can develop that is so thick that ducks can walk on top of it. It is formed during hot dry periods when algal cover (mostly *Melosira*) is high and the detached algae floats downstream and is flocculated when it drops over a 0.5 m vertical weir. The odour can be strong and has been subject of complaints.

Algal Scum on Jimmy Lee Creek, 27 January 2005

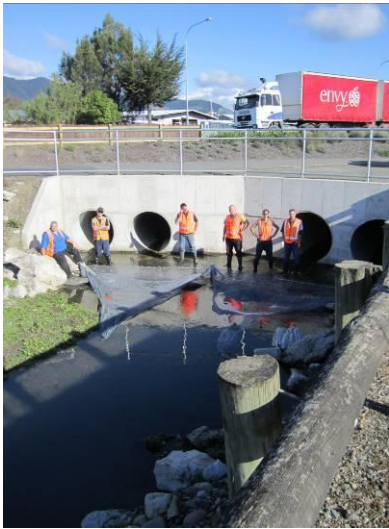
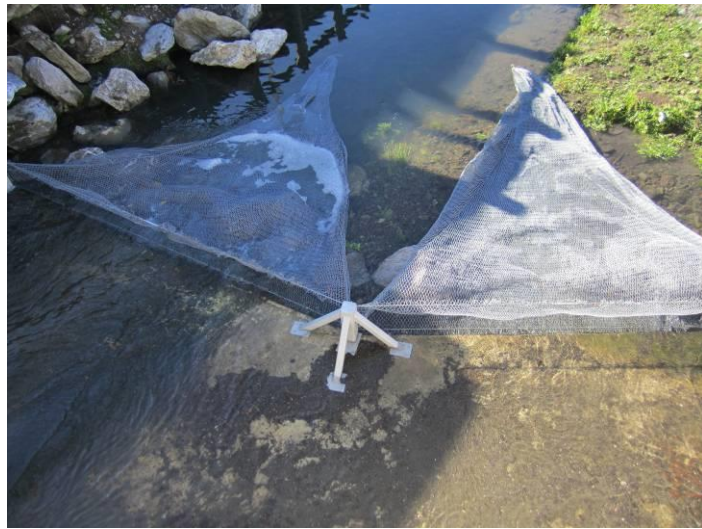
In 2011 a trial was set up to determine the debris load in this stream using nets with 5 mm mesh size (see photos below). These were designed with a partial slit in the side to ensure fish could escape. Over the four months that the nets were installed, relatively little inorganic debris was caught (soft drink cans, bottles, cigarette packets etc) compared to the large amount of leaves. Such a device appears to be only effective at reducing a small amount of the rubbish entering the estuary from Richmond. A large proportion of the rubbish load to the estuary is tough to come from more diffuse sources (particularly rubbish blown in the wind).

Jimmy-Lee Ck downstream of Wakatu Dr and piped section. Left: View upstream from near 35 Beach Rd and Right: close-up of coarse rubbish traps (both photos from May 2011)

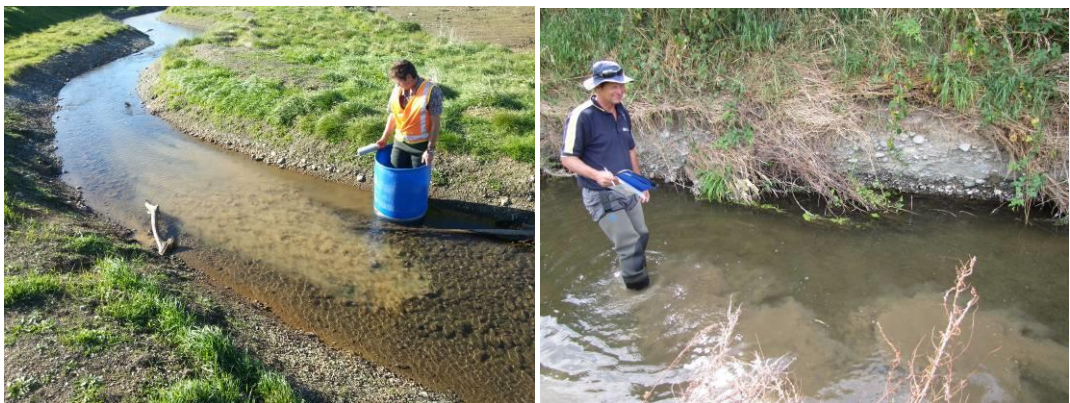
Fine sediment almost completely fills the spaces between the cobbles of the bed in Borck Creek. **Suspendable Bed Sediment Volume (SBSV) in lower Borck Creek is very high** (mean of 6 replicates range 23-57 l/m³ (2013 and 2015); see photos below). Following the new channel commissioning an even greater proportion of fine sediment was found (69 and 124 l/m³) even though 100 mm of clean gravel was added to the new stream bed. This seems to be because the fine sediment composition of the base layer is very high and the depth that this procedure stirred to was 150-180 mm (below the layer of clean gravels).

Resuspending the fine sediment in Borck Ck 400 m downstream Queen St. Left: May 2015 following diversion into a new channel, Right: Old straight channel January 2012.

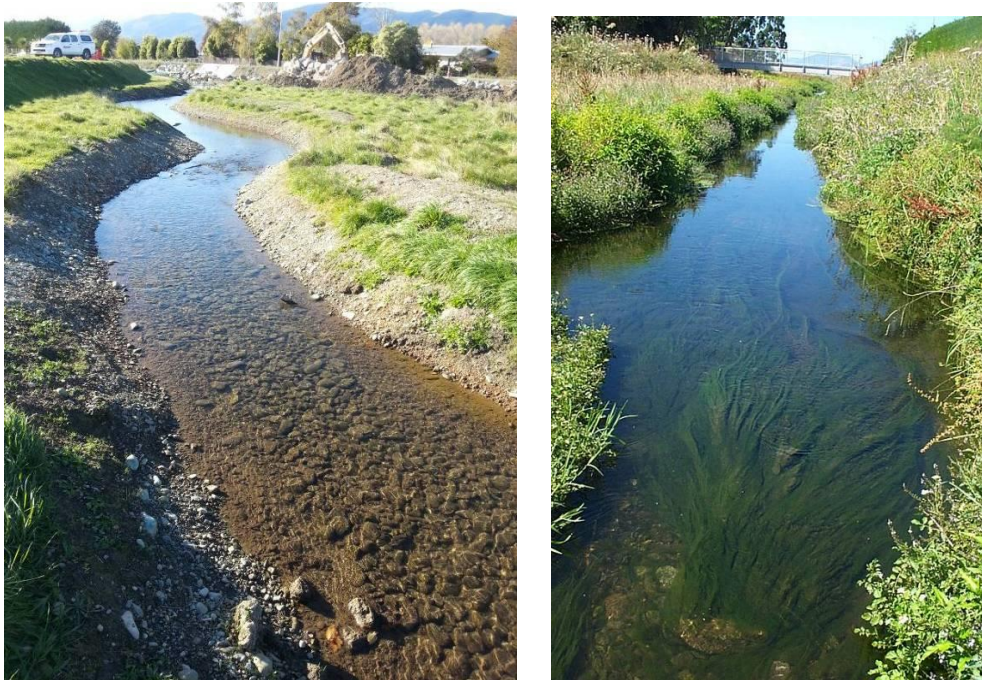
Borck Ck 400 m downstream Queen St Left: May 2015 two months after the diversion into the meandering channel, Right: January 2009 showing extensive filamentous green algae cover.

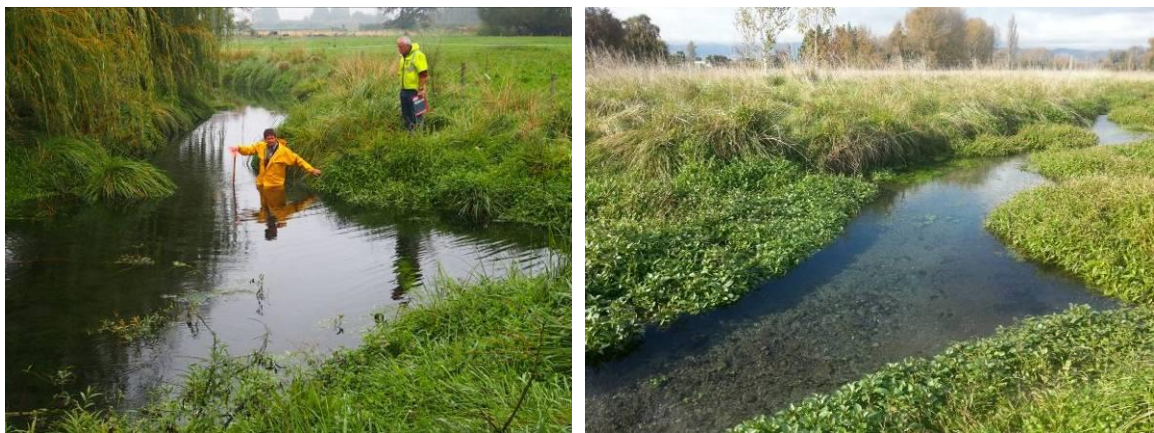
Neimann Creek viewed upstream Left: 550 m upstream Lansdowne Rd (April 2014) and Right: 600 m upstream Lansdowne Rd (May 2015)

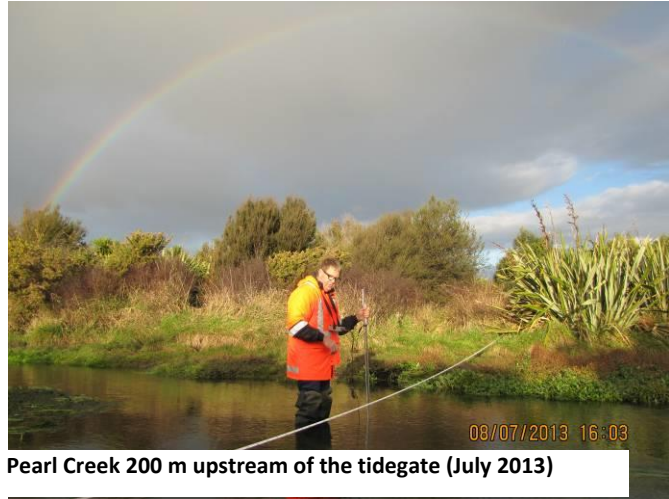
Pearl Creek 200 m upstream of the tidegate (July 2013)

Pearl Creek is expected to be ecologically compromised due to **excessive fine sediment deposits and low dissolved oxygen**. Re-suspendable sediment in riffles and wadeable runs in Pearl Creek is high (but the sediment depth has not been quantified in pools or deeper runs. Daily dissolved oxygen minima were consistently around 15% saturation with large daily fluctuations (continuous sampling in March 2014). Excessive aquatic plant growth, including the pest plant *Lagarosiphon major*, are the likely reason for this.

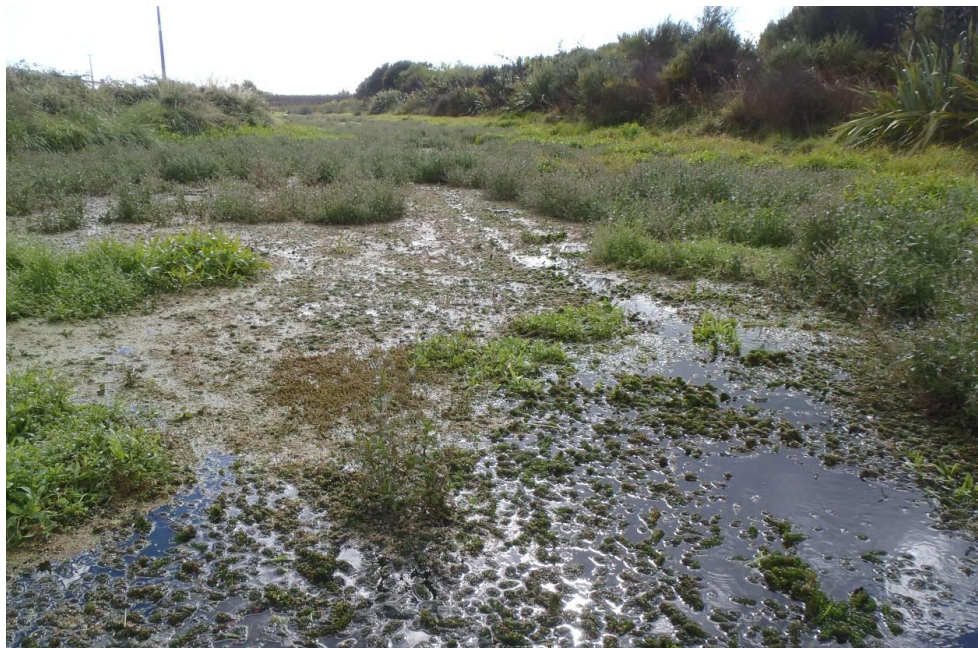
Pearl Creek 200 m upstream tidegate, view downstream (March 2014). Note extensive aquatic plant growth including *Lagarosiphon major*.

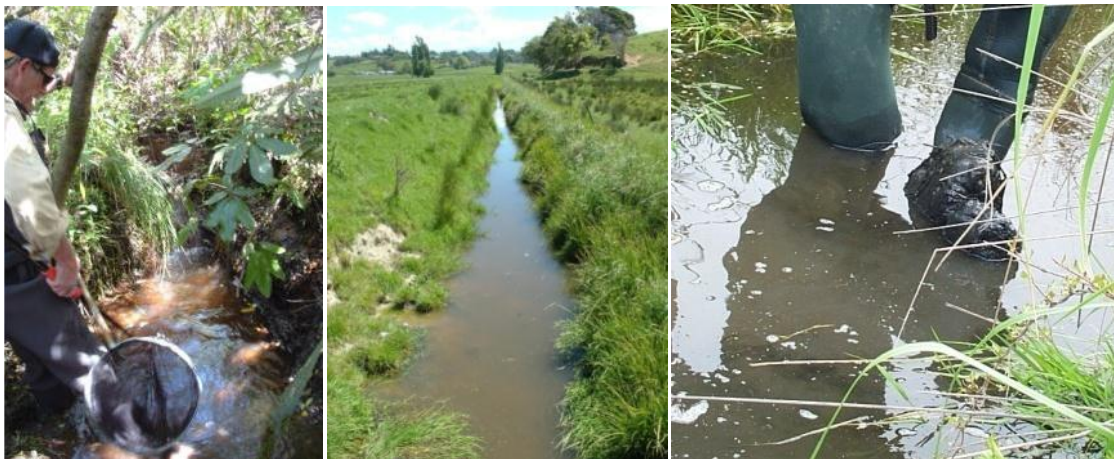
From left to right: Seaton Vly Stm 2km u-s Stafford Dr; upstream Stafford Drive looking upstream (November 2006); Anoxic sediment.

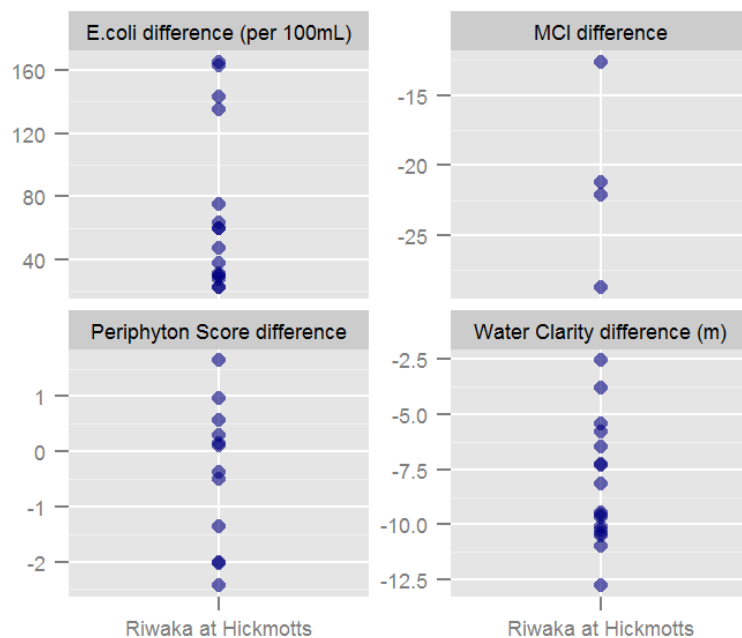
Figure 52. Difference between **Riwaka at Northbranch Source** (upstream) and **Riwaka at Hickmotts** (downstream) for water quality data collected at both sites on the same day. A positive difference means the downstream site had a higher value than the upstream site.

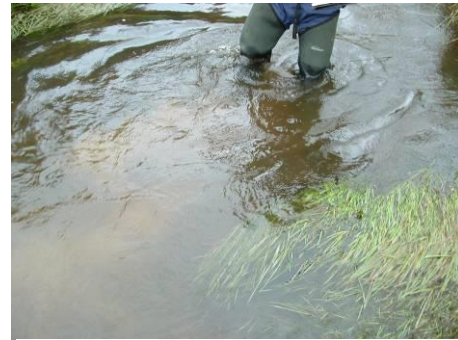
Doing the Suffle test in Waiwhero Ck

There is a lot of **fine sediment** in the bed of Waiwhero Creek (shuffle index regularly 4 and sometimes 5). A proportion of this sediment will be from bank erosion but unfenced riparian areas are also likely to contribute.

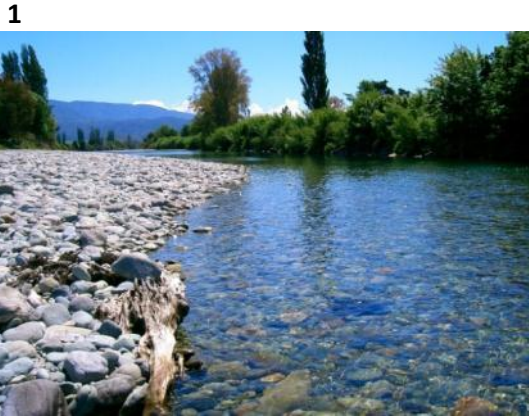
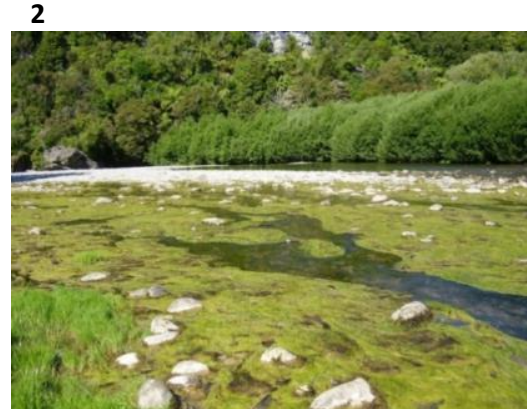
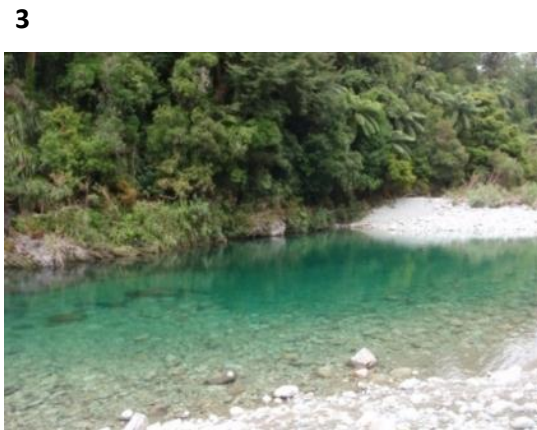
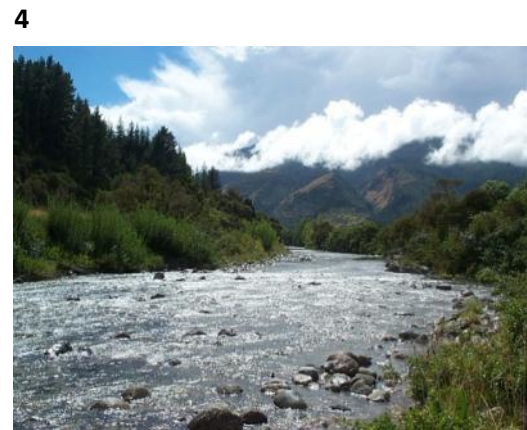
From left to right:

- 1 - Takaka Rv at Kotinga (January 2005).**
- 2 - Takaka Rv upstream Paynes Ford (November 2007). Showing heavy filamentous algae growth.**
- 3 - Waingaro Rv at Hanging Rock (January 2009). Water clarity maximum 30.5 m.**
- 4 - Takaka Rv at Harwoods (February 2005).**

However, **the coverage of filamentous green algae Takaka River upstream of Paynes Ford can be high in summer** (see photo below). This is partly due to the presence of didymo (first discovered in Dec 2007) which protects the filamentous green algae from sheer stress allowing it to grow back faster after floods.

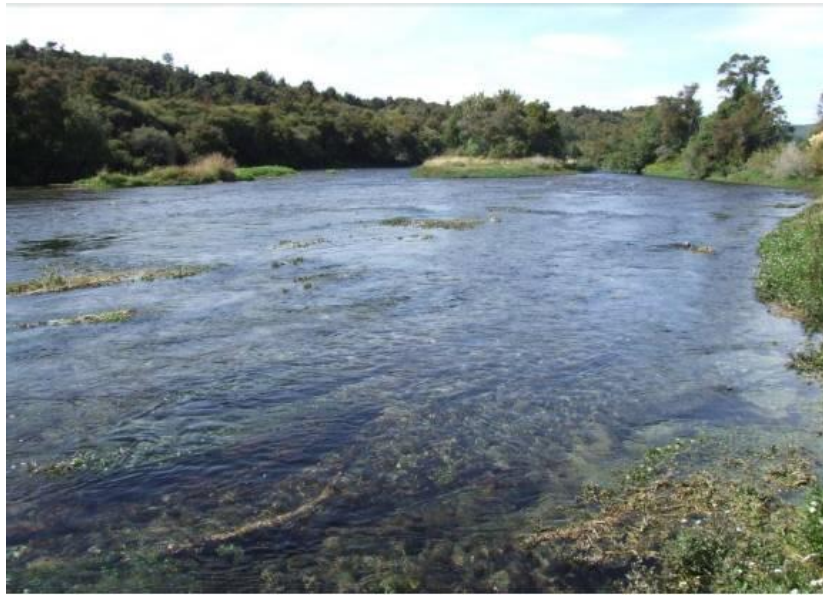
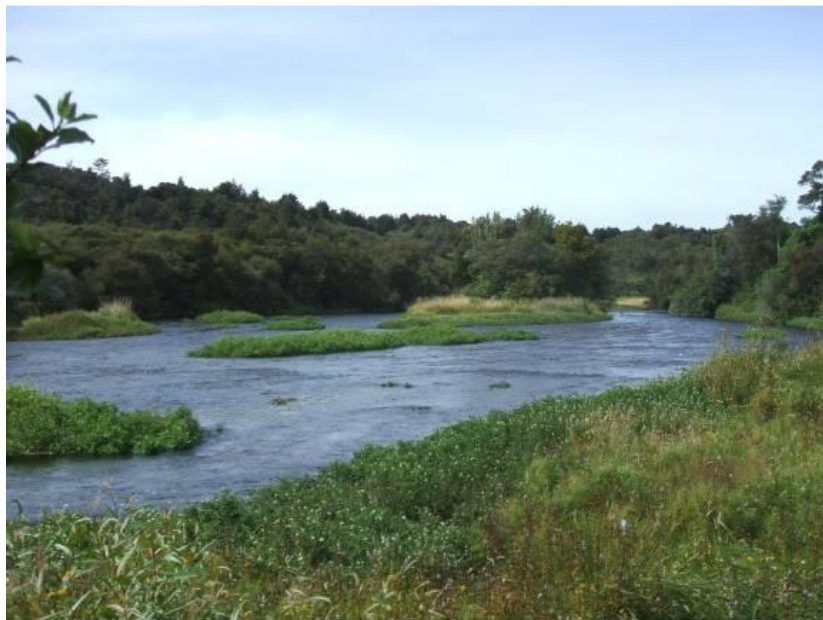
Te Waikoropū River at biomonitoring Site 3a upstream of the NZ King Salmon discharge. Top: January 2009, Bottom: February 2010. Photos: Courtesy John Stark. Note the variability in aquatic plant growth.

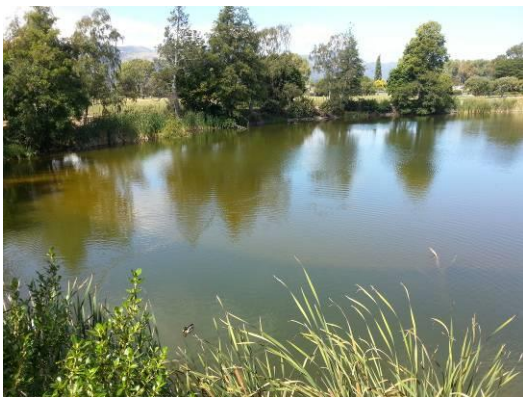
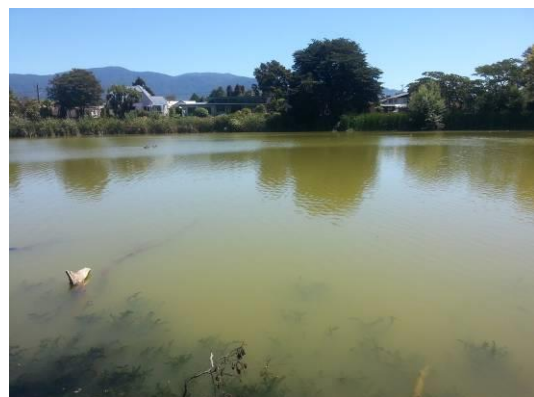
Left: Looking south over Lake Kilarney on 10 March, 2014 showing an algal bloom. Note that the bloom is not so prevalent near the shaded edge of the lake. **Right:** Looking west over Lake Kilarney on 19 February, 2015. Whole lake is highly turbid looking due to an algal bloom.

The brown coloured plume observed on Lake Kilarney on 10/3/2014 was due to the microalgae, *Peridinium*. This is a motile algae and so explains why it was found only in part of the lake (the sunniest part). This is not an uncommon occurrence, but there are no previous records of this microalgae for this lake. *Microcystis* was also found in the sample at lower concentrations. *Microcystis* can be a concern due to its ability to produce toxins and so contact recreation and stock drinking is not recommended if this alga were to build up in the lake. The present concentration of this species was probably not high enough to need to warn the public. There is a need to sample nutrient concentrations in the lake and also any input drains.
