River Water Quality in Tasman District

State of the Environment Report

River Water Quality in Tasman District 2015

A technical report presenting results of the Tasman District Council's 'State of the Environment' River Water Quality Monitoring Programme and additional data from the National River Water Quality Network. Indicators measured include: physical, chemical, and bacteriological characteristics of the water, macroinvertebrate indices and periphyton cover. The report highlights water quality condition and trends, from the Waimea, Motueka, Takaka, Aorere and Buller water management areas.

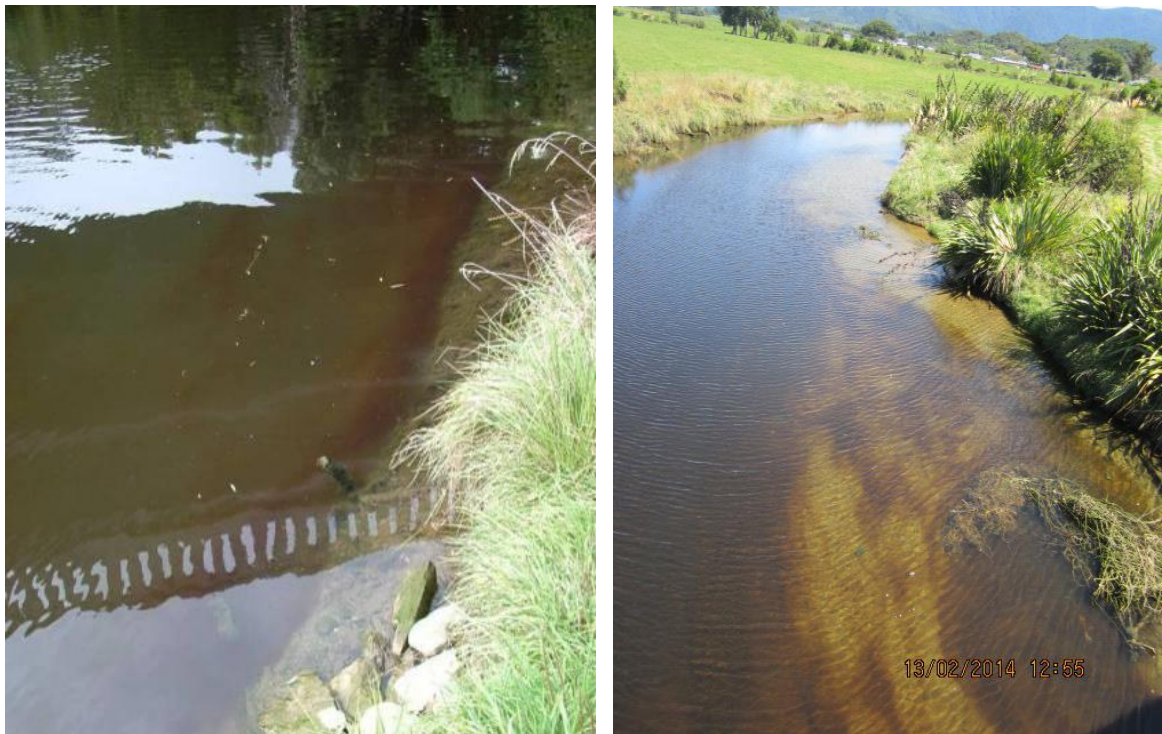
Above: *Cryptomonas* algae bloom in the lower Motupipi. Left: April 2007; Right: February 2014

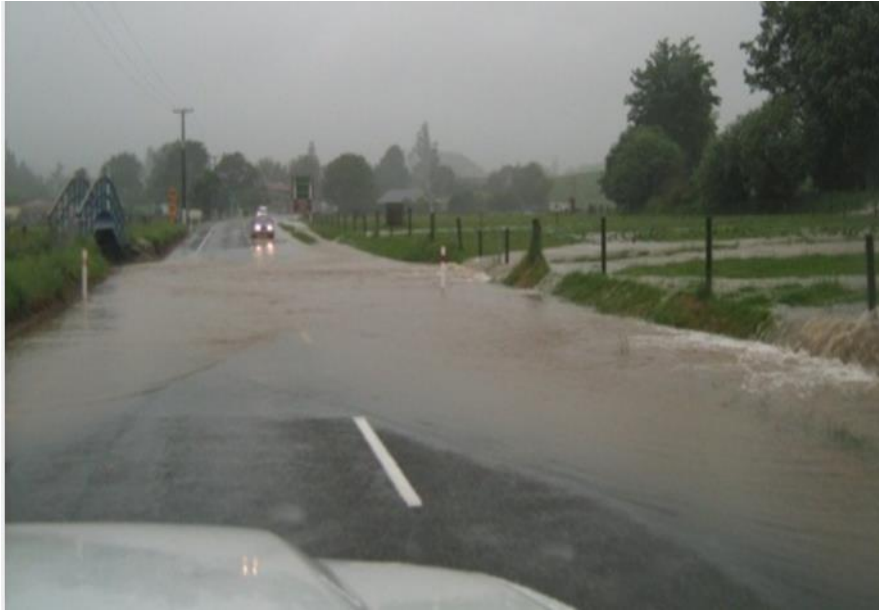
Above: Overflow from the Takaka River to the Motupipi during a flood in November 2008.

Another factor affecting the state of water quality in the Motupipi River is the **lower frequency of overflows of floodwater** from the Takaka River into the Motupipi compared to 10-20 years ago, most probably due to lower bed levels in the Takaka River. Takaka River currently overflows into the Motupipi at about 1400 m³/sec, providing flushing of fine sediment deposits and aquatic plants and algae. Anecdotal evidence suggests that the overflow from the Takaka River in 2008 (24 November) resulted in reduced algal blooms for the two years following (reports from whitebaiters). The **lack of flushing flows, over recent years, leads to greater levels of fine sediment** in the bed and more prolific aquatic plant growth. Controlled release of Takaka floodwaters to the Motupipi River

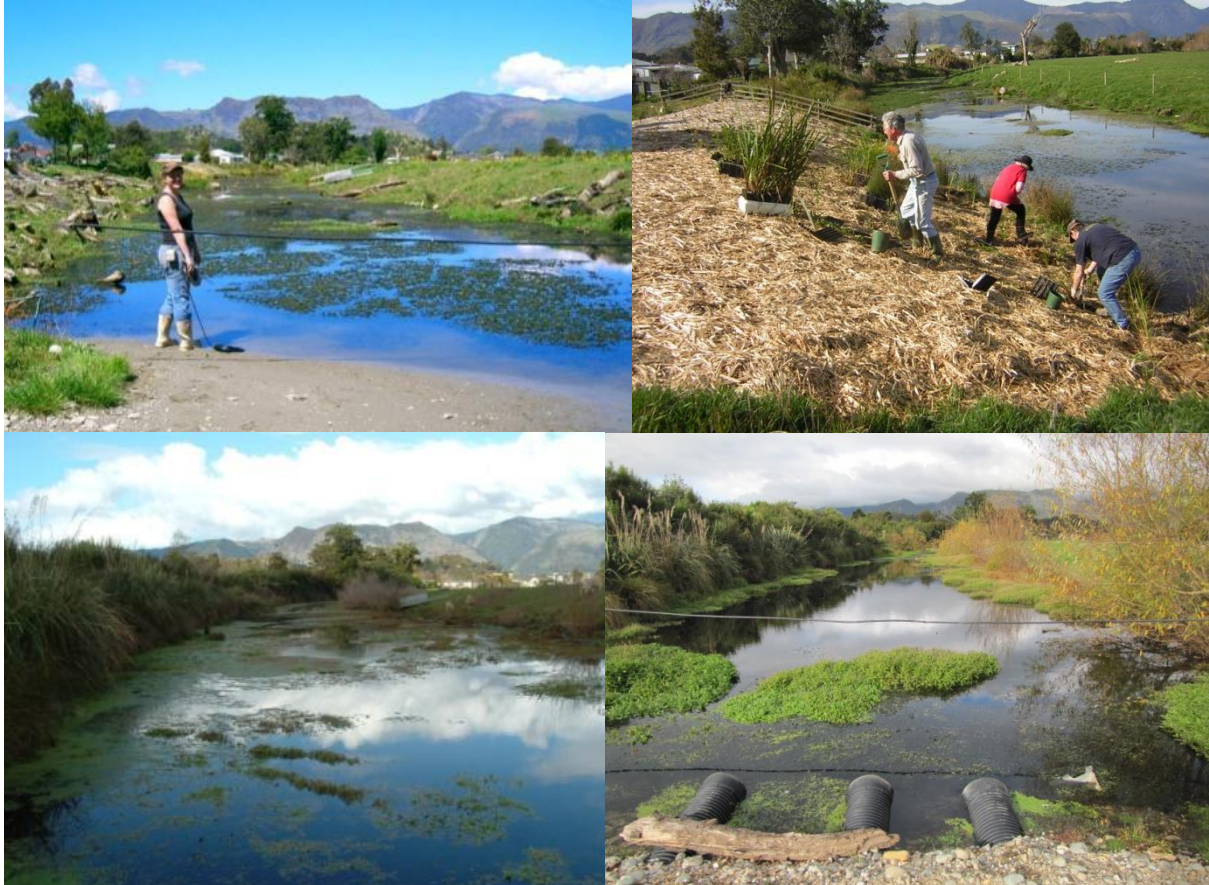
Te Kakau Stm at Haldane Rd looking upstream (Top left: October 2005, Top right: September 2005, Bottom Left: July 2010, bottom right: May 2012).

The local community has participated in the management plan process and on-the-ground work. Trials of different methods of aquatic weed control were trialled in 2007-08. While two layers of weed mat was shown to be very effective, the cheapest effective method is shading by streamside plantings. Council reserve land adjacent to the waterway has been largely planted (see photo from 2010 below) as well as several properties. Council has offered native trees for planting along the stream.

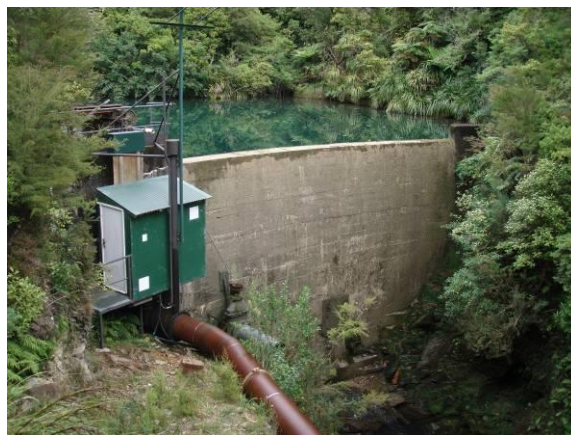
Above: Electric Waters Dam on the Onekaka River (January 2009)

Moderate levels of fine sediments deposited in the bed matrix are found in the lower reaches. Prior to 2005 sediment was dug out and discharged downstream of the dam at low flows resulting in heavy load of fine sediment in the stream bed. This practice is now not permitted under condition of resource consent.

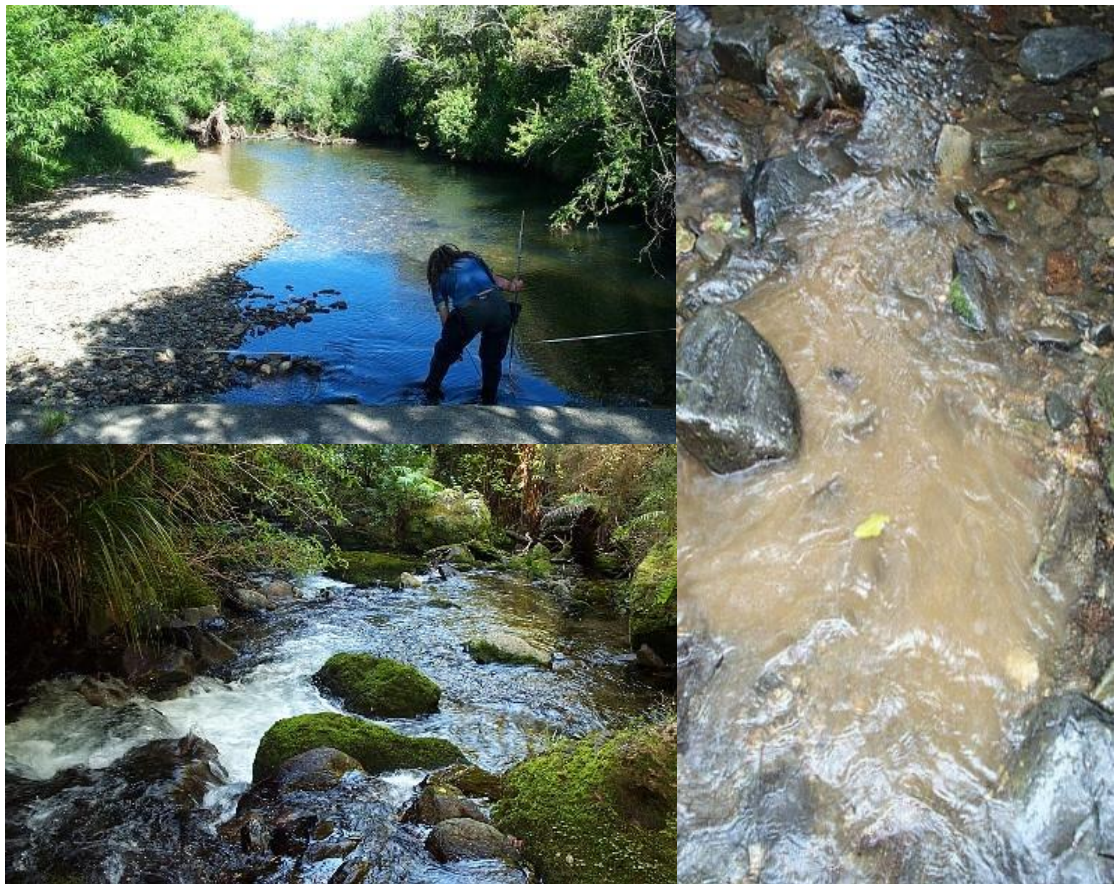
Onekaka River at the lower site at Shambala ford, November, 2004 (top left) and at the upstream site at Ironstone Ck January 2002 (bottom left), typical sediment plume from kicking in the stream bed at Shambala Rd, November, 2004 (right).

On average, **water clarity is halved in the 2km below Ironstone Creek** (median: 10 m to 5 m; u-s Ironstone to Shambala) (Figure 113). The reasons for this are unclear. It may be the geology, inputs from farmland and roads, or tannins from wetlands or particular forest type.

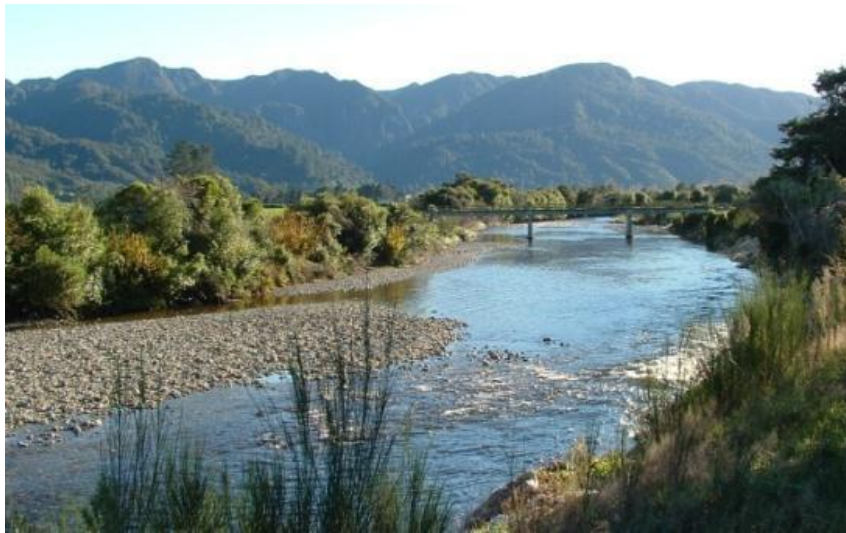
Kaituna Rv at Sollys Rd (June 2010)

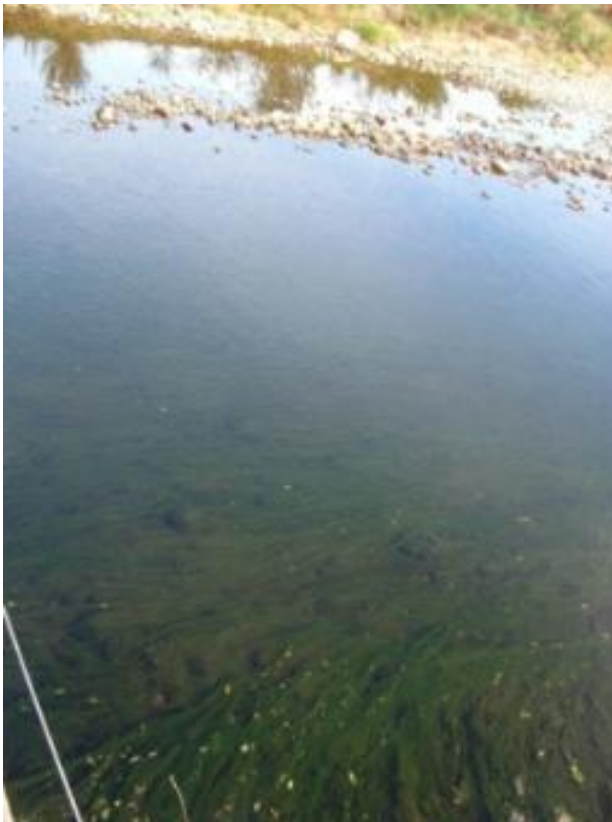
Kaituna Rv at Solllys Rd taken from stock bridge. Left: Filamentous green algae cover at 75% cover (April 2007) Right: View upstream with filamentous green algae cover at 50% (February 2013). Note there are very little filamentous algae on the true left side of the river (right side of the photo).

From 2007 until present the percent cover of **filamentous green algae** on the bed of the river at the Solly Rd site each summer has been well above nuisance levels (75% cover in each of 2007 and 2010). It is obvious that Mackay Creek is the cause of this, as there are very low (<10% cover) levels upstream of this stream confluence. The mixing profile is also very visually apparent from the presence of bright green algae (i.e. the algae spreads across the streambed as the waters of the two streams progressively mix downstream of the confluence), with almost complete mixing downstream of the stock bridge and complete mixing downstream of the next riffle. The original source of the problem was traced to **dairy effluent** treatment pond sludge that was placed near the stream and ran off into MacKay Creek. This issue has been resolved by removing the sludge as it is

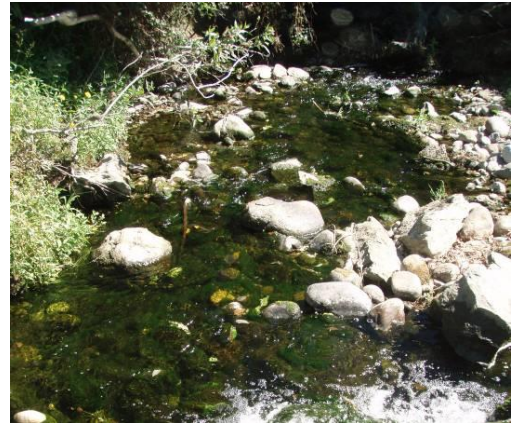
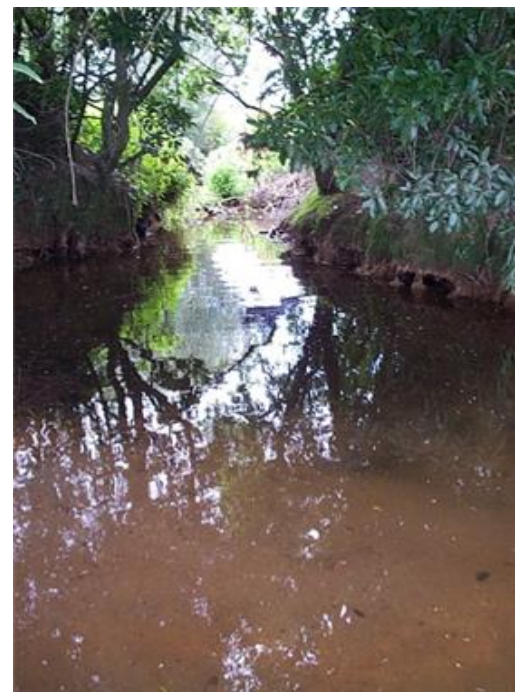
Above: Mackay Creek 30 m upstream Kaituna Rv showing high filamentous green algae coverage (January 2009). Below: 50 m upstream Kaituna Rv (February 2007).

Filamentous green algae at the site 30 m upstream of the Kaituna River is high at times (40 and 50% cover have been recorded; see photo at top of previous page) but due to shading by tree cover at this site is on average is likely to be lower than other sites.

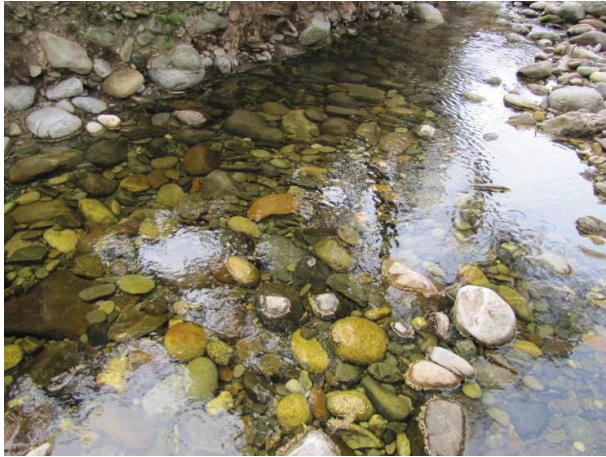
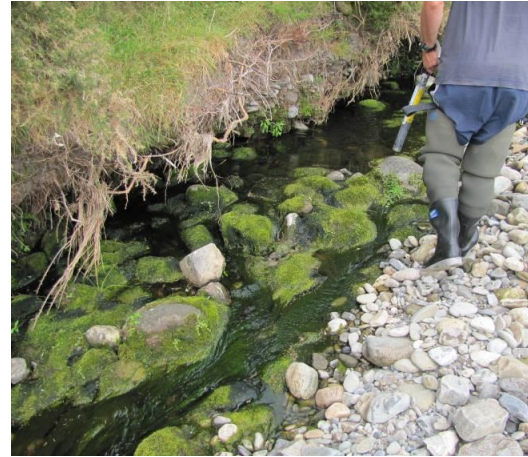
Filamentous green algae cover is high at times during summer (median summer: 25% cover, 5 of 15 samples over 30% cover and 2 of 15 samples over 90% cover at Collingwood-Bainham Rd). There was often a marked difference between filamentous green algae cover in tributaries dominated by dairy (e.g. Southern tributary) versus those dominated by sheep farming (Northern tributary) (see photos below).

Above left: Northern tributary Burton Ale Ck (9 February 2012). Above right: Southern tributary Burton Ale Ck (9 February 2012)

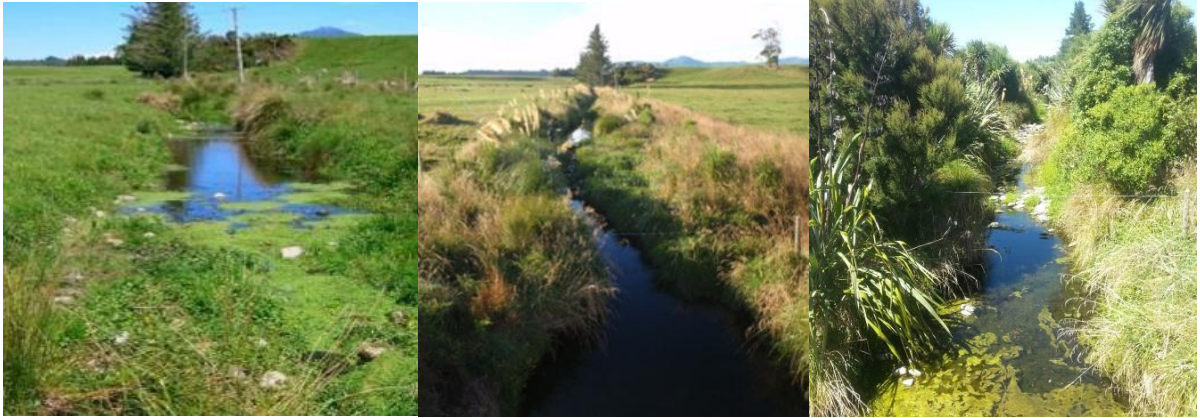
Riparian planting began in 2007 and by 2015 the shading and habitat in the stream was greatly improved and is a credit to those involved in restoring in stream habitat and overland flow interception (see photo sequence below).

James Cutting Ck viewing upstream of Collingwood-Bainham Rd (from left October 2005, January 2009, and February 2015 right).

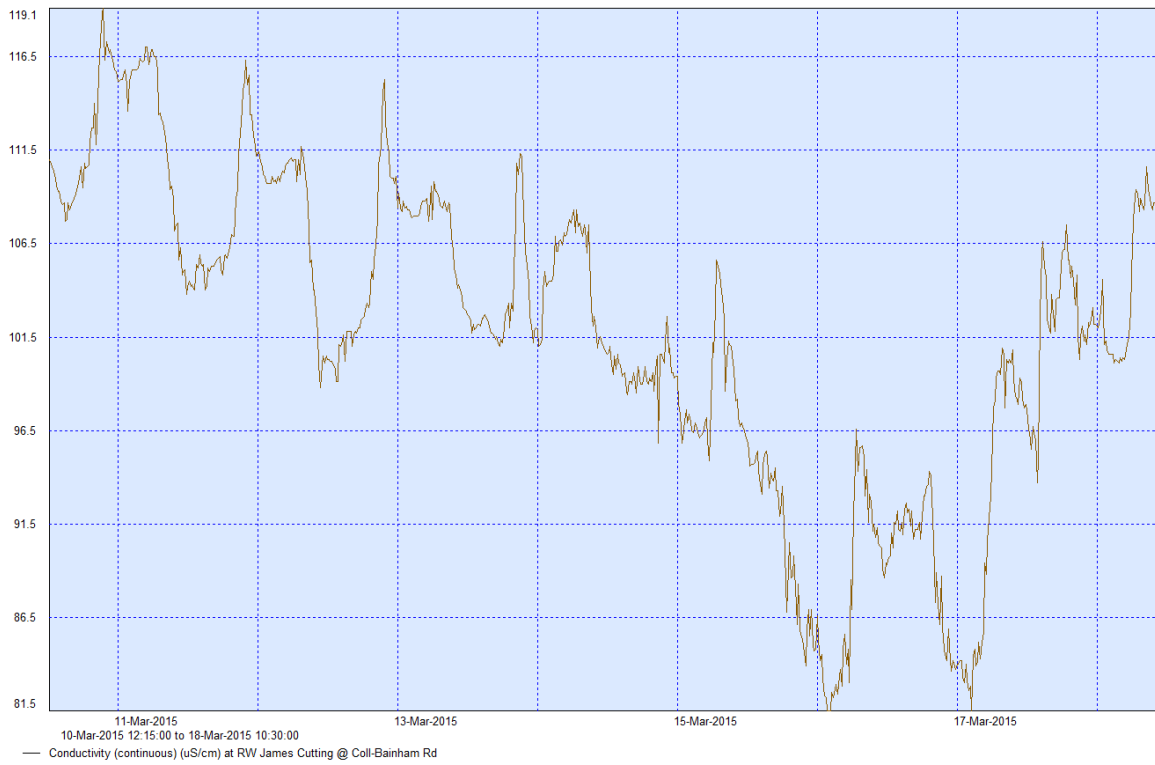
Figure 140. Conductivity at James Cutting Creek at Collingwood-Bainham Rd measured continuously from 10-18 March, 2015.

Conductivity peaked regularly late in the evening and again in the morning (Figure 140).

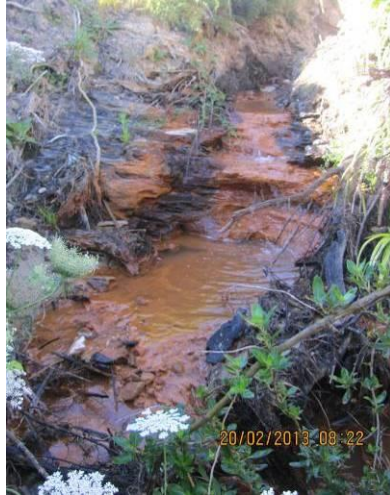
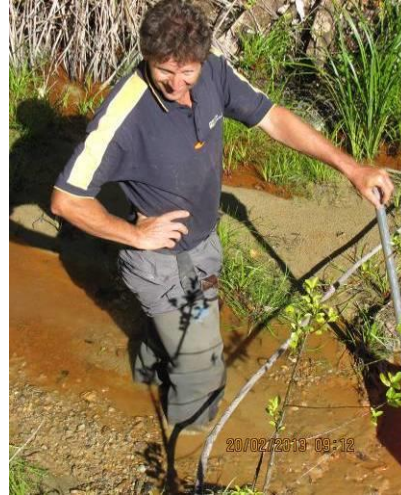
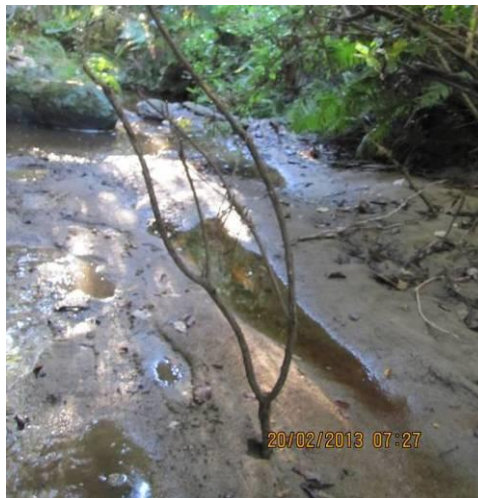
Above left: Yellow Pine Creek tributary ('Culvert 15 Ck') showing the effect of mine drainage. Above right: 'Culvert 15 Ck' showing a sediment depth of about 300 mm. Middle: Yellow Pine Ck downstream of Culvert 15 Ck sediment depths 100-200 mm.

A heavy discharge of fine sediment (estimated at least 50 m³) to Yellow-Pine Creek occurred in 2012 as a result of logging and tracking operations causing slips and erosion into 'Culvert 15 Creek' (James, Sept 2013). Sampling the effects of this discharge took place in February 2013. Fine sediment volumes in Yellow Pine Creek were much higher downstream of Culvert 15 Creek (7.5 m³/100 m reach), compared to upstream (0.2 m³/100 m reach). This activity resulted in a prosecution for the company involved.

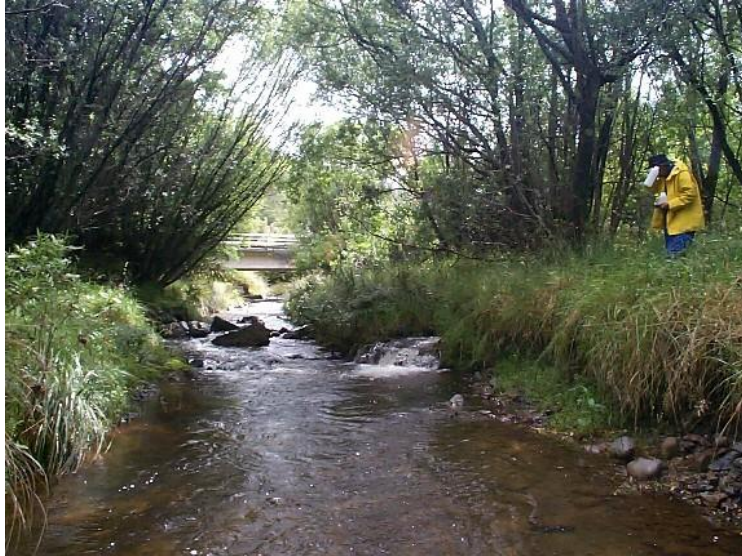
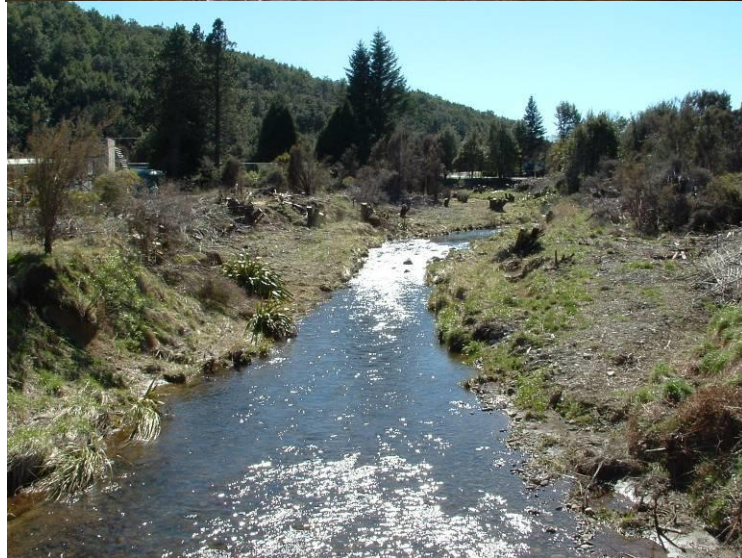
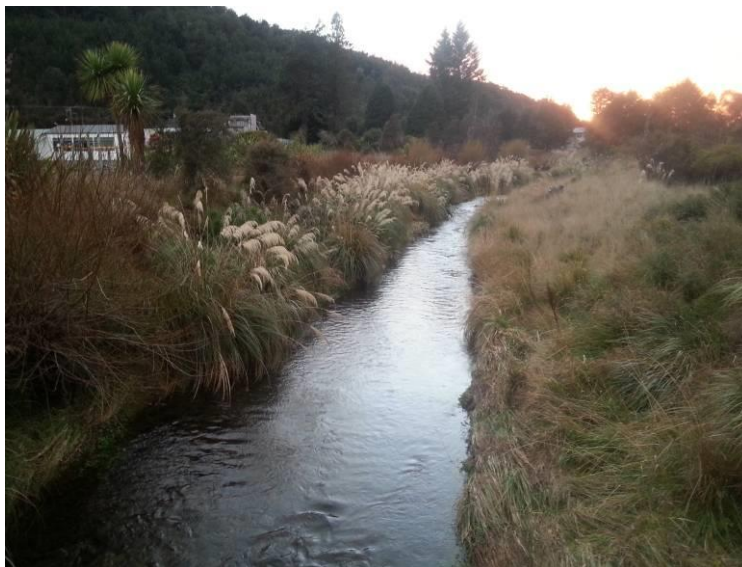
**Willow clearance and riparian plant replacement with natives on Black Valley Stream downstream SH63.
From top: November 2002, October 2012, May 2015.**

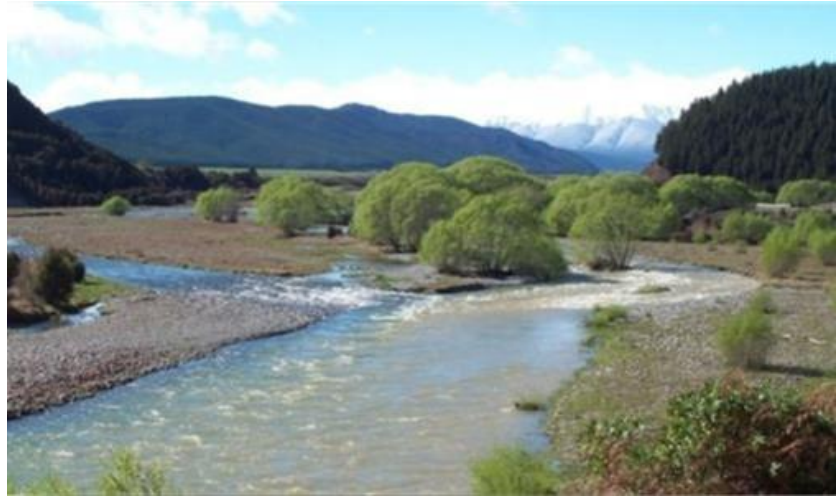
Buller River near Harleys Rock, downstream Howard River (September 2007). Clear water from the Buller River can be seen on the left of the photo (true right), and turbid water from the Howard River is coming in on the right of the photo (true left).

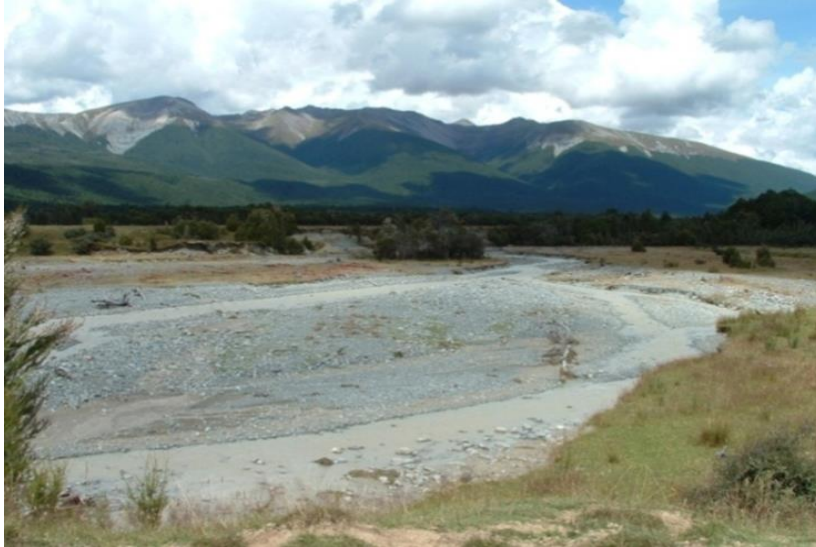
Howard River at Howard Head Station (February 2008), looking south to the Angelus Range where the source of the sediment is located.

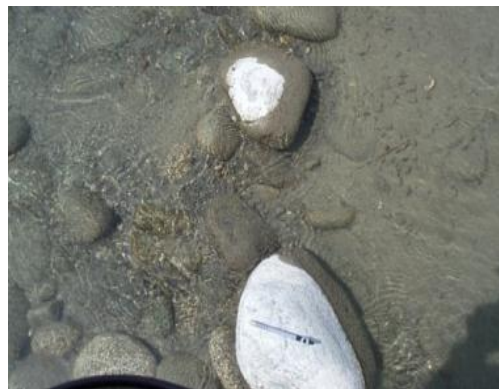
Fine sediment deposits, common at this site.

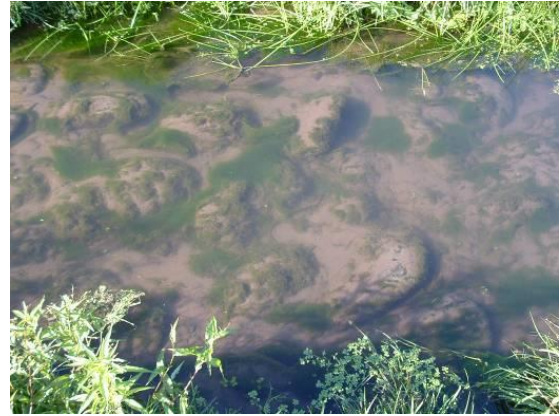
Above: Murchison (Ned's) Creek showing the thick fine sediment deposits and filamentous green algae (April 2012)

Fine sediment volume has averaged 60L/m³ of the bed volume, which is considerable. The main sources of fine sediment are from discharges from transport operations (a truck wash facility discharging into the creek ceased in 2008), slips in the hill country to the south east of the township in 2011-12 (this loading of sediment reduced to almost nil by mid 2014, even at high flows) and farming activities (particularly stock trampling the banks). Its spring-fed nature, with relatively stable flows, also means that sediment in the creek is not readily flushed.

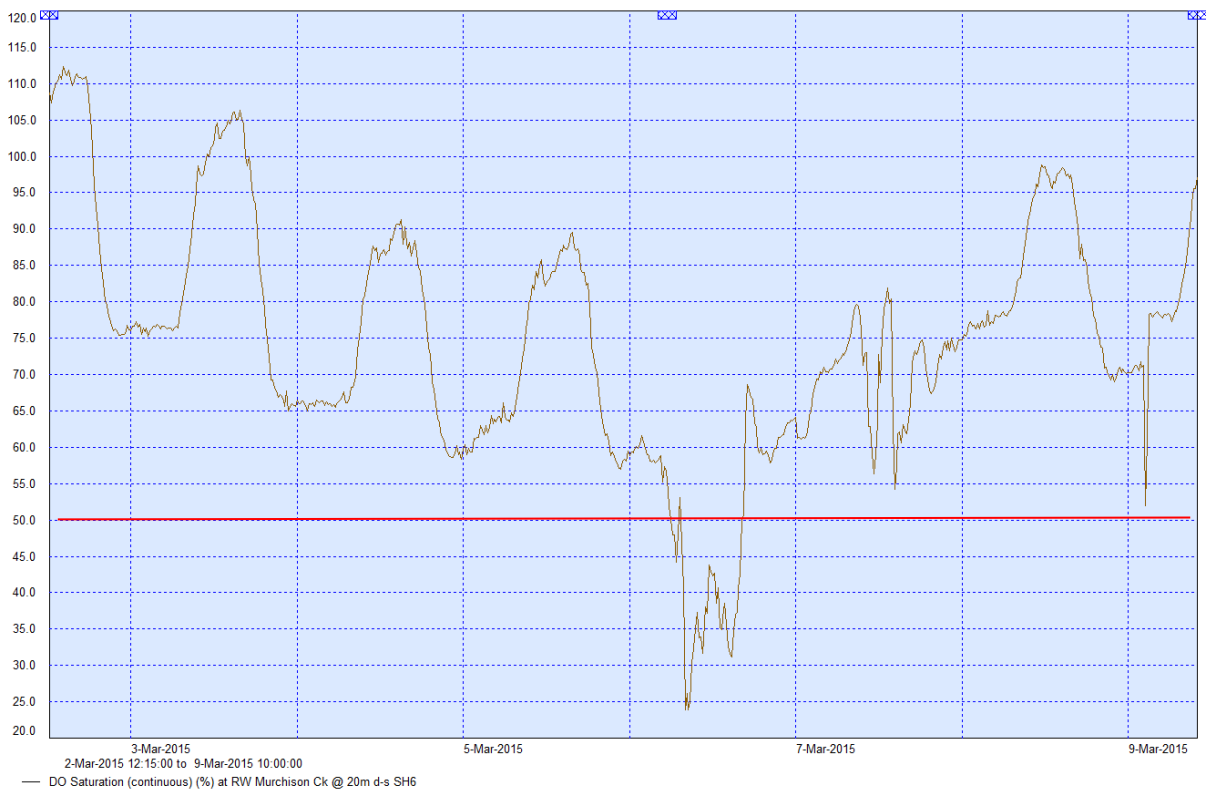
Figure 154. Dissolved oxygen % saturation at Murchison Creek 20 m downstream of SH6 from 2-9 March 2015. The national proposed bottom line for the daily 1-day minimum is shown by the red line.

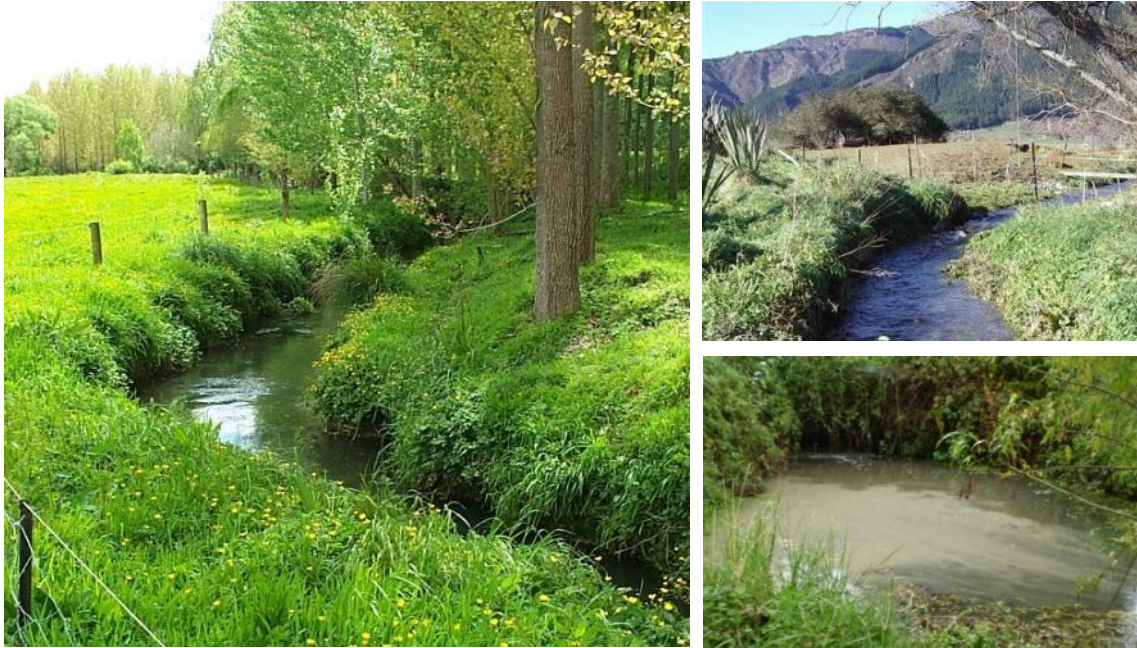
Left and bottom-right: Murchison Ck at SH6 (October 2008 and April 2007 (sediment discharge event)). Top right: Murchison Ck upstream Fairfax St (July 2007).

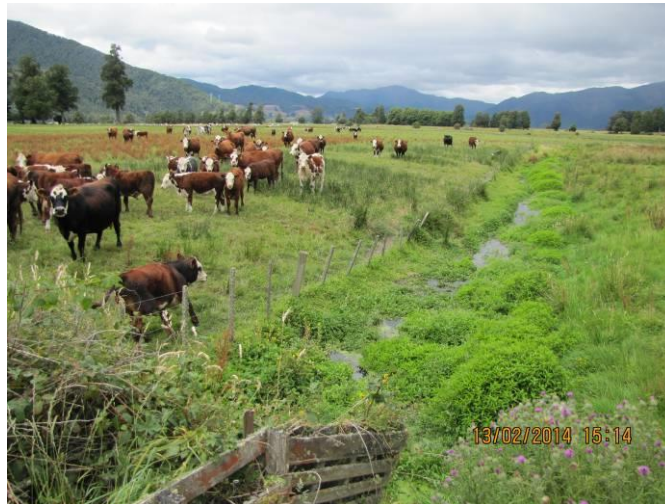
View upstream of Hinehaka Road (February 2014), note the lack of adequate riparian fencing.

While this stream has only been sampled since late 2013, most *E.coli* concentrations are within stock drinking water (median: 355 *E.coli*/100 ml, maxima: 1600 *E.coli*/100 ml). It is very difficult to measure water clarity in this waterway due to the growth of aquatic plants across the whole channel for much of the year and fine sediment depths of about 500 mm.

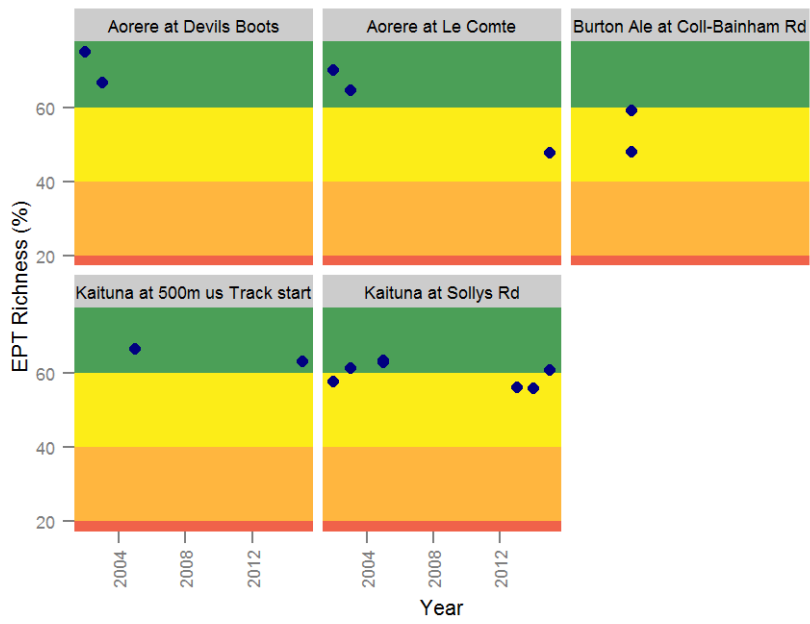
Number of macroinvertebrate taxa (top) and EPT richness (bottom) for sites in the Aorere Water Management Area. EPT richness is the percentage of mayflies, stoneflies and caddisflies compared to total macroinvertebrate taxa.
