The Health of Freshwater Fish Communities in Tasman District 2018

This report presents results of targeted investigations and monitoring into the freshwater fish communities of rivers and streams in Tasman District from 2011 to 2018. The purpose of the surveys varied: (1) exploratory surveys to determine species diversity, including targeting rare species; (2) surveys to determine the impact of particular stream habitat modifications or man-made in-stream structures (control-impact comparisons); (3) monitoring at set sites to track changes in the fish community over time; and (4) fish salvage associated with stream works such as gravel removal or waterway diversion operations. Although the fish surveys stand alone, together they provide insights into fish community health across the Tasman region.

Prepared by:
Jonathan McCallum¹ and Trevor James¹

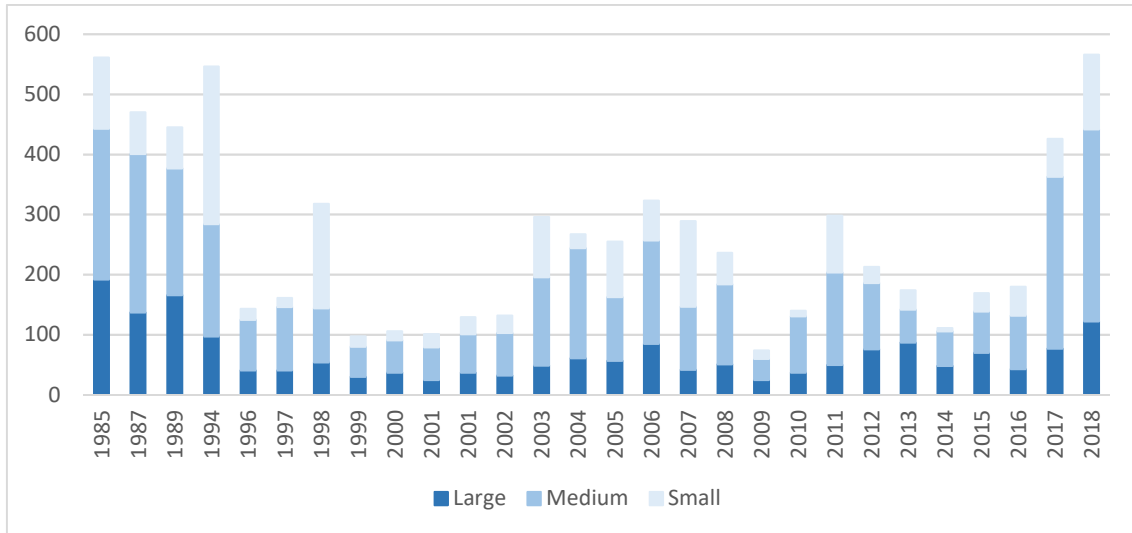
Figure 4. Number of brown trout seen by drift diving in the Motueka River at Woodstock 1985 to 2018 (courtesy of Nelson Marlborough Fish and Game Council)

Floods during the months of trout spawning (May to September) can reduce the spawning success for that year. In the Motueka River, there were few floods in 2015 or 2016. This period of relatively stable flows has led to a jump in trout numbers recorded in 2017 and 2018 (Figure 4). The most noticeable change is in the number of medium sized trout (2-3 year olds).

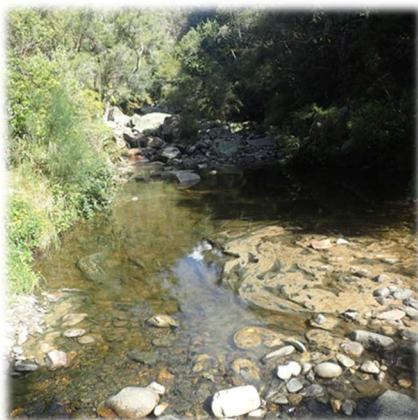
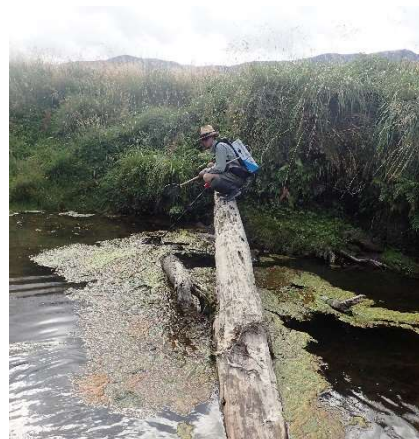
A 180m length of Basin Creek from the confluence with the Aorere River to Quartz Range Road was electric fished on 29 Feb 2015. The stream was 17 m wide at the confluence and narrowed to 4 m near the Quartz Range Road bridge. The habitat was mostly long, flat runs with sand/gravel/cobbles in the lower part and faster water and pools with more cobbles and larger boulders in the upper part. Overhanging tall grasses and *Carex* spp lined both banks. There was algae growth on the bed and some surface plants.

No lamprey were sighted during the survey. However, it was encouraging to see a very large female longfin eel at an estimated 1300mm long and a healthy population of redfin bullies. There were also several large shrimp (40 – 50mm), which is surprising being so far from the sea, and two kōura (40 – 70mm). Given the generally large size of the resident eels, predation of the smaller fish is likely to be high.

Left: View of Basin Creek upstream road crossing showing algae. Right: Lower section, habitat of a large female longfin eel.

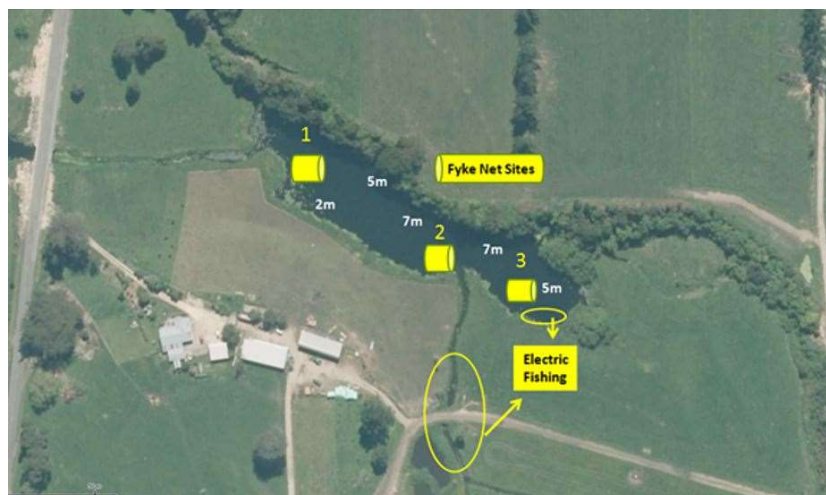
Fyke net sites and electric fishing locations in Dalls Ck and Dalls Lake, Feb 2015. The measurements in white are water depths.

In February 2015, two fish survey methods were used to search for giant kōkopu. Fyke nets were set in Dalls Lake at three locations (shown below) and left overnight. Two locations were electric fished, a 30m length of stream above the lake and a 10 metre section of the south-east lakeshore.

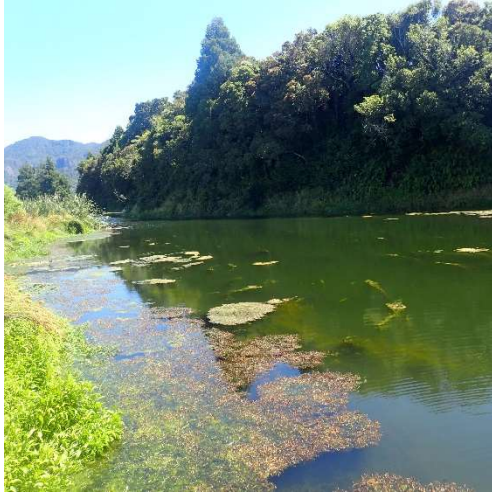
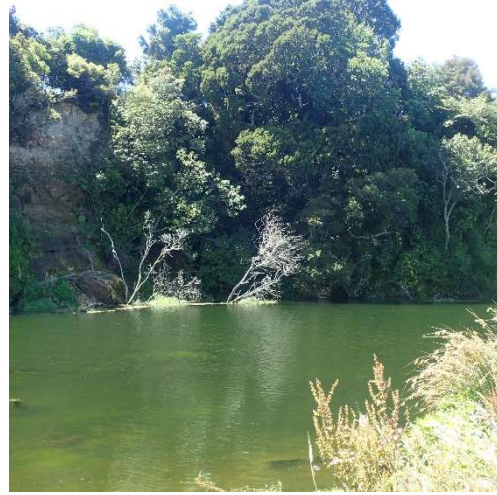
On the south-eastern edge of the lake, the water was green with algae and had poor clarity. This section of the lake also had large areas of submerged algae and surface clumps of emergent aquatic vegetation.

Left: Dalls Lake view North West to outlet. Right: View to north shoreline

Apart from along the shoreline, the lake is too deep to set fyke nets. Any future fish survey would benefit from using the spotlighting method from a boat or kayak to search for giant kōkopu in Dalls Lake. Spotlighting would be of limited use in Dalls Creek due to the surface vegetation.

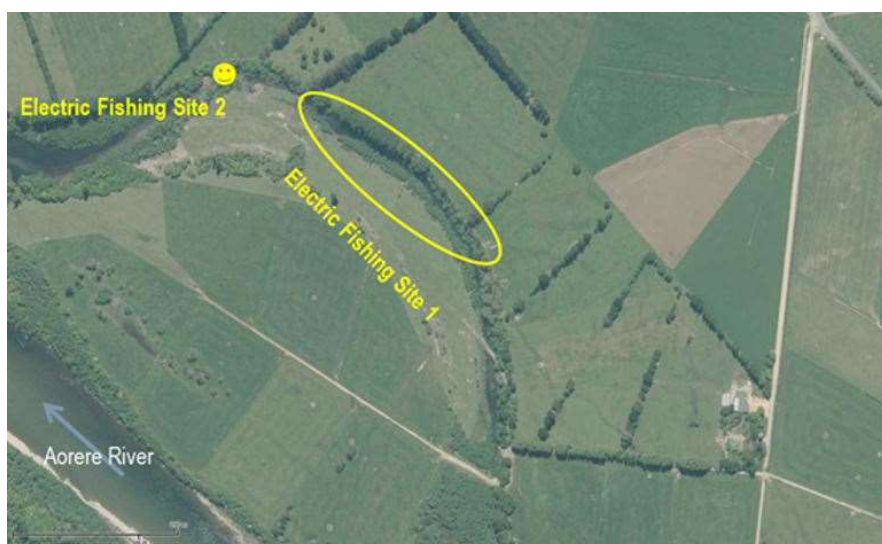
Aorere Oxbow at 42 Pah Road North, Feb 2015

The Aorere Oxbow is an old channel of the Aorere River downstream of Pah Road North. Along its length (1.8km), the oxbow contains numerous pools, overhanging branches and large amounts of woody debris. It was thought that giant kōkopu may be found in the oxbow because of these habitat features.

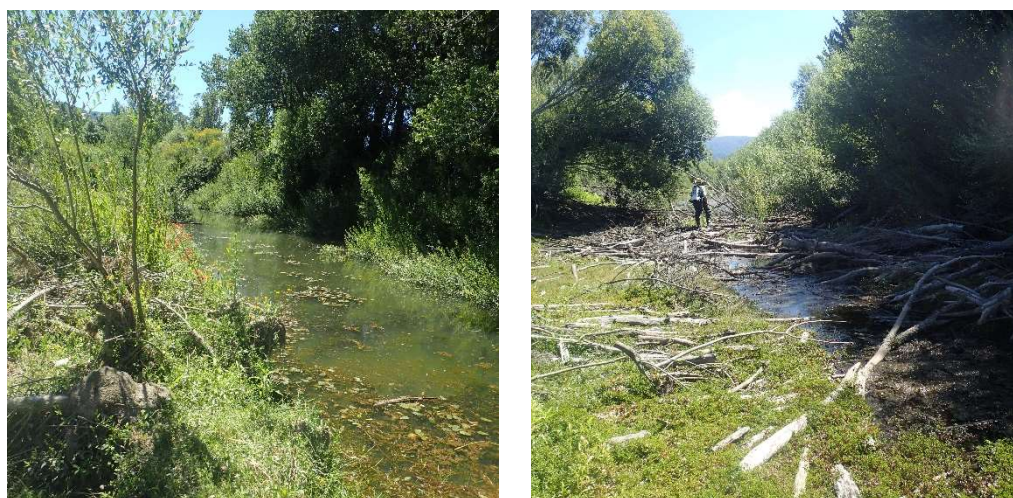
At site 1, there was a strong sulphur odour emitted when walking in the water due to rotting organic matter. There was a large amount of weed growth and the water was green with algae. The true left bank was lined with small willow trees and the true right bank was elevated with a mature tree canopy. Shortfin eels and inanga were abundant here.

Site 2 had poor water clarity (less than 1m) and a large amount of wood and branches piled on the bed with some pools in between. The occasional shortfin eel was observed, but no other fish.

Left: Aorere Oxbow electric fishing site 1. Right: Site 2

The fish species observed (shortfin eels and inanga) are the most tolerant of the poor water clarity and large amount of weed growth present. The log cover and overhanging tree branches would provide shelter for giant kōkopu, but the poor water quality is likely to be a limiting factor.

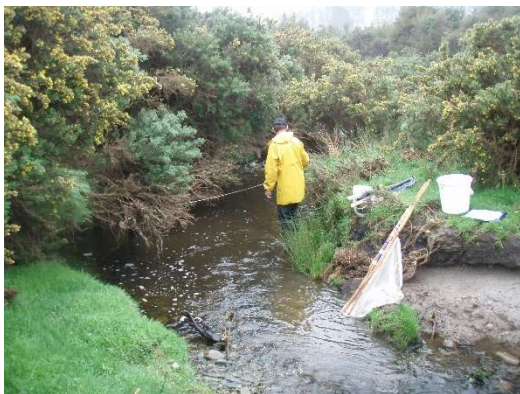
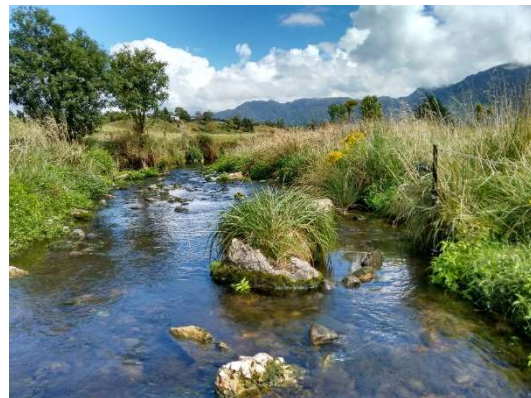
The total area of this catchment is 802 ha with 247 ha in sheep and beef, 450 ha in dairy farming and about 65 ha in scrub and forest. The flow in this creek can be as little as 5 L/sec in the driest summers. Dense gorse cover was present over the stream at Burton Ale Creek at 200m upstream of Win Creek.

Left: Burton Ale Creek 200m upstream of Win Creek. Right: At Collingwood-Bainham Rd

Riparian planting was carried out in the lower reaches of this waterway (upstream and downstream of Collingwood-Bainham Rd) starting from 2005.

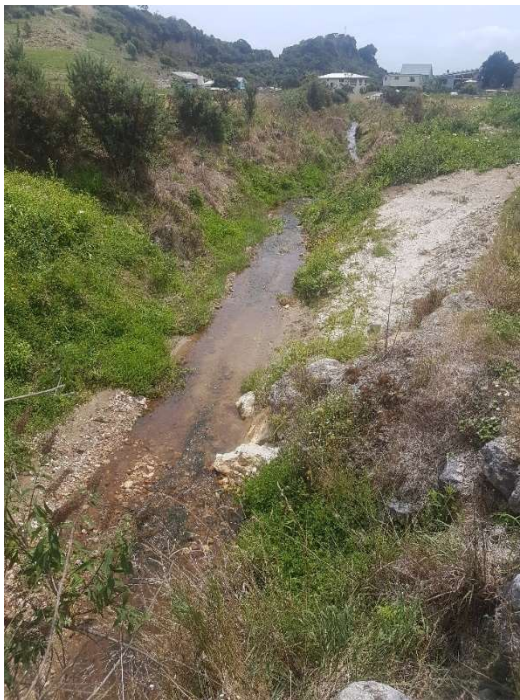
Left: Matenga Creek downstream of Matenga Rd view downstream. Right: Steep country above Ligar Bay about a year after forest harvest.

The culvert at 57 Matenga Road is scheduled for fish passage remediation. Ligar Bay Developments Ltd applied for subdivision consent and will go to a hearing in late 2018. Setbacks of 5m from the top of the bank have been provided for along with riparian tree planting.

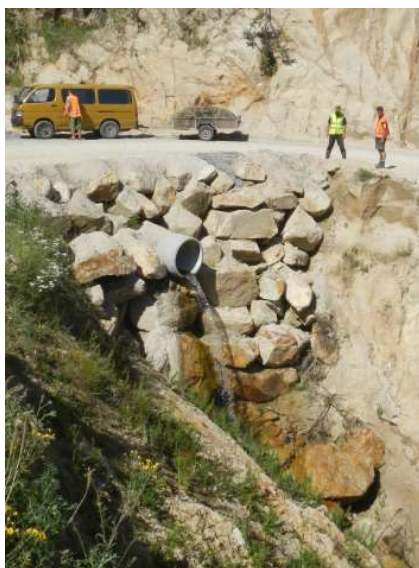
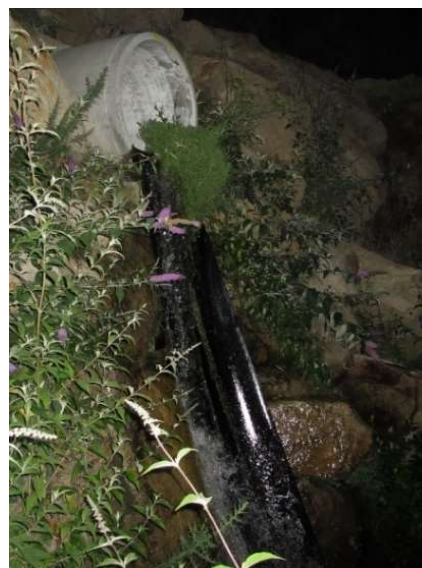
Left: Totaranui Rd Culvert 18 before a rubber apron and mussel spat rope were attached to encourage fish passage (Dec 2012). Right: With rubber apron attached to the culvert outlet (Jan 2014).

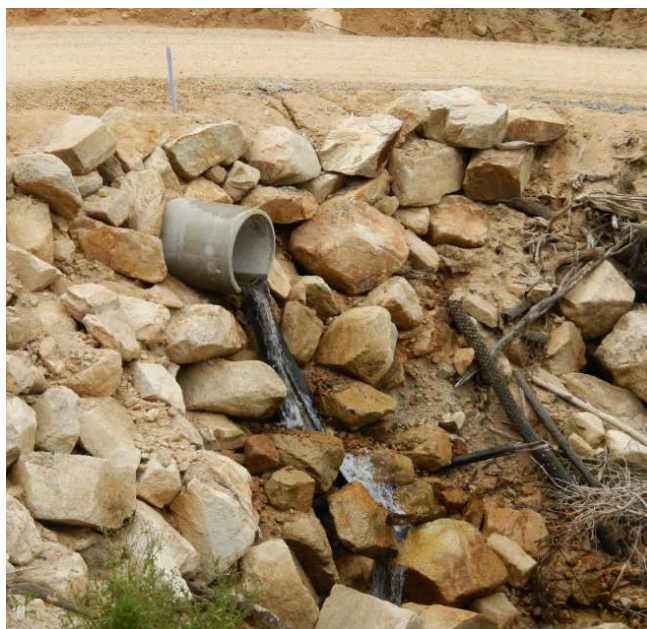
Totaranui Rd Culvert 31 with rubber apron and mussel spat rope attached to the outlet to encourage fish passage (Dec 2012).

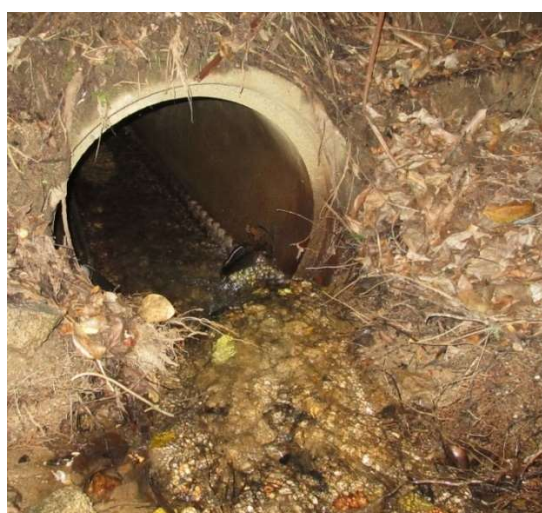
Inlet of Awaroa Rd Culvert 9, Jan 2014. Mussel spat ropes on the inside of the pipe slow down the water to allow better fish passage.

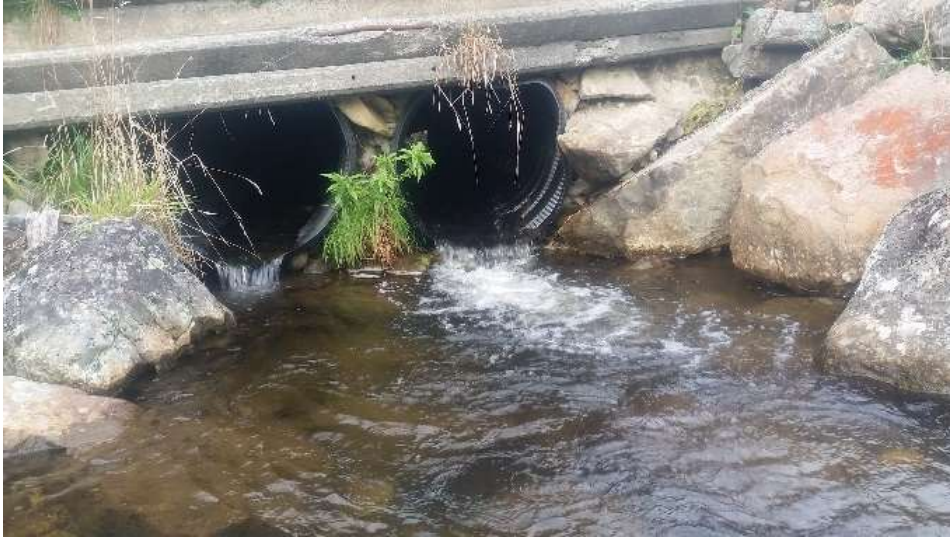
Roundell Creek at Tophouse, showing perched culvert outlet (creating a short waterfall and potential barrier to fish passage).

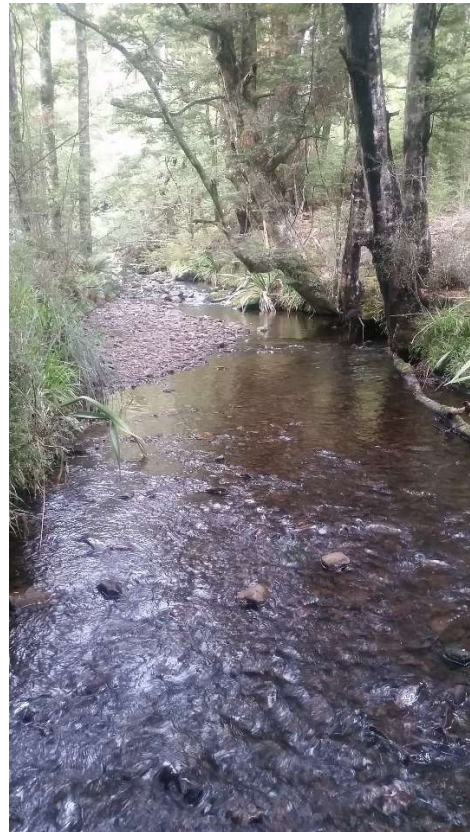
Left: Roundell Creek downstream of culvert. Right: Upstream of culvert, showing the riparian margin of beech forest.

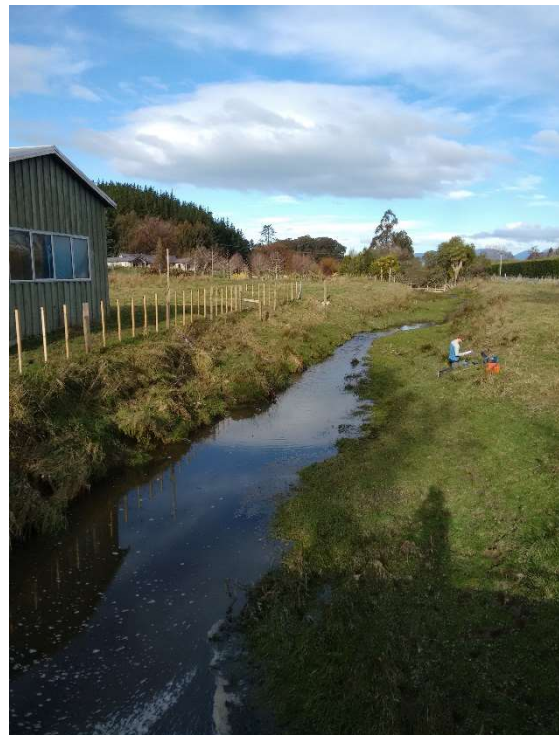
Tasman Valley Stream upstream of Jester House, July 2017

Parts of the stream are in a degraded state. On Tasman Valley Stream, immediately upstream of the Jester House café, there is a long-term river water quality monitoring site. At this location, the water quality is poor, with high water temperatures over summer, low dissolved oxygen concentrations, high concentrations of disease-causing organisms and moderately high nutrient concentrations.

In January 2014, a spotlighting survey of Tasman Valley Stream at Jester House and at Potter's Bush Creek was completed. Tasman Valley Stream upstream of Jester House, the stream had a silty bed and was slow-flowing. There was slight bank damage by cattle, but in 2017 this stream was fully fenced. The stream contained abundant smelt (40 to 60mm), occasional kōaro (120 to 180mm), occasional long-fin eels (200 to 400mm) and banded kōkopu, but not shortfin eel or bullies. Fish surveys less than 700m upstream at the Aporo Rd bridge, in 2006 and 2008, recorded common bully, longfin eel, shortfin eel, inanga and banded kōkopu. Over a dozen large longfin eel reside at Jester House as part of a tourist attraction.

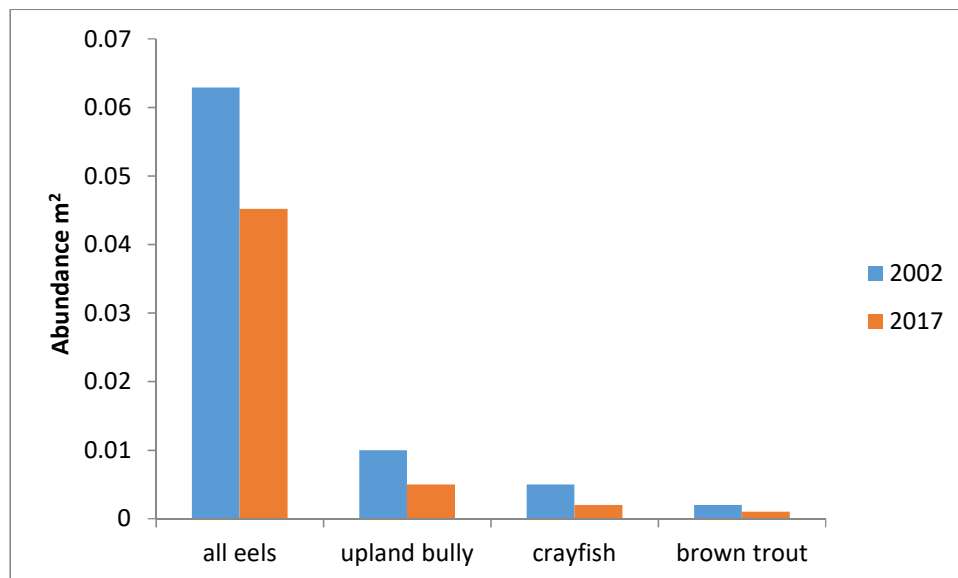
Figure 22. The results of fish surveys in 2002 and 2017 within Quail Valley Stream at a lower Valley site near Quail Valley Rd Bridge. Note that that abundance values have been adjusted to reflect the area fished during each survey.

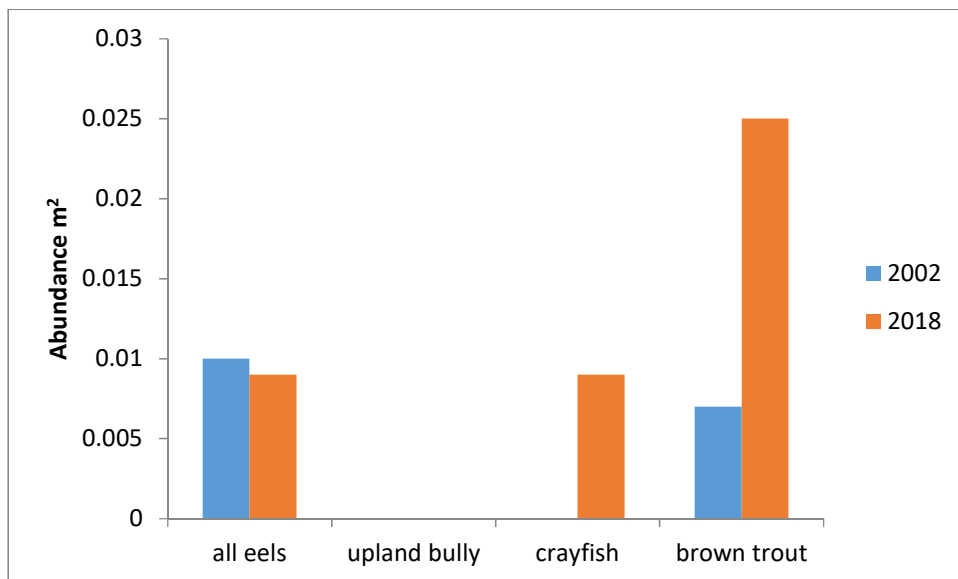
Figure 23. The results of fish surveys in 2002 and 2017 within Quail Valley Stream at an Upper Valley site near the boundary of the pasture with the forested hill side. Note that that abundance values have been adjusted to reflect the area fished during each survey.

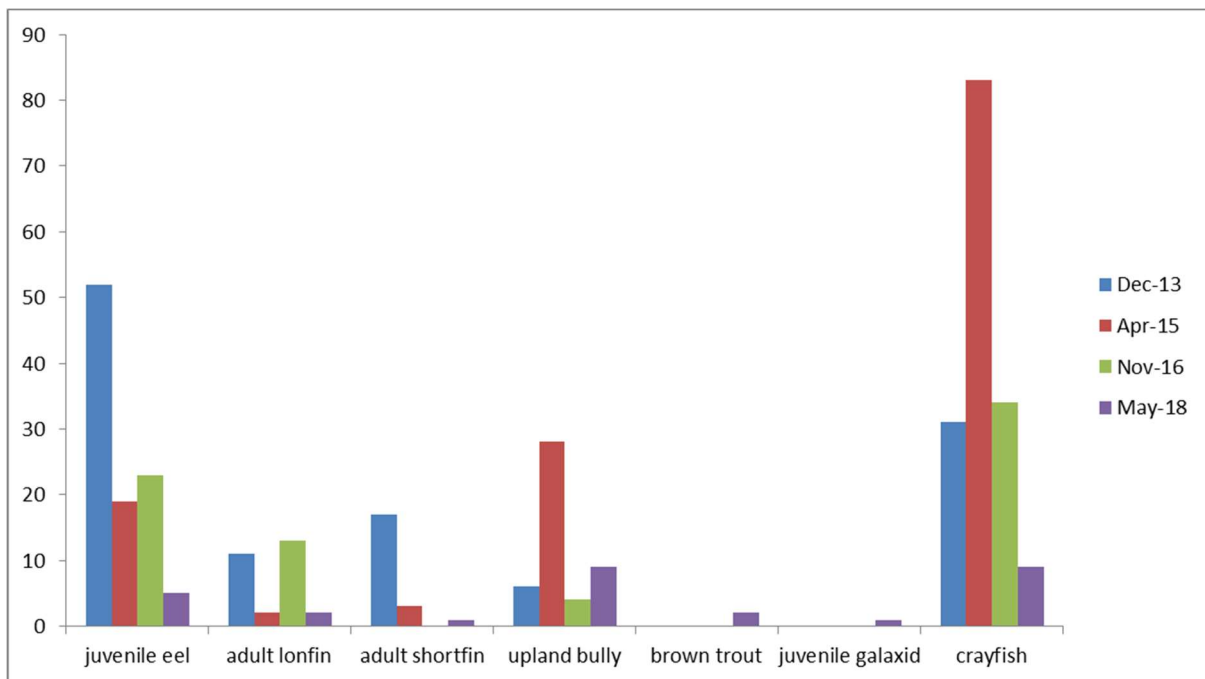
Figure 24. The results of fish surveys with the golf course reach of Kainui Stream, downstream of Wai-iti Valley Road, from 2013 to 2018.

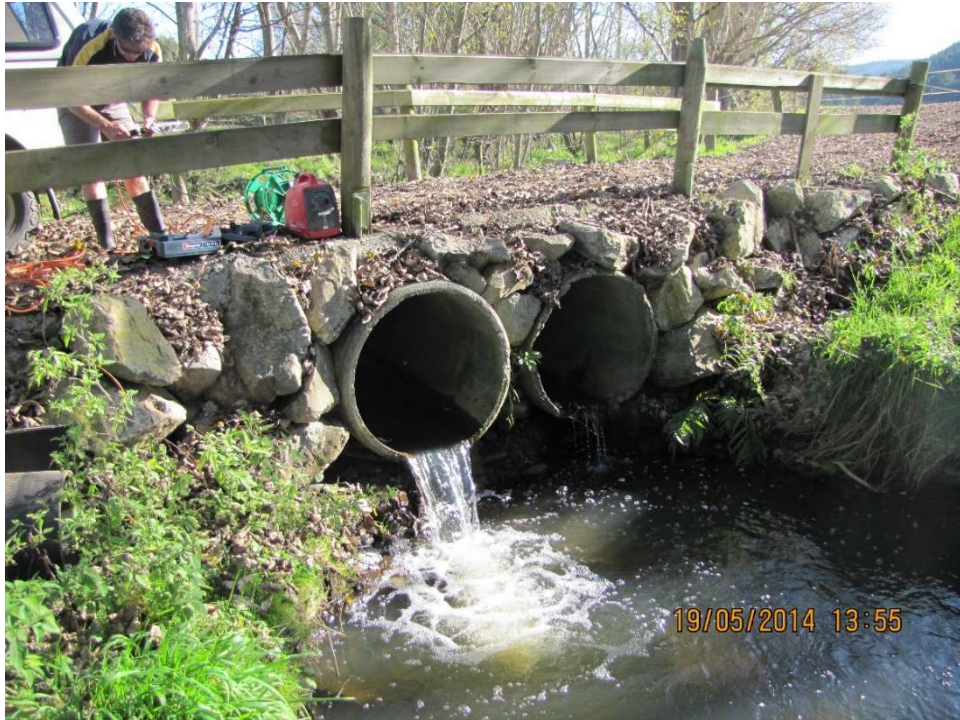
Teapot Valley Stream 1.1 km upstream confluence of Wai-iti River prior to fish passage remediation May 2014

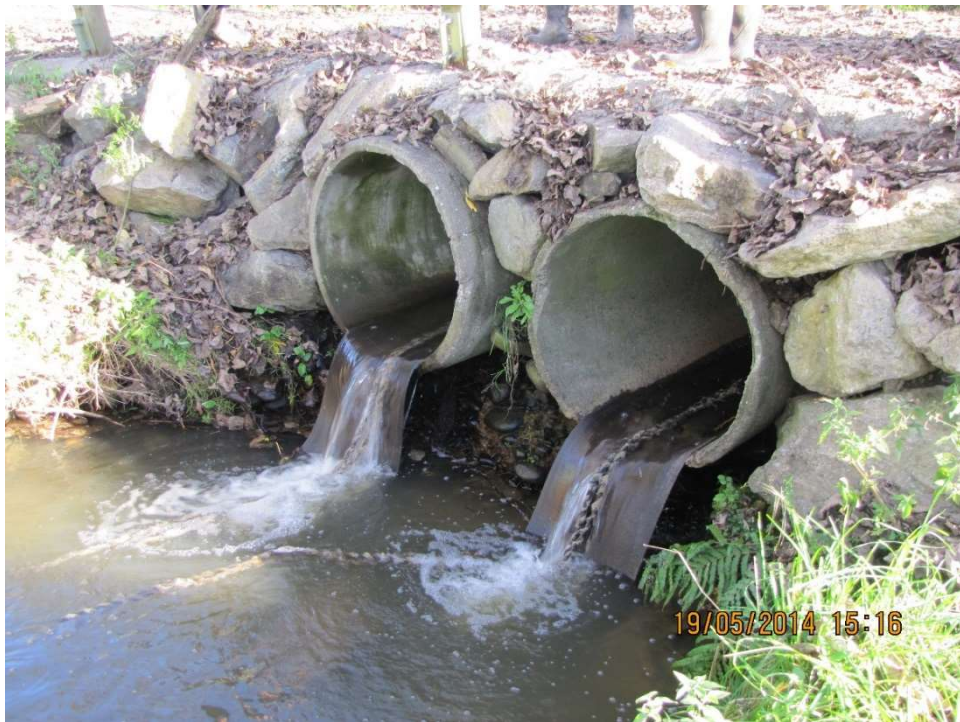
Teapot Valley Stream 1.1 km upstream confluence of Wai-iti River following fish passage remediation May 2014

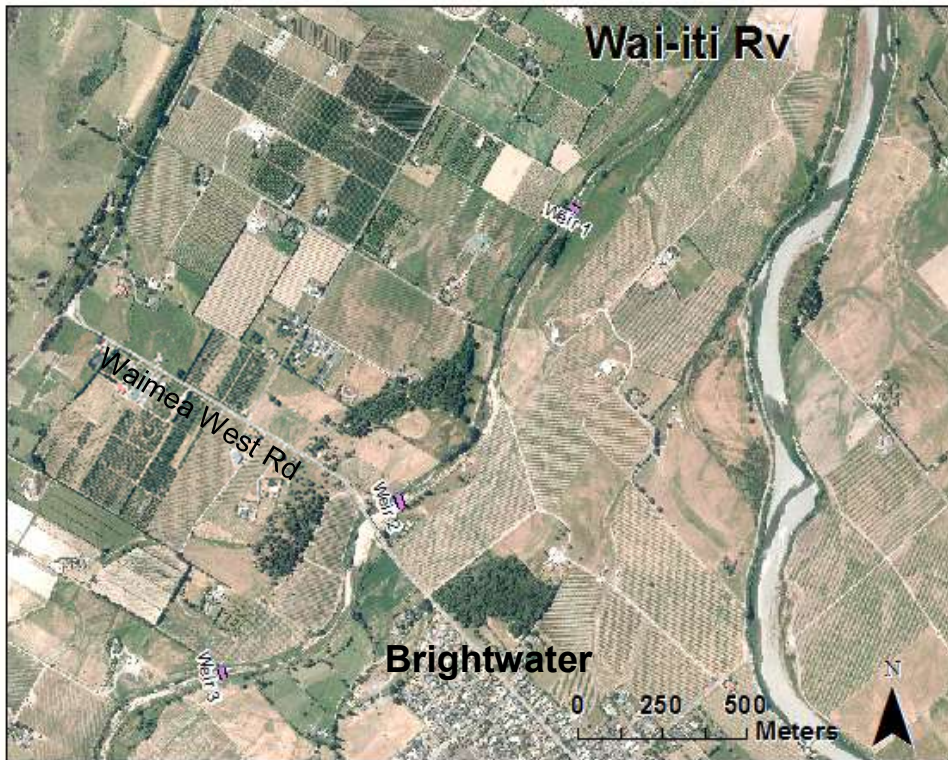
Figure 26. Location of Wai-iti River Gravel Retention Weirs

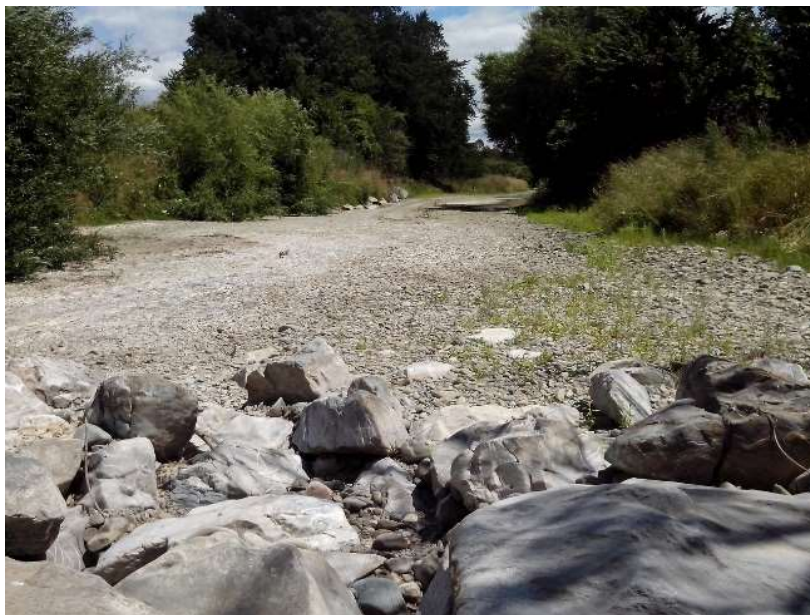
Wai-iti River at lowest weir, view upstream showing dry riverbed, 23 December 2015

In both the 2012 and 2015 surveys, the Wai-iti River was dry above and below Weir 1. In both cases there had been less than 40 mm of rain in the previous four weeks (Wai-iti at Birds rain gauge). In 2012, the lowest 500 metres of the river had dried up. In December 2015, the river was dry from approximately 100m above to 200m below Weir 1. No moving water was visible within the weir itself but there were several small pools. The pool below the weir contained a school of several hundred smelt (see photo below). An effort was made to rescue some of the fish trapped in the remaining pools. In all, six trout, 26 eels and one crayfish were salvaged from pools within the weir and immediately upstream of the weir. A lamprey was found dead within the boulders of the weir.

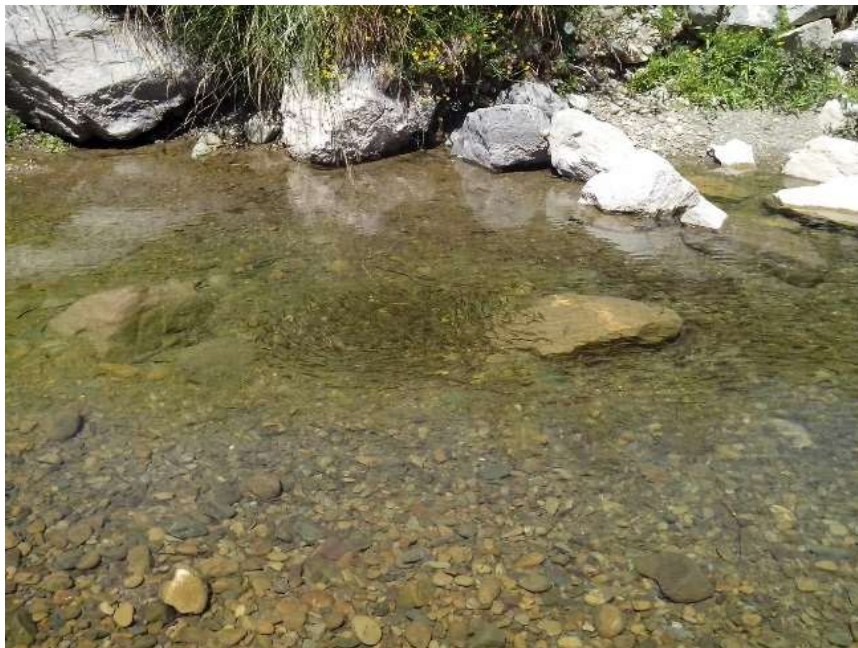
Wai-iti River at lowest weir, view upstream showing dry riverbed and school of smelt below the lowest weir (December 2015)

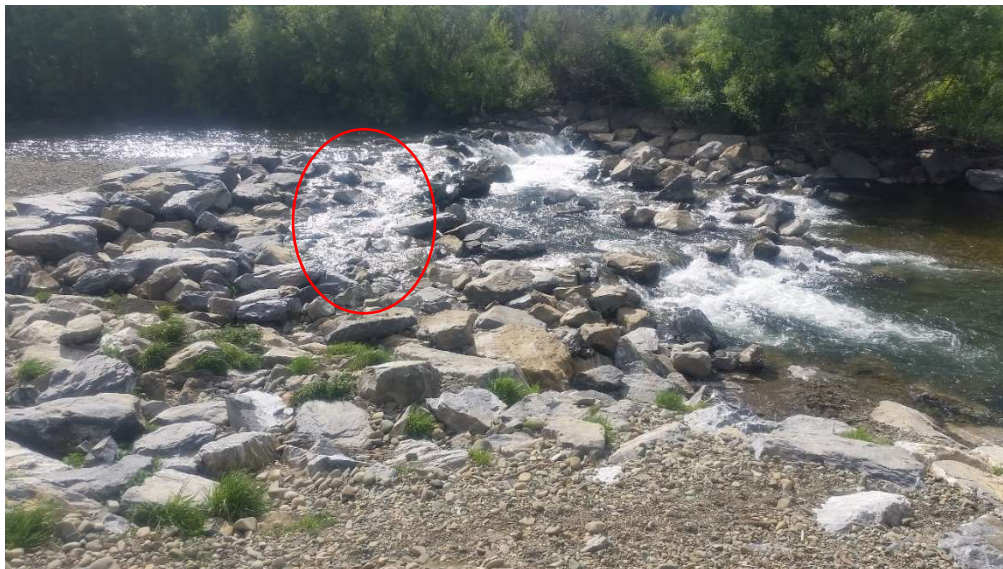
Wai-iti Weir 2 about 100m downstream of Waimea West Rd in November 2017. Note the concreted ramp (circled) provides a channel with lower water velocities and less turbulent flow. This ramp now needs to be extended across to the true right (towards the foreground of the photo).

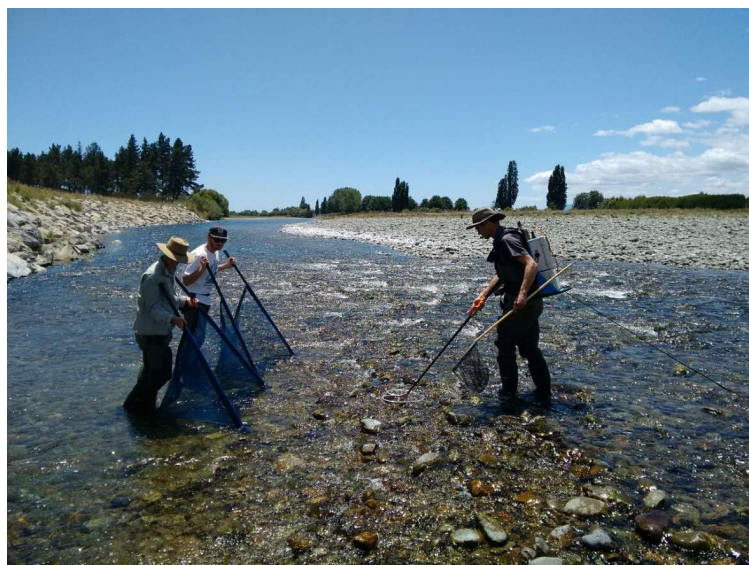
Electric Fishing at 300m upstream Challies Rd (riffle 7 in map below)

All electric fishing was completed on 23 December 2015, after 10 days of low flows in the river (less than 4 m³/sec). Nine riffles were surveyed along a 3km stretch of river between SSH60 and the Wai-iti River confluence using single-pass electric fishing. As the riffles were wide (10 to 40 m), they were fished in sections, working from the right bank to the left bank. At each riffle, the percentage cover of vehicle tracks across the area fished was estimated.

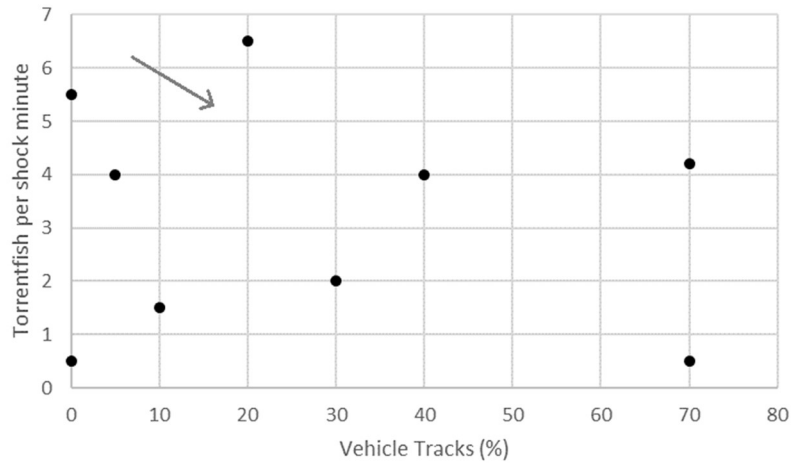
Figure 28. Torrentfish per shock minute against vehicle track density (%) in riffles on the Waimea River. The arrow indicates the direction of relationship expected.

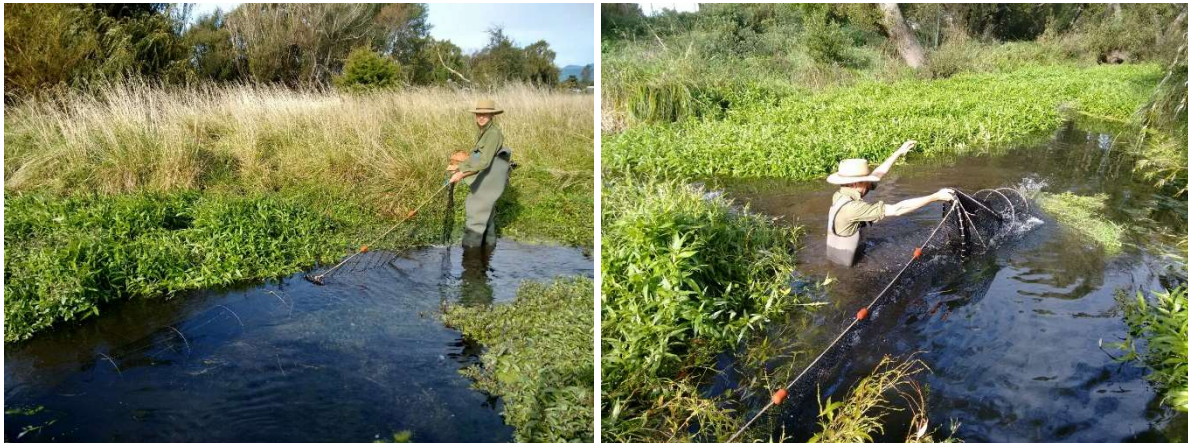
Setting fyke nets in Neimann Ck, 29 March 2016

Three fyke nets and six gee-minnow traps were set at 4pm on 29 March and collected at 9am on 30 March. The nets were arranged such that two gee-minnow traps were in close proximity to each fyke net (approximately 3m upstream and 3m downstream). The location of the fyke nets are shown below. Species and length were recorded for all fish caught.

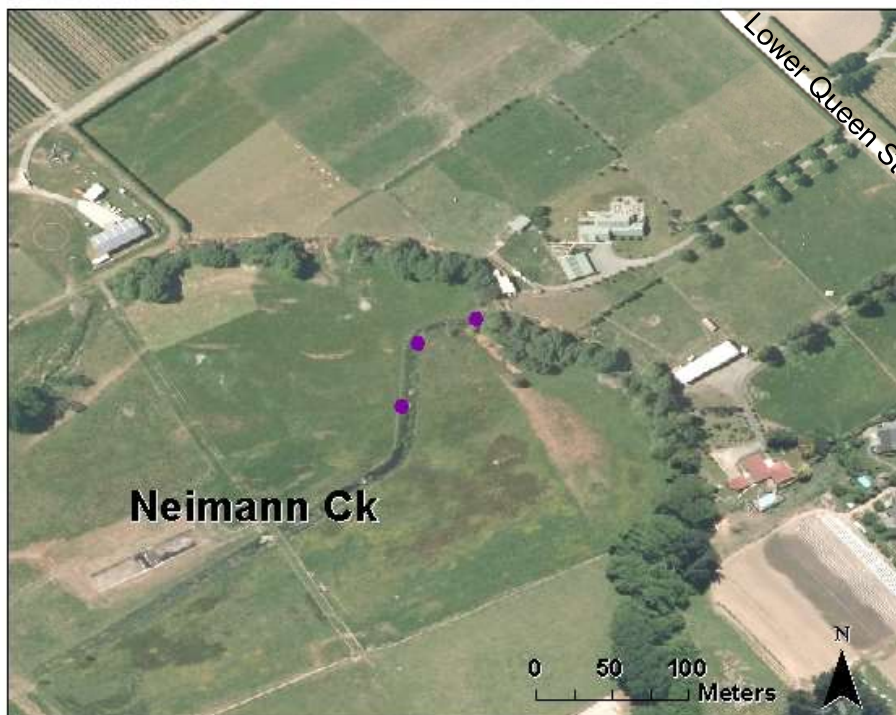
Figure 29. Location of fyke nets in Neimann Ck, 29 March 2016

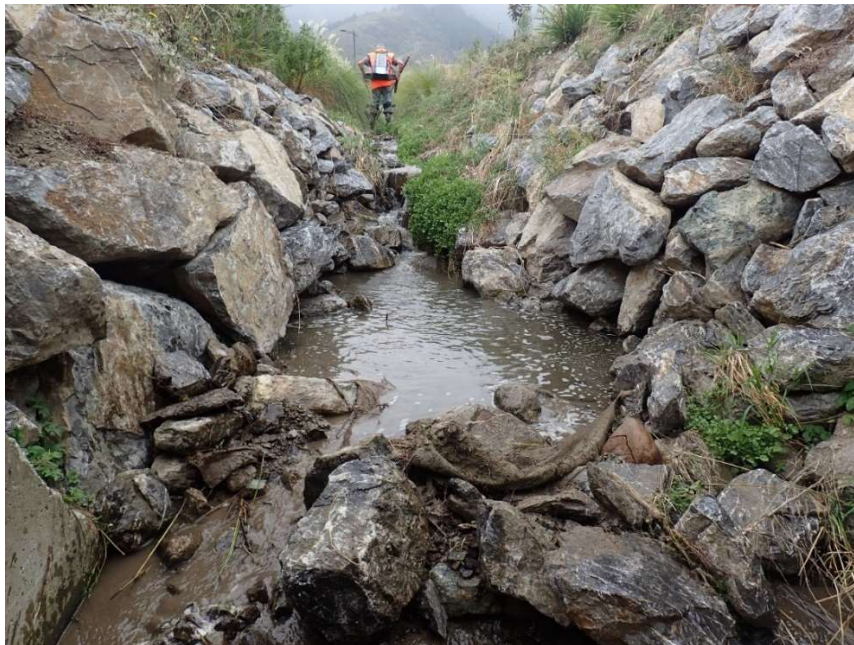
Reservoir Creek about 10m upstream of Hill St, March 2016.

The Hill Street culvert and the rock work and geotextile filter cloth at the upstream end, were identified as a major fish passage barrier (see photo below). Whilst the geotextile filter cloth was partially cleared to create fish passage, the Hill Street culvert remains a barrier to inanga and bullies.

Eels are able swim or climb up the culvert and even wriggle on land around obstacles. Eels (both adult and juvenile shortfin and longfin) were the only fish found at the top of the survey site. Because eel numbers were much lower in comparison to downstream reaches, it is considered very likely that the culverts are acting as a significant impedance to fish passage.

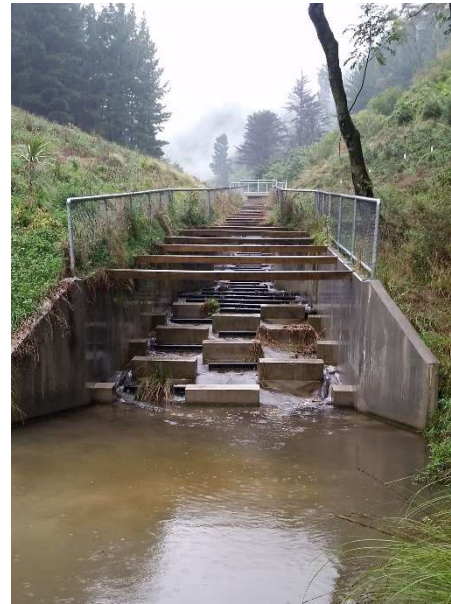
The spillway/fish pass on Reservoir Creek 2016

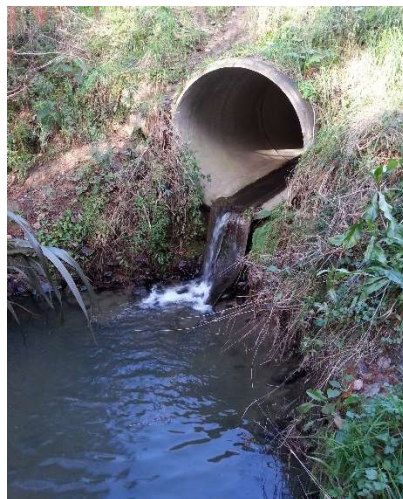
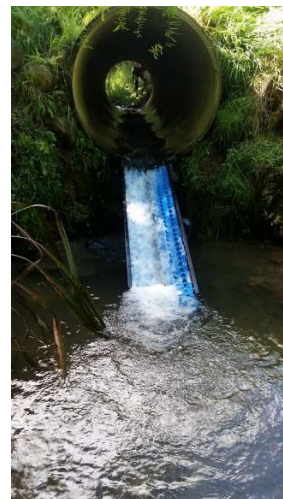
Left: Tower Road culvert with a rubber apron (February 2014). Right: With a floating ramp and baffles within the culvert (November 2016).

Fish passage remediation using flexible plastic baffles was tested in Reservoir Creek (Richmond) at two long culverts (almost 500m total) after fish surveys proved that very few fish apart from eels were able to get past Hill Street. The reason that this trial was given such a priority is that the NZ Fish Passage Guidelines (April 2018) recommend a very expensive option for spoiler baffles in culverts because that was the only option that was tested and proven to assist in getting a large proportion of fish up the culvert. We had observations of fish making it up through the flexible plastic baffles (which cost about 10% of the recommended option, including labour) but not quantitative data on the efficacy of them for fish passage. We now know that while whitebait make it up a 3% grade with baffles at 2.4m spacings, they don't make it up a 6% grade with 0.6m spacings. Installing of additional baffles is expected to result in the majority of the fish being able to make it up this steeper grade. This result reinforces the need to ensure that culverts are not set at gradients more than 5%.
