Groundwater Monitoring Review Following Soil Remediation at the Mapua FCC Site

✦ Prepared for
Tasman District Council

✦ March 2011

JOB REFERENCE CJ41604

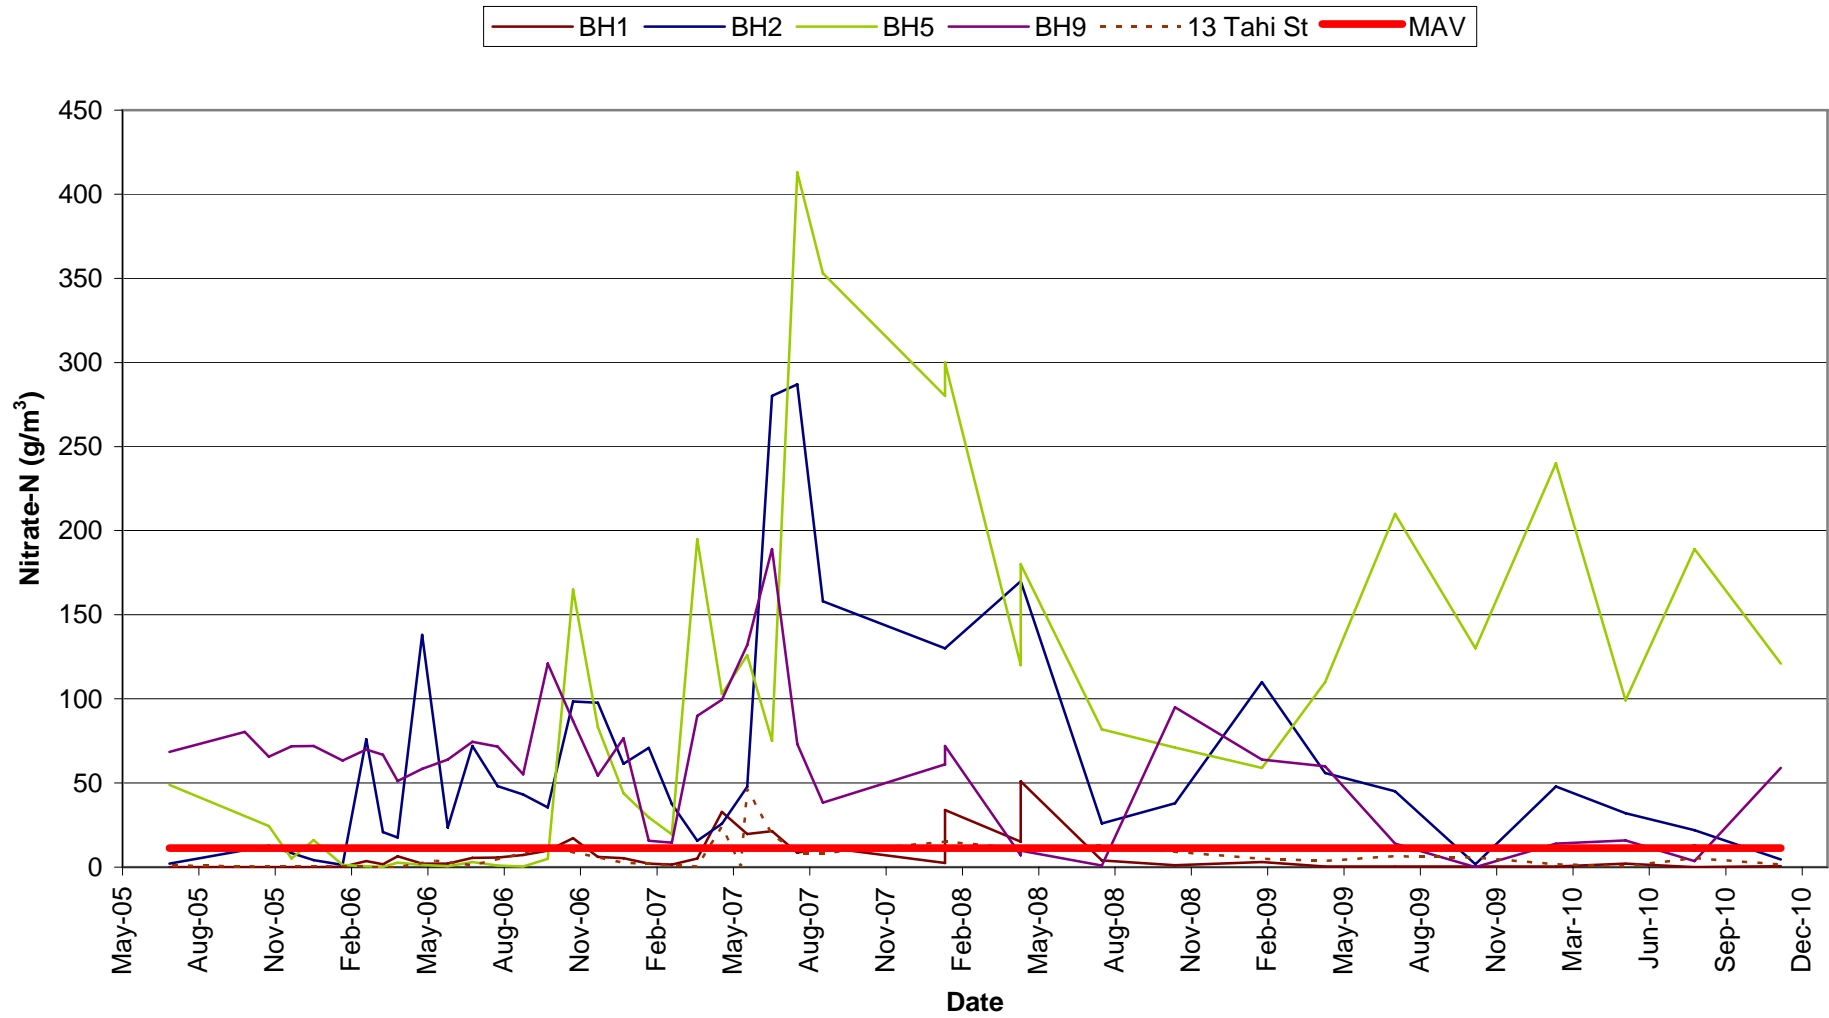
**Figure 12: Nitrate-N
MAV DWSNZ 11.3 NO3-N g/m3**

- Figure 12 shows nitrate-nitrogen concentrations. Three boreholes have historically shown elevated concentrations: BH2, BH5 and BH9. Since late 2007, concentrations have decreased substantially, which coincides with the cessation of the MCD reactor in mid-2007. Despite this general decline, BH5 continues to show significantly elevated concentrations. At the present time, only BH9 and BH5 currently have nitrate-N concentrations above the Maximum Acceptable Value in the Drinking Water Standards for New Zealand 2005 (Revised 2008). BH5 is located downgradient of an area of mixed Treated Fines (Figure 10). From 2004 until late 2007 BH9 is reported to have had a broken well casing and received direct inflows of stormwater around the well casing which will have impacted on groundwater quality data from this borehole around that time. In more recent times, BH9 could be showing the effects from the Treated Fines buried in the western portion of the site (Figure 9). Figure 12a shows the boreholes that have typically displayed lower nitrate-N concentrations. Both BH1 and 13 Tahi Street remain at stable, low concentrations;

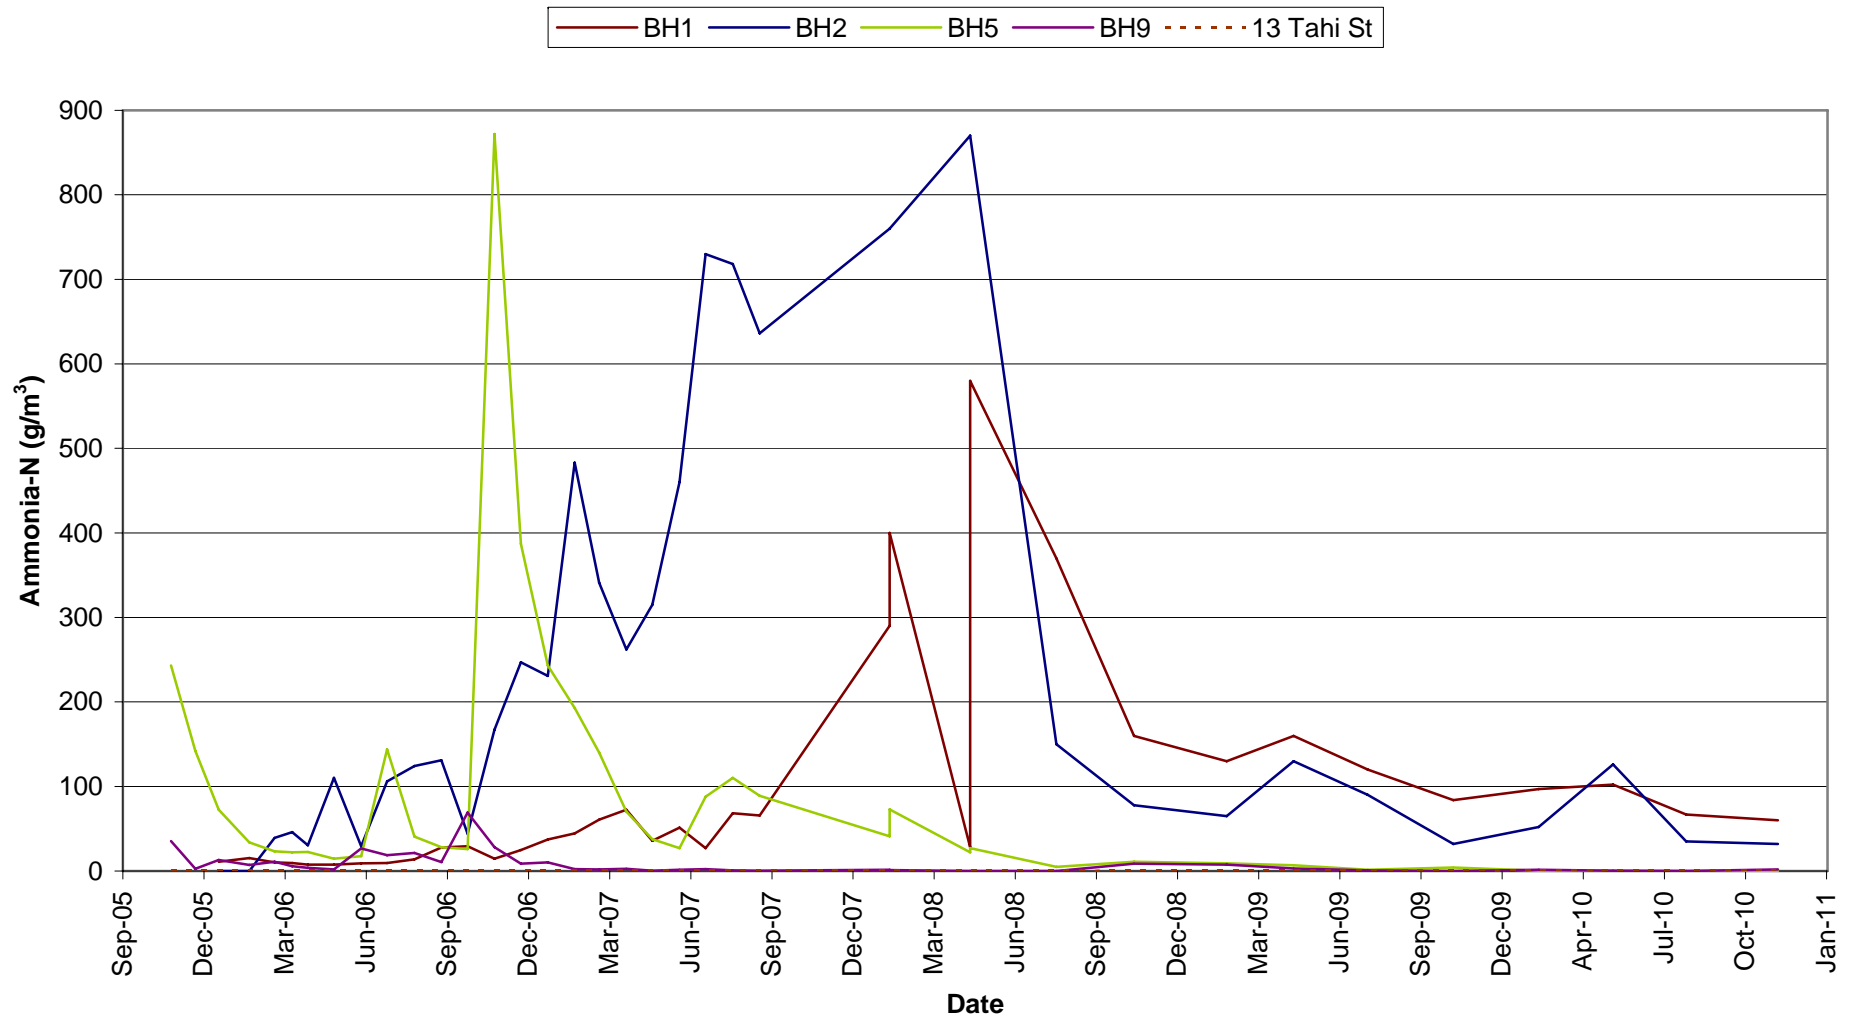
Figure 13: Ammonia-N
GV Aesthetic DWSNZ 0.30 NH3-N g/m3; Aquatic Ecosystem Guideline 0.71g/m3

- Figure 13 shows ammonia-nitrogen concentrations. BH1, BH2 and BH5 have all had elevated concentrations which have reduced significantly from those peaks since 2006-2008. Despite these declines, BH1 and BH2 still show high concentrations of 60 g/m³ and 32 g/m³ relative to guidelines for drinking water aesthetics (0.3 g/m³) and ecosystems (0.71 g/m³). Both these boreholes are located downgradient of the Treated Fines placed in the eastern site (Figures 9 and 10). Those bores with lower ammonia-N concentrations (Figure 13a) show decreasing concentrations in BH5, BH9 and 13 Tahi Street. BH9 currently shows the highest concentration of this group at 1.8 g/m³;

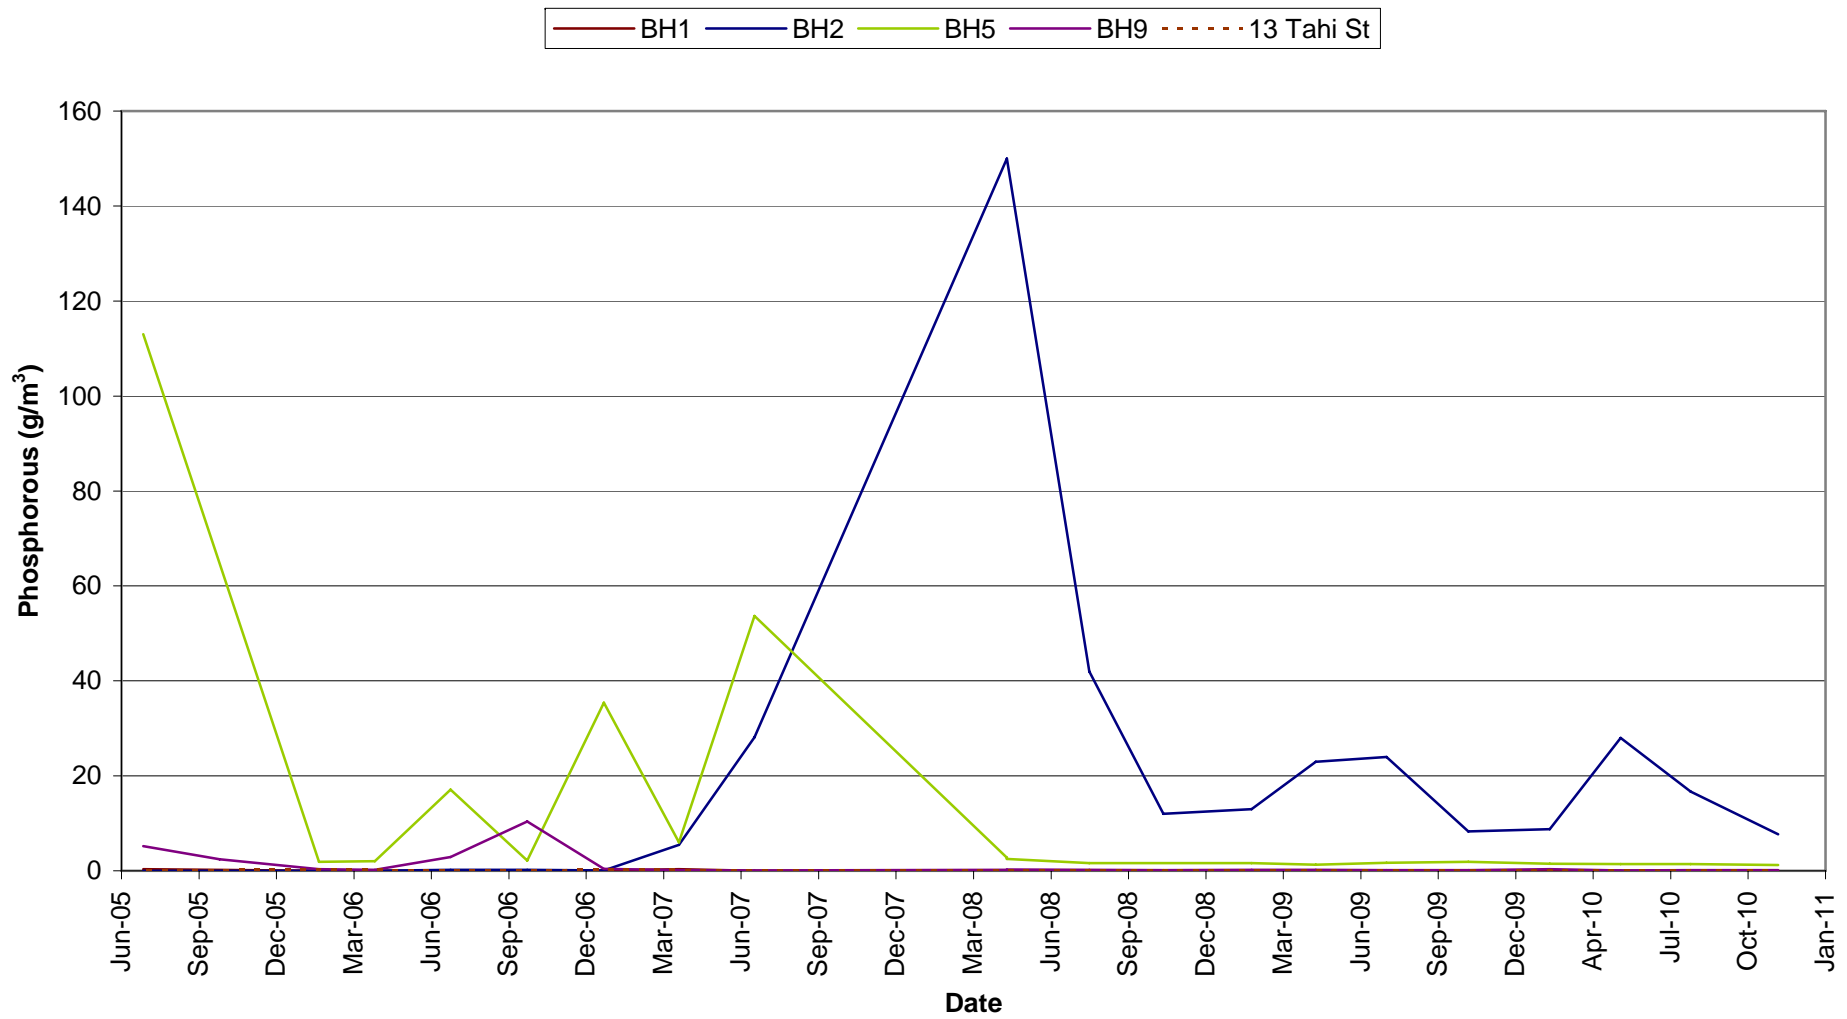
**Figure 14: Phosphorous
Aquatic Ecosystem Guideline 0.01g/m3**

- Figure 14 shows dissolved reactive phosphorous concentrations, which are most elevated in BH2, currently at 7.7 g/m³, but have decreased from their former peak;

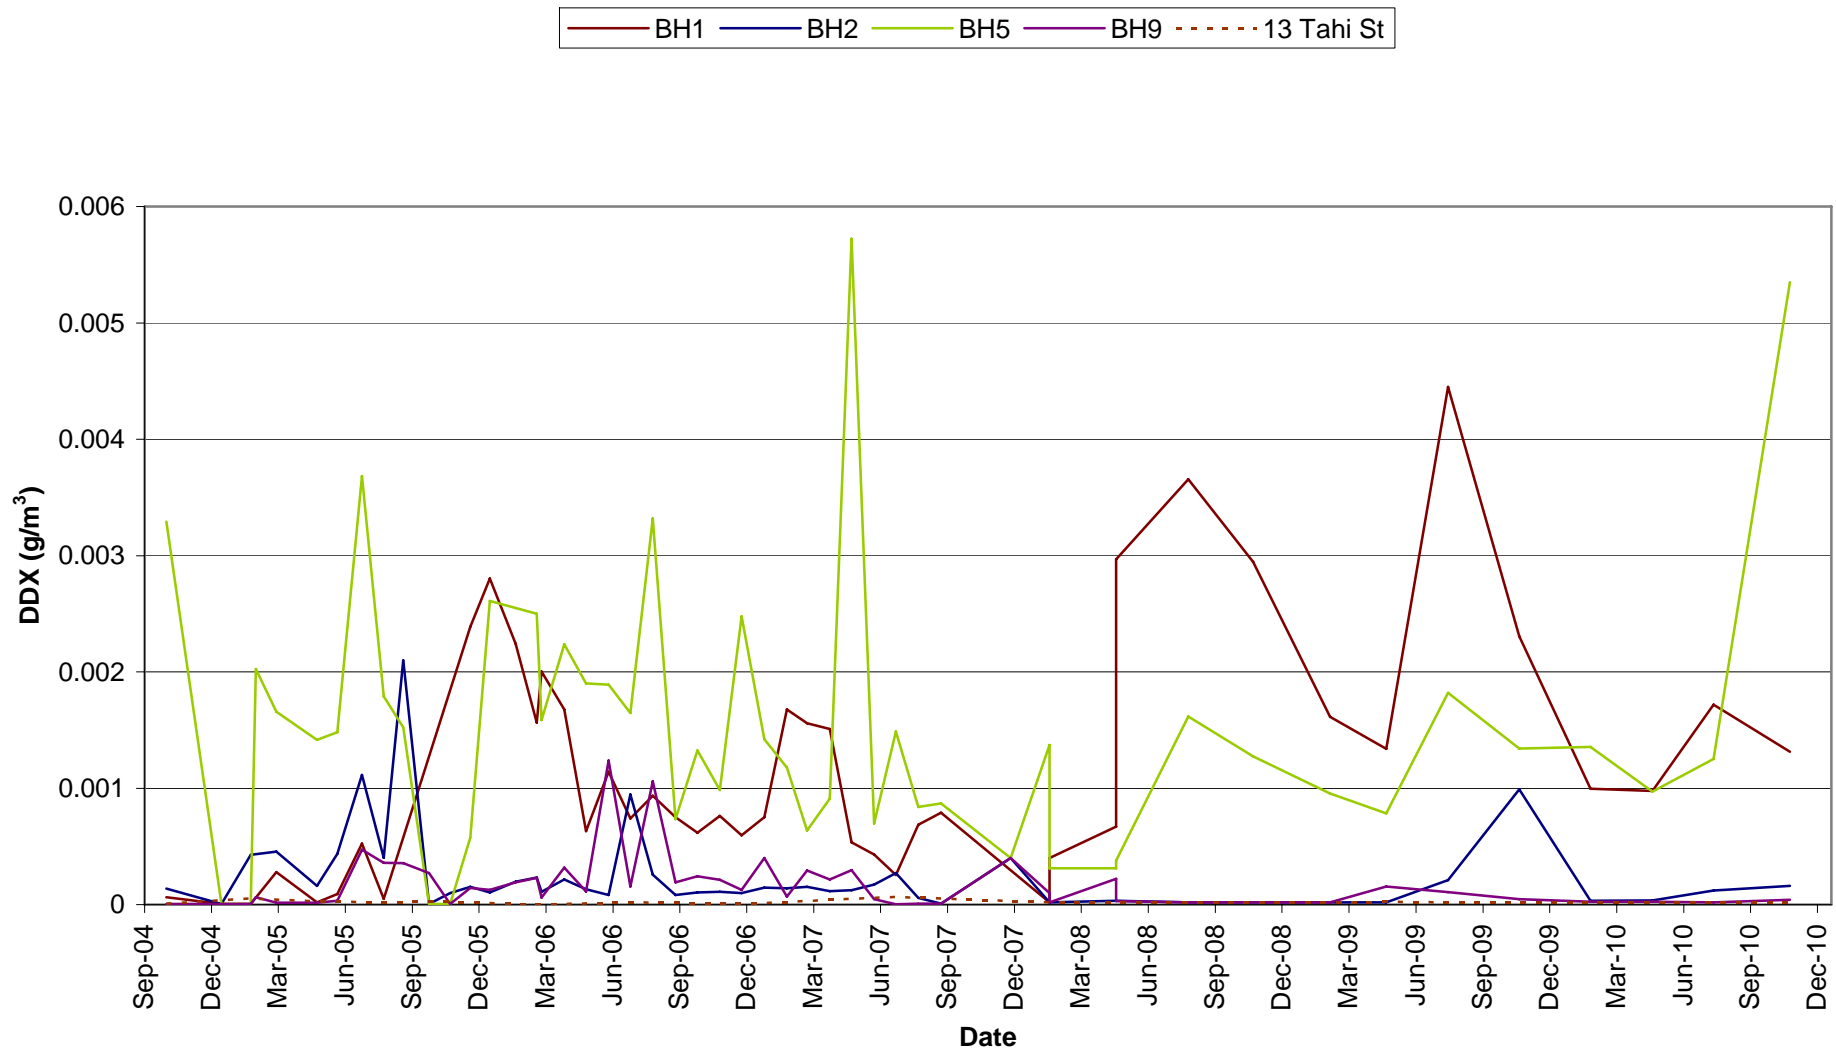
Figure 15: DDX (g/m3)

- Figure 15 shows DDX concentrations for the isomers 2,4'-DDD, 4,4'-DDD, 4,4'-DDE and 4,4'-DDT. Most bores show decreasing concentrations, although BH1 and BH5 remain elevated above the Drinking Water Standards health based MAV of 0.001 g/m³ for DDT and its isomers, with BH2 showing lower but variable concentrations;

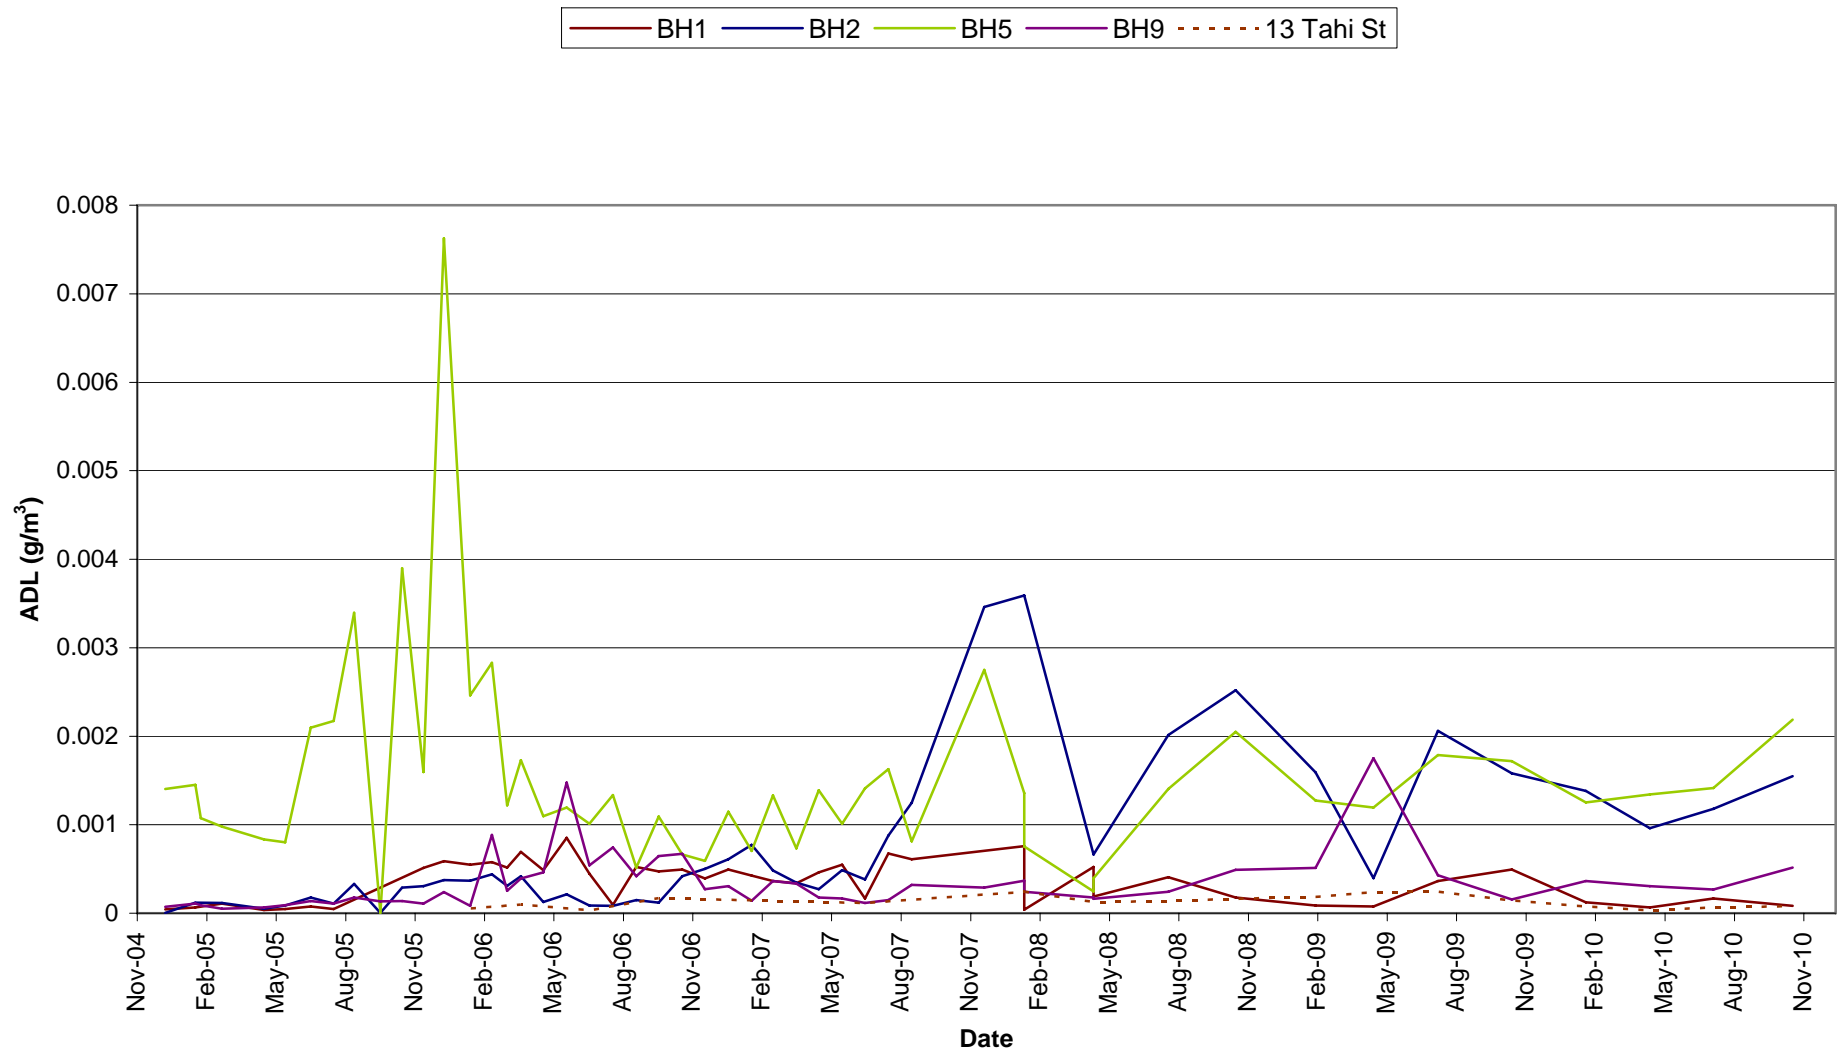
Figure 16: ADL (g/m3)

- Figure 16 shows ADL concentrations. These concentrations continue to show a relatively stable pattern, with no significant declining trend. BH5 and BH2 show the most elevated concentrations, with BH9 at lower values. All values in Figure 16 currently sit above the Drinking Water Standards health based MAV of 0.00004 g/m³ for aldrin and dieldrin, the most elevated concentrations occurring in BH2 and BH5;

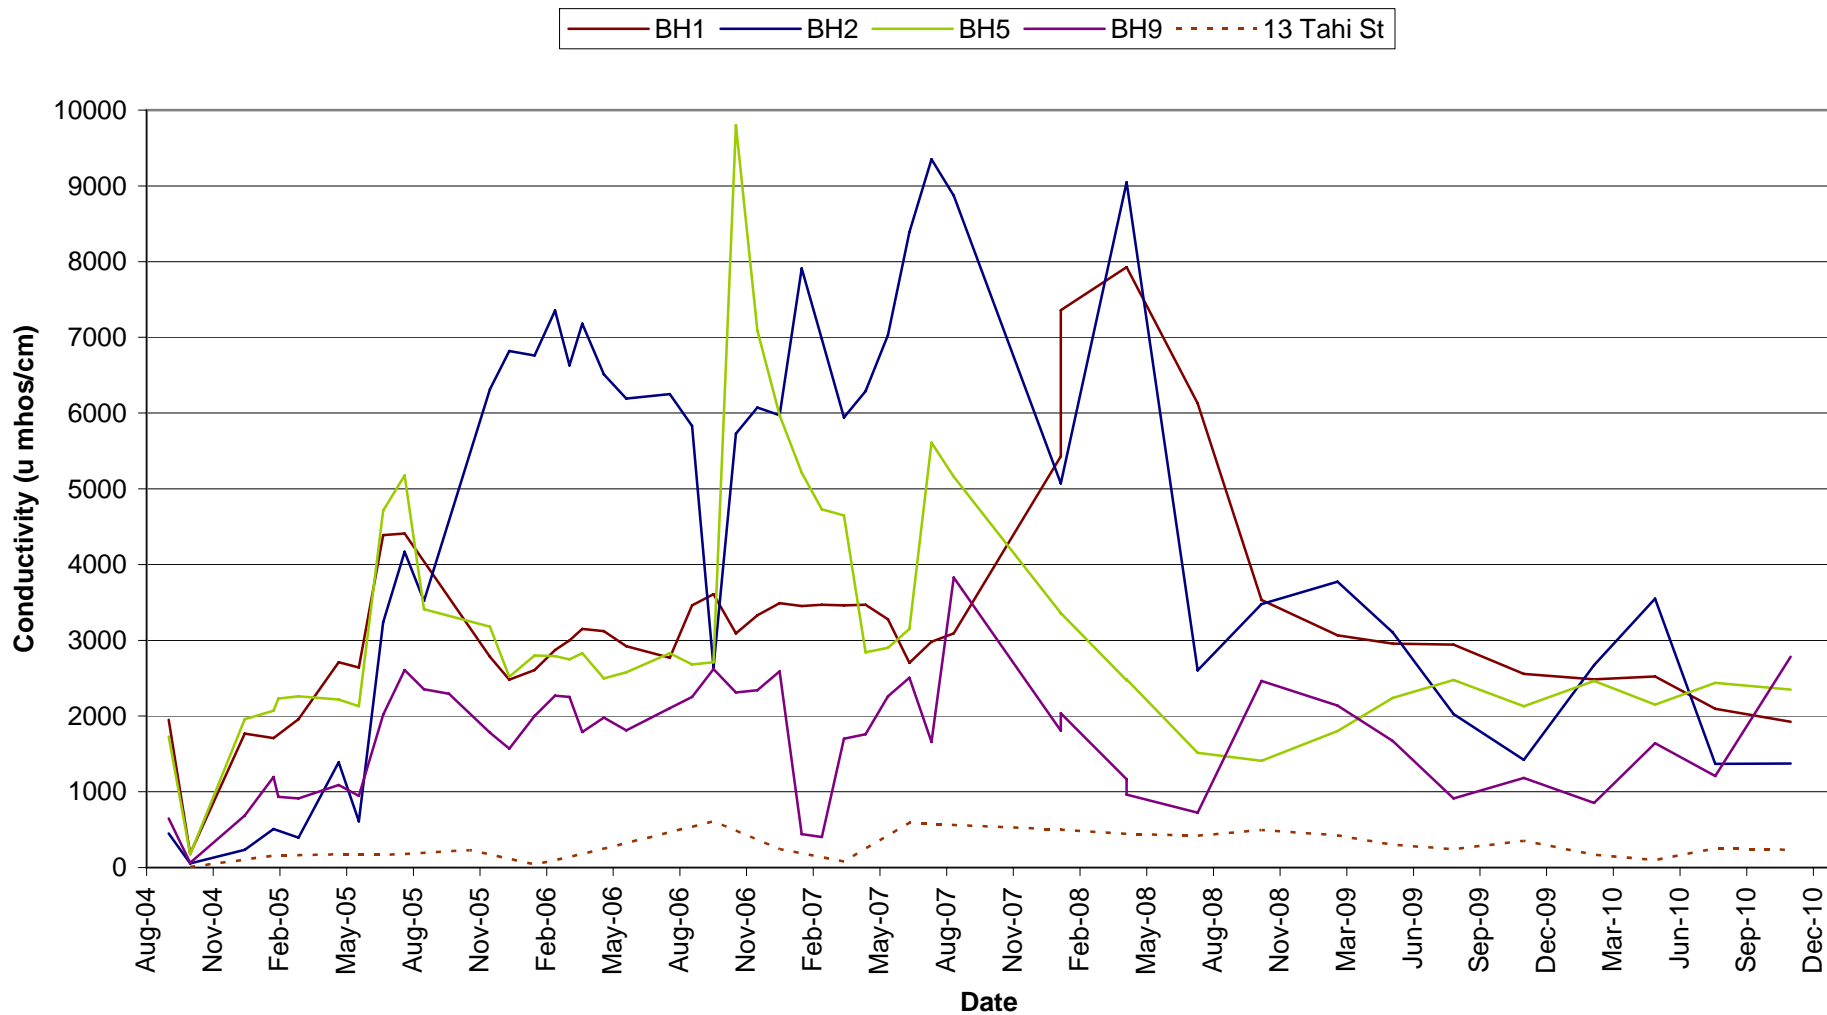
Figure 17: Conductivity (u mhos/cm)

- Figure 17 shows electrical conductivity values, which are a general indicator of all the chemicals dissolved in the water. These show a decrease from high values that occurred from 2005-2008 with relatively lower stable values over the last 12 months. The comparison between current values at 13 Tahi Street (235 µS/cm) relative to the on-site bores (1,373-2,780 µS/cm) indicates the significantly higher concentration of chemicals dissolved in groundwater beneath the site;

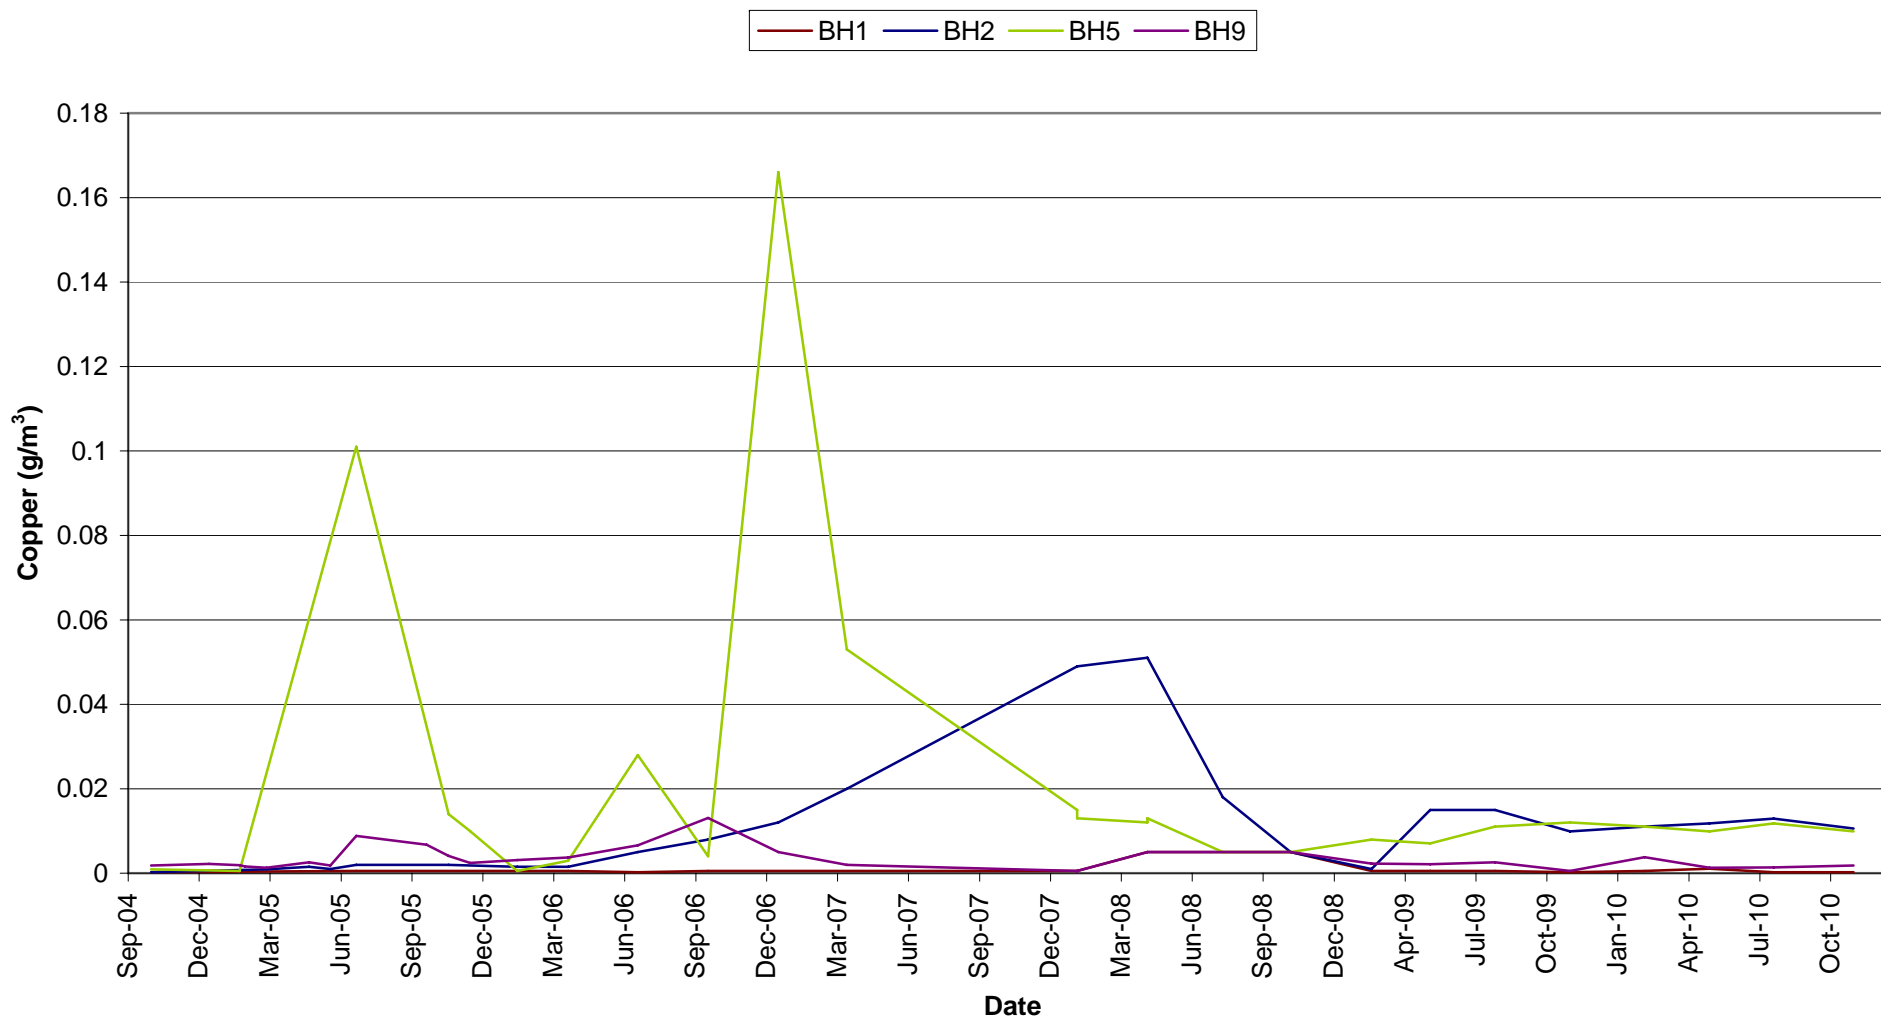
Figure 18: Copper
MAV DWSNZ 2 g/m3, ANZECC Marine Guideline = 0.0013 g/m3

- Figure 18 shows dissolved copper concentrations. Copper was one of the reagents used in the MCD process. The results show currently stable concentrations at values that are generally above the ANZECC marine ecosystem guidelines of 0.0013 g/m³;
- Iron was also utilised in the MCD process, but has only been sampled since January 2008. The results are shown in Figure 19. Detectable concentrations only occur in BH1A, which has shown quite variable but decreasing concentrations.

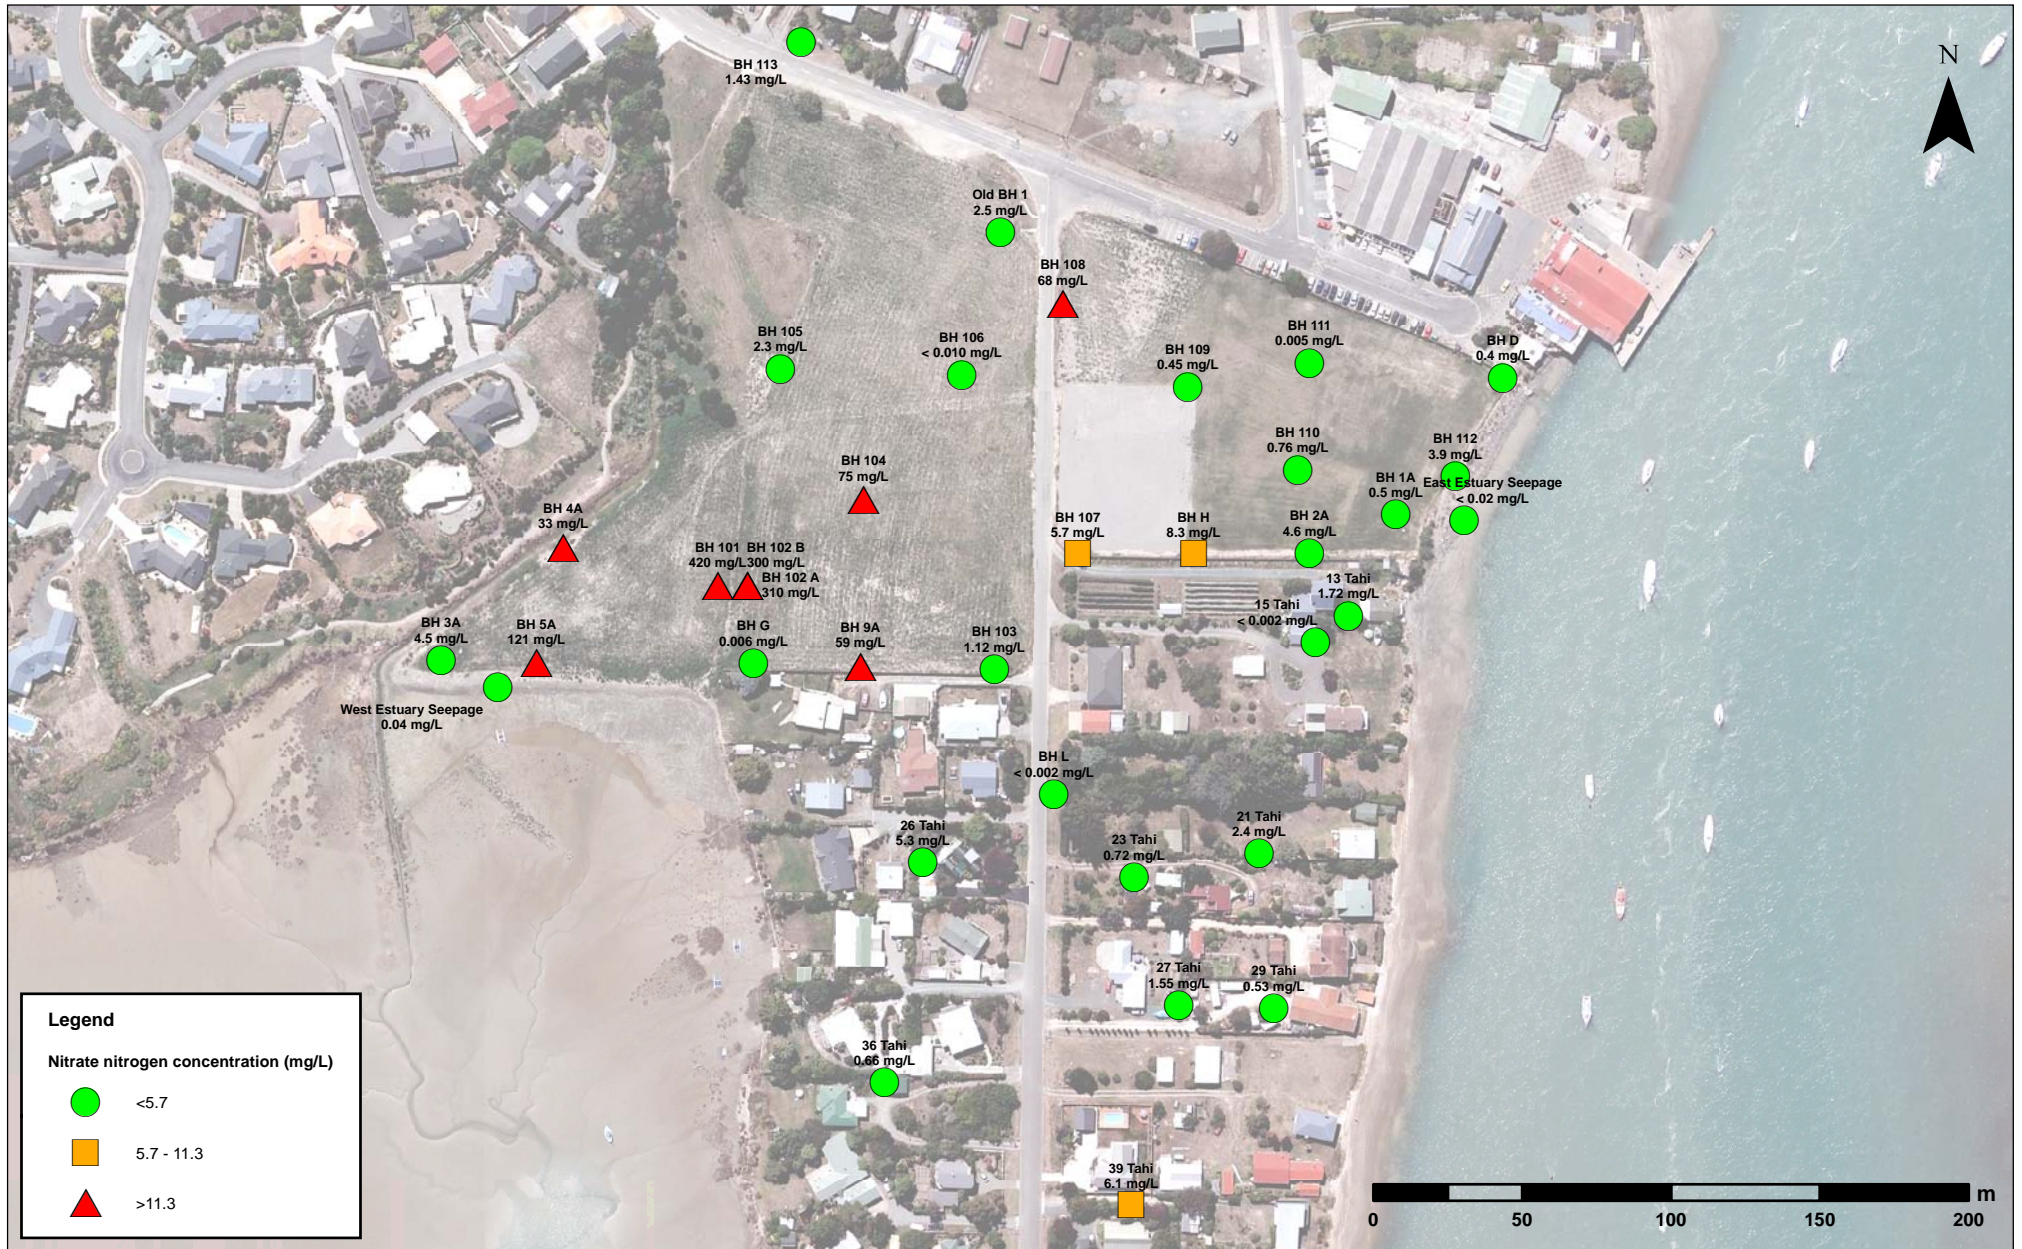
Figure 22 : Nitrate nitrogen concentrations in November 2010

Figure 22 shows the nitrate-nitrogen concentrations, which have been colour coded as follows:

A comparison between Figures 22 and 23 indicates a predominance of ammonia in the eastern part of the site, suggesting a more reducing chemical environment, possibly due to the greater amount of Treated Fines in that area (Figures 6 and 7). Figures 22 and 23 also indicate no significant migration of nitrate or ammonia in a southerly direction to affect bores further down Tahi Street.

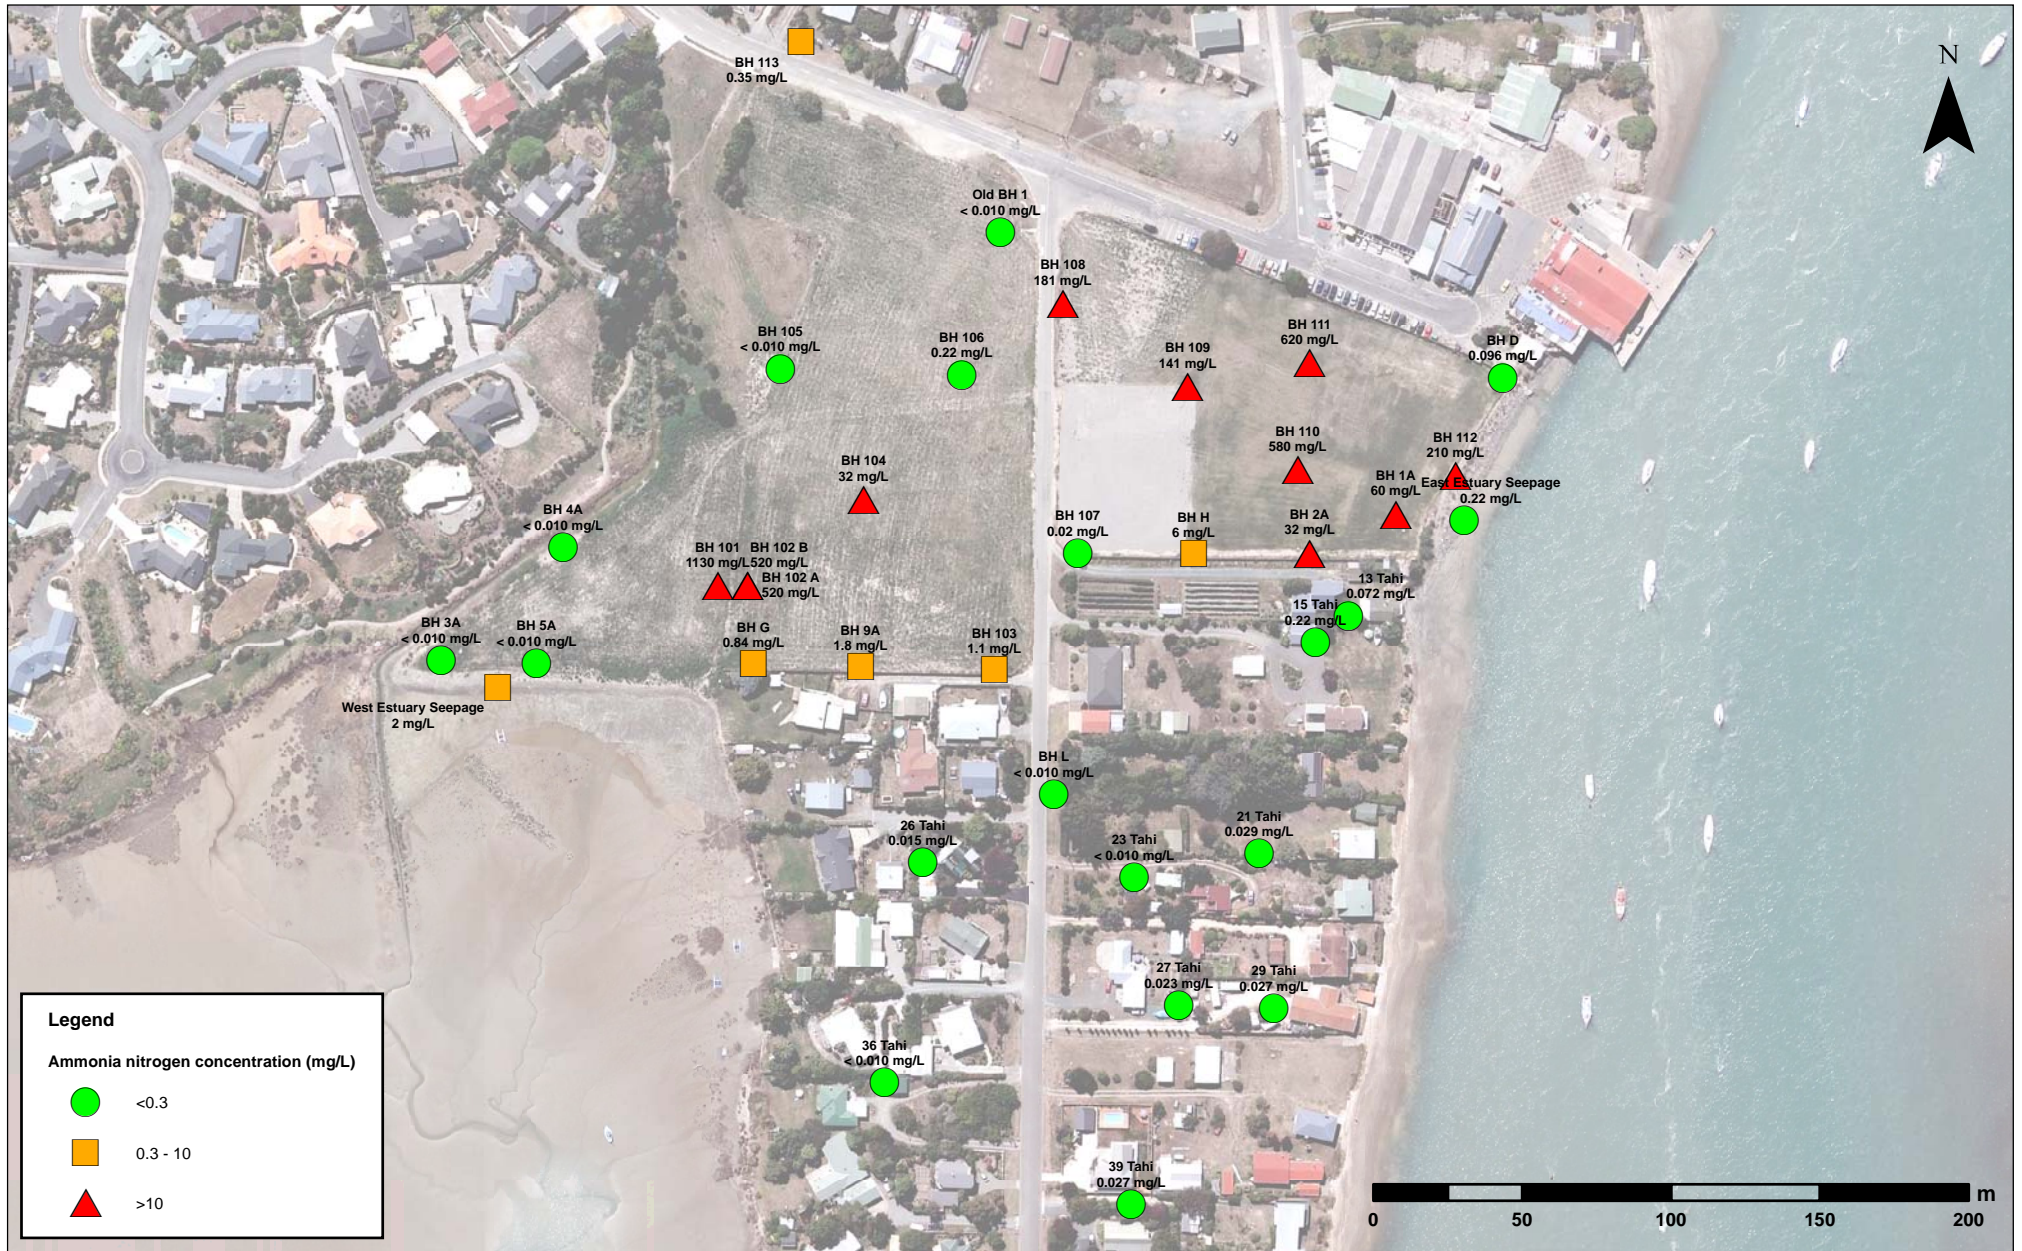
Figure 23 : Ammonia nitrogen concentrations in November 2010

Figure 23 shows the ammonia-nitrogen concentrations, which have been colour coded as follows:

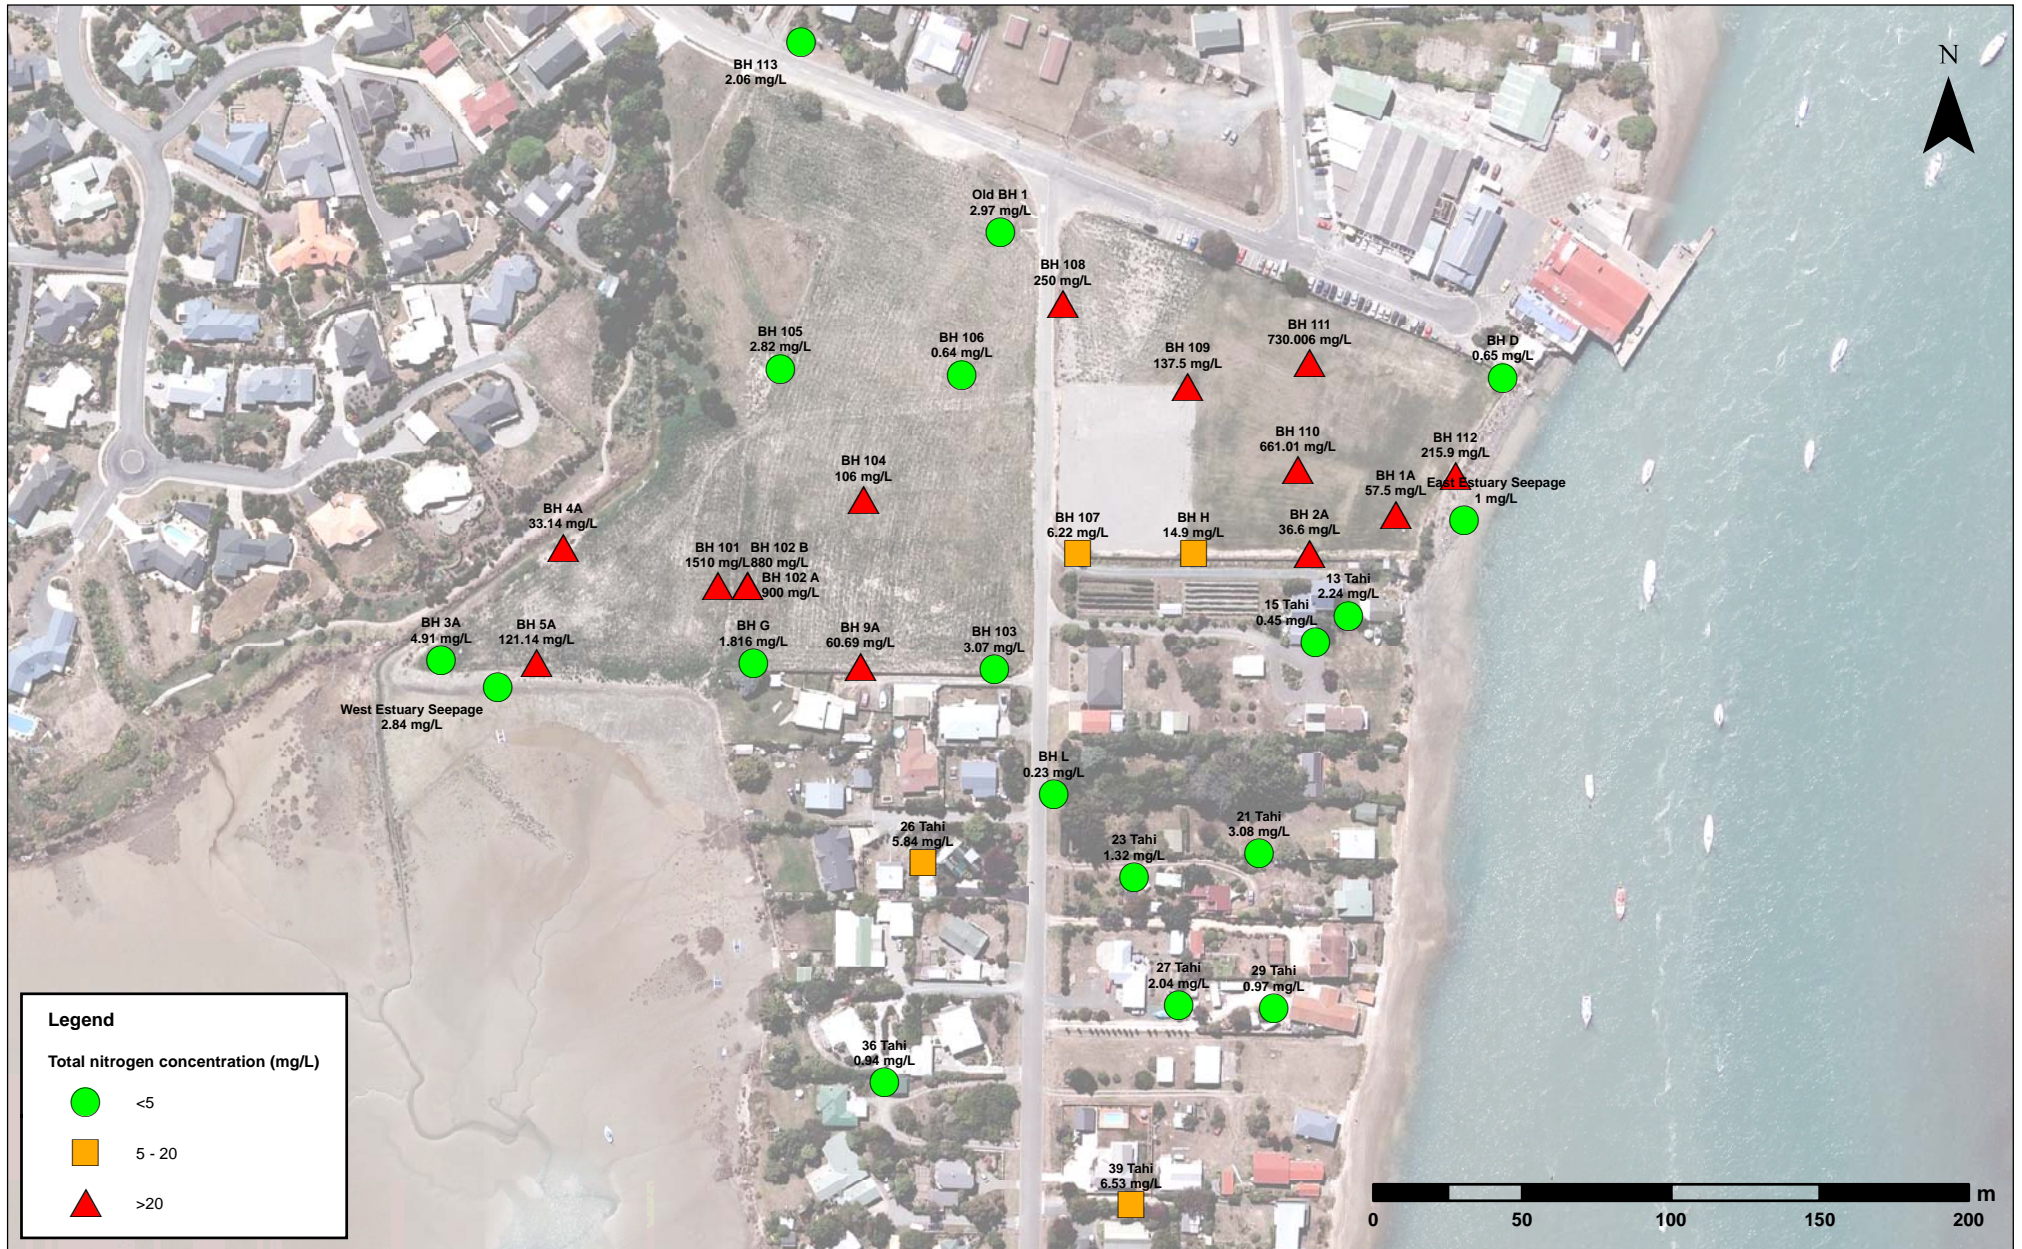
Figure 24 : Total nitrogen concentrations in November 2010

Figure 24 shows the total Nitrogen concentrations, which have been colour coded as follows:
