Groundwater Monitoring Review Following Soil Remediation at the Mapua FCC Site

✦ Prepared for
Tasman District Council

✦ March 2011

JOB REFERENCE CJ41604

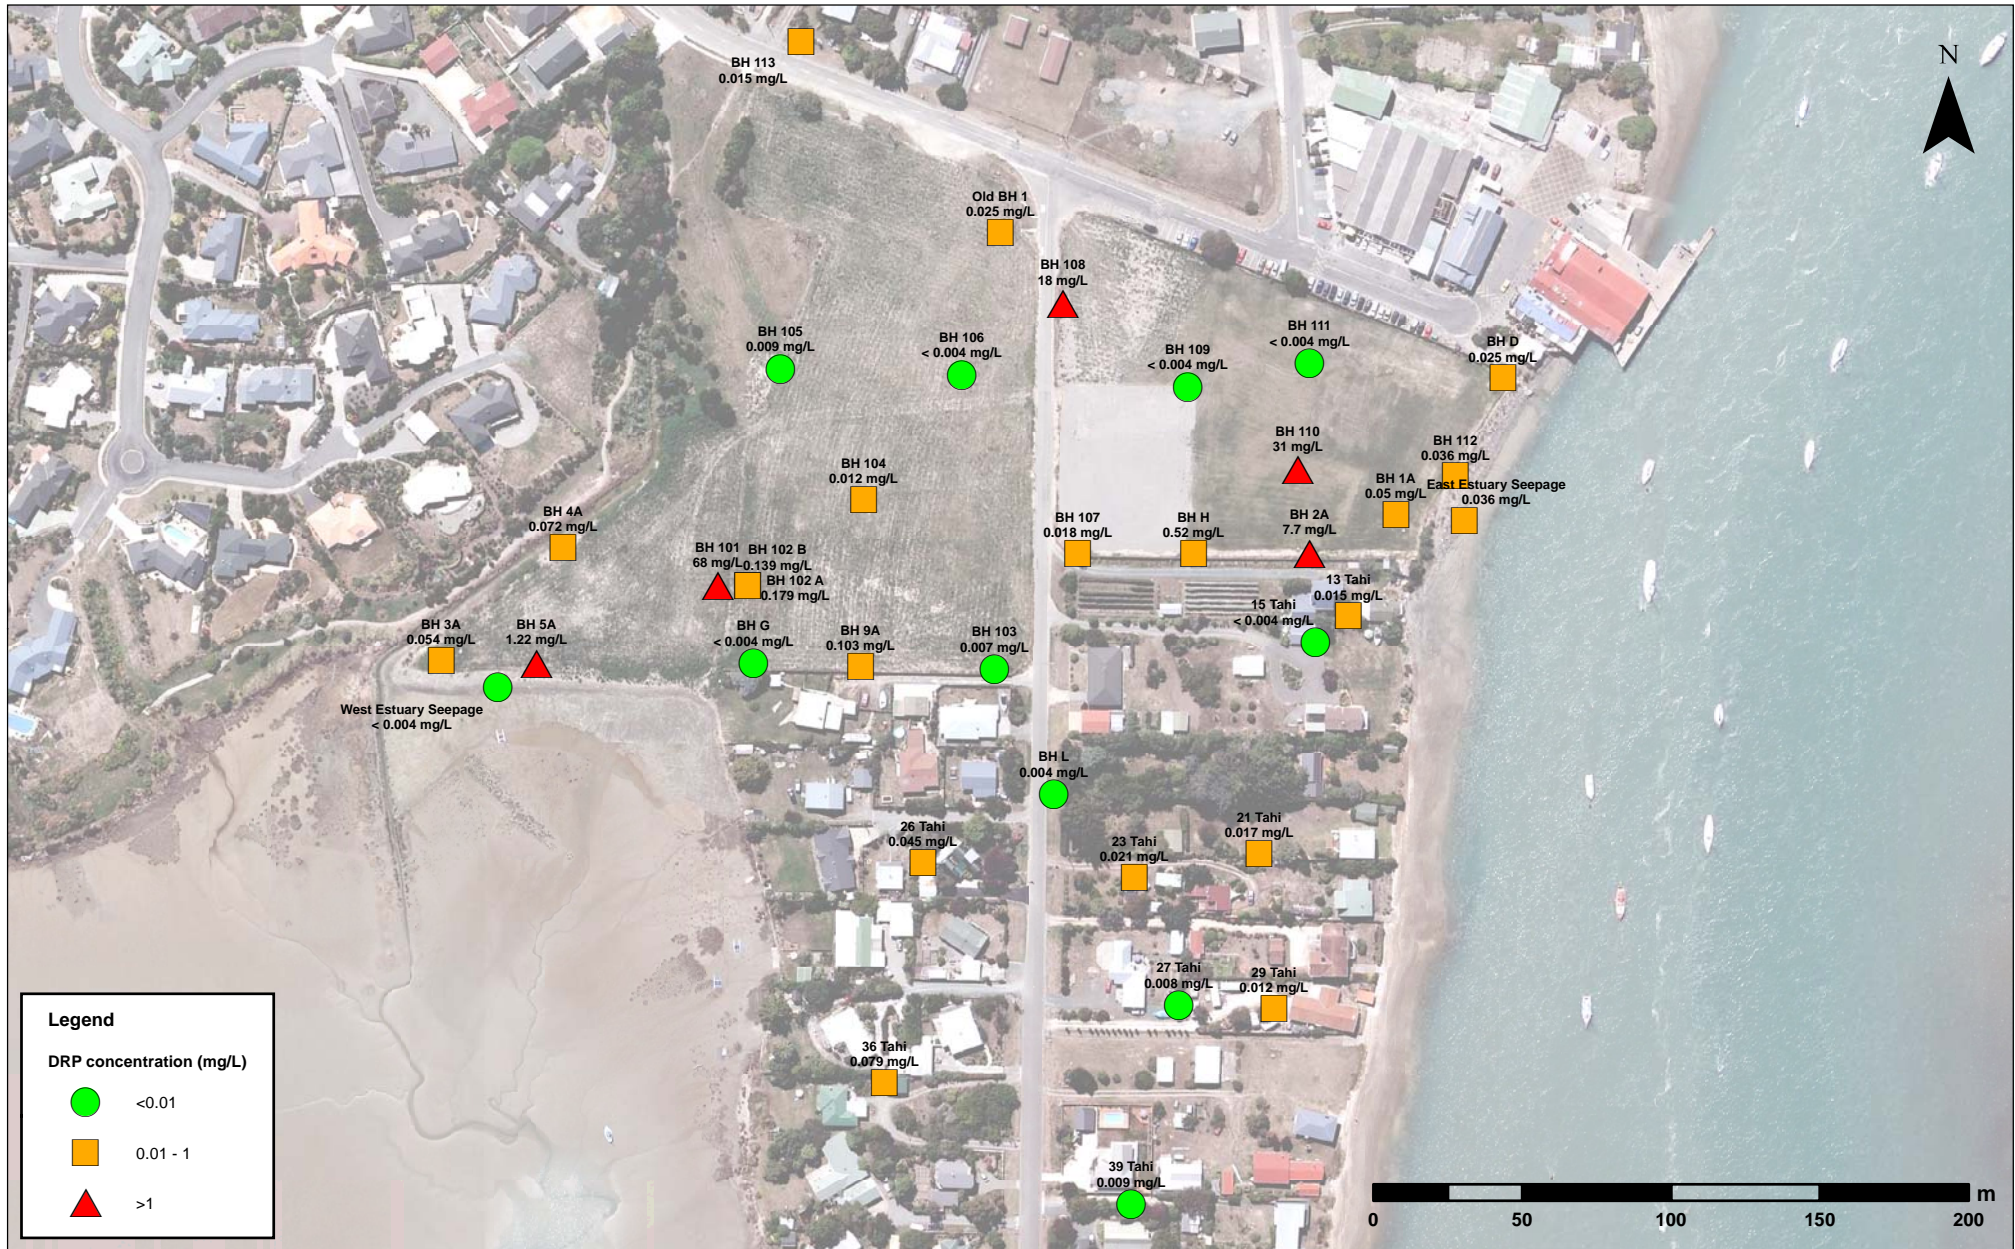
Figure 25 : Dissolved reactive phosphorus concentrations in November 2010

Figure 25 shows the DRP concentrations, which have been colour coded as follows:

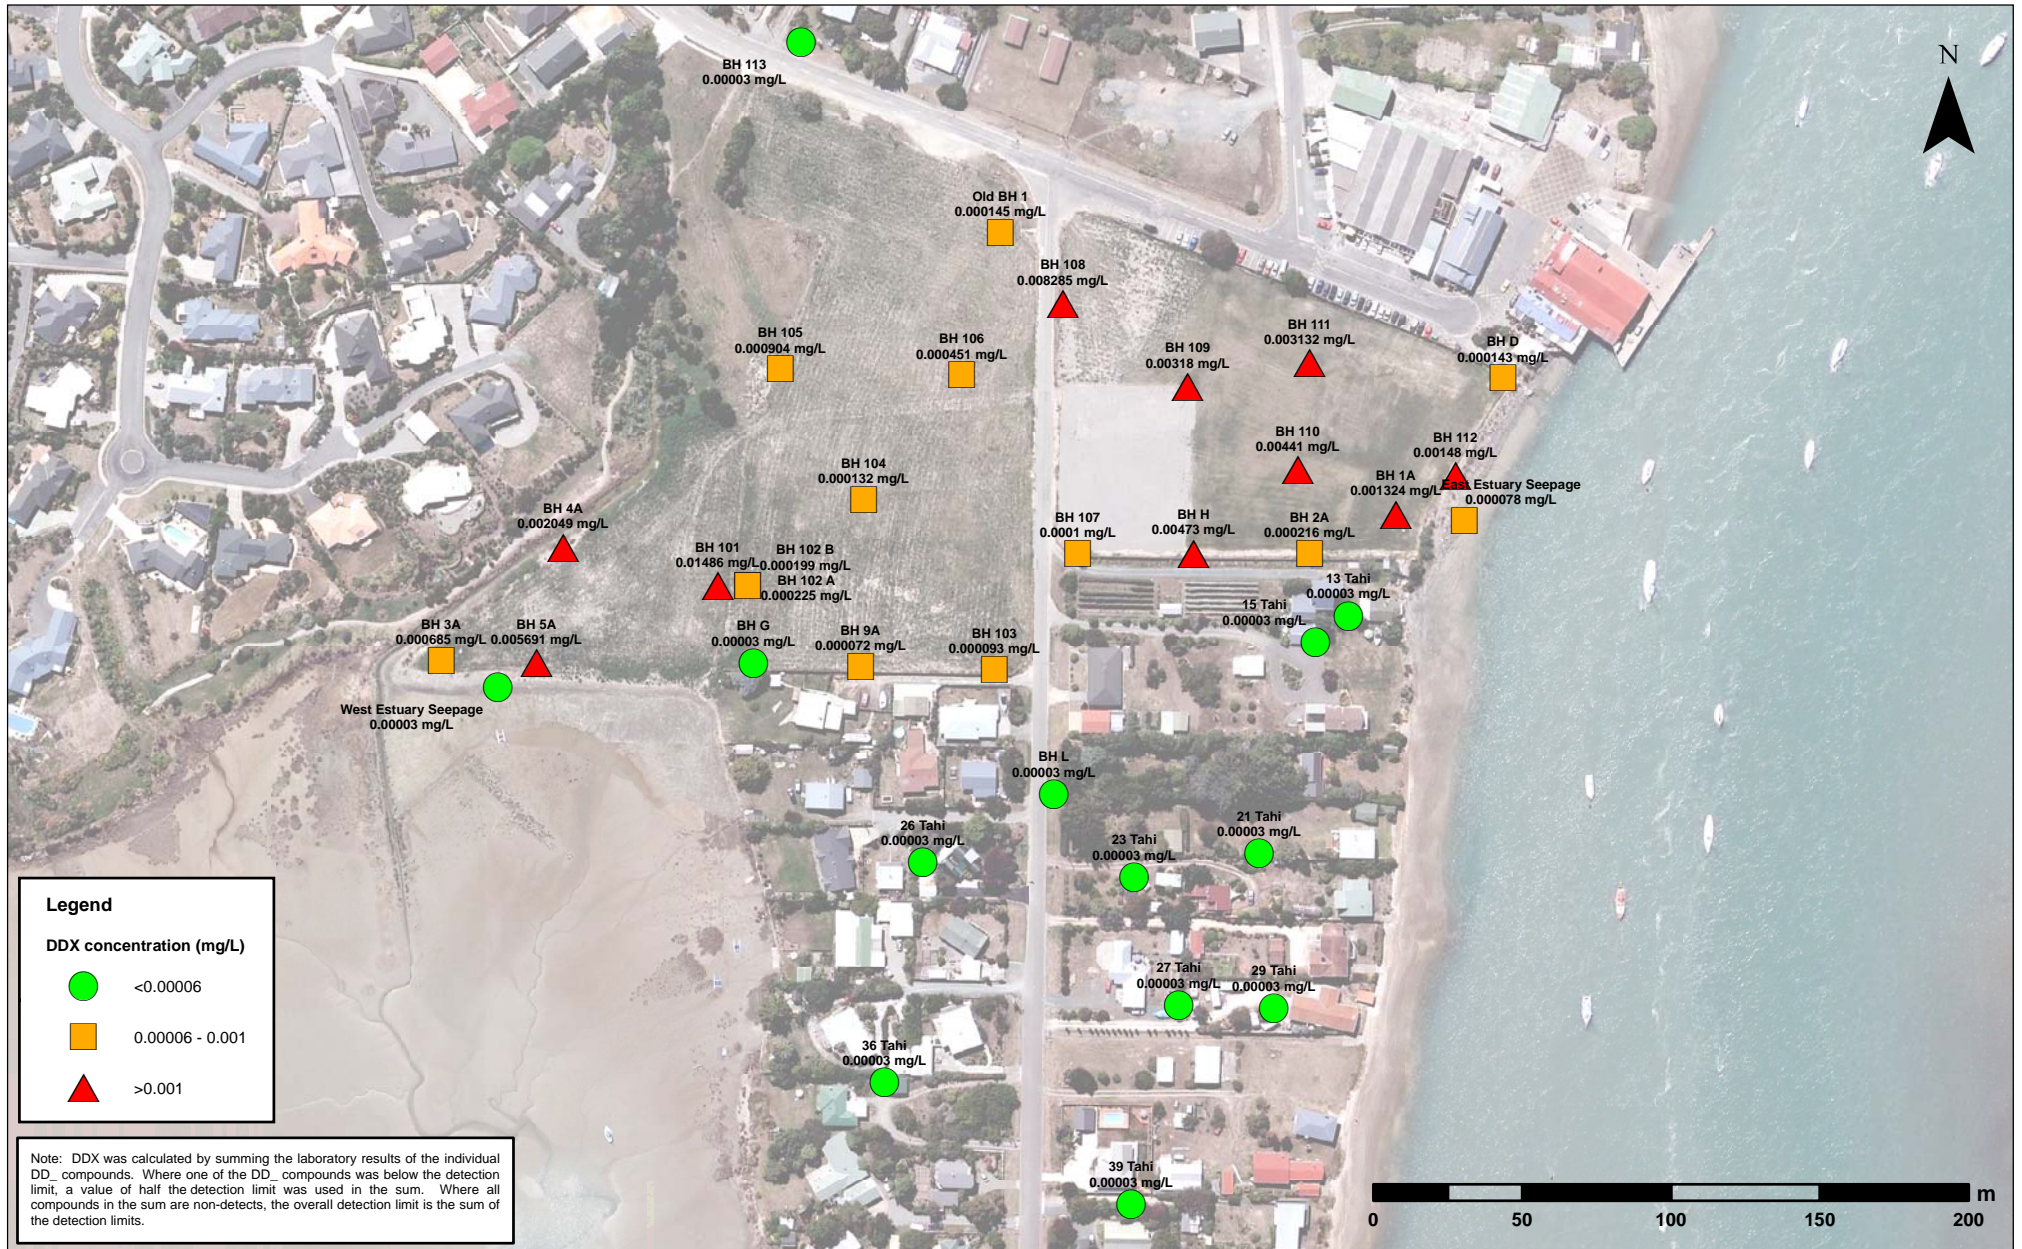
Figure 26 : DDX concentrations in November 2010

Figure 26 shows the DDX concentrations (for six isomers), which have been colour coded as follows:

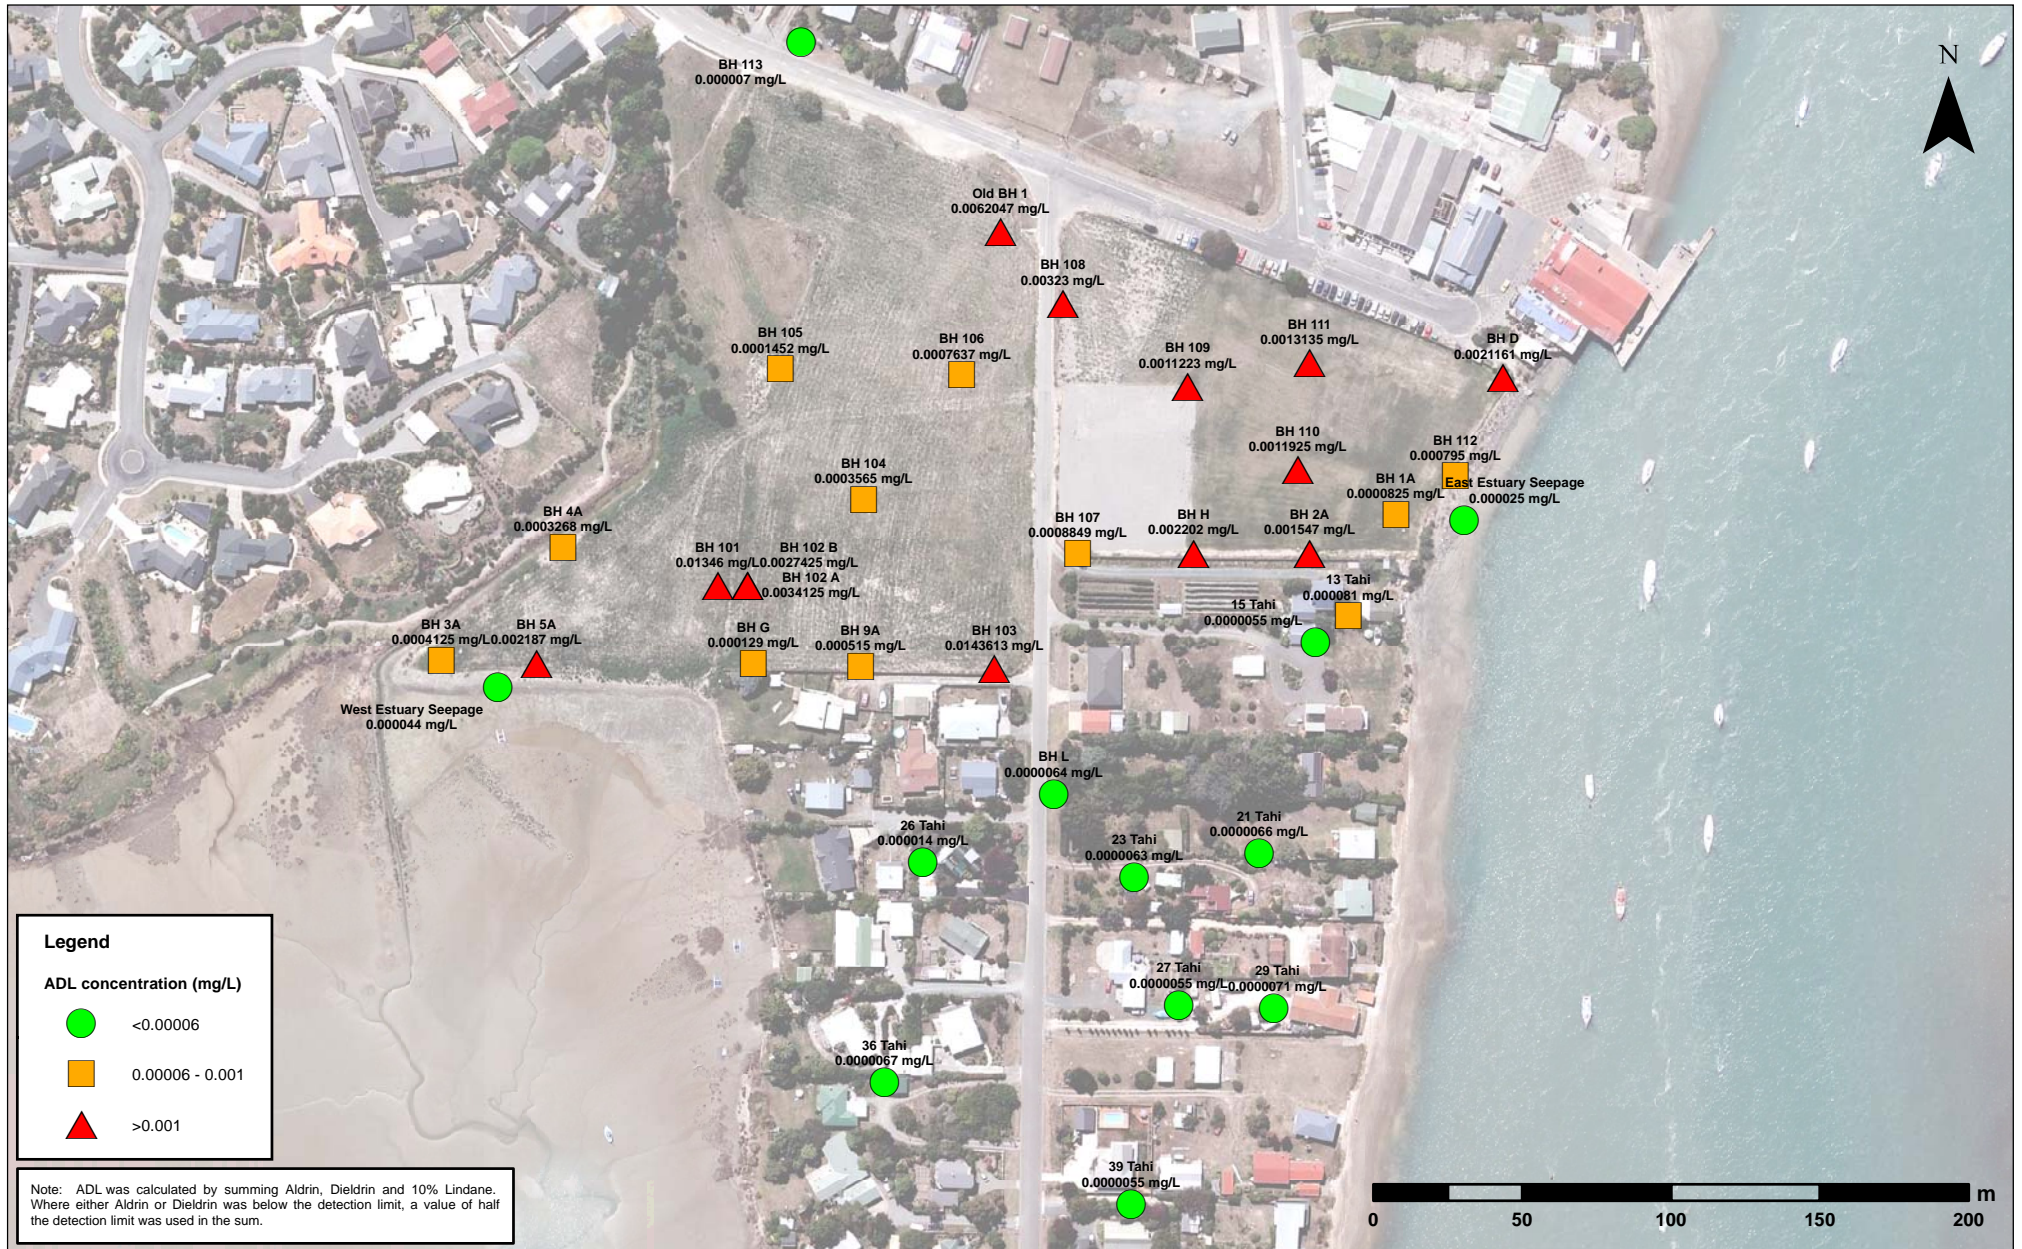
Figure 27 : ADL concentrations in November 2010

Figure 27 shows the ADL concentrations, which have been colour coded as follows:

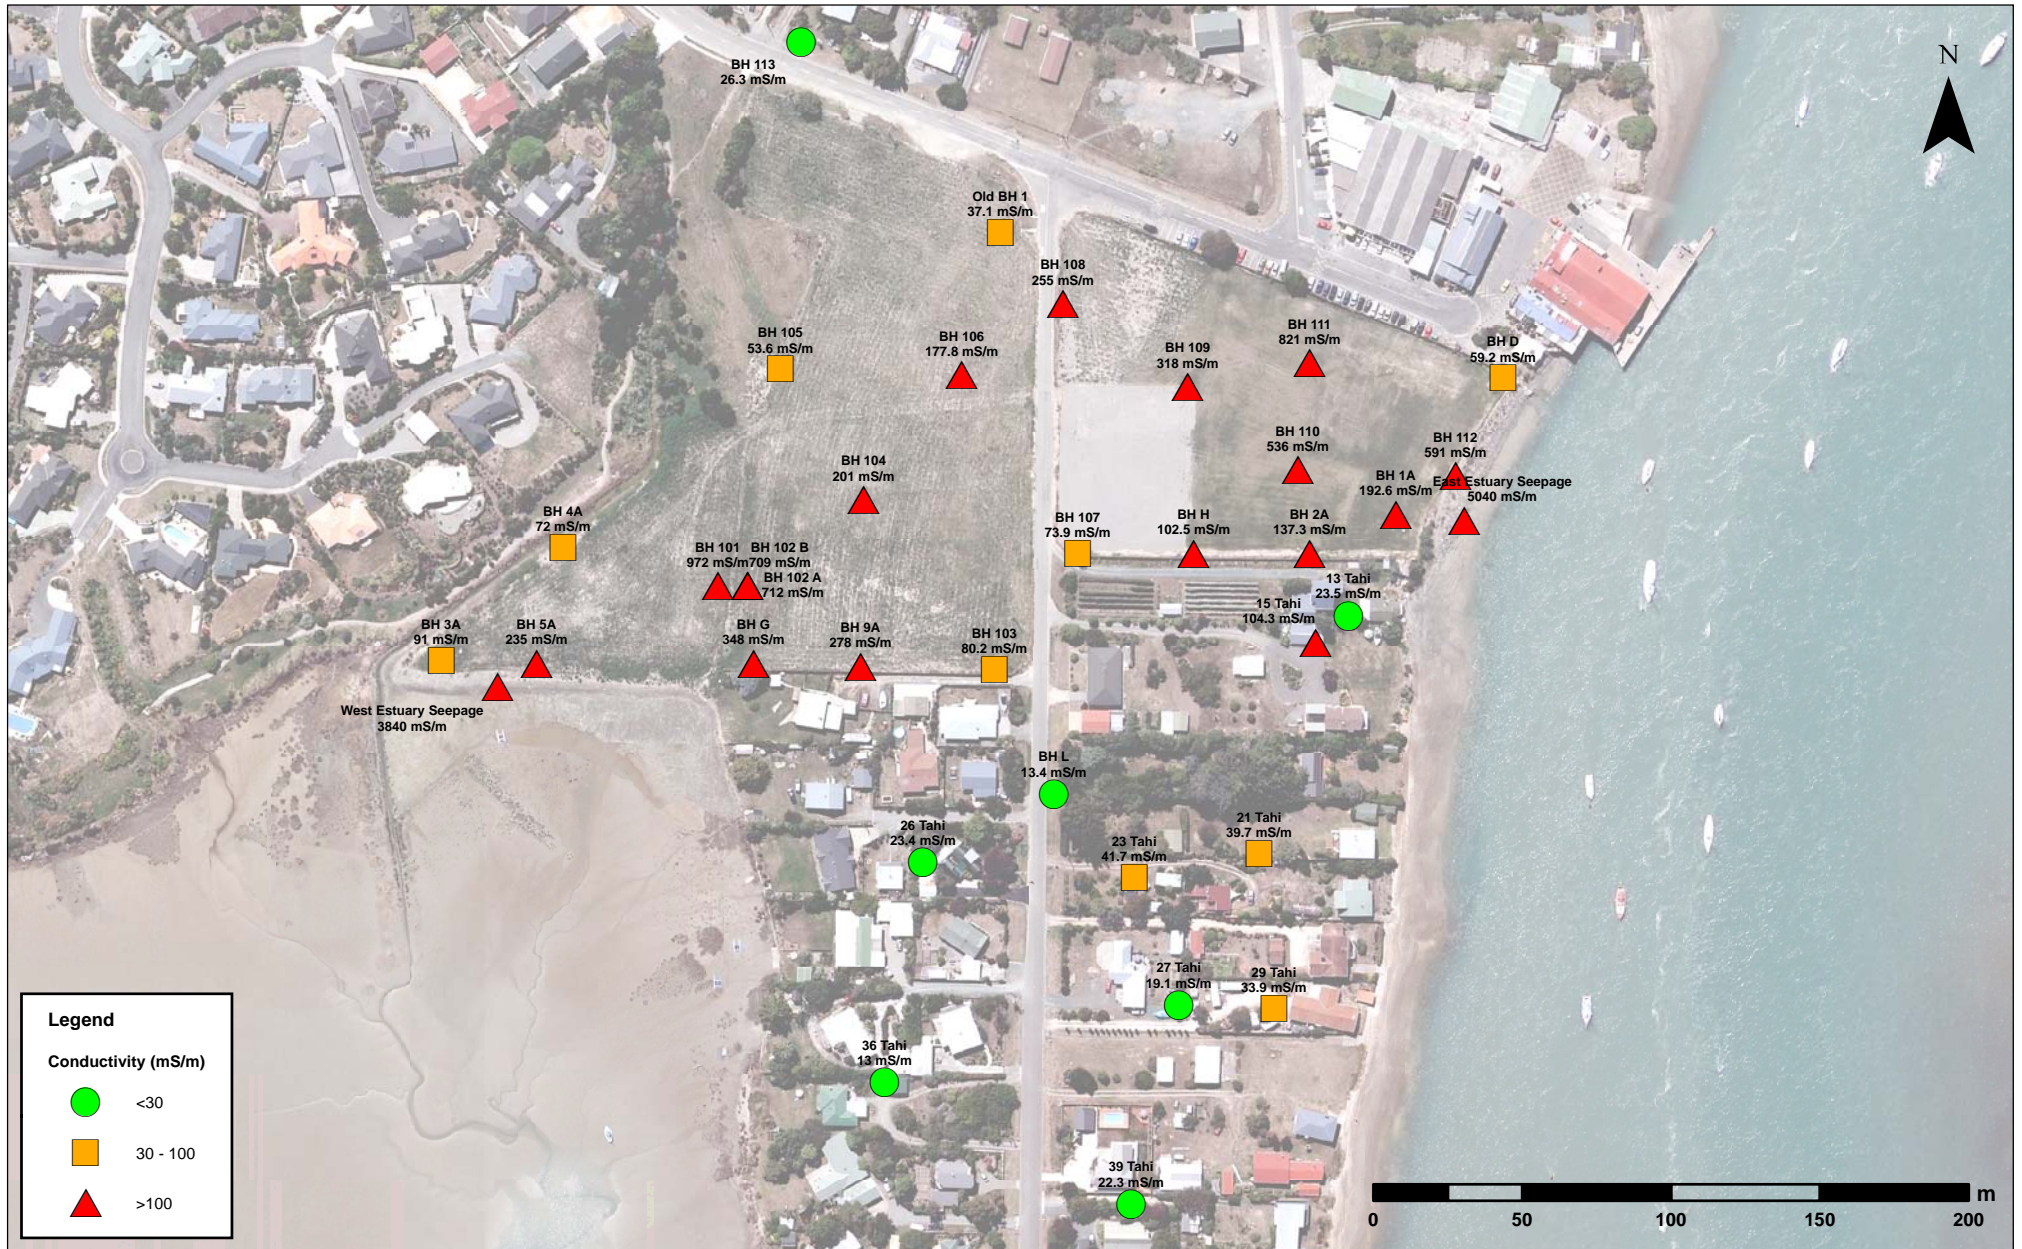
Figure 28 : Conductivity values in November 2010

Figure 28 shows the pattern of electrical conductivity values in the groundwater. This is a general indication of all the chemicals dissolved in the groundwater. The following colour coding has been used:

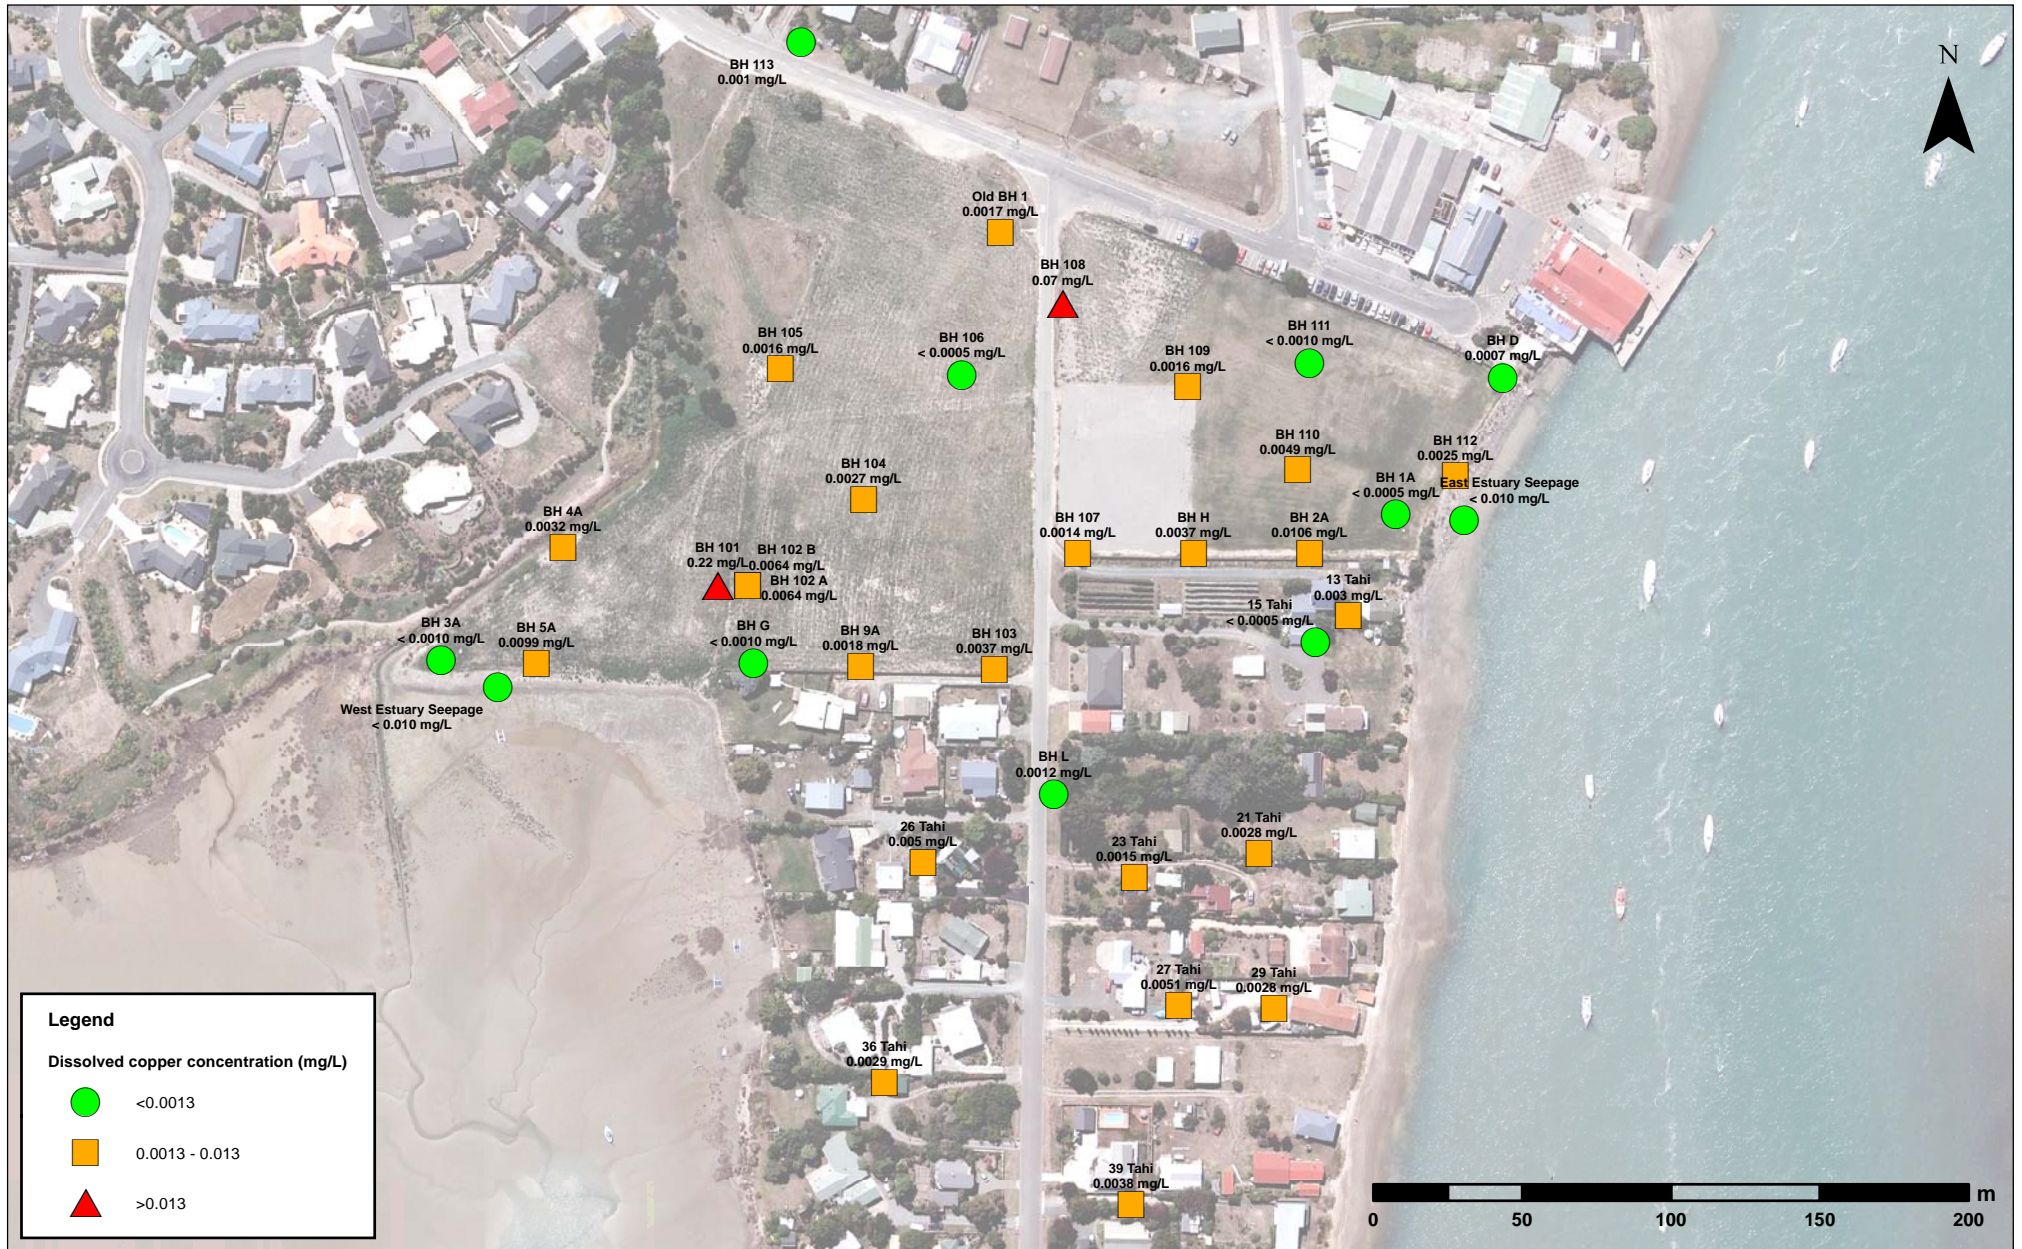
Figure 29 : Dissolved copper concentrations in November 2010

Figure 29 shows the pattern of copper concentrations, which have been colour coded as follows:
