# Moutere Catchment Ecological and Water Quality Survey

Trevor James, 2018

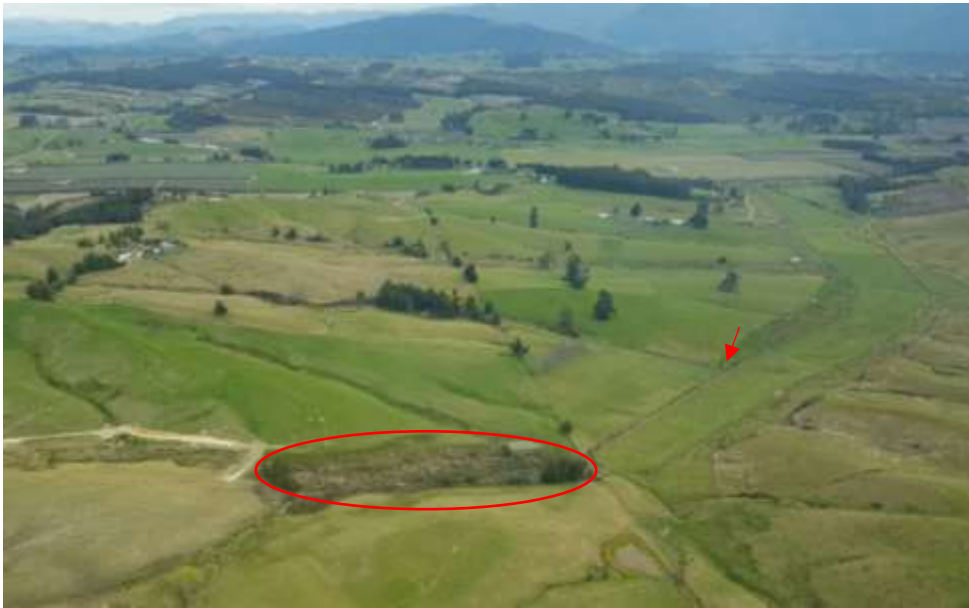
Left: While this creek has been dug straight to drain the original swampland, there is surprisingly good hydraulic and bank shape diversity (see bottom photo). The wetland circled in red the upper part of the catchment provides good stream flow all year round. Reasonable fish diversity where there is tree cover.

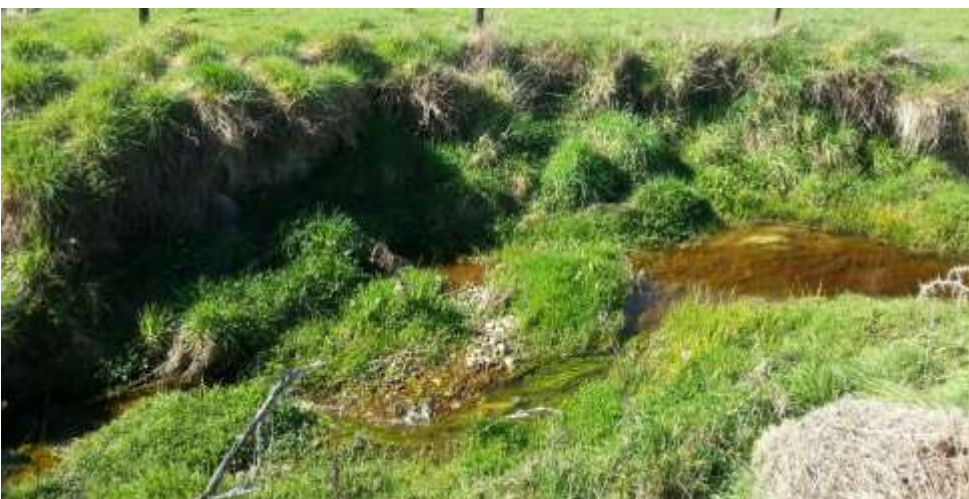
Left: Close-up showing hydraulic diversity (fast and slow flowing zones, backwaters, deep pools and runs).

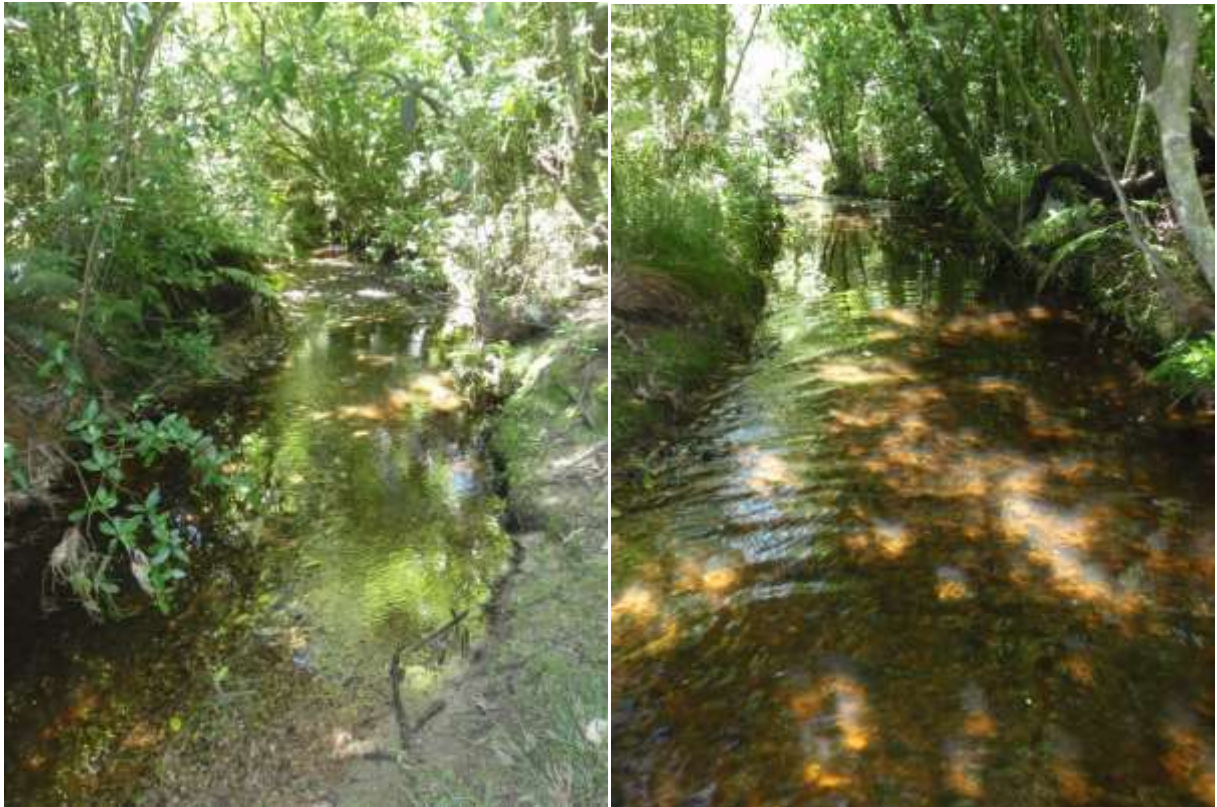
Left and below: **Blue Creek at Fickling Bush**, upstream of Drummond Road. Very good habitat provided in this 170m long remnant of native bush. Inanga, banded kokopu and koura were abundant with longfin eel rare.

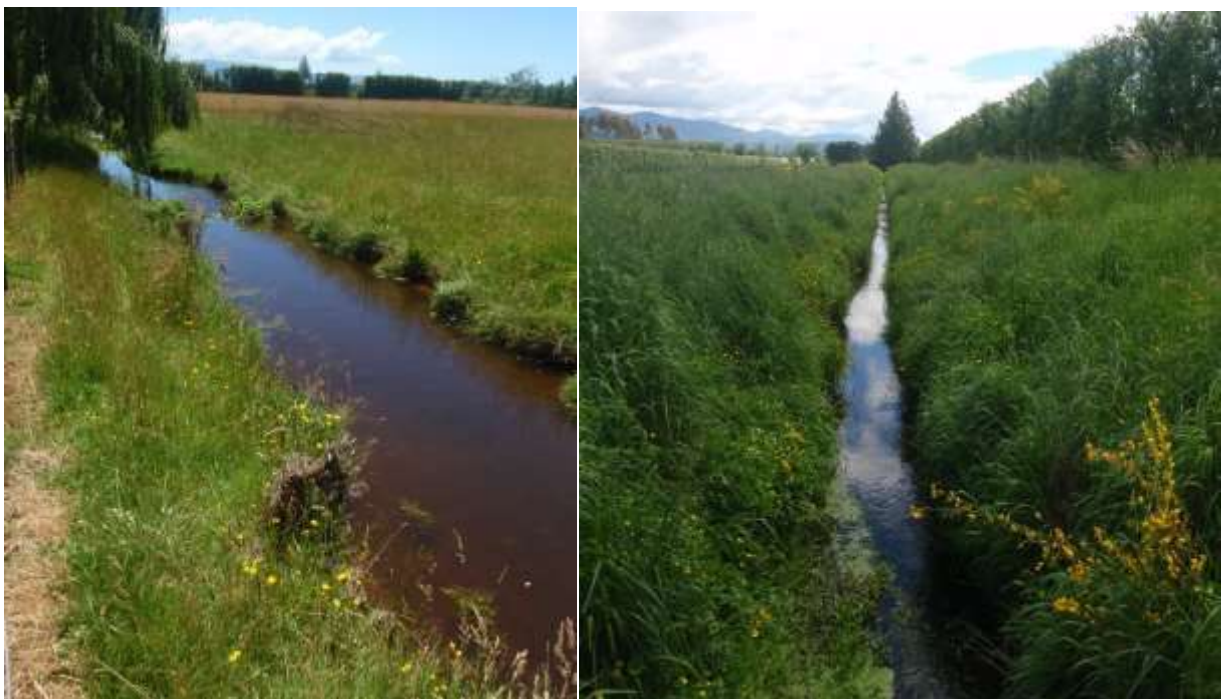
**Below left: Blue Creek upstream of Fickling Bush** (looking downstream). If this riparian zone could be 'connected' with Fickling Bush and the 2km section of Blue Creek between Edwards and Chings Roads, there could be a large improvement to this part of the catchment. **Below right: Blue Creek downstream of Holdaway Road** (looking downstream).

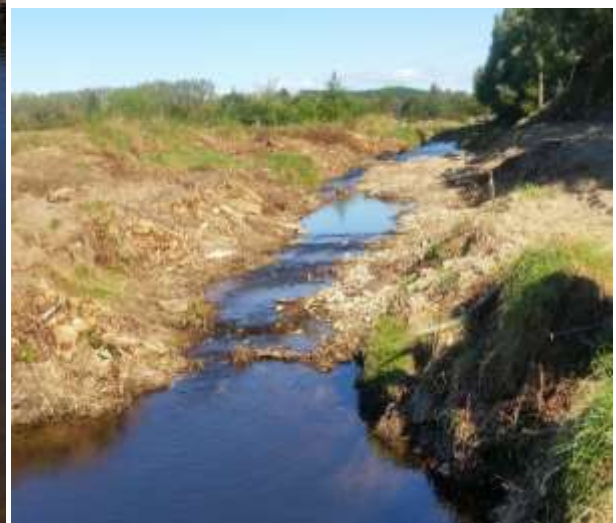
Below: **Company Ditch No1** approximately 300m downstream Wills Road.

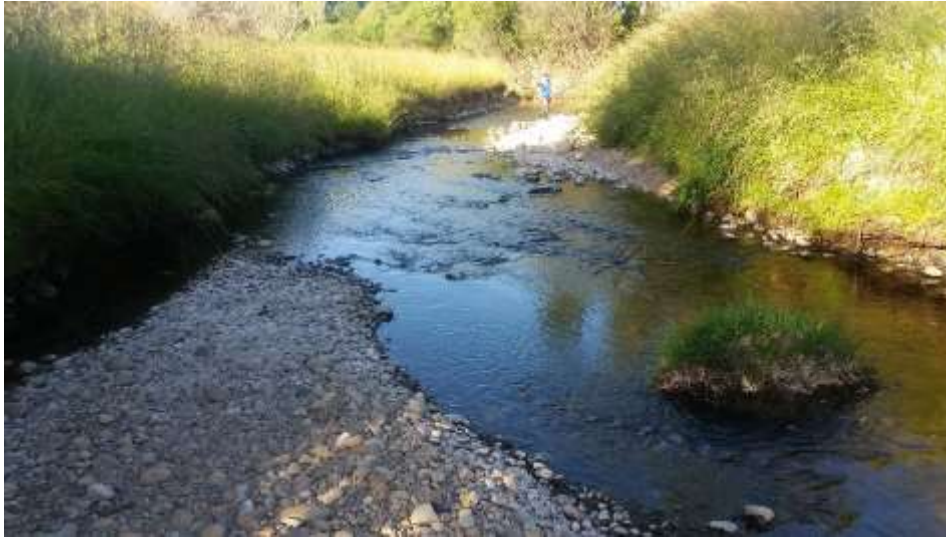
Left: Moutere River 1km downstream Old House Road (E1600176 N5435630). Note the backwater seen to the left of the photo) and the riffle (more turbulent water) in the centre of the photo.

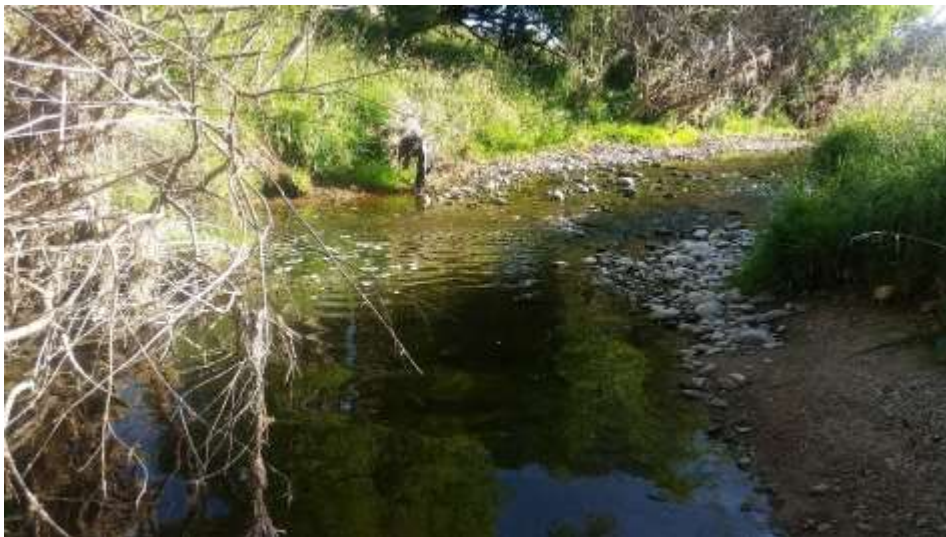
Left: 1.06km downstream Old House Road. This shows a pool about 1m deep adjacent to a shrubby willow.

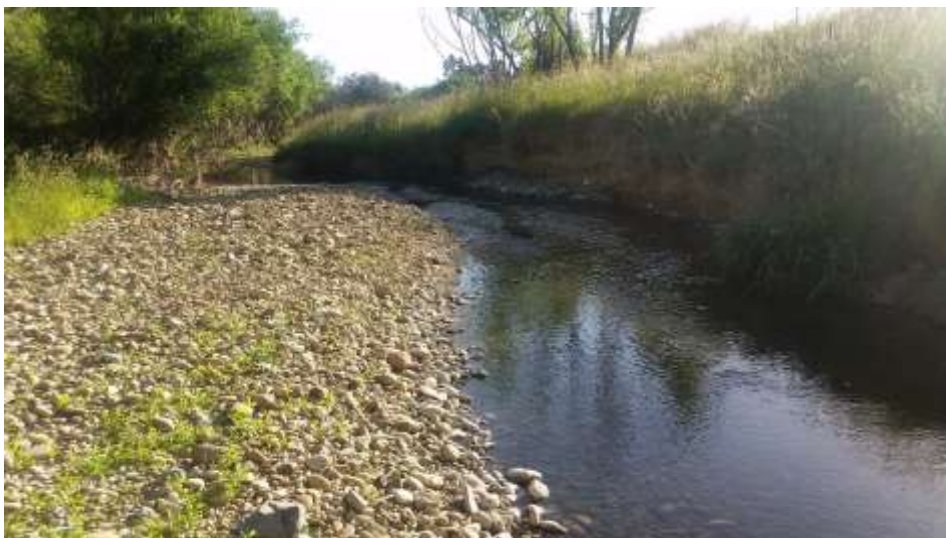
Left: 1.3km downstream Old House Road. Shows good bank shape variety with a steep bank on the outside of the bend and a beach on the inside of the bend.

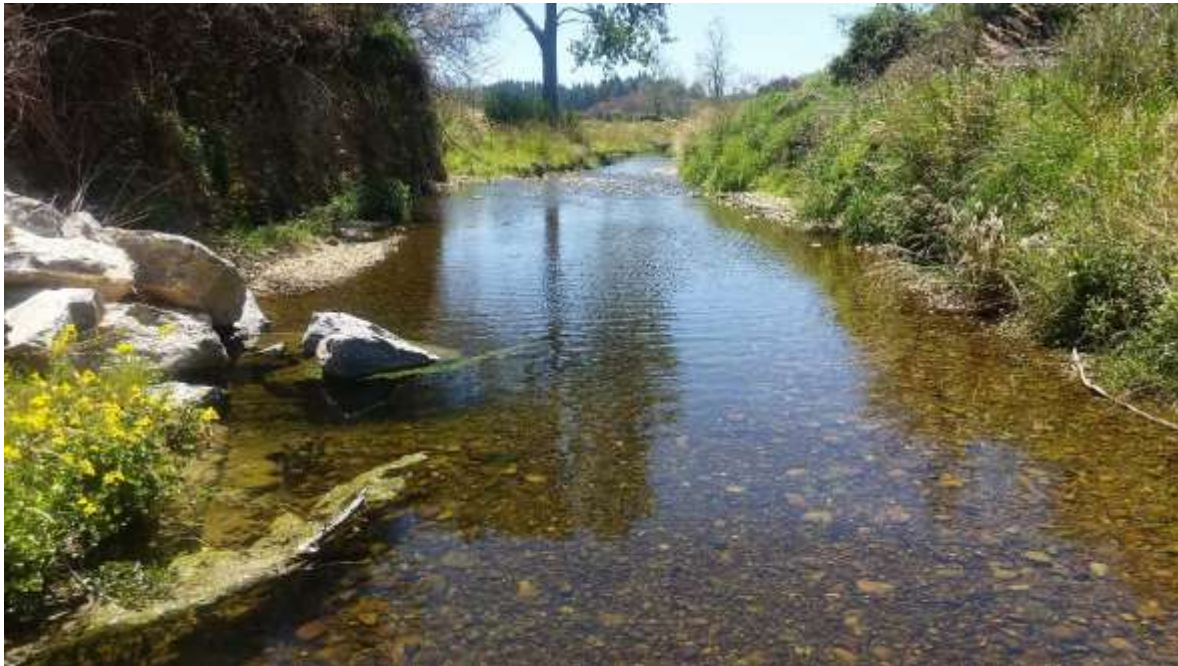
Photo below: Small rock groynes like this create good variety of water depth. **Moutere River 250m downstream Kelling Road**. Note the almost vertical bank of original Moutere glacial outwash gravel/clay that is relatively common in this section of the waterway.

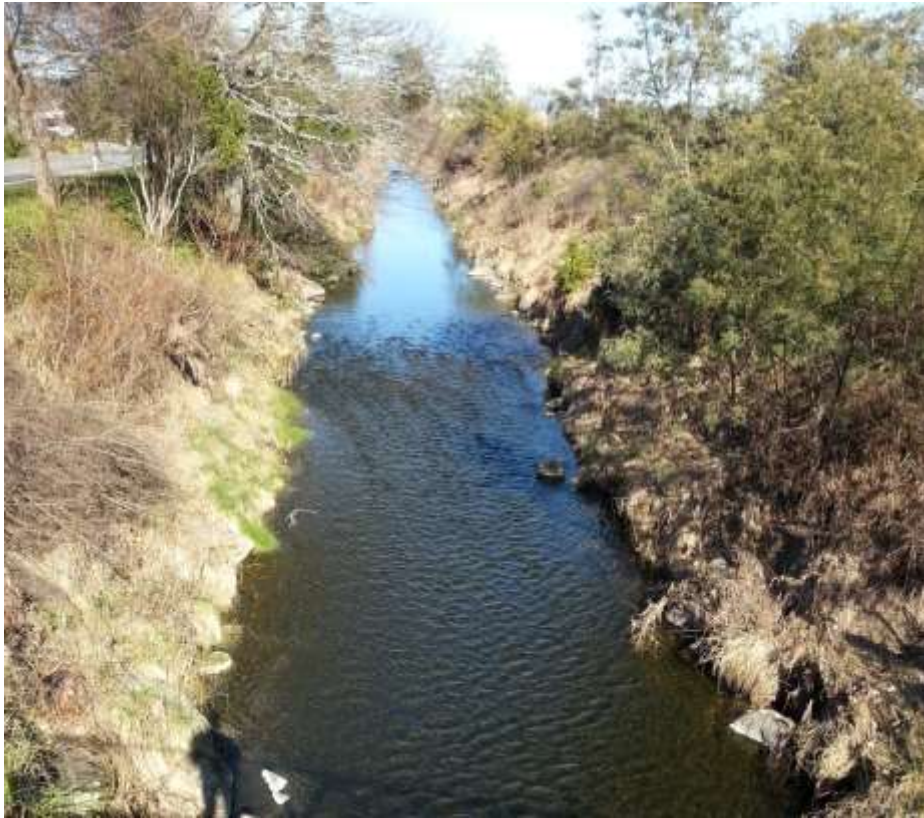
Left: **Moutere River at Chings Road**, view upstream. Reasonable shading is provided in this section.

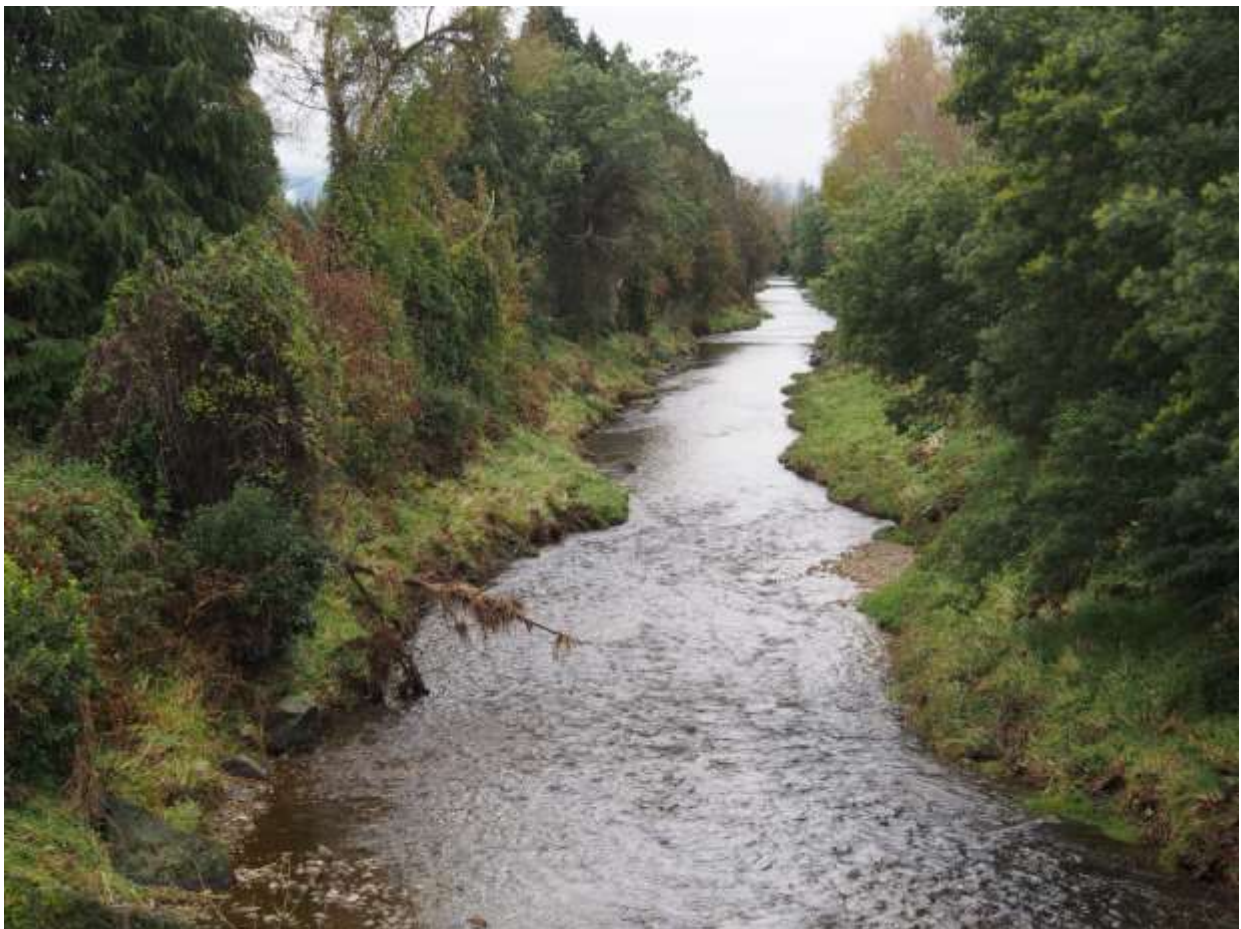
Below: **Moutere River at Edwards Road**, view downstream. Reasonable shading is provided in this section.
