Tipple Residence, Kaiteriteri

Geotechnical and Structural Deck Commentary

Brief: 38 Kaiteriteri Sandy Bay Road, Kaiteriteri – New Deck Commentary

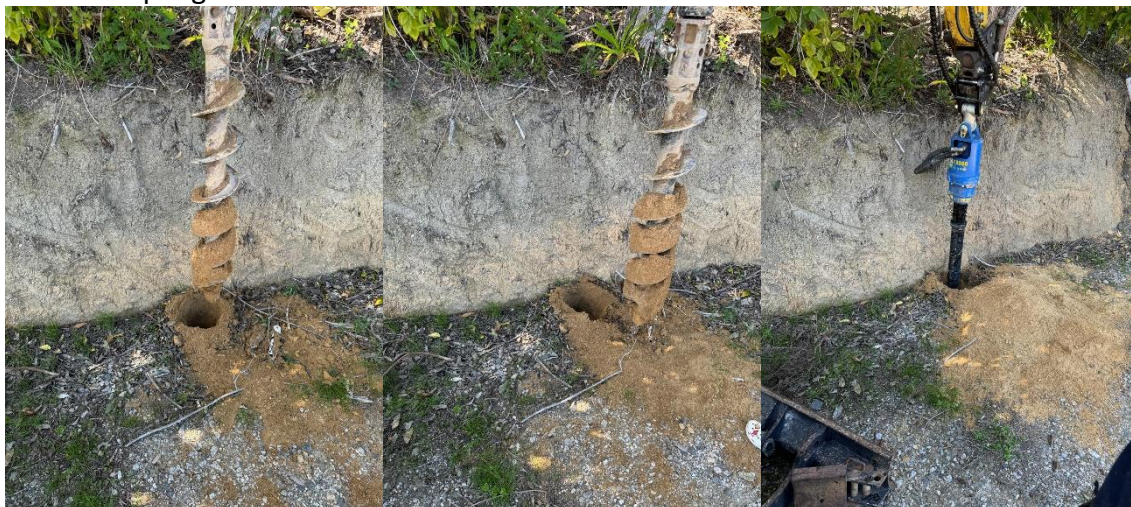
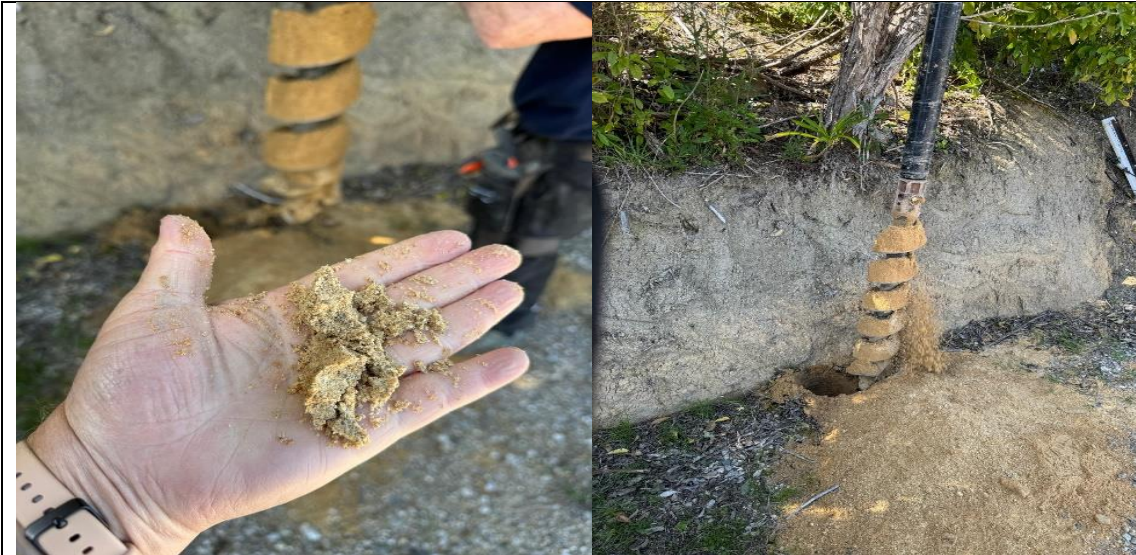
SH1 – Sampling Hole 1

Site Terrain Images: SH1 (GDM) /HA1 above the Bank firming up Geoconsult's report.
