## Memo

## Re: Navigation Safety Report for Proposed Boat Ramp at Māpua

This memo evaluates the navigation safety implications of the proposed boat ramp proposed by RM230253 at Māpua, providing recommendations for mitigating potential risks.

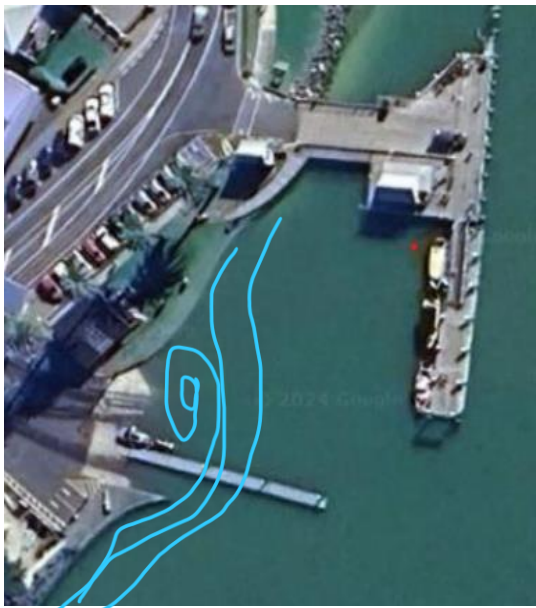
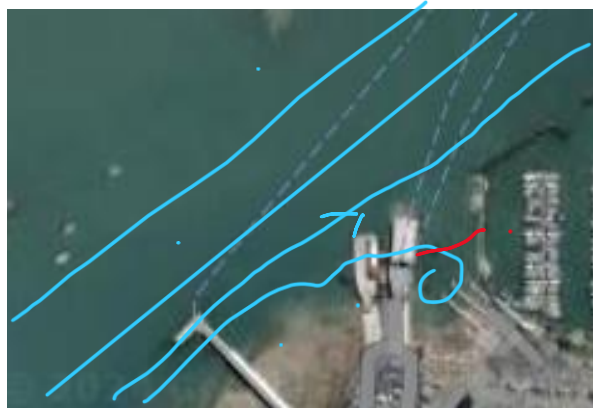
Left: Whitianga ramp not one I have personally visited but is well know for having current I would consider it close to the current found at Grossi point.

Right: Half moon bay, I have used several times, and it has no current worth considering in the basin close the ramp the current kicks in around the red line.

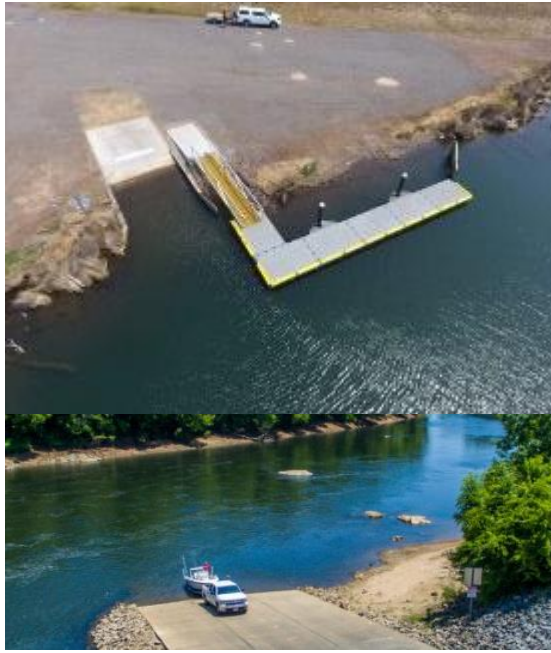
- This image is a small single lane ramp in Tasmania swan river note the dug-out ramp set back and the floating dock running parallel not perpendicular to the current. There is also a debris deflector at either side not easily visible in the image

- This ramp is on a 35-degree angle to the flow allowing for an easier approach to the trailer. I do not know the location but there is a sandy beach just down stream for

vessel to land on to sort out the trailer and await their turn.

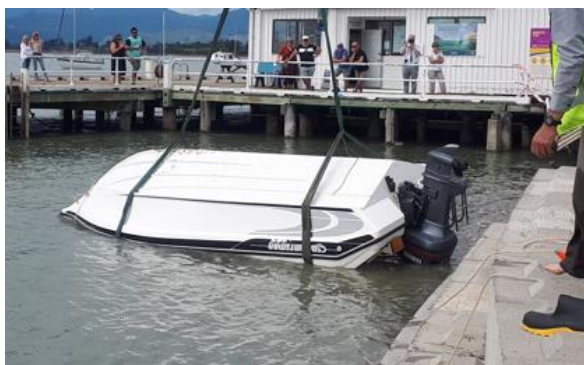
This vessel got swamped when the tide changed from bow on to stern too whilst unattended. Sinking the vessel and rotating her upside down under the floating dock at Mapua.

- The applicant proposes moving a couple of moorings to allow more space to maneuver, using a floating barriers.
- I strongly recommend the inclusion of a small floating dock running parallel to the current, close to shore, as an essential safety measure. However, vessels should not be left unattended on this dock. Historically, the current has caused multiple vessels to sink when moored alongside the existing floating dock and main wharf. This highlights the critical need for careful management and additional safety features to prevent similar incidents.

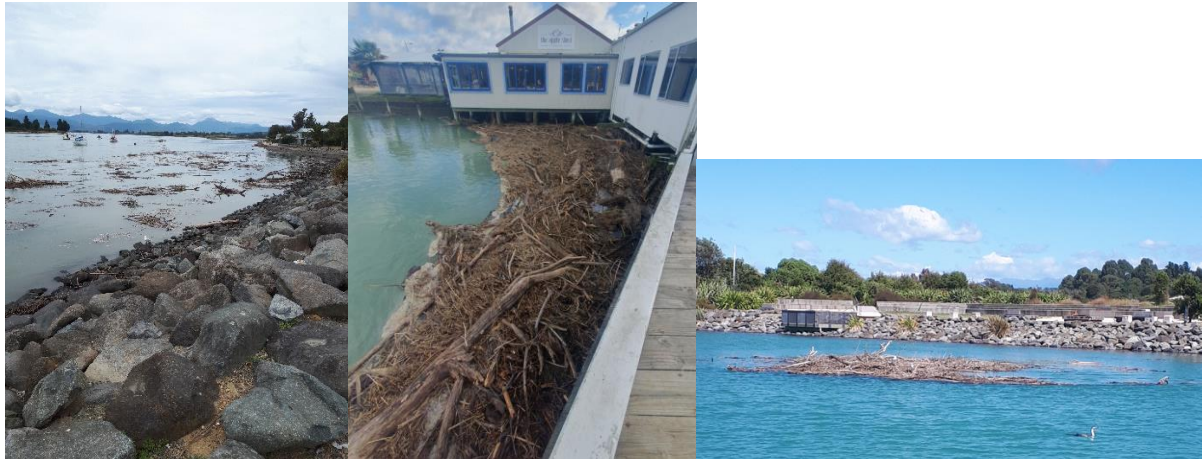
Left: debris the proposed ramp site

Middle: Mapua debris wharf

Right: debris raft at Mapua

- Site is know to have significant debris (see OCEL report)
- Regular checks and maintenance by the Māpua Boat Club could ensure debris does not obstruct the ramp.
