Review of TDC Slope Instability Risk Areas

Richmond Foothills, Collingwood, Clifton/ Pohara/ Ligar Bay

Prepared for Tasman District Council
Prepared by Beca Limited

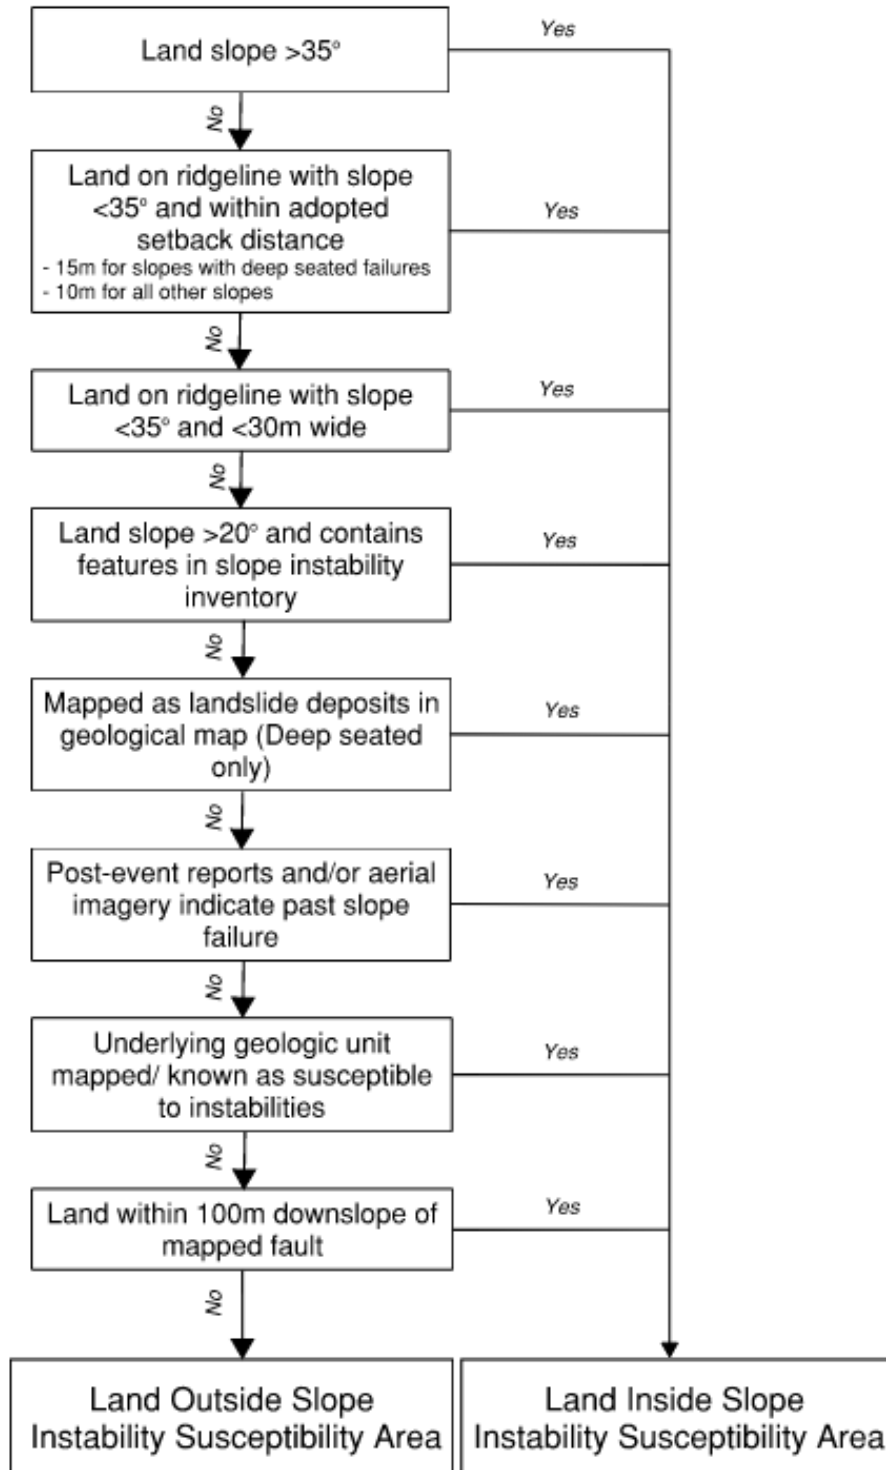
Figure 1: Methodology tree outlining steps taken in assessment of slope instability susceptibility.

A methodology tree outlining the steps taken in our assessment is presented in Figure 1 and is described in detail in Appendix B. Land meeting the prescribed criteria is considered potentially susceptible to slope instability and is included within the identified area.

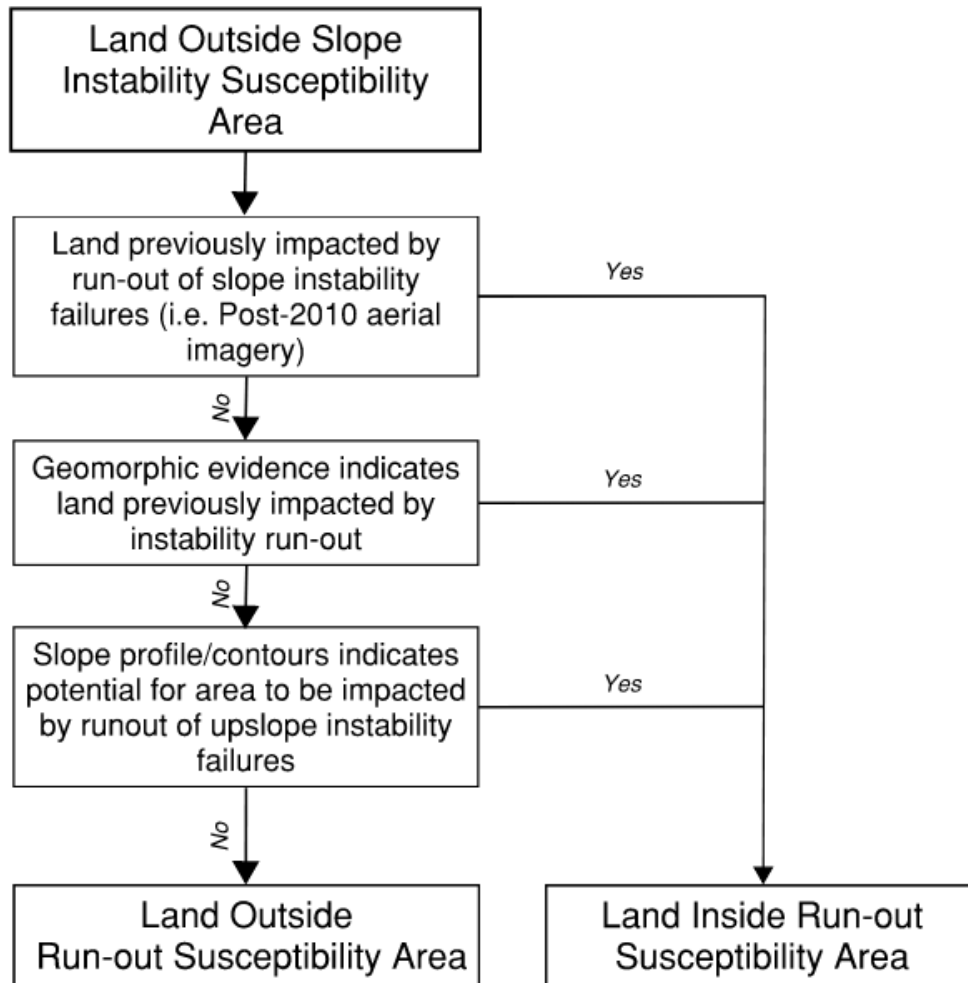
Figure 2: Methodology tree outlining steps taken in assessment of run-out susceptibility.

A methodology tree outlining the steps taken to identify land within the area potentially susceptible to debris run-out is presented in Figure 2 and summarised in Appendix B. The assessment identified land outside the instability susceptibility area that may be impacted from soil and rock debris from upslope failures with potential to cause land damage. The area is not intended to represent the maximum extent of debris nor muddy water from debris flows. Land with no instability features mapped or identified upslope of the site has been excluded from the run-out assessment.
