**WAIMEA WATER AUGMENTATION
COMMITTEE/TASMAN DISTRICT
COUNCIL**

**Waimea Water Augmentation
Component 2 - Storages
Assessment**

TONKIN & TAYLOR LTD

May 2007

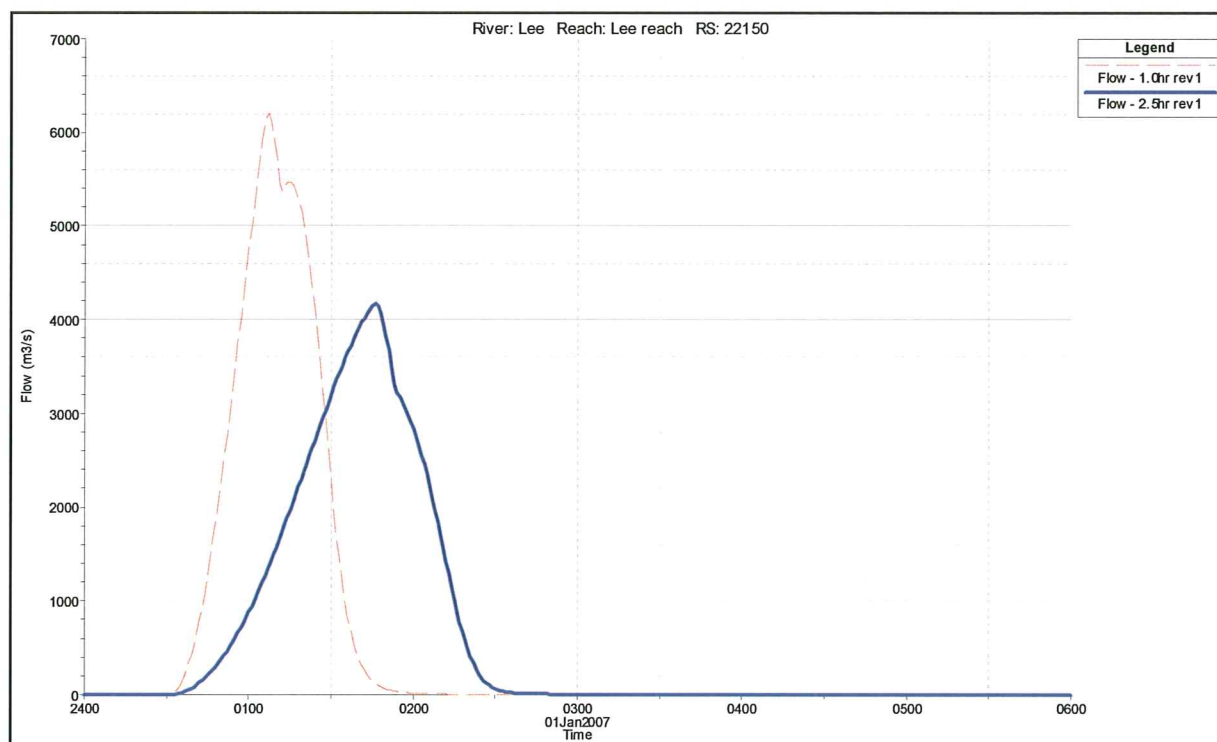
Figure 4.2 Lee River Storage Dam – dam breach outflow hydrographs
(dashed red line – 1 hour failure, bold blue line – 2.5 hour failure)

Figure 4.2 shows the outflow hydrograph from the dam for the two modelled scenarios.

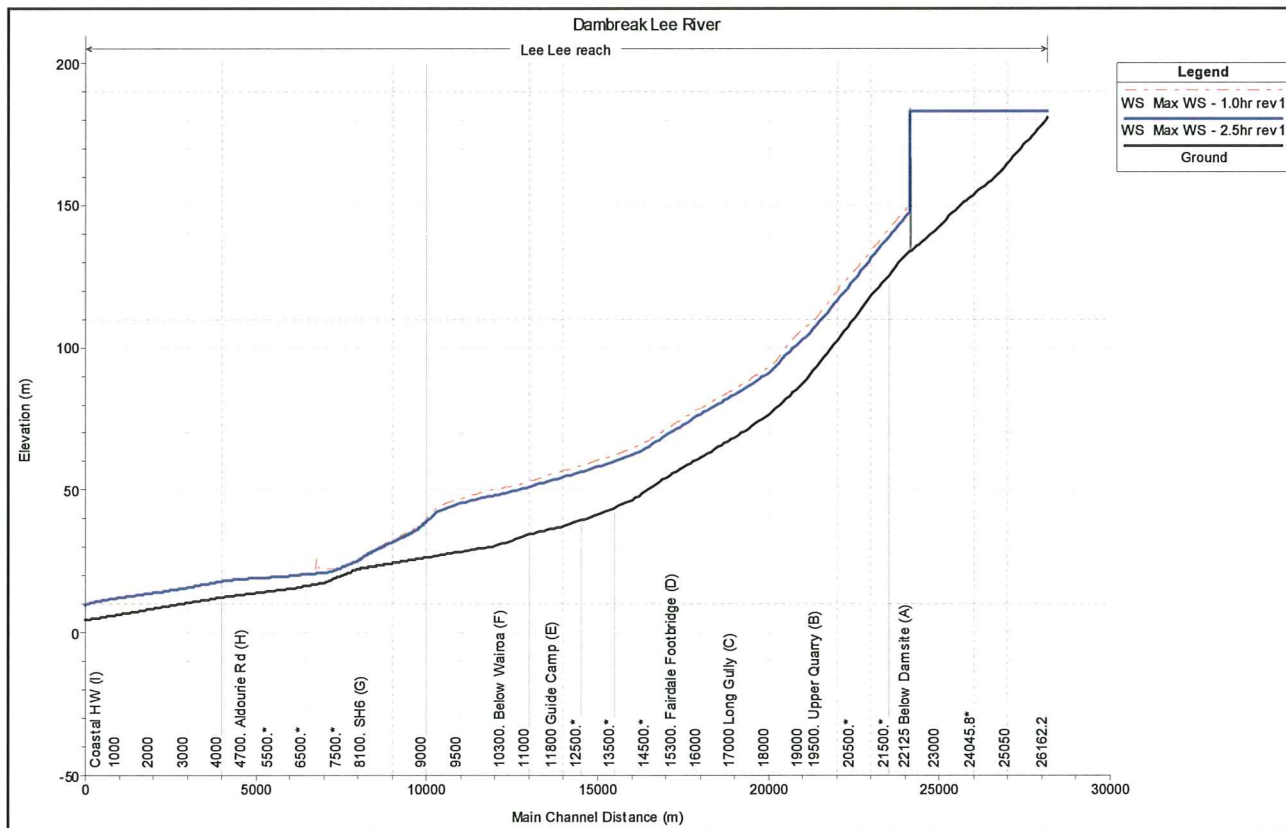
Figure 4.5 Lee – Wairoa River Profile and Maximum Water Levels

(red line – 1 hour failure case, blue line – 2.5 hour failure case)

Figure 4.5 plots the riverbed profile (longitudinal section) and the maximum water levels from a dam breach along the modelled reach for both the 1 hour and 2.5 hour failure cases.

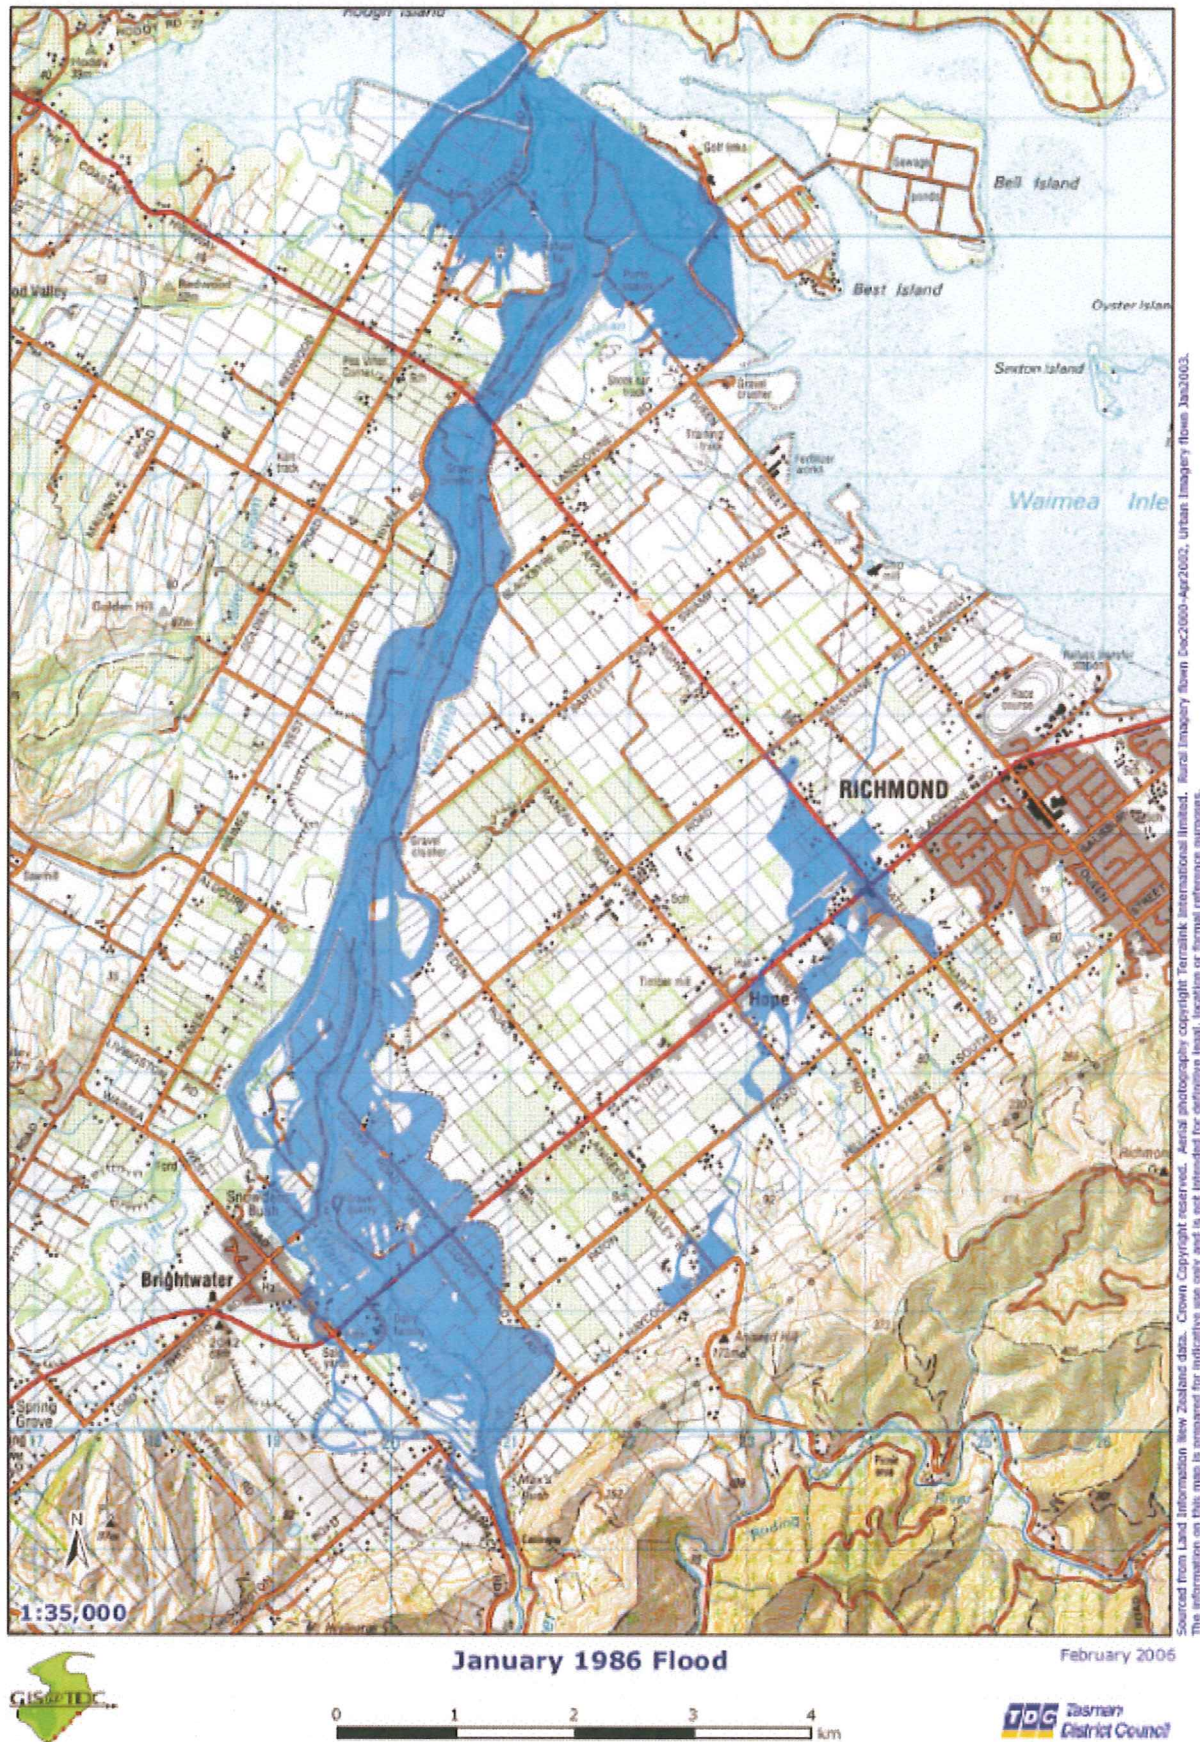
Figure 4.6 Extent of Inundation in the January 1986 Flood (Estimated by TDC)

Figure 4.6 supplied by Tasman District Council maps the approximate extent of inundation below the Wairoa Gorge to the coast from the 1986 flood event. Floodplain flows (out-of-bank flows) were estimated to have commenced at about 900 m³/s to 1000 m³/s and eventually spread out to inundate the area shown (pers. comm. Verstappen)
