STAFF REPORT

SUBJECT: **WATER QUALITY SURVEY OF FARM STREAMS IN NW GOLDEN BAY – EP05/11/08** – Report prepared for the meeting of 16 November 2005

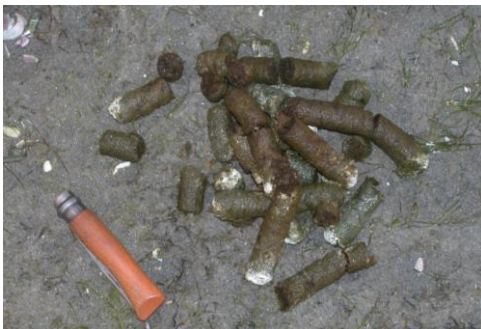
Black Swan Faecal Pellets

The *E. coli* concentration in the five samples of Swan faeces taken as part of this study was highly variable and ranged from <2000 to 20,000,000 cfu/100g (wet weight).

From limited observations made during this study, it appears that swan faeces dissolve completely in seawater during one tide cycle. No faecal pellets remain intact once the tide has been over them. In clear, saline water, coliform die-off is two-three orders of magnitude per day. Dilution is expected to be significant. It is not known how such attenuation and dispersion compares to that from dairy farm sources.
