## STAFF REPORT

**SUBJECT:** **SPEED LIMIT REVIEWS:**

- Lord Rutherford Road South
- Higgins Road
- Bird Road

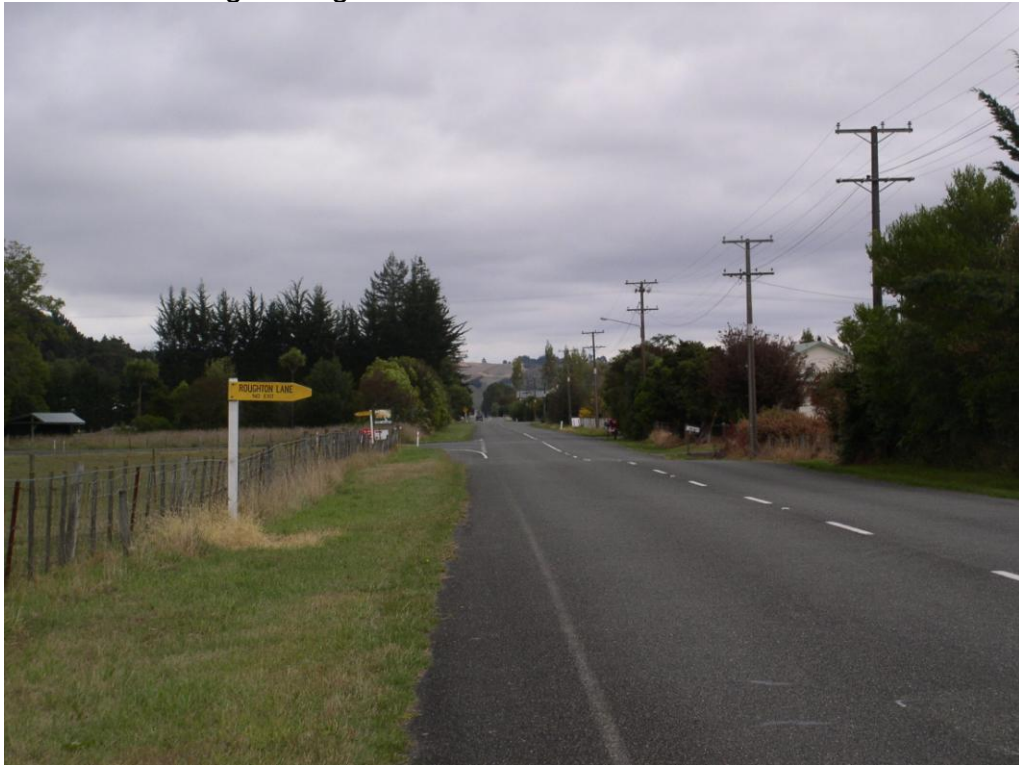
**3.1 Lord Rutherford Road South (Between existing 50/100kph speed limit and Telenius Road)**

Average rating for this road section is **2.6**

**Lord Rutherford Rd South – Opposite Barton Lane looking South**

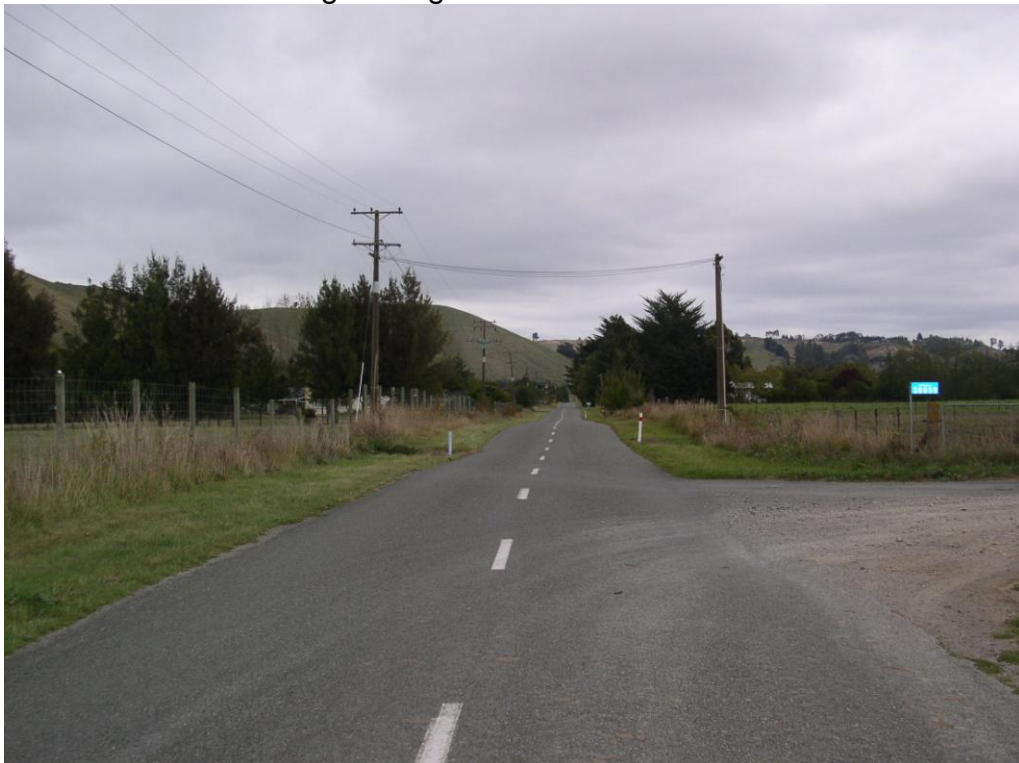
**3.2 Higgins Road (Between Telenius Road and Bird Road)**

Average rating for this road is **2.0**

**Higgins Road - looking South**

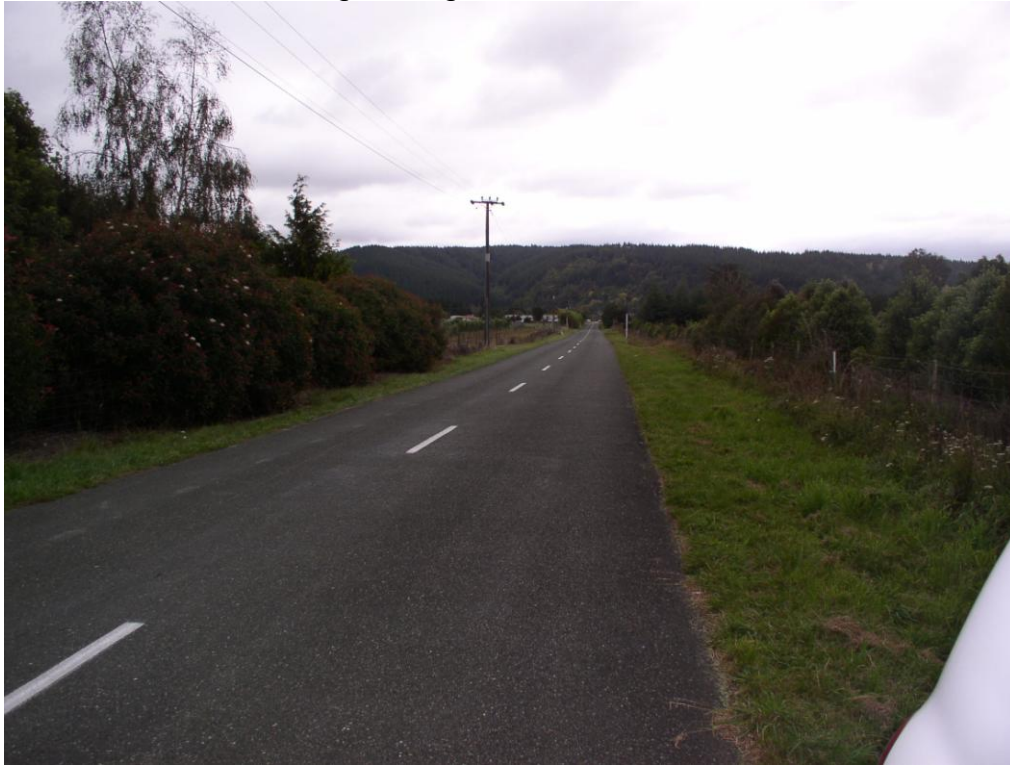
### 3.3 Bird Road (Between SH6 and Higgins Road)

Average rating for this road is **0.8**

**Bird Road – Looking towards Higgins Rd**

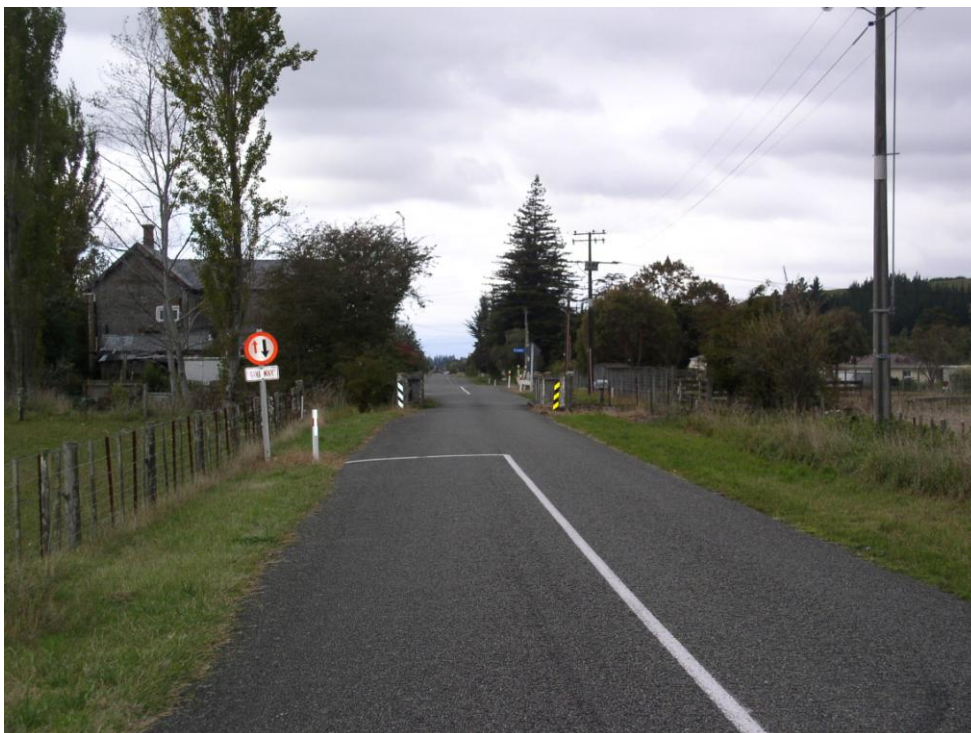
**Telenius Bridge on Higgins Road** – The single lane bridge close to Telenius Road makes for an awful layout however, based on LTNZ Crash Analysis Database there fortunately has only been two minor injury crashes in the last 10years involving the bridge. In the most recent crash in 2003, alcohol was the main factor where as in a previous crash of 1996, the vehicle involved was travelling north bound and it would appear the driver was dazzled by the sun and misjudged the bridge. Since this first reported crash in 1996, signage improvements have been undertaken and the priority changed.

**Telenius Bridge on Higgins Road – Looking North**

Ideally investigation needs to be undertaken into either widening the bridge or replacing the structure. As a minimum option, the side walls require replacing with Guard Railing however this cost needs to be considered against widening or replacing the structure.
